Leak Report

9 Catherine Street McCrae Victoria 3938 Australia

Service Stream

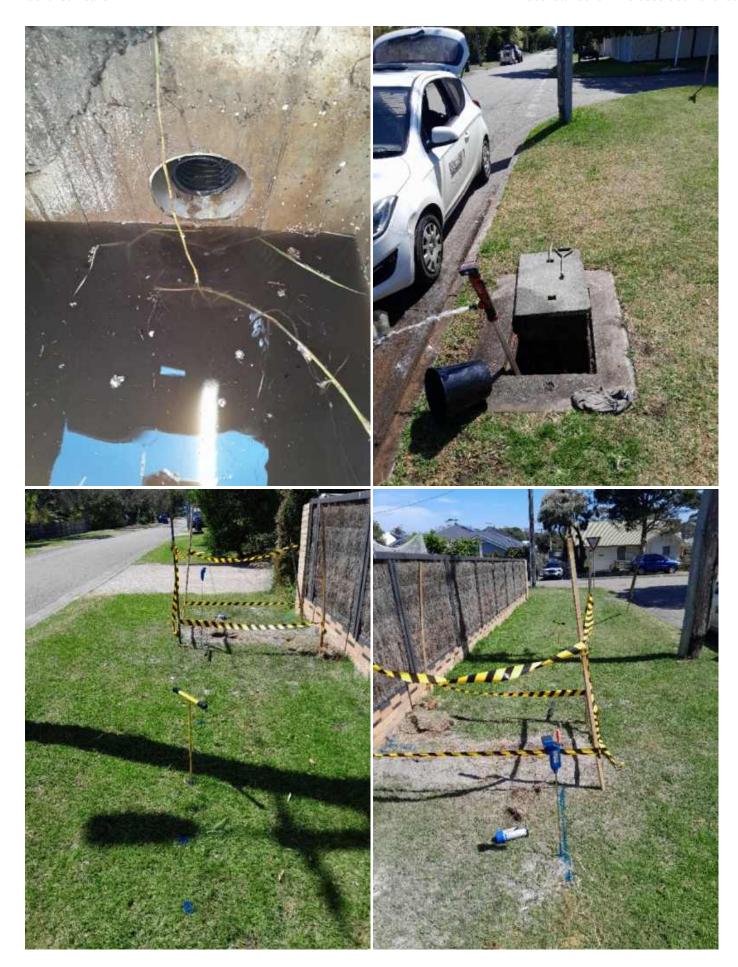
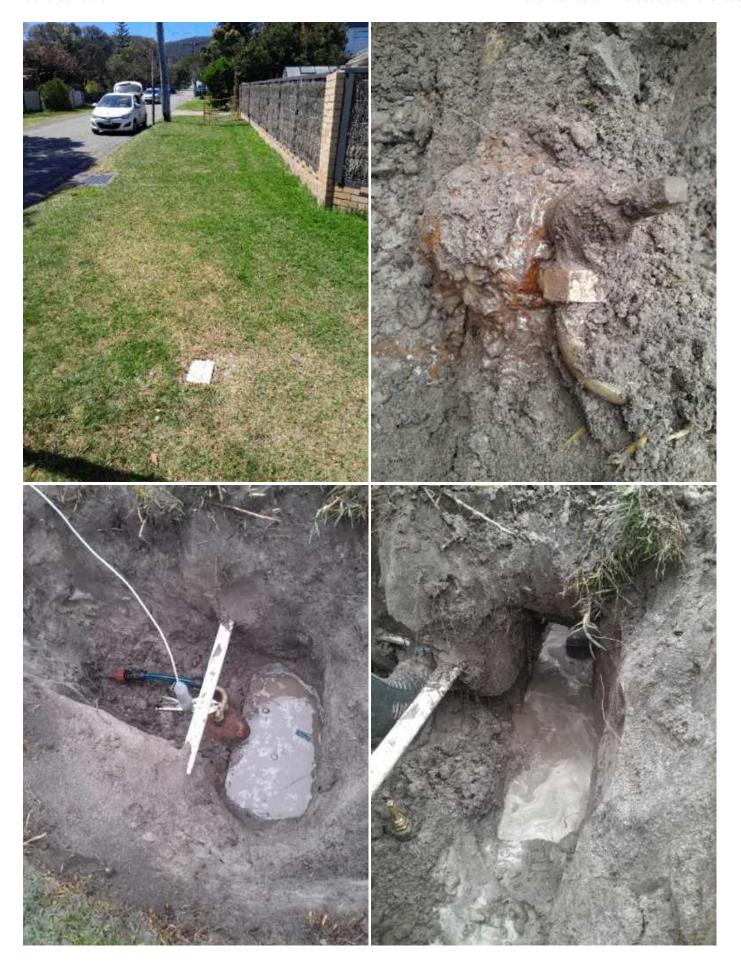
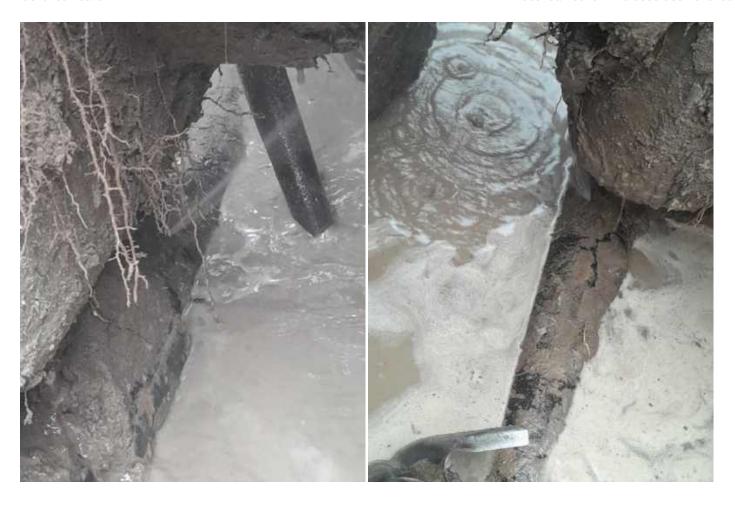
Photo

Exposed ferrule, Correlation peaked on ferrule, tiny leak on tapping connection....may have been knocked whilst excavating,

Replaced tapping, still leaking, found tiny leak on ferrule, replaced ferrule

Recharged main, still leak noise present . Ran another correlation, still peaking on ferrule.

Probed a few more holes, loudest hole approximately 1m away from ferrule

Dug down, discovered buried telstra pit & found leak directly below telstra pit, pinhole leak on 80ac main
