Leak Report

Bayview Rd McCrae VIC 3938 AU

LOCATION-38.348946, 144.939569**PROJECT**Service Stream

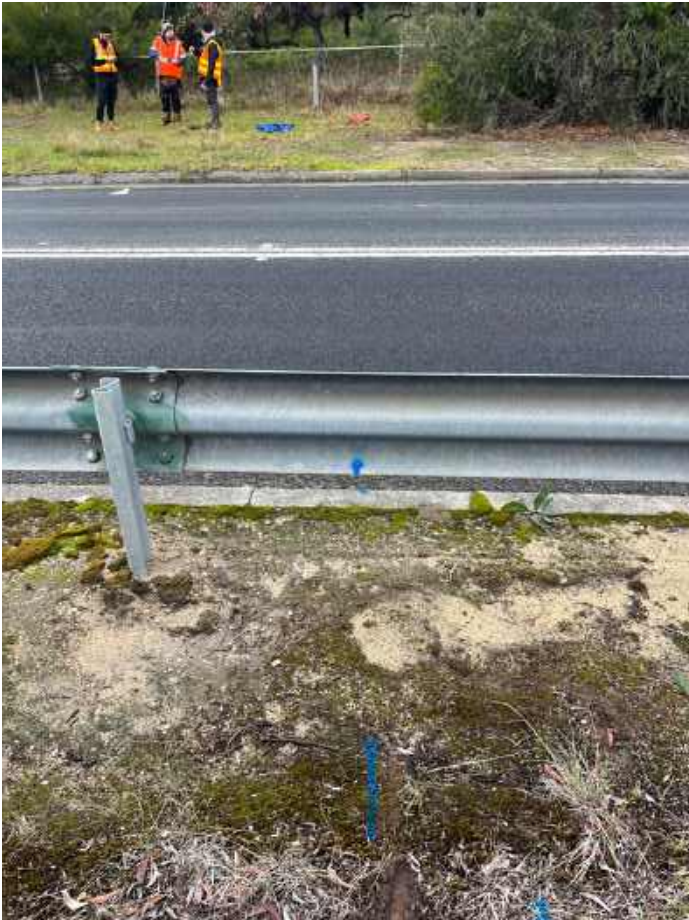
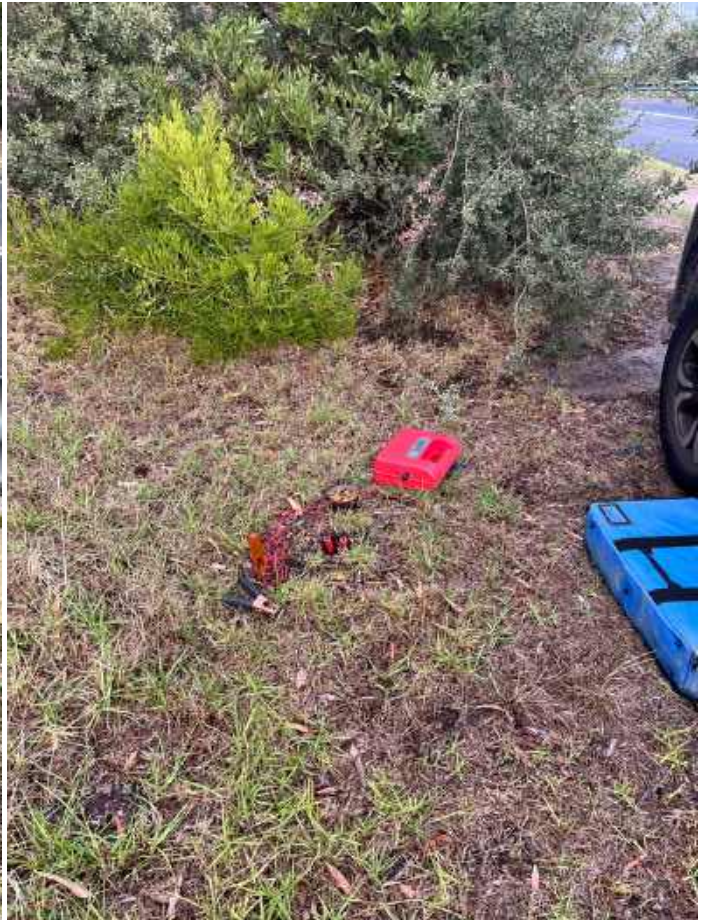
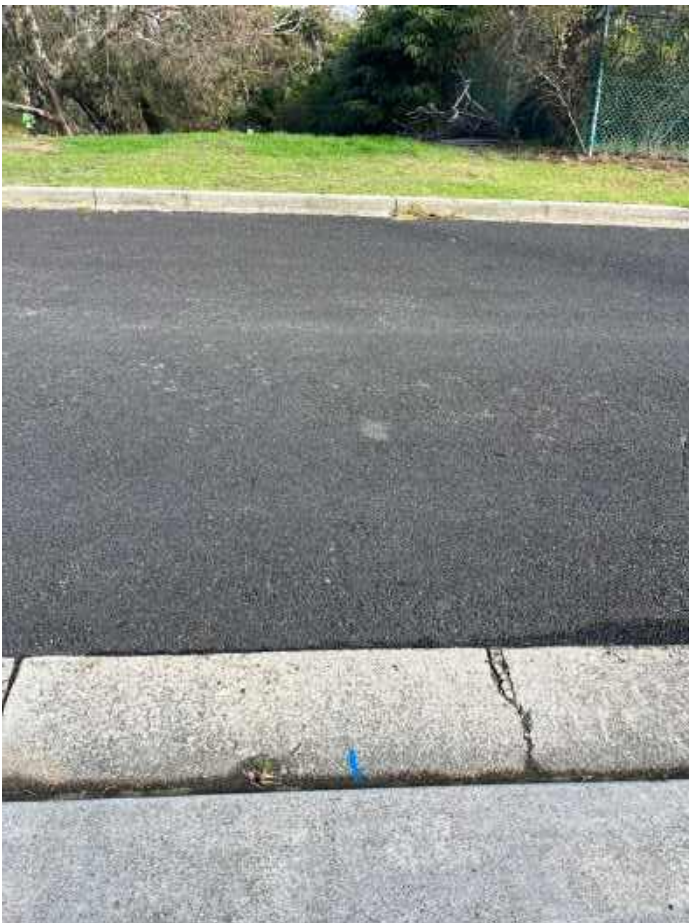
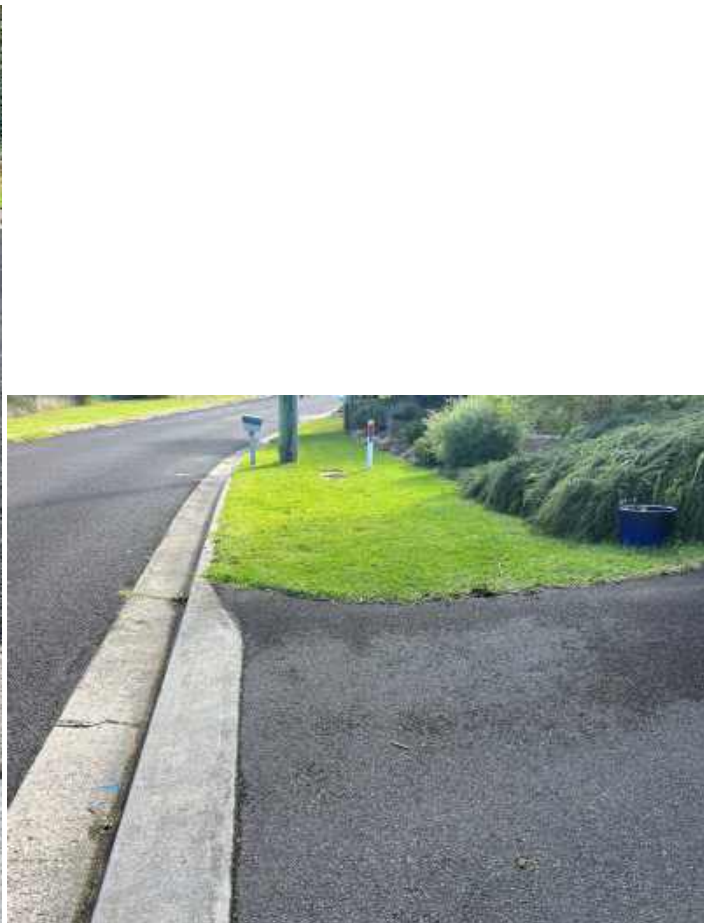
Photo

Met surveyor/SEW on-site to attempt to trace metallic and PVC pipelines.

Successfully traced metallic pipeline which crossed Bayview Road and run down near the Fence-line to valves/hydrants.

Struggled to pick up the PVC pipeline using the AML tool. Would require Vac truck to prove what was being picked up with the AML tool.

Another option to trace the PV pipeline would be to use GPR, dependent on soil type, depth of main etc.
