# TECHNICAL MEMORANDUM

| <b>Project</b> | Penny Lane, McCrae | <b>Date</b> | 7/12/2022 |
| <b>Subject</b> | Geotechnical Assessment | <b>Ref No.</b> | V220600Report01.1 |

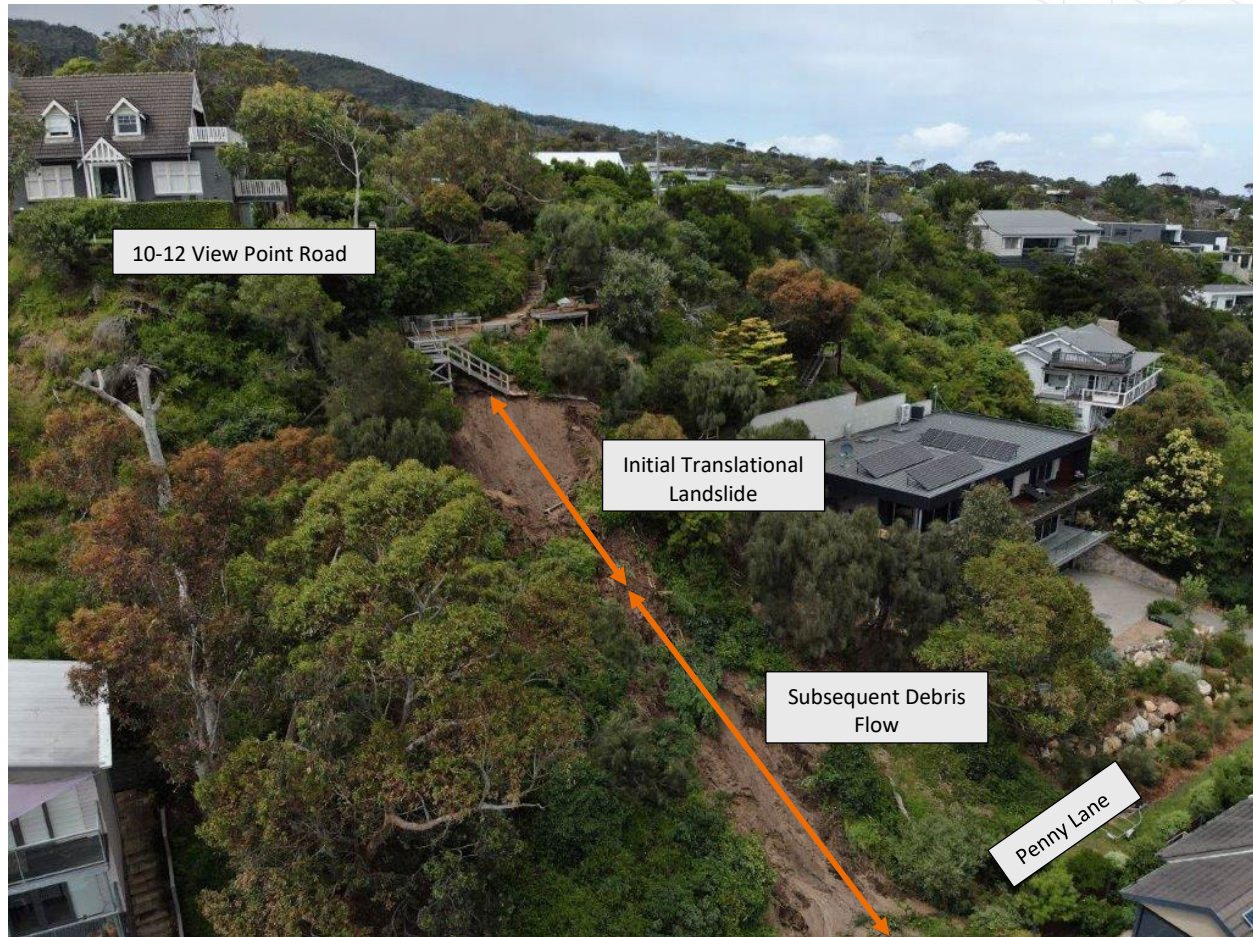
Figure 3-1: Oblique view of landslides

From the anecdotal discussions it is understood that an initial landslide is likely to have occurred in the late afternoon on Monday 14 November 2022. This day was a day of very heavy rain with approximately 80mm of rain recorded at the Bureau of Meteorology rain gauge located at Rosebud Country Club approximately 3-4km away. According to the data this was the highest single day of rainfall at that rain gauge since February 2005. This was coupled on top of what had already been a wet year. This landslide appears to have occurred as a translational landslide of the upper slope to the rear (north) of the house at 10-12 View Point Road.

Subsequently in the early morning of Tuesday 15 November 2022 a second landslide occurred. This landslide appears to have occurred as a debris flow from the middle part of the slope down to the toe resulting in impact on the dwelling at 3 Penny Lane as well as debris flowing into the yard of 3/613 Pt Nepean Road. From evidence on site, it appears that the debris flow may have been triggered by an irrigation pipe that could have been ruptured by the initial landslide.

While the initial landslide may have been relatively moderate to rapid in nature (i.e. in the order of metres per hour to metres per minute), it is likely that the subsequent debris flow would have been very rapid to extremely rapid (i.e. in the order of metres per second).

An oblique view of the site showing the locations of the two parts of the landslide is shown in Figure 3-1.

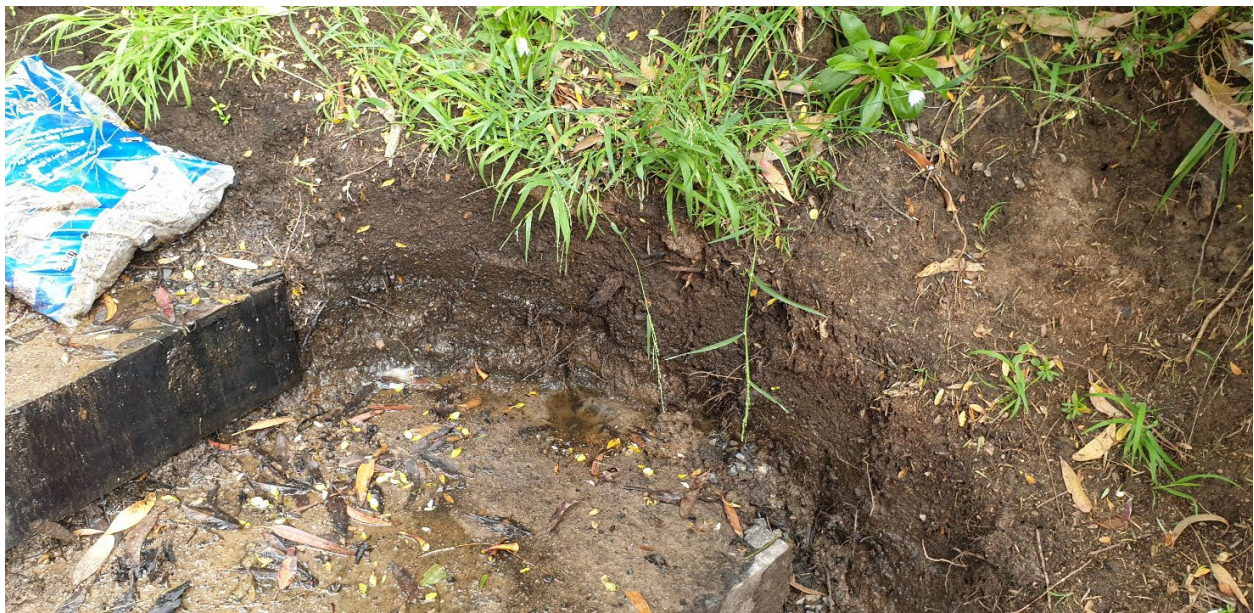
Figure 4-9: Water seepage on left side of site

The conditions on either side of where the debris flow occurred were observed to be significantly different. On the right (western) side the conditions were quite dry and there was no evidence of water seepage. However, on the left (eastern) side there were a number of water seeps observed. These water seeps were observed to be flowing freely more than 24 hours after the heavy rainfall event.

Based on the evidence of tension cracks up slope of this eastern area and that there are significant springs in the area, it is considered that there is potential for a landslide or debris flow to develop within the eastern area especially if there is another heavy rainfall event. However, such a landslide would be unlikely to extend as far east as the property at 2 Penny Lane.

An example of one of the water seeps is shown in Figure 4-8.

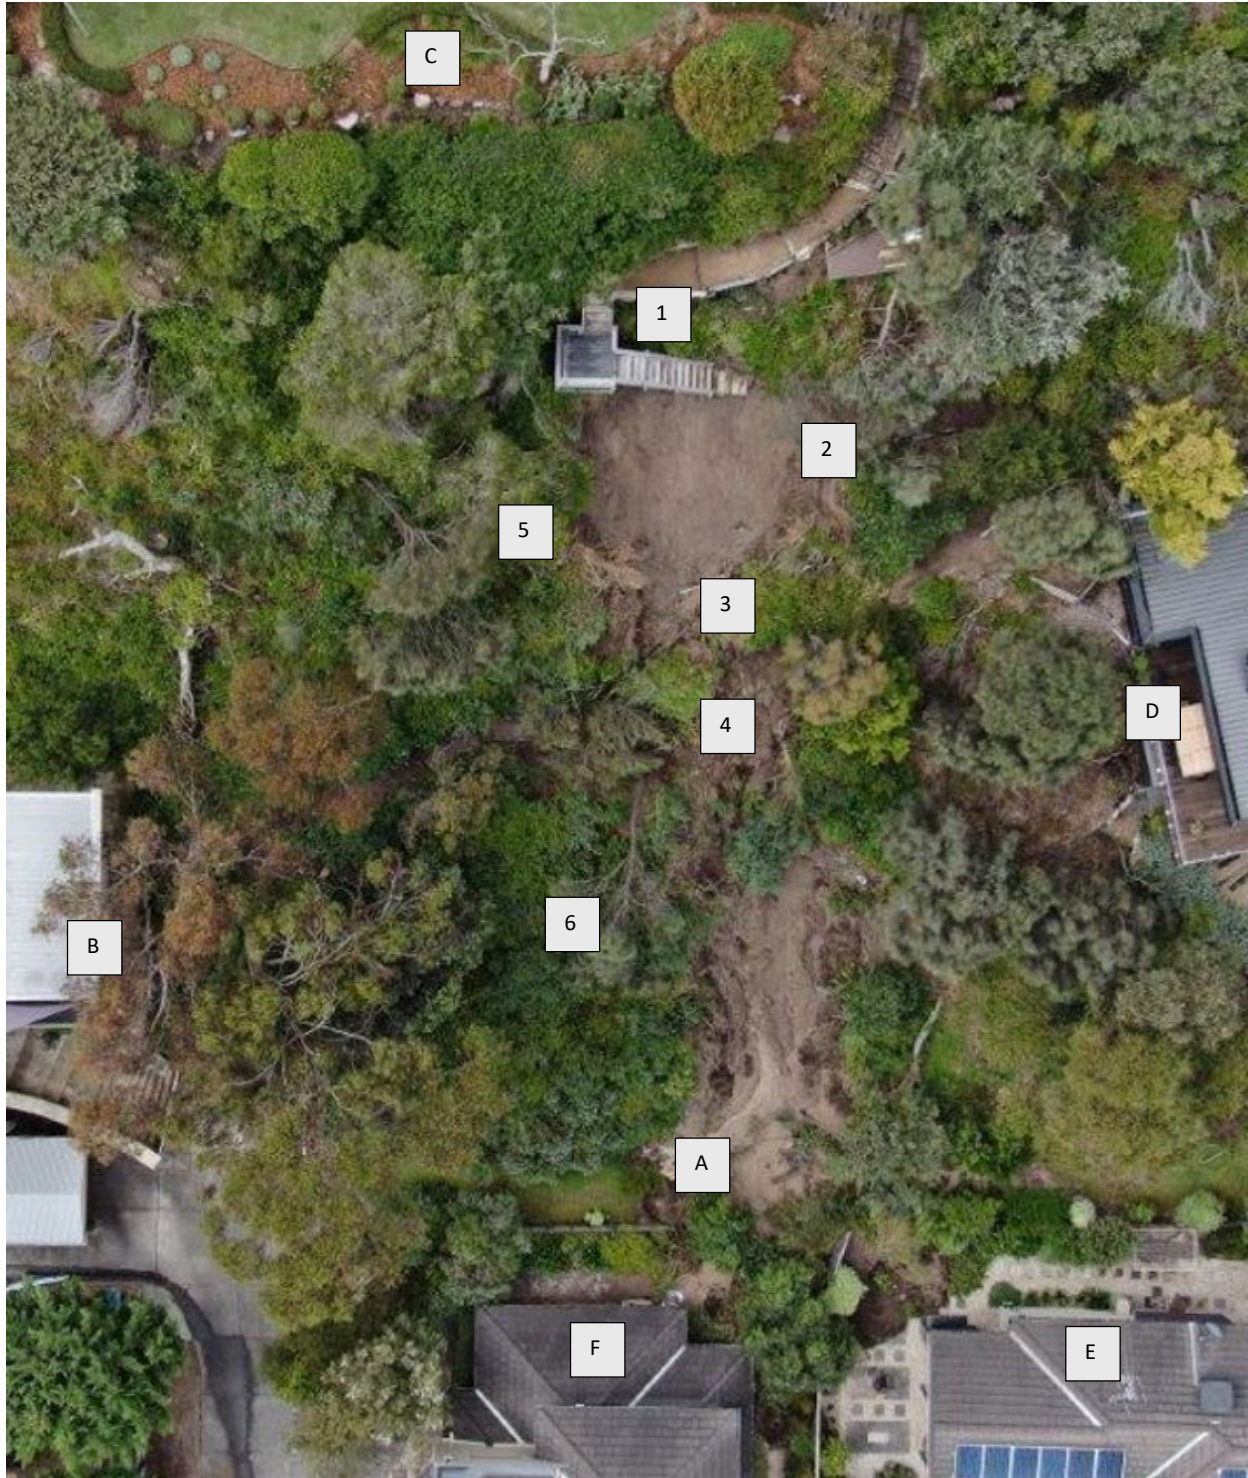
Figure 5-1: Potential Landslide Hazards and Properties at Risk

A number of different potential landslide hazards have been identified for the site. These are identified on Figure 5-1 as numbers 1 to 6 with a description provided below. The properties at risk are shown as letters A to F.

1. Recession of the head scarp of the upper landslide resulting in a translation landslide down slope. It is considered such a landslide would be similar to that which recently occurred on the upper slope such that material would most likely translate to a lower part of the slope but most likely not cross Penny Lane such that it remains within Property C. The landslide would most likely be moderate to rapid. While most likely people in the area would identify the landslide moving and move out of the way, there is potential some people would be impacted.

2. Widening of the landslide on the upper slope to the right of the existing landslide, where the tension cracks are currently located. It is considered such a landslide would be similar to that which recently occurred on the upper slope such that material would most likely translate to a lower part of the slope but most likely not cross Penny Lane. This landslide would predominantly be within Property C but could flow over the eastern edge of Property D. The landslide would most likely be moderate to rapid. While most likely people in the area would identify the landslide moving and move out of the way, there is potential some people would be impacted.

3. Reactivation of the upper landslide debris as a translational landslide. This landslide could occur due to moisture build up within the landslide debris resulting in this material translating down slope. It is considered that there is sufficient material that the landslide could flow into the rear of Property F and potentially Property E. The landslide would most likely be rapid to very rapid and as such people would have difficulty avoiding the landslide if they were engaged in other activities in the area at the time.

4. New debris flow similar that that which previously occurred. Due to the build up of material at the base of the upper landslide there is potential for this material to become saturated, especially if a heavy rainfall event occurred. Should a debris flow occur rather than a translational landslide then the event would be very rapid to extremely rapid and would flow into the rear of Property E and F with similar or greater impact than the recent debris flow.

5. Widening of the landslide on the upper slope to the left of the existing landslide. It is considered such a landslide would be similar to that which recently occurred on the upper slope such that material would most likely translate to a lower part of the slope but most likely not cross Penny Lane. This landslide would predominantly be within Property D and would be unlikely to extend to Property B. The landslide would most likely be moderate to rapid. While most likely people in the area would identify the landslide moving and move out of the way, there is potential some people would be impacted.

6. Activation of a translational landslide on the lower slope to the left of the existing landslide. This area is very wet and showing some signs of movement. If such a landslide were to occur it could flow across Penny Lane and impact on the dwelling at Property F. It could also potentially flow as wide as the drive way of Property B. The landslide would most likely be rapid to very rapid and as such people would have difficulty avoiding the landslide if they were engaged in other activities in the area at the time.

- A. The Penny Lane Road Reserve
- B. 3 Penny Lane
- C. 10-12 View Point Road (Only considers area to north (rear) of house, house not at risk)
- D. 14-16 View Point Road
- E. 3/613 Pt Nepean Road
- F. 2 Penny Lane

The risk analysis has shown that the Risk to Life for Property A (the Penny Lane road reserve) is 'Not Tolerable' in the slope's current condition. The risk for Property A will continue to remain at this level of risk until appropriate remediation works have been conducted to reduce the risk. As such it is recommended that Penny Lane be barricaded off from the driveway of Property D through to the driveway of Property B. Barricading off the site will significantly reduce the temporary probability of people being impacted by the landslide such that the risk can be reduced to a 'Tolerable' level.

The risk analysis has shown that the Risk to Life for Property C (10-12 View Point Road) is 'Not Tolerable' in the slope's current condition. However, the 'Not Tolerable' is considered to only apply to the steep section of the site and the area within 5m of the crest of the slope. The area beyond 5m from the slope at the crest is considered to have a 'Tolerable' risk. As such it is recommended that the area within 5m of the crest of the slope be barricaded off to prevent access to the site. The barricade should extend from one side of the

property to the other and then down the boundaries with the neighbouring properties to Penny Lane. This will reduce the risk to a 'Tolerable' level for the occupiers of Property C provided that they do not enter the barricaded area. In addition, the occupiers should be provided with the AGS(2007e) so that they are aware of appropriate hillside practices. It is important to note that in order to conduct remediation works it will be necessary for workers to enter the affected area. Remediation works should include an appropriate safety plan that outlines methodologies and practices that will be adopted to reduce the risk to workers to an acceptable level as well as minimize the risk to the buildings of Properties E & F during these works.

The risk analysis has shown that the Risk to Life for Properties E (3/613 Pt Nepean Road) and F (3 Penny Lane) is 'Not Tolerable'. Unfortunately barricading off the properties is not considered sufficient to allow people to return. This is because the barricades would not prevent the landslides from occurring and the risk to people even within the houses would not be tolerable. As such it is recommended that the occupants of these two properties are not allowed to return to living to their homes until appropriate rectification works are undertaken. Limited access to the properties may be allowed to the properties to gather belonging etc. provided that it is conducted under the control of a Shire engineer who will need to inspect the site prior to the occupants entering the area and be on site while the occupants are on site.
