# TECHNICAL MEMORANDUM

| <b>Project</b> | Penny Lane, McCrae | <b>Date</b> | 7/12/2022 |
| <b>Subject</b> | Geotechnical Assessment | <b>Ref No.</b> | V220600Report01.1 |

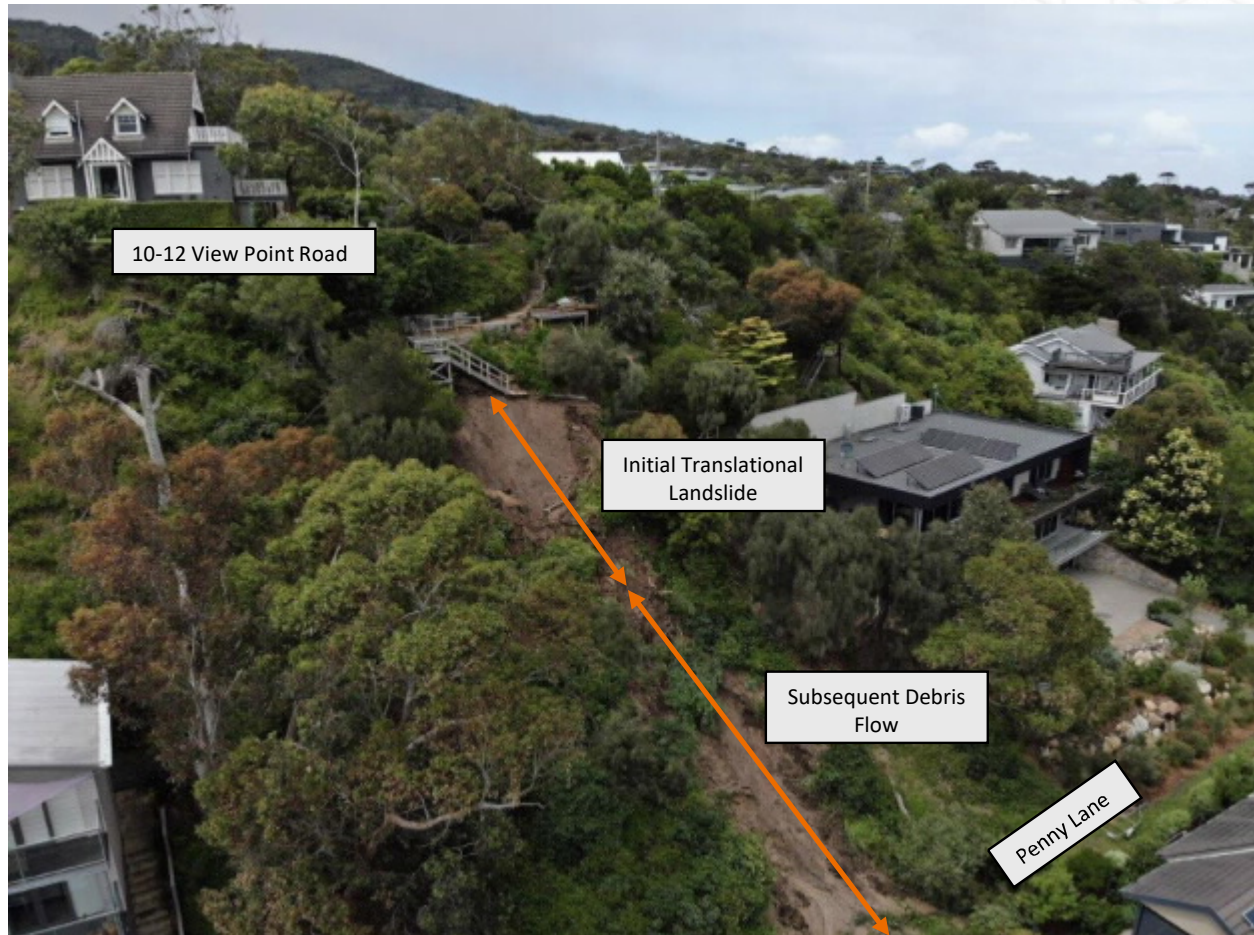
Figure 3-1: Oblique view of landslides

From the anecdotal discussions it is understood that an initial landslide is likely to have occurred in the late afternoon on Monday 14 November 2022. This day was a day of very heavy rain with approximately 80mm of rain recorded at the Bureau of Meteorology rain gauge located at Rosebud Country Club approximately 3-4km away. According to the data this was the highest single day of rainfall at that rain gauge since February 2005. This was coupled on top of what had already been a wet year. This landslide appears to have occurred as a translational landslide of the upper slope to the rear (north) of the house at 10-12 View Point Road.

Subsequently in the early morning of Tuesday 15 November 2022 a second landslide occurred. This landslide appears to have occurred as a debris flow from the middle part of the slope down to the toe resulting in impact on the dwelling at 3 Penny Lane as well as debris flowing into the yard of 3/613 Pt Nepean Road. From evidence on site, it appears that the debris flow may have been triggered by an irrigation pipe that could have been ruptured by the initial landslide.

An oblique view of the site showing the locations of the two parts of the landslide is shown in Figure 3-1.

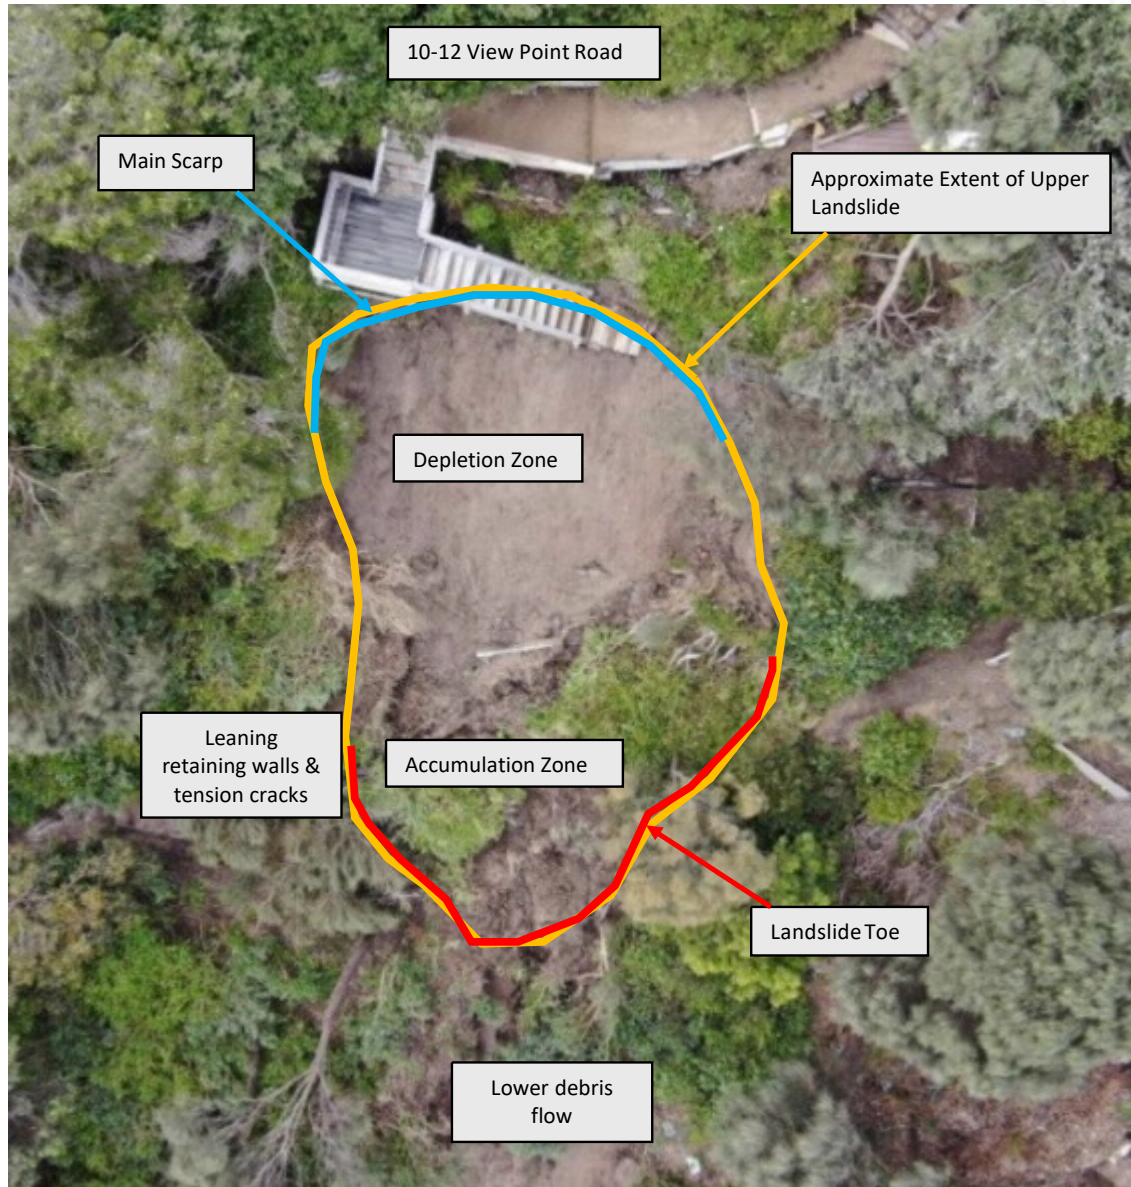
**Figure 4-1: Aerial view of upper slope**

The upper slope is dominated by a translational landslide that appears to have occurred in the upper soils overlying the underlying completely weathered granite. Across the area of the landslide a majority of the upper soils have translated downslope while the completely weathered granite has generally remained in place and is exposed in areas.

Figure 4-1 shows an aerial view of the site taken by Victoria Police drones. It shows the extent of the upper landslide and pertinent features associated with the landslide.

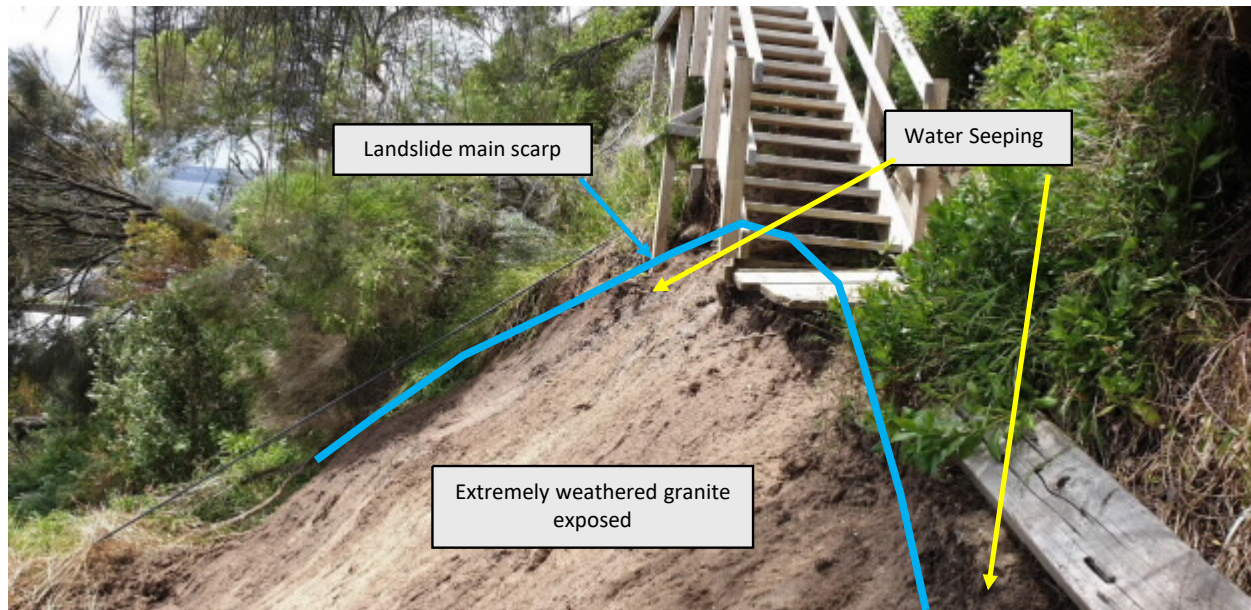
Figure 4-2: Main scarp of landslide

Figure 4-2 shows the main scarp of the landslide where it has undermined the existing stairs. It can be seen that the failure surface of the landslide runs parallel to the ground surface. The weathered granite is exposed in the failure surface. Looking at the side flank it can be seen that the thickness of soil that would have overlain the weathered granite is relatively shallow, possibly less than 0.5m.

Water was observed to be seeping from the head scarp at several locations more than 24 hours after the storm occurred. These seeps appear to be associated with natural springs further up slope.

The irrigation pipe that is likely to have failed during the initial landslide can be seen to be stretched tight in both figures.

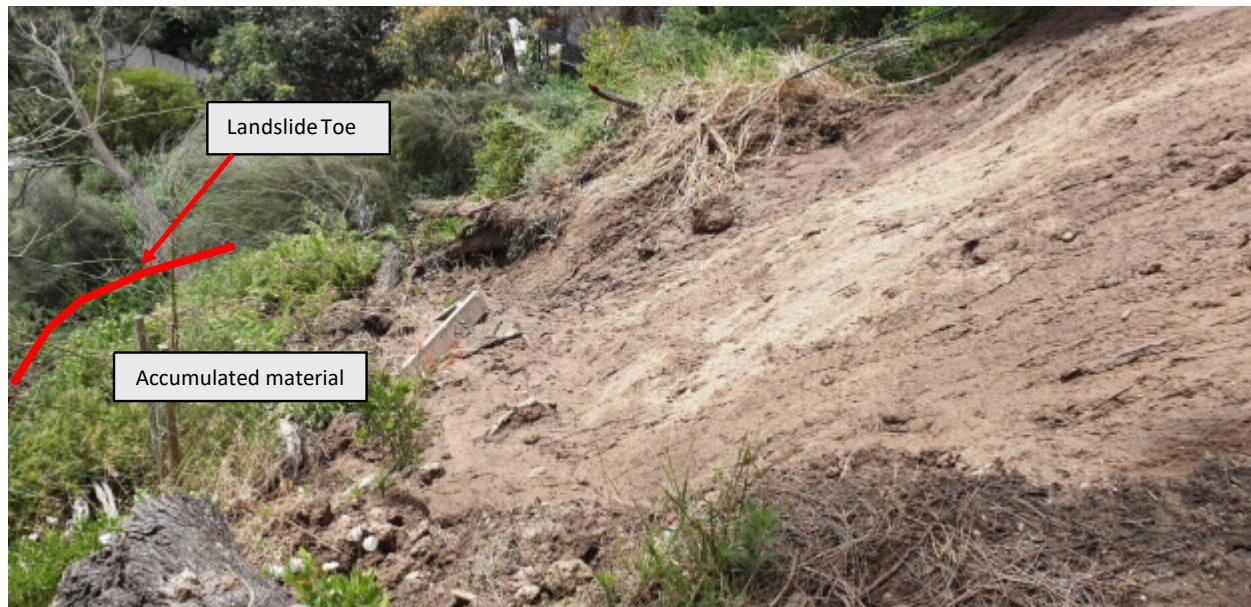
Figure 4-3: Accumulation zone of landslide

Figure 4-3 shows the accumulation zone of the upper landslide. It can be seen in the photograph that there is a significant volume of accumulated material and debris sitting at the toe of the landslide.

It is considered possible that with another significant rainfall event the material in the accumulation zone could remobilize and flow down slope. In addition, it is possible that some regression of the head scarp

could occur but that it would most likely be confined to the steep section of the slope or the immediate vicinity of the flatter area upslope.

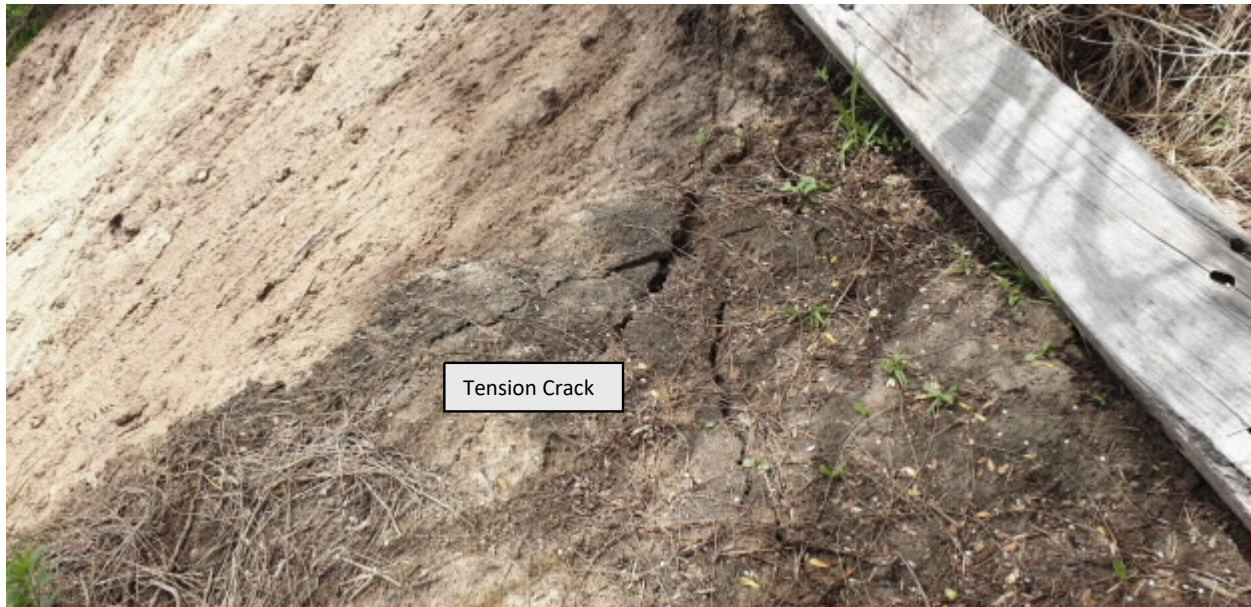
**Figure 4-4: Tension crack on right flank**

As shown in Figure 4-4 there is a tension crack on the right flank of the upper landslide. It appears to be confined to the immediate vicinity within 2-3m of the landslide. It is considered possible that the landslide could widen in this area by several metres.

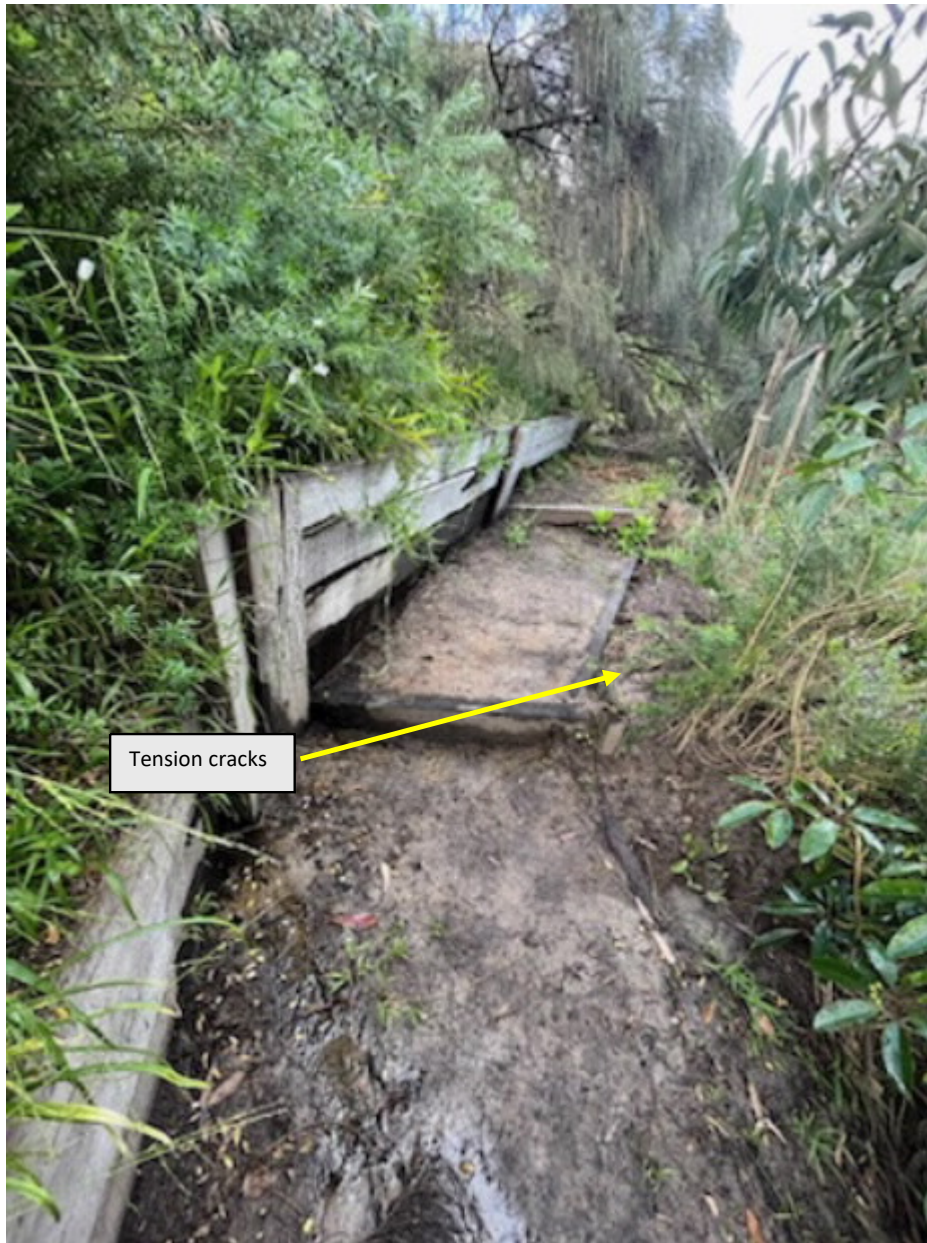
Figure 4-5: Leaning retaining wall and tension cracks on left flank

On the left flank there was an old timber retaining wall present. It was significant leaning and there was evidence of water seeping through the wall. To the front of these walls there were several tension cracks. These tension cracks appeared to be in two forms. One set of cracks appeared to indicate the rupture surface at the toe of movement further up slope while the second set of cracks appeared to indicate a developing head scarp of a landslide of the lower slope.

The tension cracks on the left flank appeared to extend approximately 5m from the existing landslide. This indicates that there is potential for widening of the existing landslide by several metres should heavy rainfall continue.

The retaining wall and tension cracks are shown in Figure 4-5.

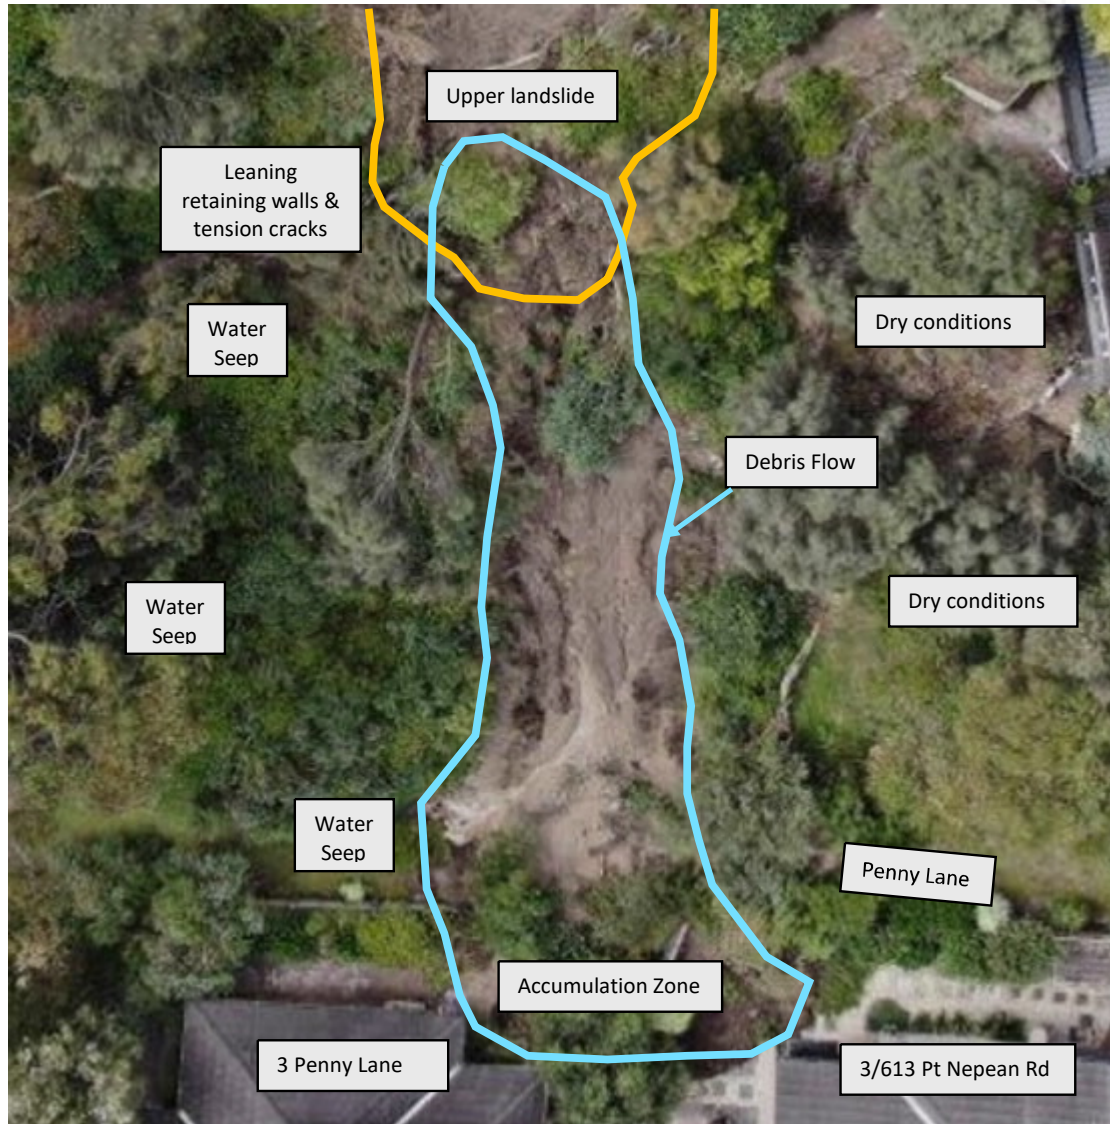
**Figure 4-6: Aerial view of lower debris flow**

The lower slope is dominated by a debris flow that has been initiated by a significant increase in ground moisture, most likely as a combination of significant rainfall and potentially the failure of an irrigation pipe after the upper landslide occurred. Figure 4-5 shows an aerial view of the site taken by Victoria Police drones. It shows the debris flow initiated within the accumulation zone of the upper landslide and then flowed downslope across Penny Lane and into the rear of the properties of 3 Penny Lane and 3/613 Pt Nepean Road.

Figure 4-6 shows the path of the debris flow. It can be seen that the upper vegetation has been stripped and that there has been some scour of the underlying soils. The deepest sections of scour have eroded down to the top of the extremely weathered granite.

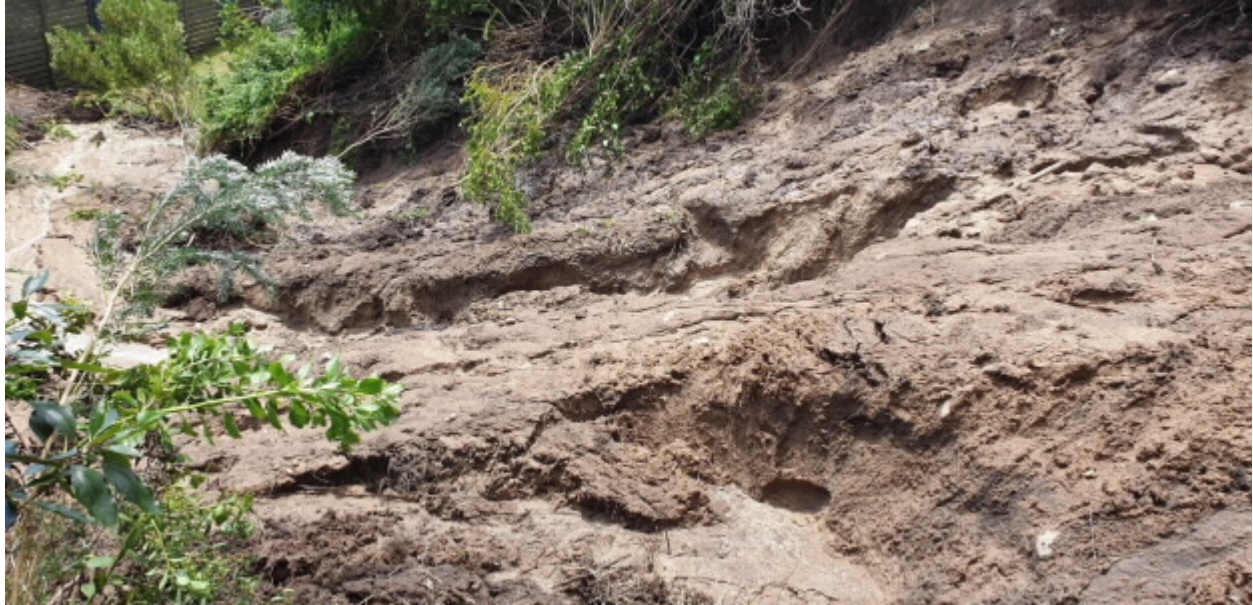
Figure 4-7: Debris flow path

Figure 4-7 shows the accumulation zone of the debris flow. It can be seen that the debris flow crossed over Penny Lane, which lies between 10-12 View Point Road and the houses along Pt Nepean Road, and into the rear of two properties.

While a large amount of the upper soils have already flowed down slope, it is considered that there is potential for addition debris flows to initiate in the accumulation zone of the landslide and impact on the area down slope.

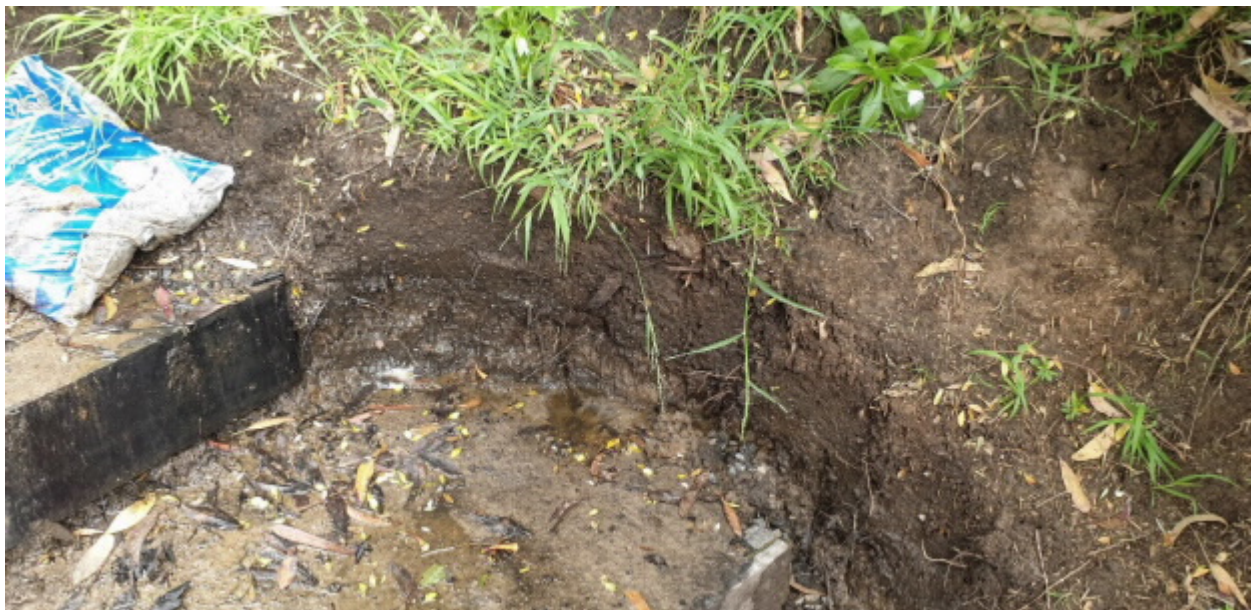
Figure 4-9: Water seepage on left side of site

The conditions on either side of where the debris flow occurred were observed to be significantly different. On the right (western) side the conditions were quite dry and there was no evidence of water seepage. However, on the left (eastern) side there were a number of water seeps observed. These water seeps were observed to be flowing freely more than 24 hours after the heavy rainfall event.

Based on the evidence of tension cracks up slope of this eastern area and that there are significant springs in the area, it is considered that there is potential for a landslide or debris flow to develop within the eastern area especially if there is another heavy rainfall event. However, such a landslide would be unlikely to extend as far east as the property at 2 Penny Lane.

An example of one of the water seeps is shown in Figure 4-8.

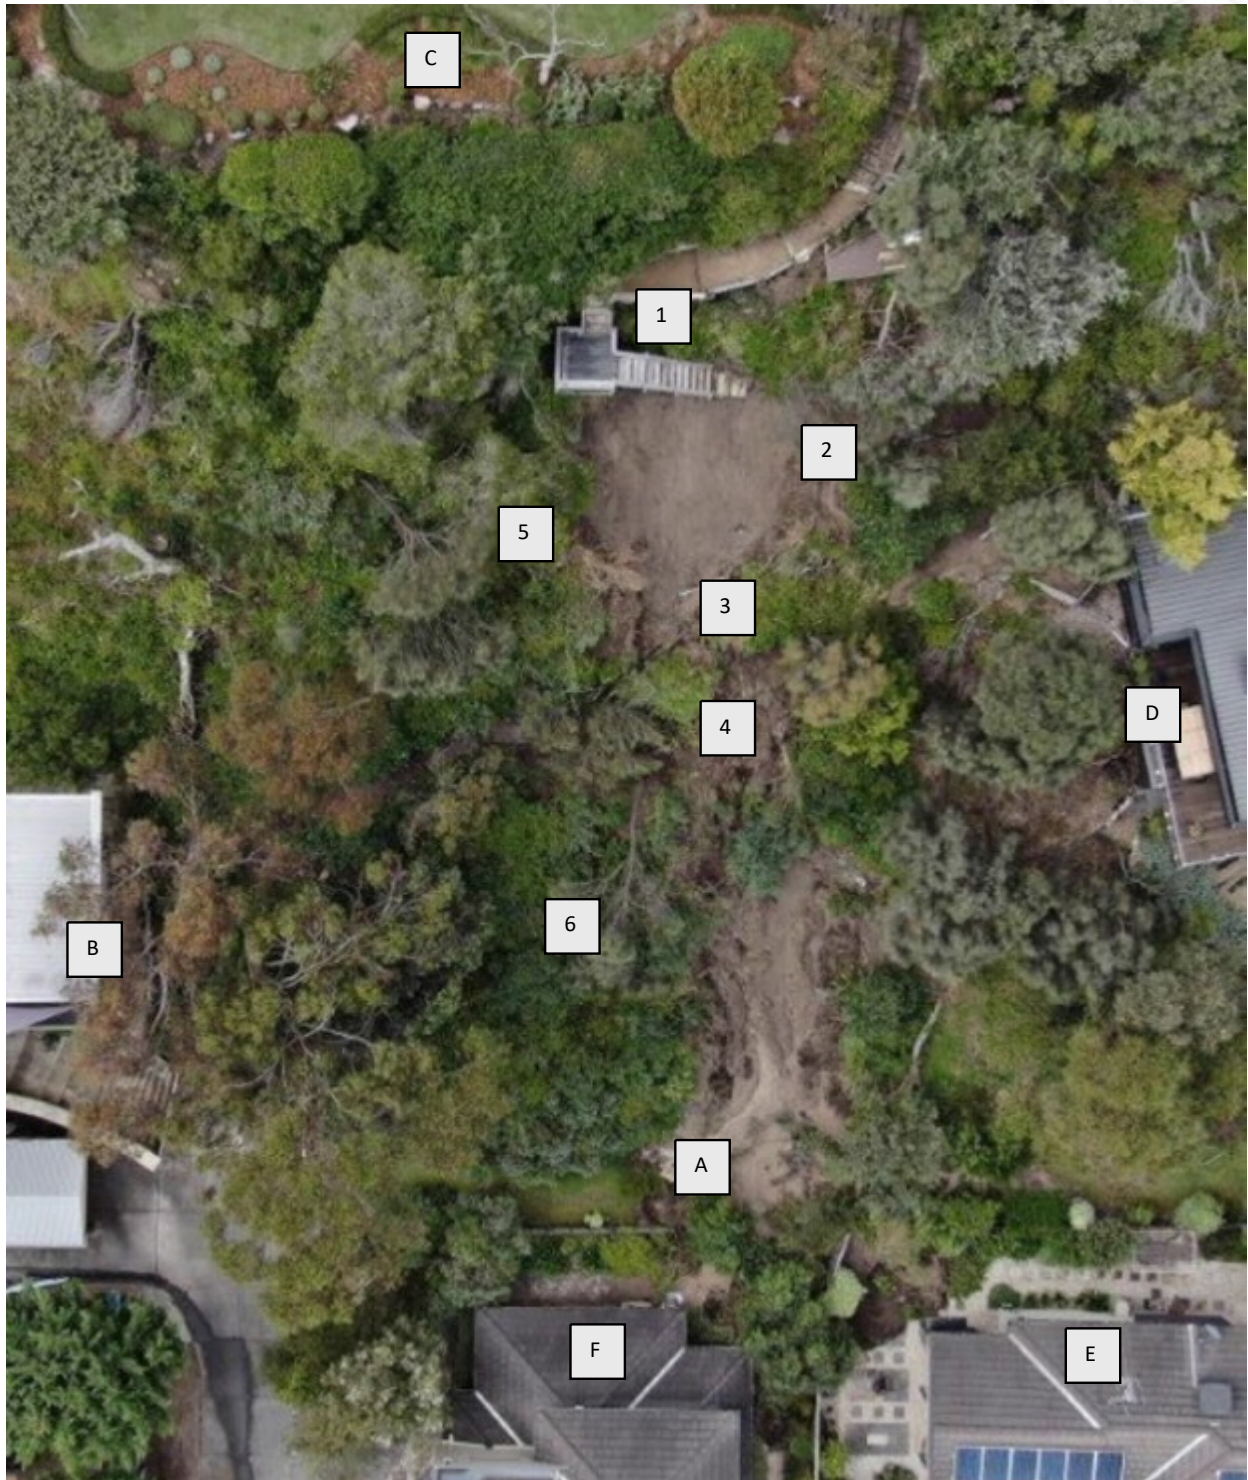
Figure 5-1: Potential Landslide Hazards and Properties at Risk

A number of different potential landslide hazards have been identified for the site. These are identified on Figure 5-1 as numbers 1 to 6 with a description provided below. The properties at risk are shown as letters A to F.

1. Recession of the head scarp of the upper landslide resulting in a translation landslide down slope. It is considered such a landslide would be similar to that which recently occurred on the upper slope such that material would most likely translate to a lower part of the slope but most likely not cross Penny Lane such that it remains within Property C. The landslide would most likely be moderate to rapid. While most likely people in the area would identify the landslide moving and move out of the way, there is potential some people would be impacted.

2. Widening of the landslide on the upper slope to the right of the existing landslide, where the tension cracks are currently located. It is considered such a landslide would be similar to that which recently occurred on the upper slope such that material would most likely translate to a lower part of the slope but most likely not cross Penny Lane. This landslide would predominantly be within Property C but could flow over the eastern edge of Property D. The landslide would most likely be moderate to rapid. While most likely people in the area would identify the landslide moving and move out of the way, there is potential some people would be impacted.

3. Reactivation of the upper landslide debris as a translational landslide. This landslide could occur due to moisture build up within the landslide debris resulting in this material translating down slope. It is considered that there is sufficient material that the landslide could flow into the rear of Property F and potentially Property E. The landslide would most likely be rapid to very rapid and as such people would have difficulty avoiding the landslide if they were engaged in other activities in the area at the time.

4. New debris flow similar that that which previously occurred. Due to the build up of material at the base of the upper landslide there is potential for this material to become saturated, especially if a heavy rainfall event occurred. Should a debris flow occur rather than a translational landslide then the event would be very rapid to extremely rapid and would flow into the rear of Property E and F with similar or greater impact than the recent debris flow.

5. Widening of the landslide on the upper slope to the left of the existing landslide. It is considered such a landslide would be similar to that which recently occurred on the upper slope such that material would most likely translate to a lower part of the slope but most likely not cross Penny Lane. This landslide would predominantly be with within Property D and would be unlikely to extend to Property B. The landslide would most likely be moderate to rapid. While most likely people in the area would identify the landslide moving and move out of the way, there is potential some people would be impacted.

6. Activation of a translational landslide on the lower slope to the left of the existing landslide. This area is very wet and showing some signs of movement. If such a landslide were to occur it could flow across Penny Lane and impact on the dwelling at Property F. It could also potentially flow as wide as the drive way of Property B. The landslide would most likely be rapid to very rapid and as such people would have difficulty avoiding the landslide if they were engaged in other activities in the area at the time.
