# Expert Opinion Report - Rectification

10-12 View Point Road, McCrae

PSM5226-005R 11 June 2024

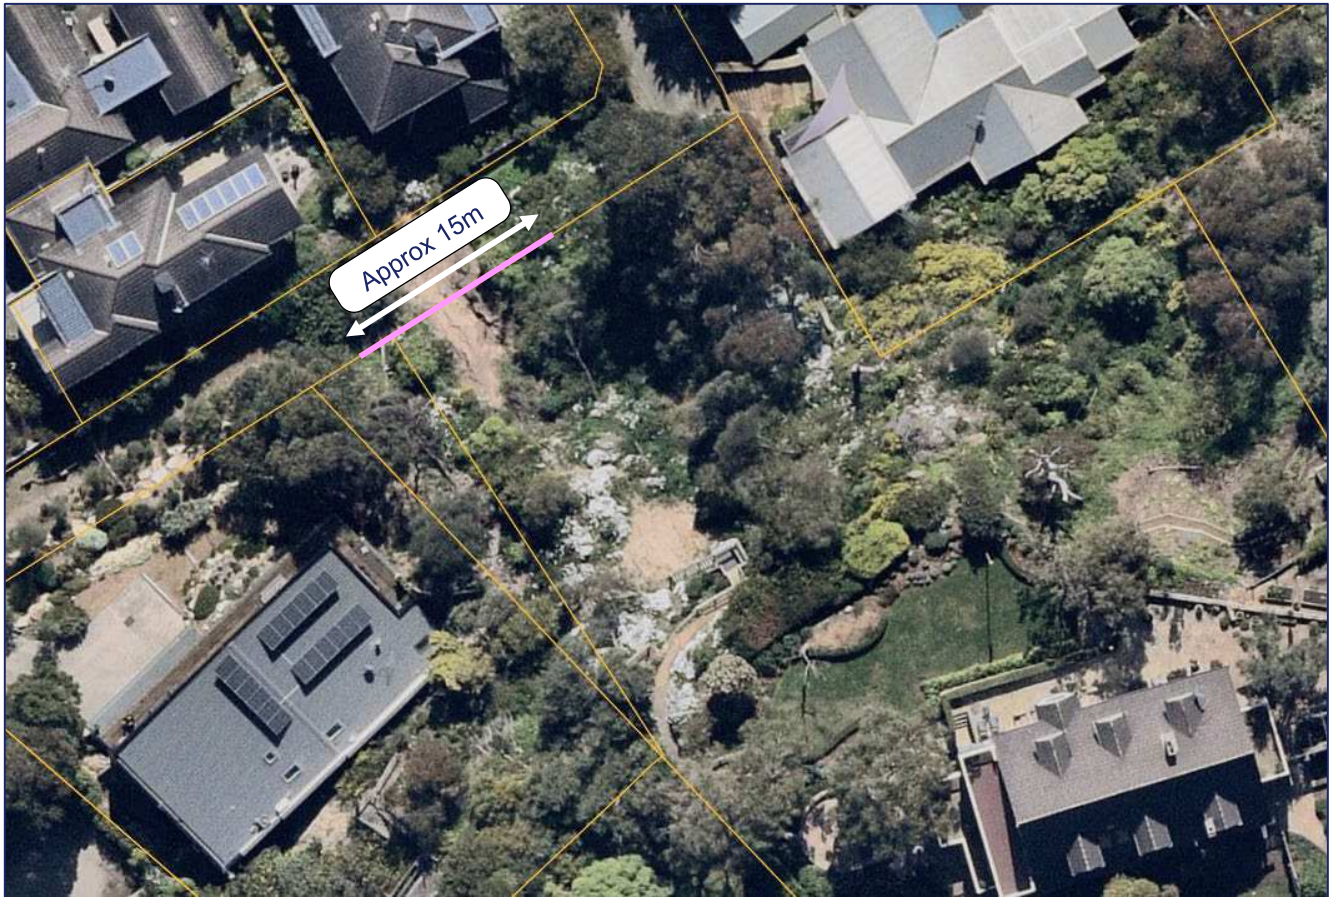
83. In my opinion the STS does not reduce risk to life and property for Property P1. As per paragraph [82], a debris fence does not prevent a landslide from occurring, therefore in my opinion landslides may still occur on Property P1. In my opinion a residual risk assessment post clean-up of Landslide and for:
- (a) A pedestrian on the slopes of P1 is likely to indicate an unacceptable risk to life for future landslide events as no controls have been introduced to control repeat landslides.
  - (b) The dwelling at P1 is likely to indicate a tolerable risk to the dwelling and occupants within the dwelling with risks unchanged owing to the offset to the Landslide.

**Inset 17: Assumed extent of debris fence shown in pink (Aerial image from Nearmap)**

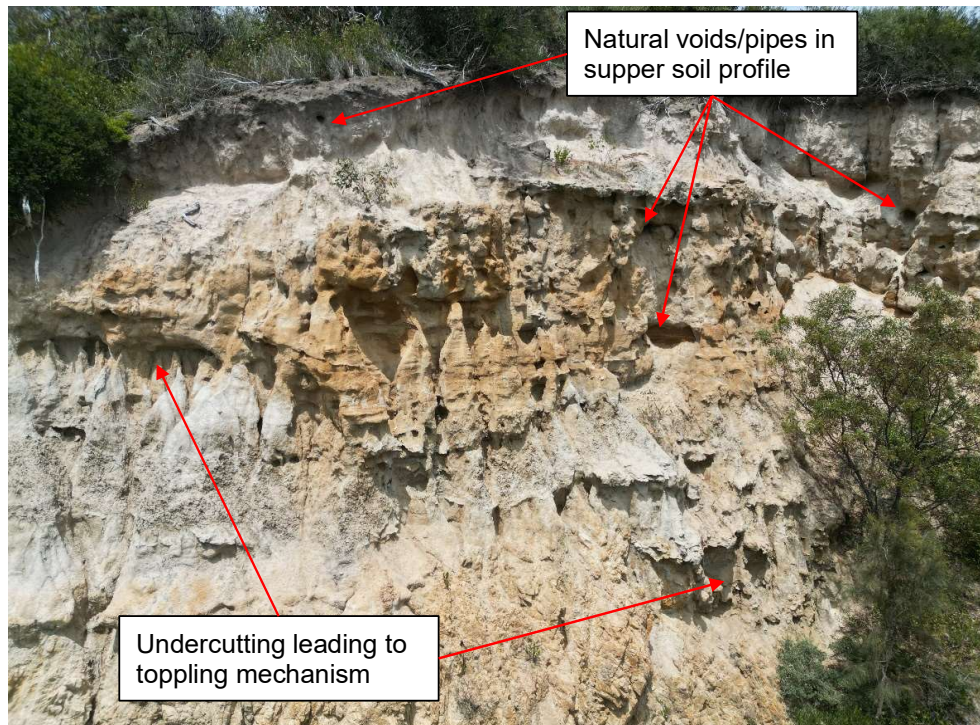
- iii. Granite rock is exposed in shore platform below the road.
    - iv. Steep to sub-vertical upper slopes are inferred to fail by undercutting and erosion of the lower slope leading to toppling style failures, Photo 12 Appendix C.

Photo 12 - Natural cliff profile near Anthony's Nose
