# Expert Opinion Report - Rectification

10-12 View Point Road, McCrae

PSM5226-005R 11 June 2024

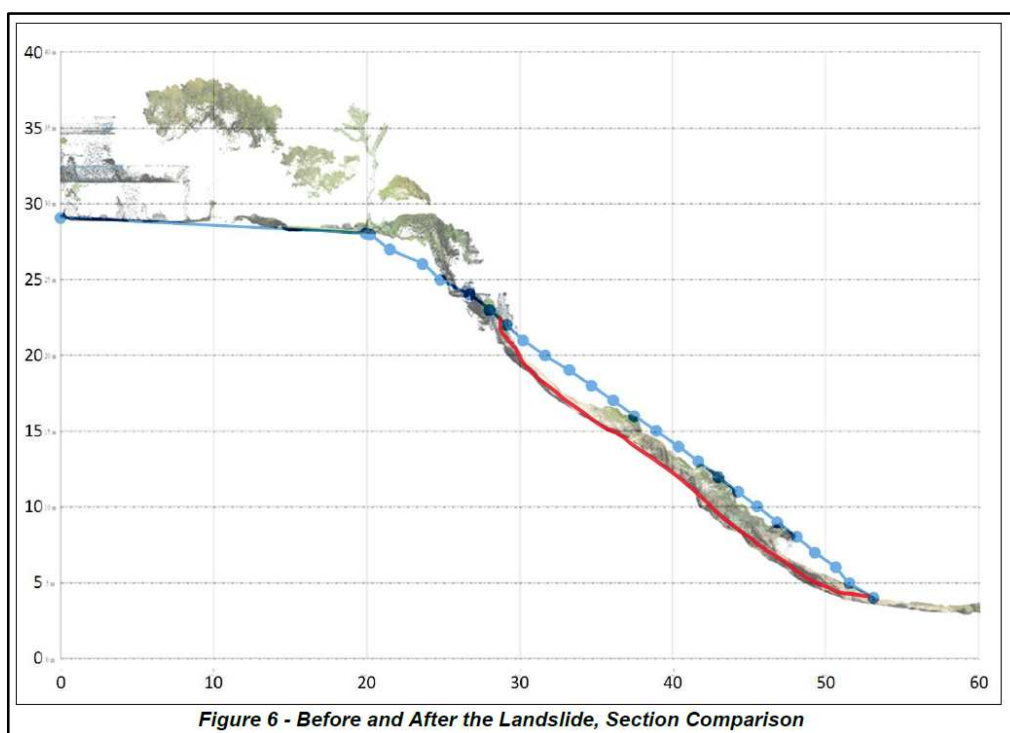
**Figure 6 - Before and After the Landslide, Section Comparison**

- (c) The typical and maximum observed thickness of the Landslide was 0.3 m and 0.5 m respectively. The comparison between the CivilTest drone and feature survey, Inset 2, overestimates the thickness of the Landslide by as much as 1.5 m.

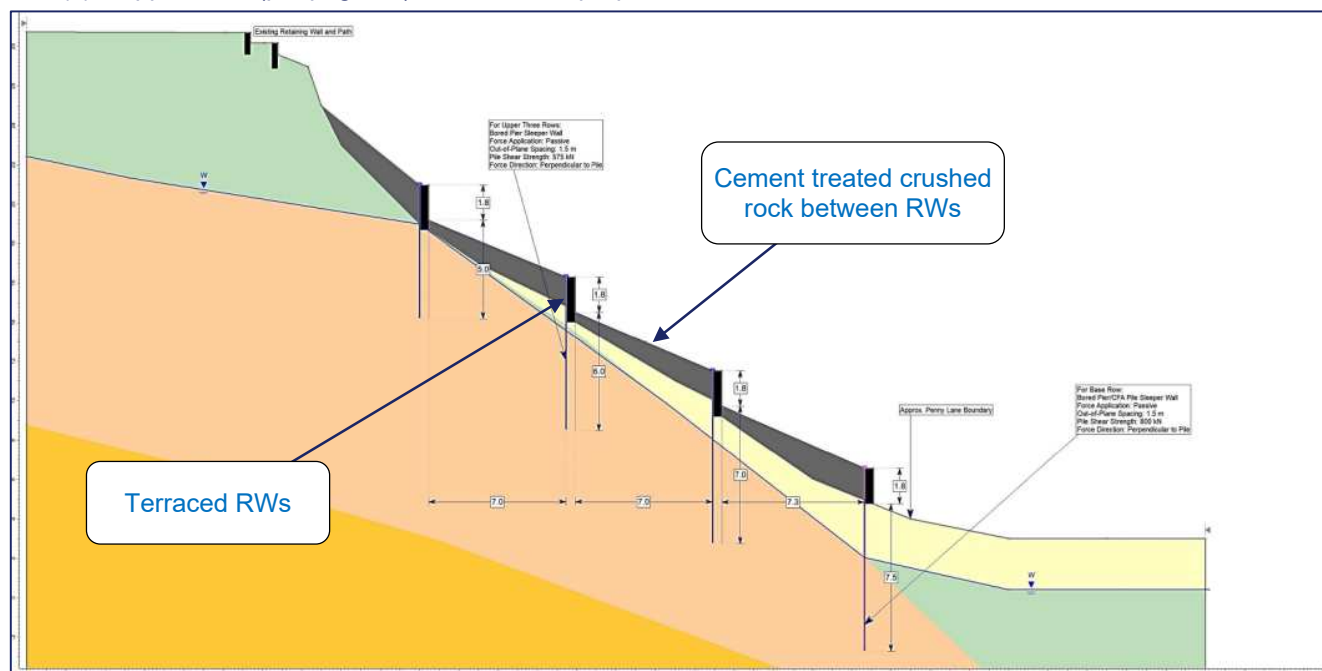
**Inset 4:** CivilTest section with proposed RW remediation (Document 12, pdf page 29). I have added my commentary in blue.

- ii. Cement treated crushed rock (CTCR) placed between retaining walls with a maximum 22 degree slope angle.
    - iii. “Loose colluvium/landslip material should be removed from the slope”.

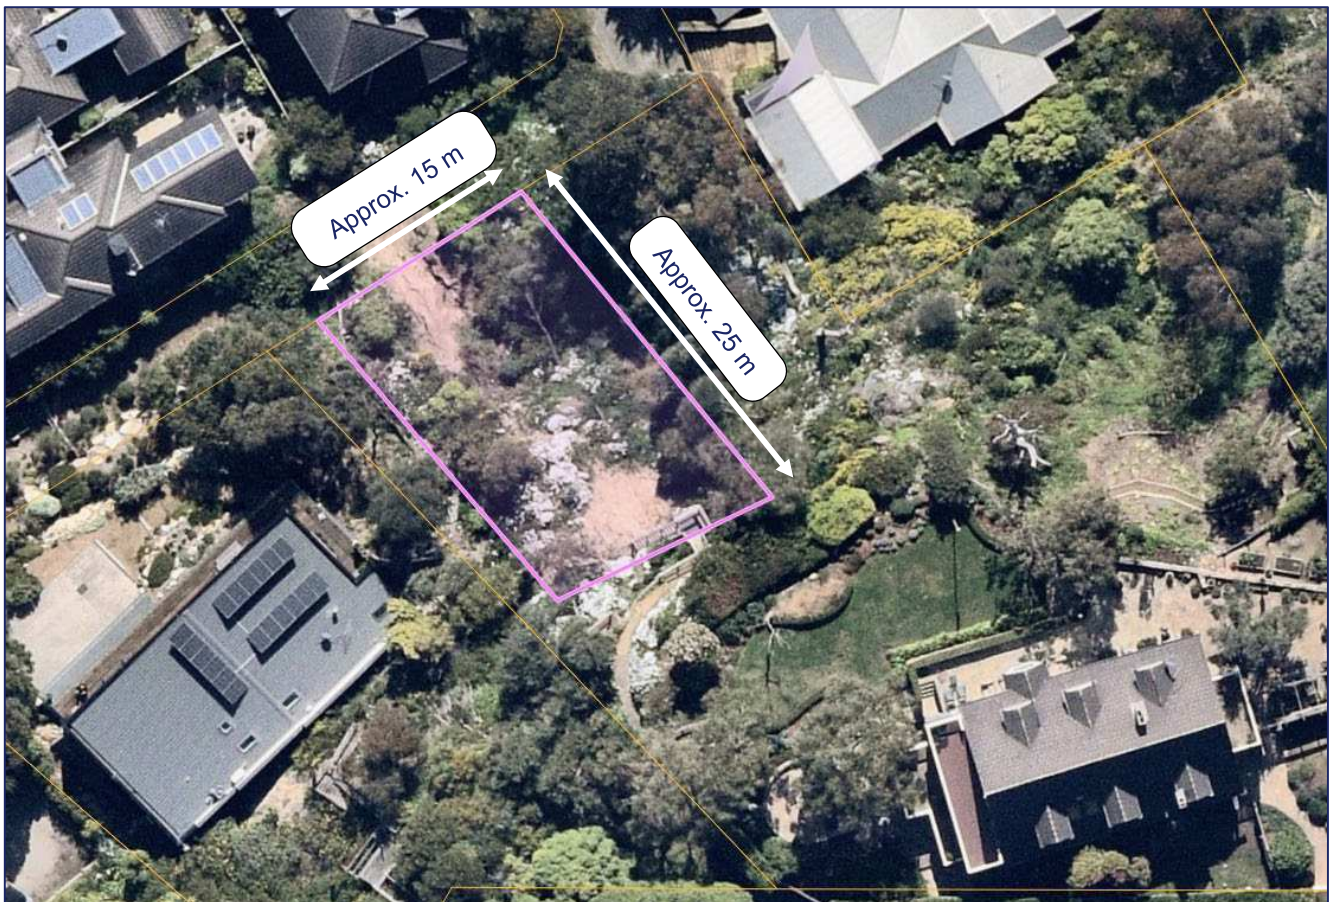
**Inset 16:** Indicative extent of rectification shown in pink (Aerial image from Nearmap)

74. The approximate extent of rectification required is shown in Inset 16. The approximate extents in plan are 15 m wide by 25 m long with 370 m<sup>2</sup> of total area (in plan) to be rectified. I note that the angle of the slope will mean that the actual ground surface area to be rectified is approximately 480 m<sup>2</sup>.
75. The indicated area of rectification extends beyond the observed boundaries of the Landslide to provide stability to the flanks, and to allow for possible uncertainty in the extent of unstable ground (refer to paragraph [26(e)]).

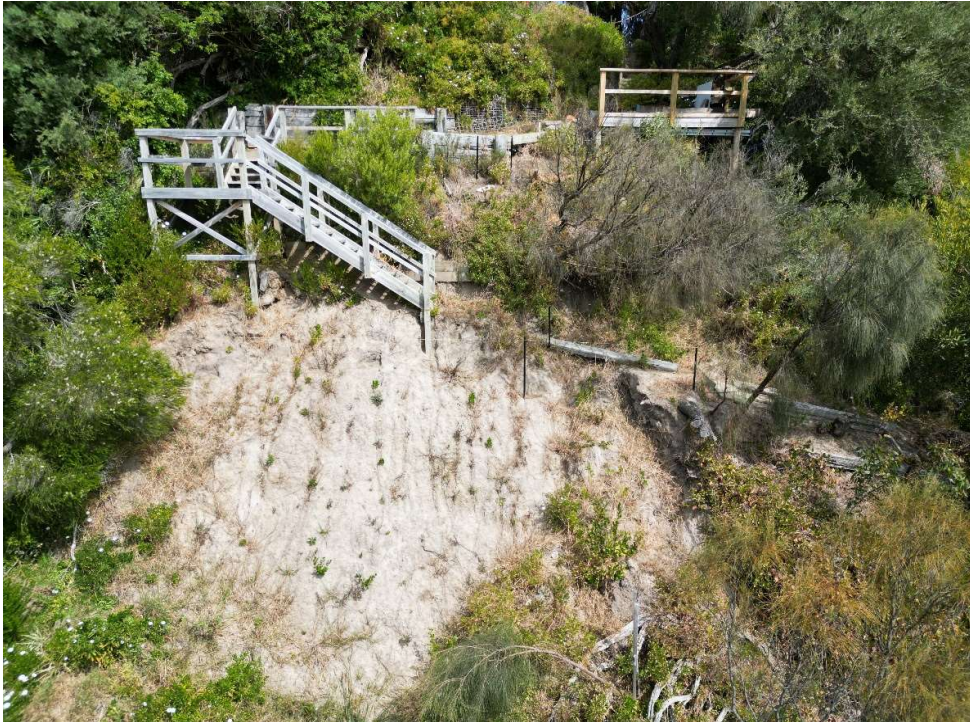
Photo 1 - Upper translational sliding area

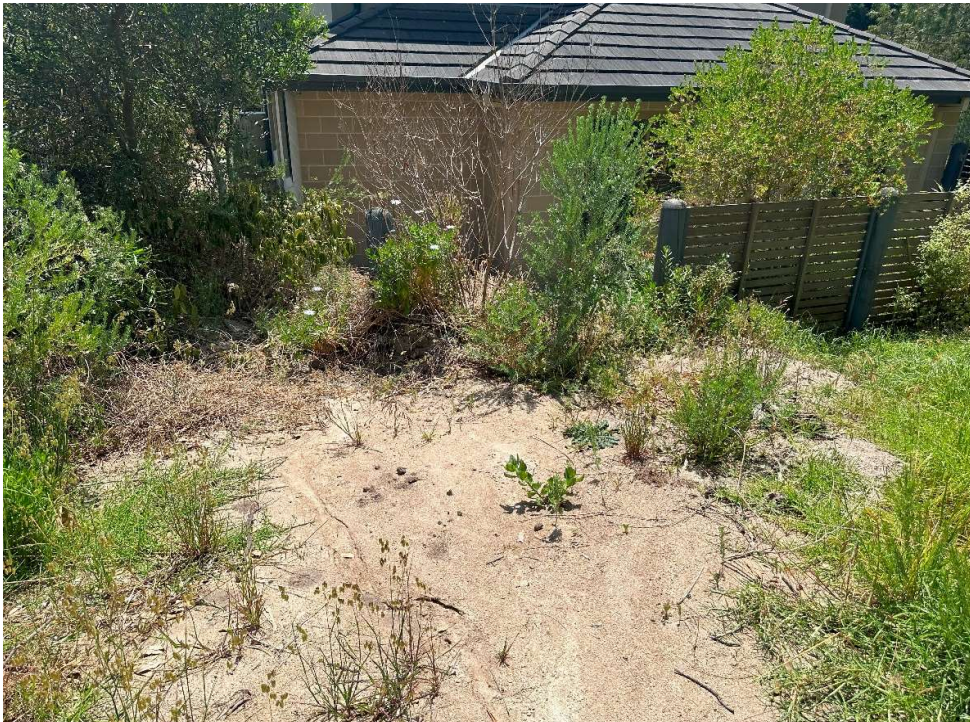
- (b) It was inferred to have initiated as a translational slide followed by mobilisation of failed material into a debris flow which was deposited at the toe of the slope, Photo 2 Appendix C.

Photo 2 - Debris flow runout area, Property P2 visible in background

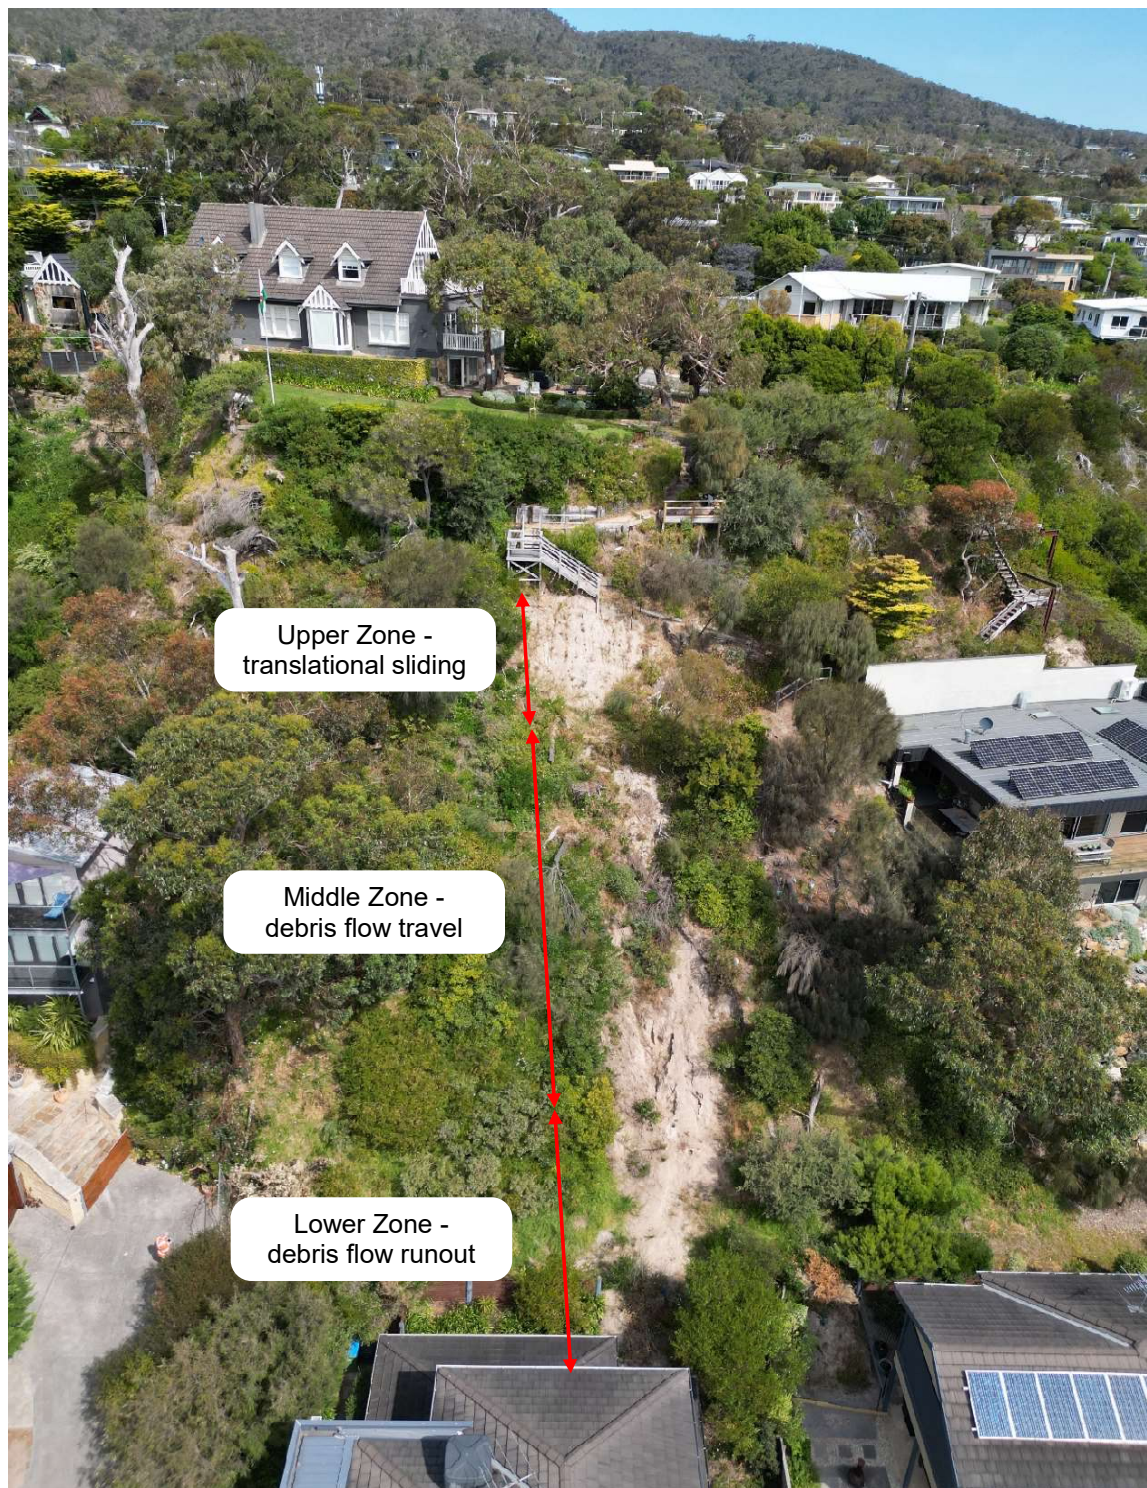
Photo 3 - Landslide Overview, with zones indicated

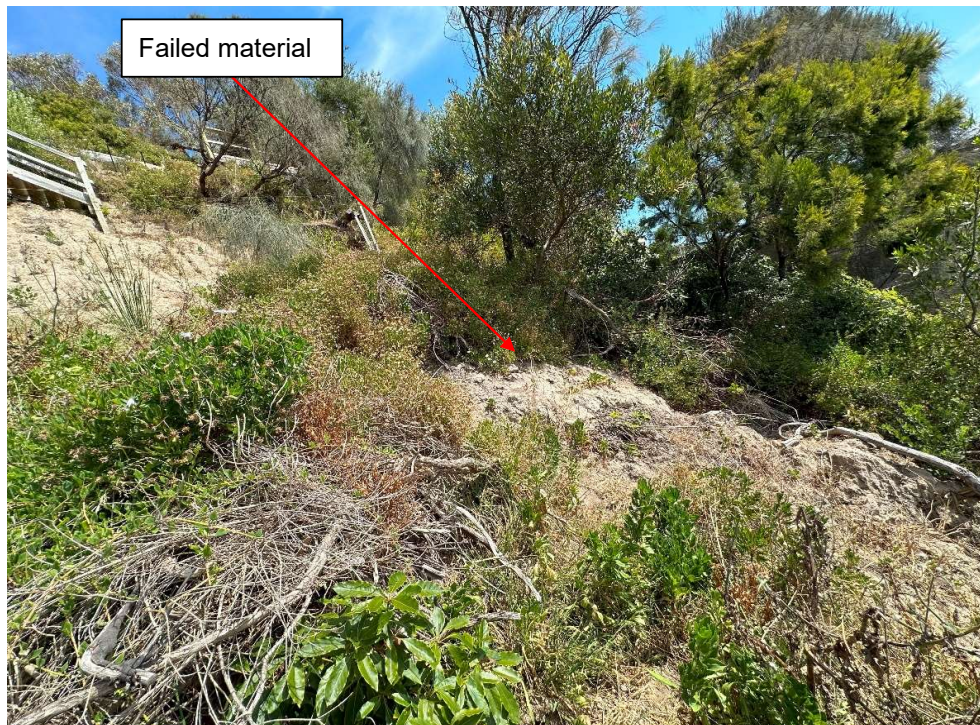
- (d) Disturbed ground that had undergone translational sliding but did not mobilise into a debris flow was observed on the right (western) flank of the Landslide, Photo 4 Appendix C.

Photo 4 - Failed material still on slope

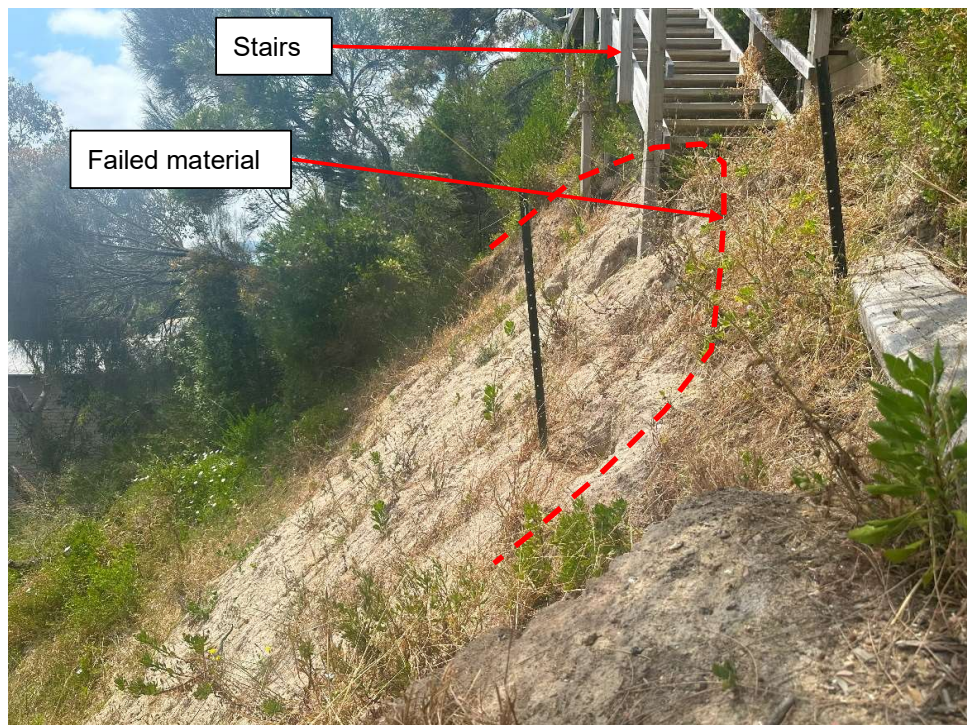
- (f) A lack of prominent backscarp, Photo 5 Appendix C, with minor steepening observed in the backscarp area and with a slope angle of approximately 45 degrees.

Photo 5 - Rear scarp of landslide, note lack of oversteepened backscarp

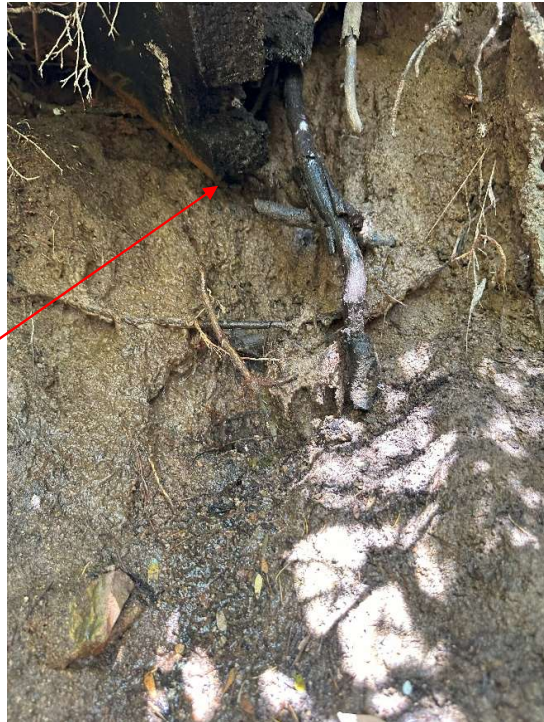
Photo 6 - Groundwater seepage

- (c) Groundwater was observed to be seeping from the slope to the east of the stairs, Photo 6 Appendix C
  - (d) A variety of water infrastructure was observed across the site, Photo 7 Appendix C including:

Groundwater seeping from slope

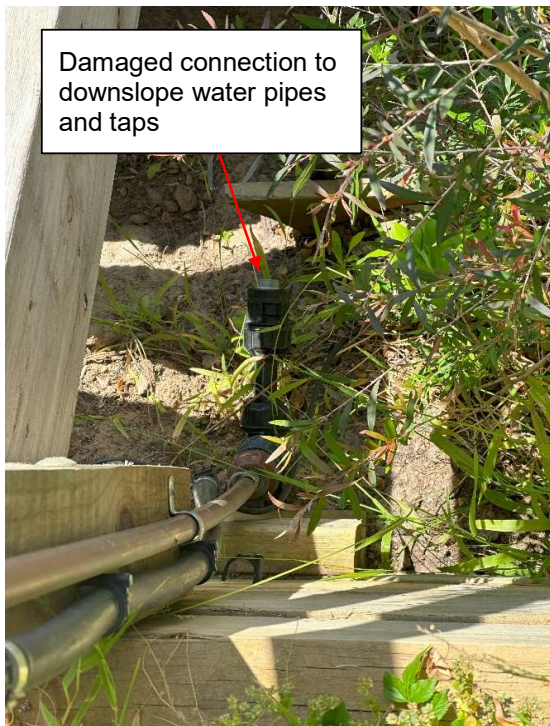
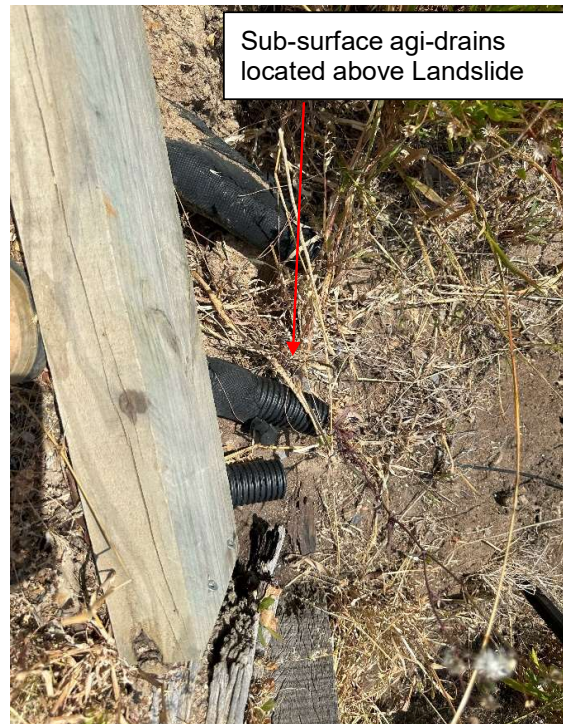
Damaged connection to downslope water pipes and taps

Sub-surface agi-drains located above Landslide

Photo 7 - Water infrastructure including water pipes (on left), and subsurface 'agi drains' (on right)

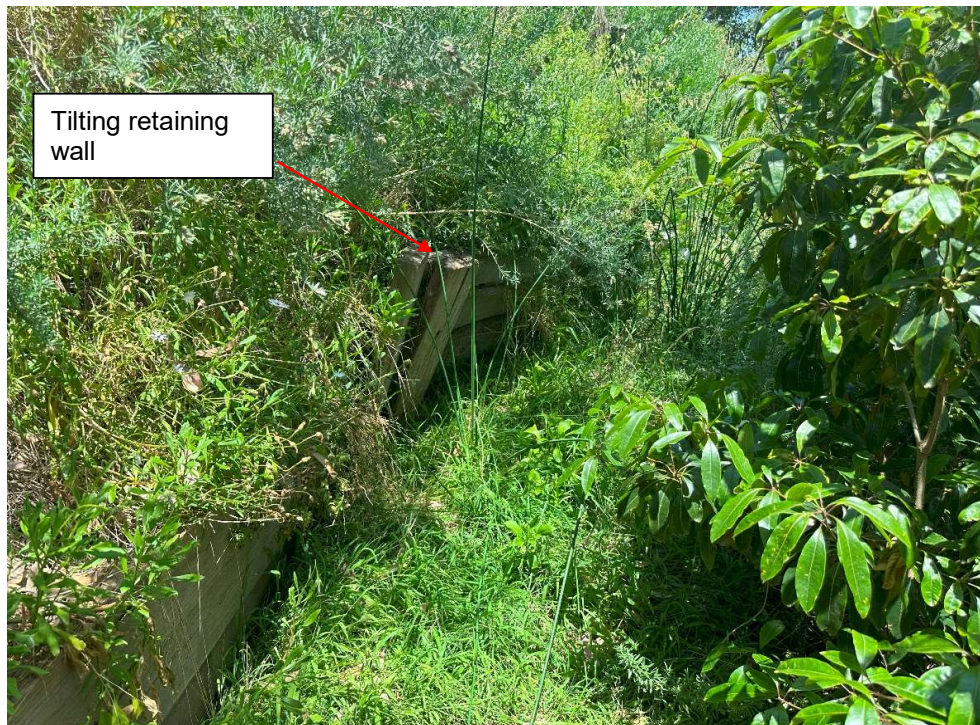
- (g) The condition of RWs across the Site was generally poor, with overturning and bulging RWs observed. A section of RW to the east of the Landslide had significant tilts. This indicates to me possible instability in the ground above the RW and possible structural or geotechnical failure of the RW, Photo 10 Appendix C.

Photo 10 - Tilting retaining walls on left side of Landslide

- (b) The stability of the Surficial Sand slopes above the existing stairs at the crest of the Landslide is excluded, as this is controlled by the performance of P1 RWs. Where the RWs are showing signs of failure, the owner of P1 should address this separately.

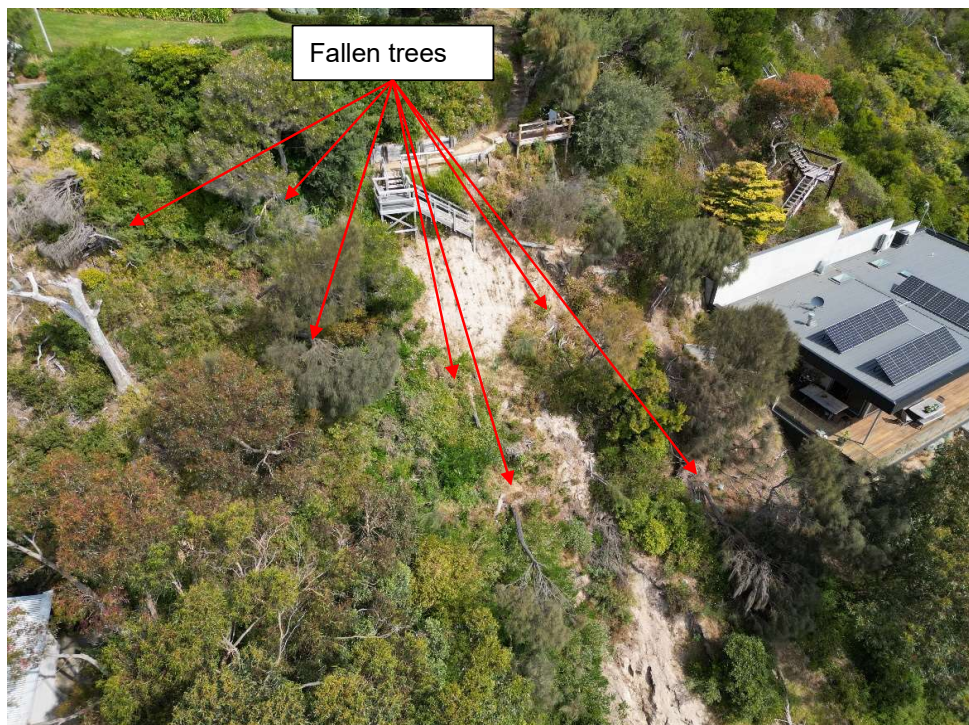
- (h) Numerous fallen trees were observed across the escarpment slope, Photo 11 Appendix C.  
I note that most of the failed trees appear to have failed from causes unrelated to the Landslide, i.e., wind or poor root embedment. I note at least one tree appears to have fallen because of the Landslide.

Photo 11 - Fallen trees

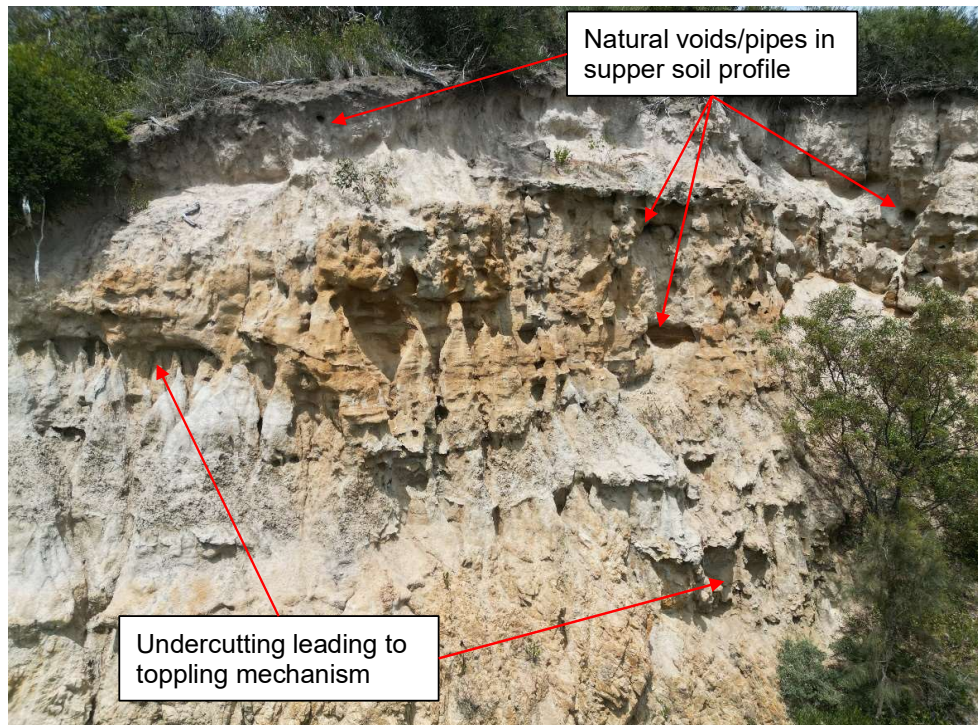
- iii. Granite rock is exposed in shore platform below the road.
    - iv. Steep to sub-vertical upper slopes are inferred to fail by undercutting and erosion of the lower slope leading to toppling style failures, Photo 12 Appendix C.

Photo 12 - Natural cliff profile near Anthony's Nose
