# Expert Opinion Report - Rectification

10-12 View Point Road, McCrae

PSM5226-005R 11 June 2024

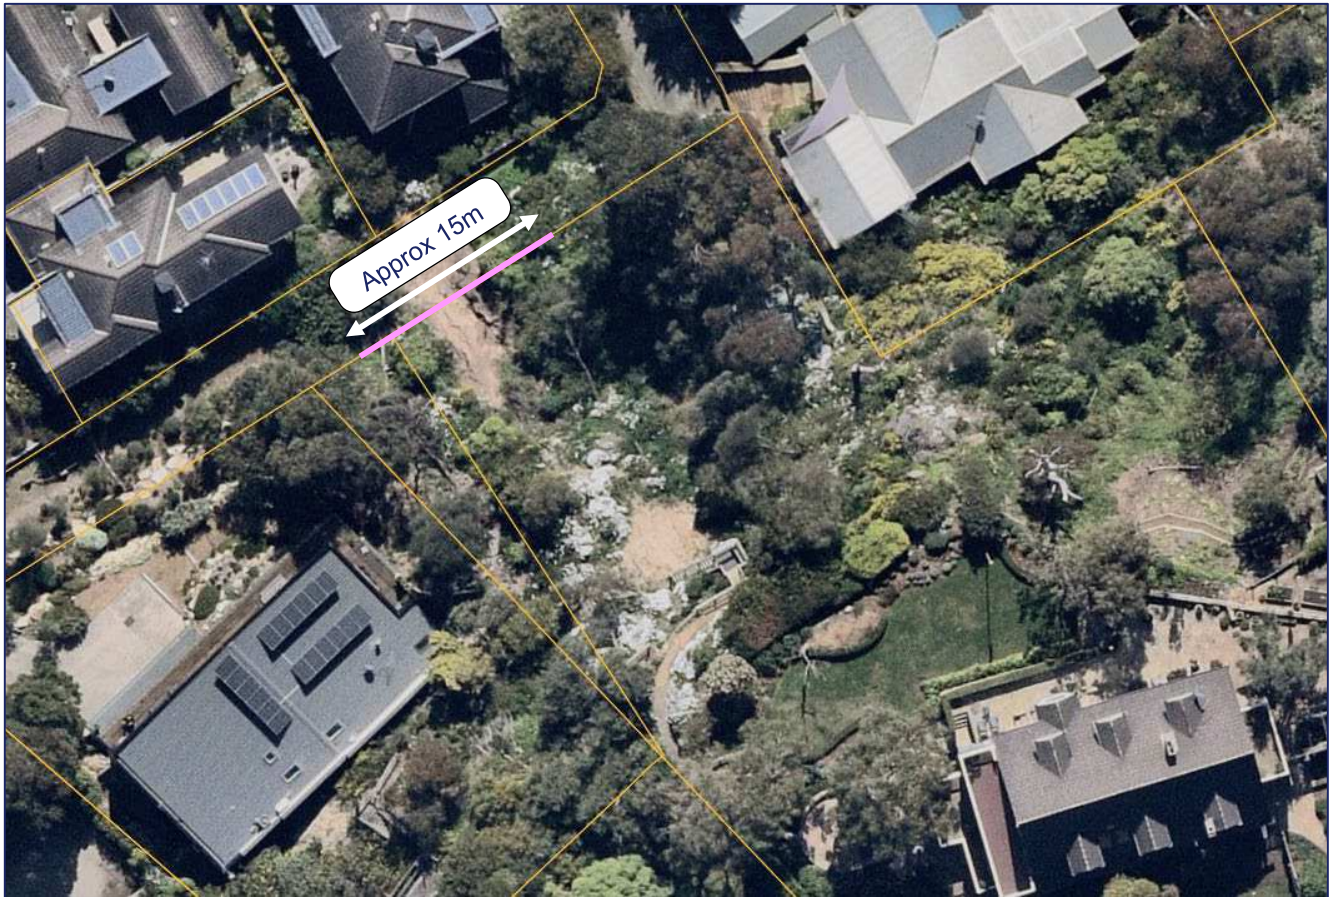
83. In my opinion the STS does not reduce risk to life and property for Property P1. As per paragraph [82], a debris fence does not prevent a landslide from occurring, therefore in my opinion landslides may still occur on Property P1. In my opinion a residual risk assessment post clean-up of Landslide and for:
- (a) A pedestrian on the slopes of P1 is likely to indicate an unacceptable risk to life for future landslide events as no controls have been introduced to control repeat landslides.
  - (b) The dwelling at P1 is likely to indicate a tolerable risk to the dwelling and occupants within the dwelling with risks unchanged owing to the offset to the Landslide.

**Inset 17: Assumed extent of debris fence shown in pink (Aerial image from Nearmap)**

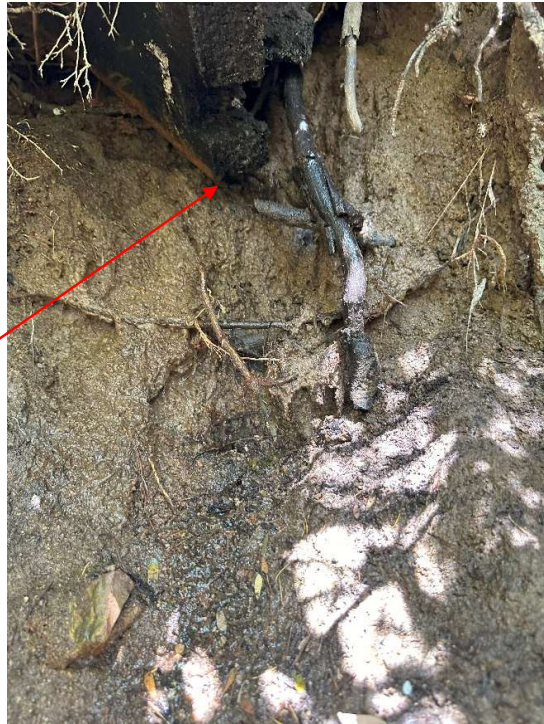
- (c) Groundwater was observed to be seeping from the slope to the east of the stairs, Photo 6 Appendix C
  - (d) A variety of water infrastructure was observed across the site, Photo 7 Appendix C including:

Groundwater  
seeping from slope

Photo 6 - Groundwater seepage

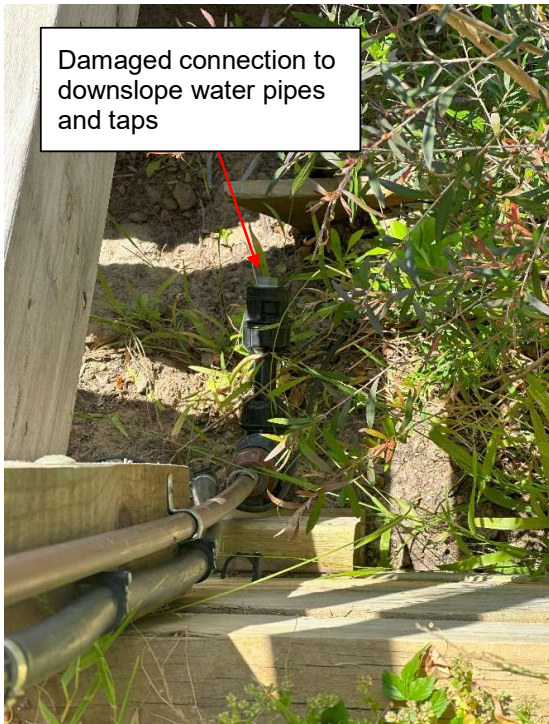
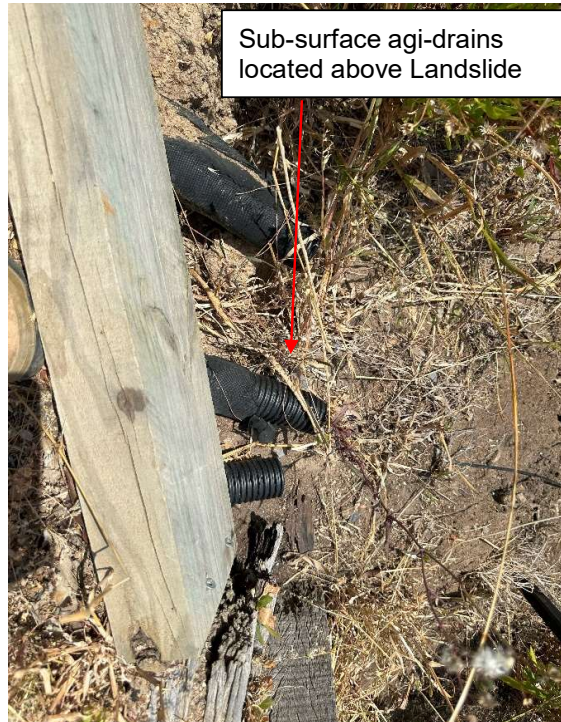
Damaged connection to  
downslope water pipes  
and taps

Sub-surface agi-drains  
located above Landslide

Photo 7 - Water infrastructure including water pipes (on left), and subsurface 'agi drains' (on right)
