# Expert Opinion Report - Rectification

10-12 View Point Road, McCrae

PSM5226-005R 11 June 2024

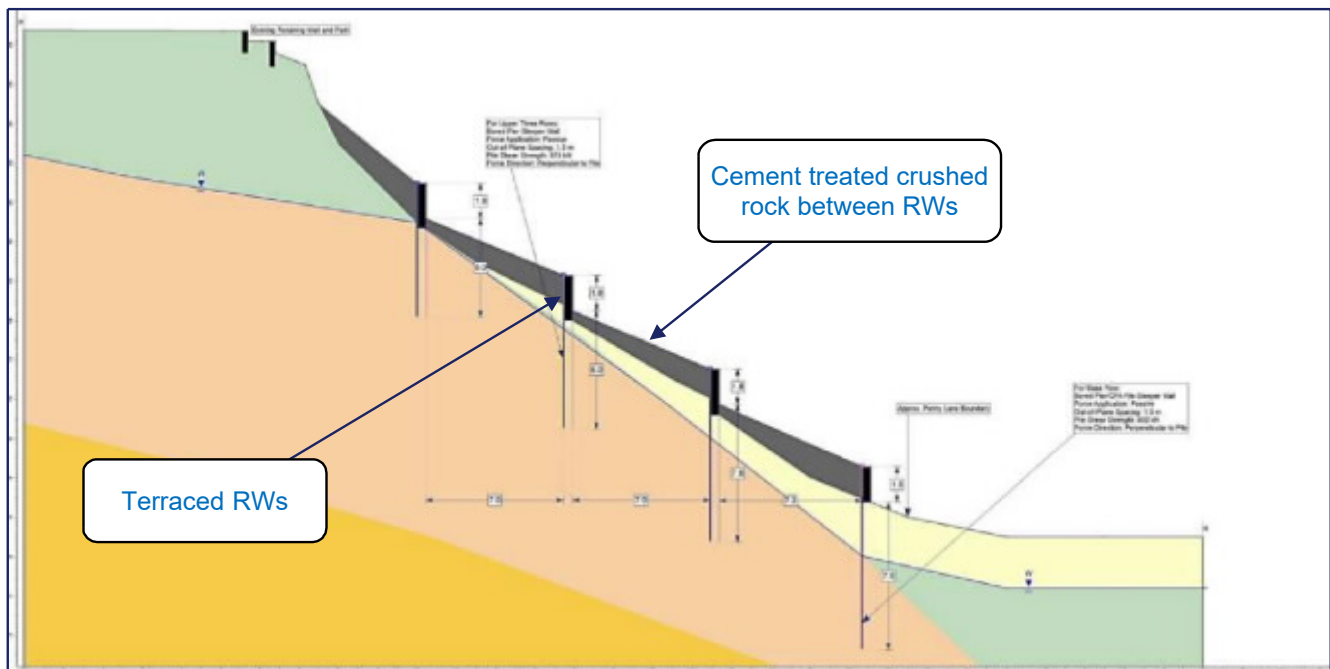
**Inset 4:** CivilTest section with proposed RW remediation (Document 12, pdf page 29). I have added my commentary in blue.

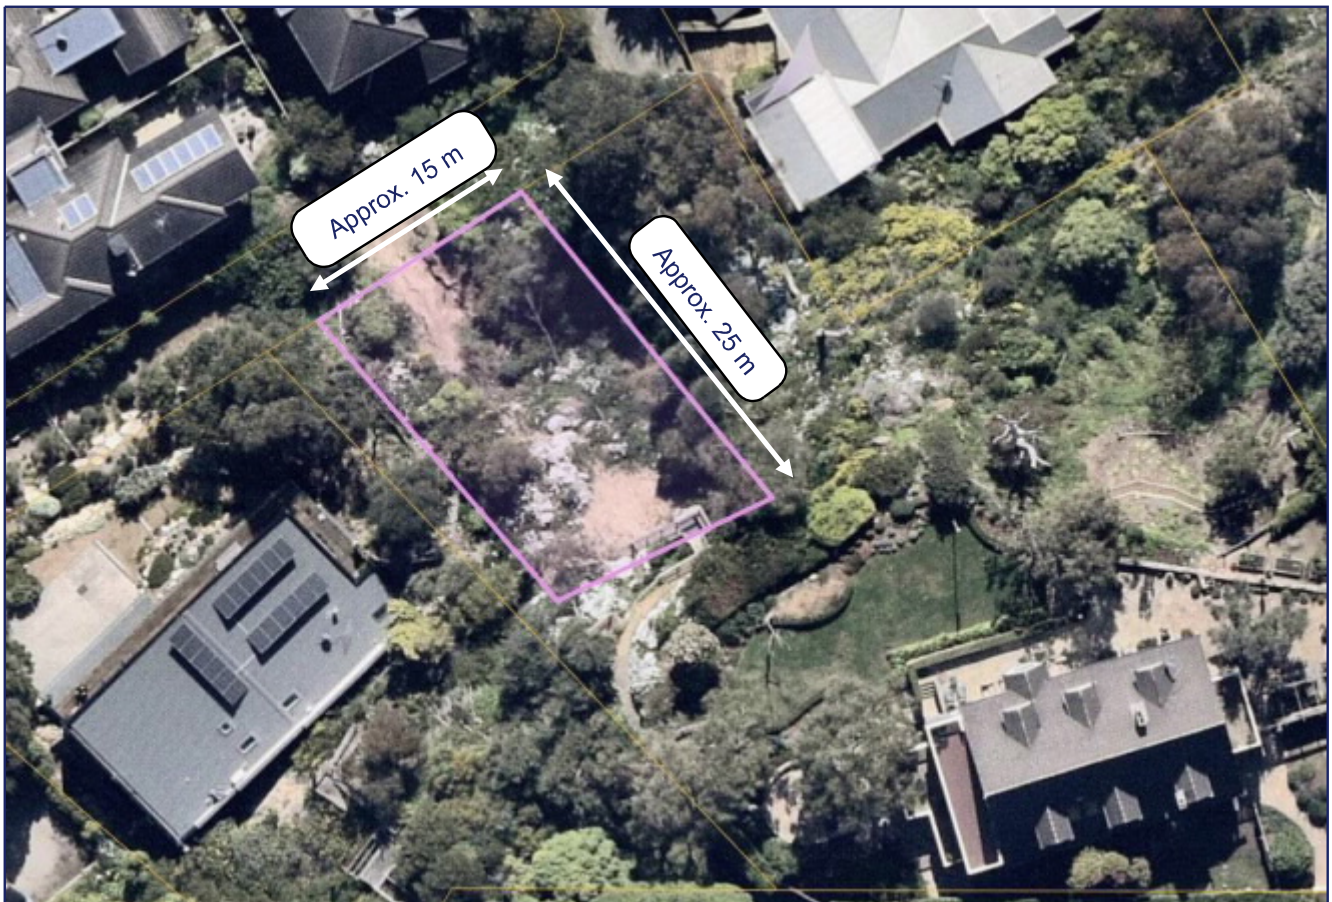
**Inset 16:** Indicative extent of rectification shown in pink (Aerial image from Nearmap)

74. The approximate extent of rectification required is shown in Inset 16. The approximate extents in plan are 15 m wide by 25 m long with 370 m<sup>2</sup> of total area (in plan) to be rectified. I note that the angle of the slope will mean that the actual ground surface area to be rectified is approximately 480 m<sup>2</sup>.
75. The indicated area of rectification extends beyond the observed boundaries of the Landslide to provide stability to the flanks, and to allow for possible uncertainty in the extent of unstable ground (refer to paragraph [26(e)]).

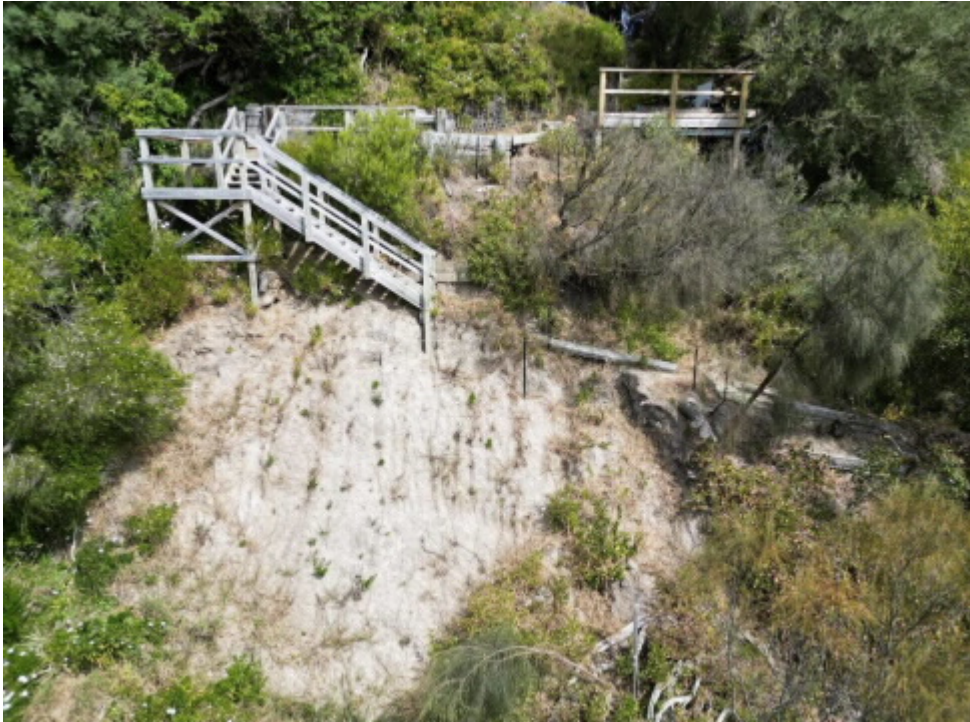
Photo 1 - Upper translational sliding area

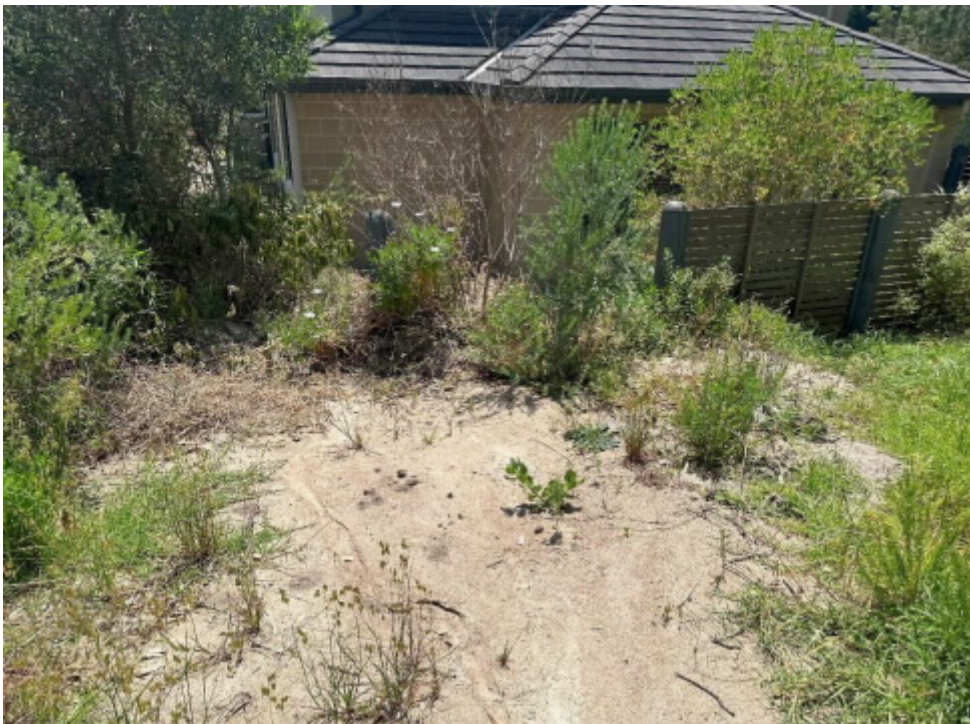
- (b) It was inferred to have initiated as a translational slide followed by mobilisation of failed material into a debris flow which was deposited at the toe of the slope, Photo 2 Appendix C.

Photo 2 - Debris flow runout area, Property P2 visible in background

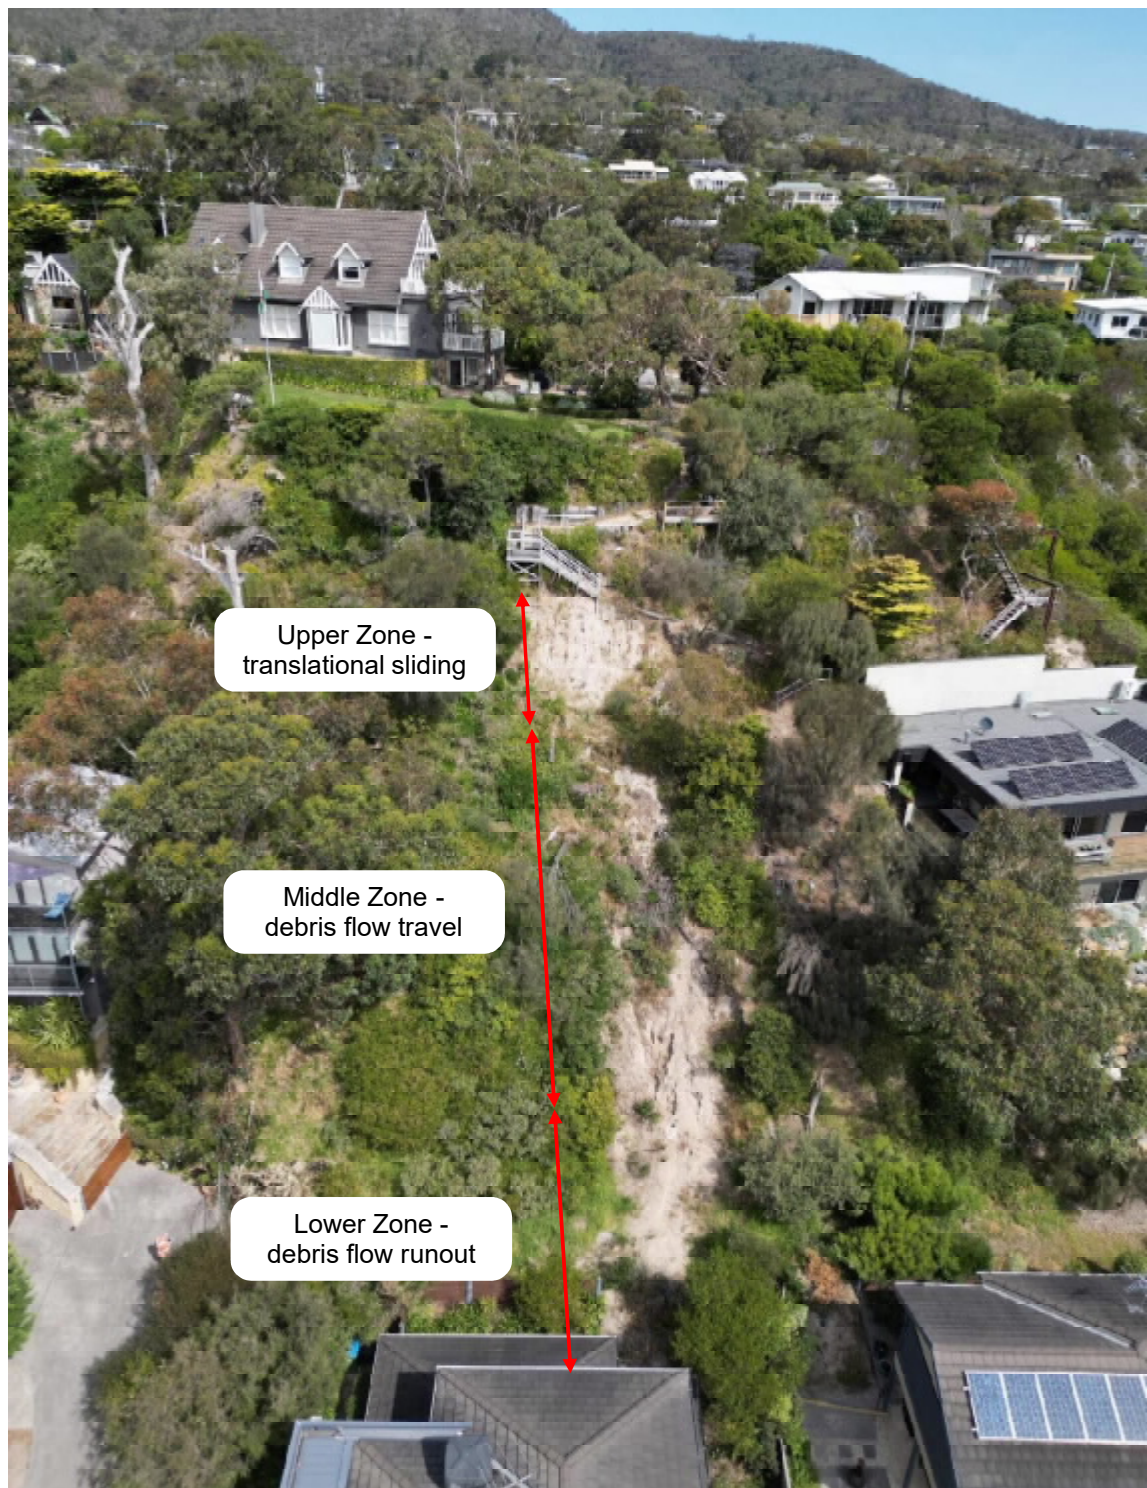
Photo 3 - Landslide Overview, with zones indicated

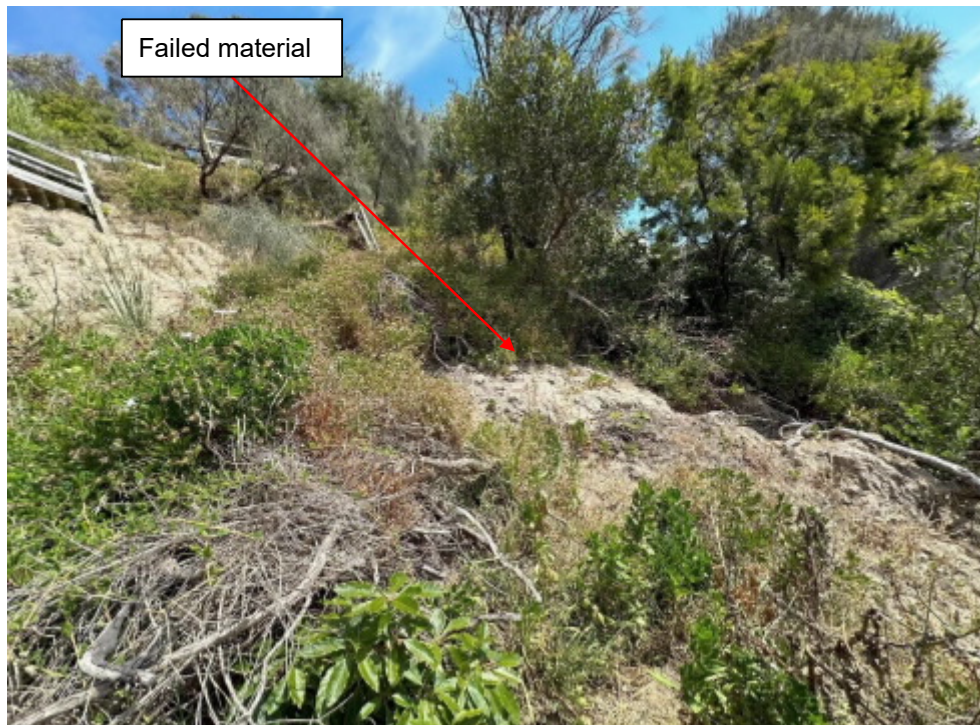
- (d) Disturbed ground that had undergone translational sliding but did not mobilise into a debris flow was observed on the right (western) flank of the Landslide, Photo 4 Appendix C.

Photo 4 - Failed material still on slope

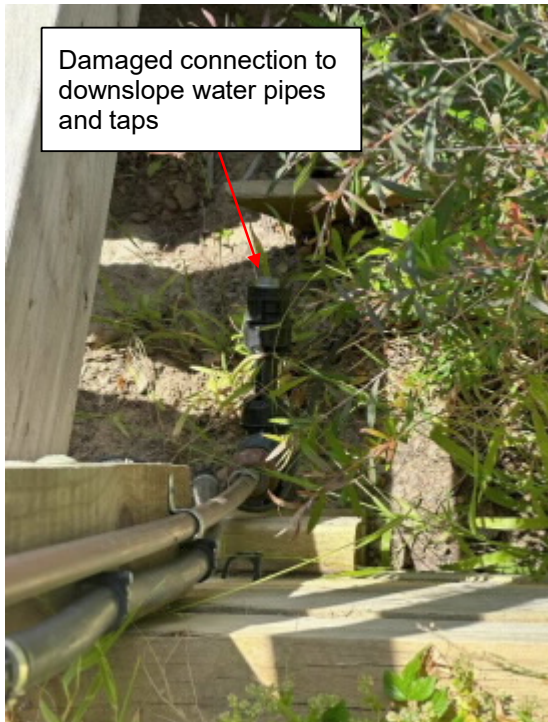
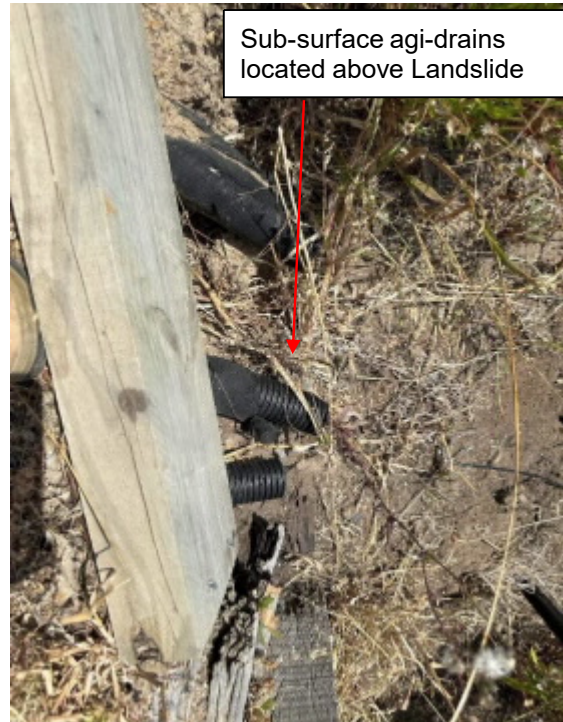
Damaged connection to downslope water pipes and taps

Sub-surface agi-drains located above Landslide

Photo 7 - Water infrastructure including water pipes (on left), and subsurface 'agi drains' (on right)

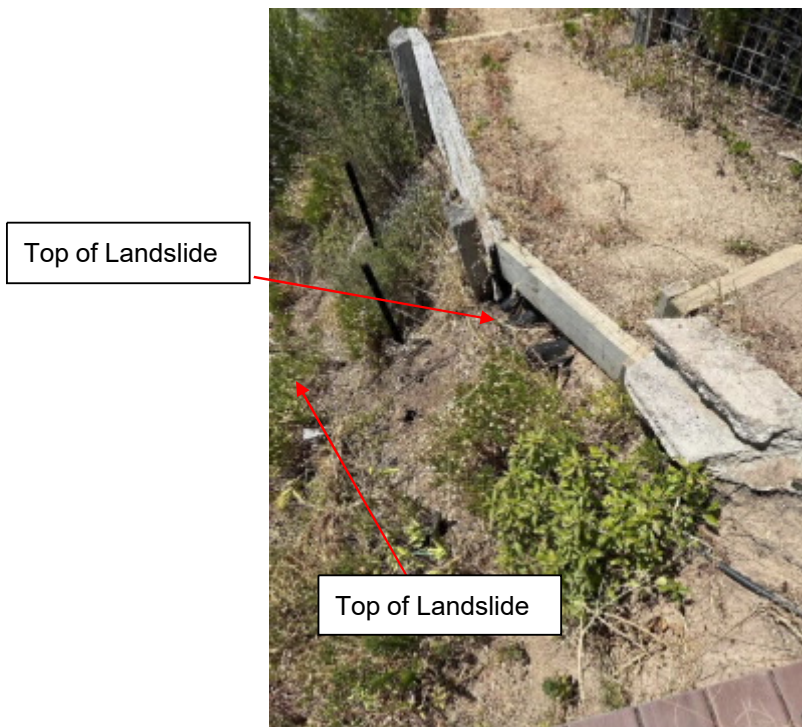
Photo 8 - Path above Landslide, note minor retaining walls and 'agi drains' from Photo 7

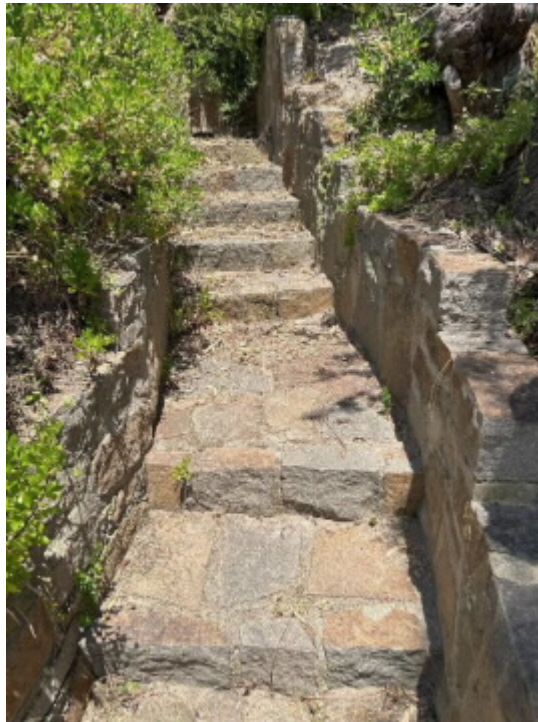
Photo 9 - Granite stairs leading from garden area to path at top of landslide

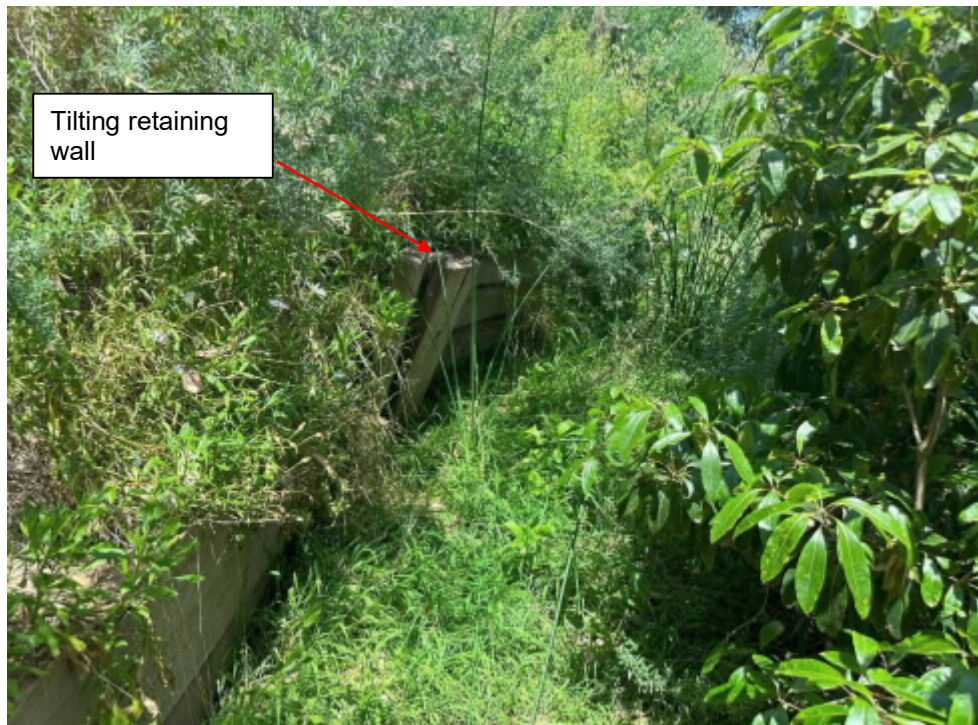
- (g) The condition of RWs across the Site was generally poor, with overturning and bulging RWs observed. A section of RW to the east of the Landslide had significant tilts. This indicates to me possible instability in the ground above the RW and possible structural or geotechnical failure of the RW, Photo 10 Appendix C.

Photo 10 - Tilting retaining walls on left side of Landslide

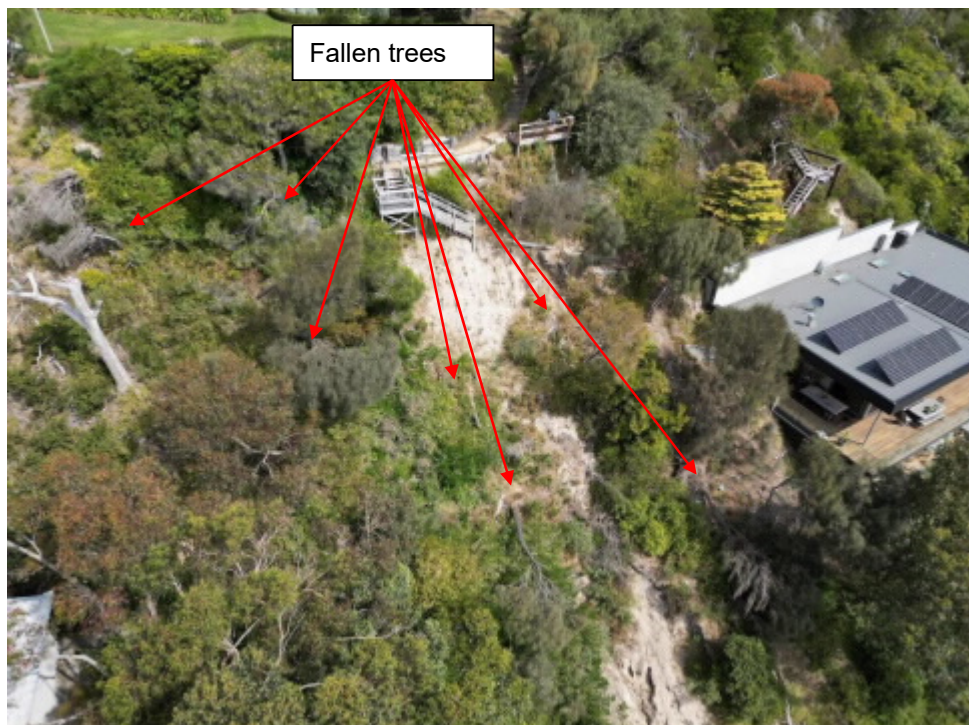
- (h) Numerous fallen trees were observed across the escarpment slope, Photo 11 Appendix C.  
I note that most of the failed trees appear to have failed from causes unrelated to the Landslide, i.e., wind or poor root embedment. I note at least one tree appears to have fallen because of the Landslide.

Photo 11 - Fallen trees

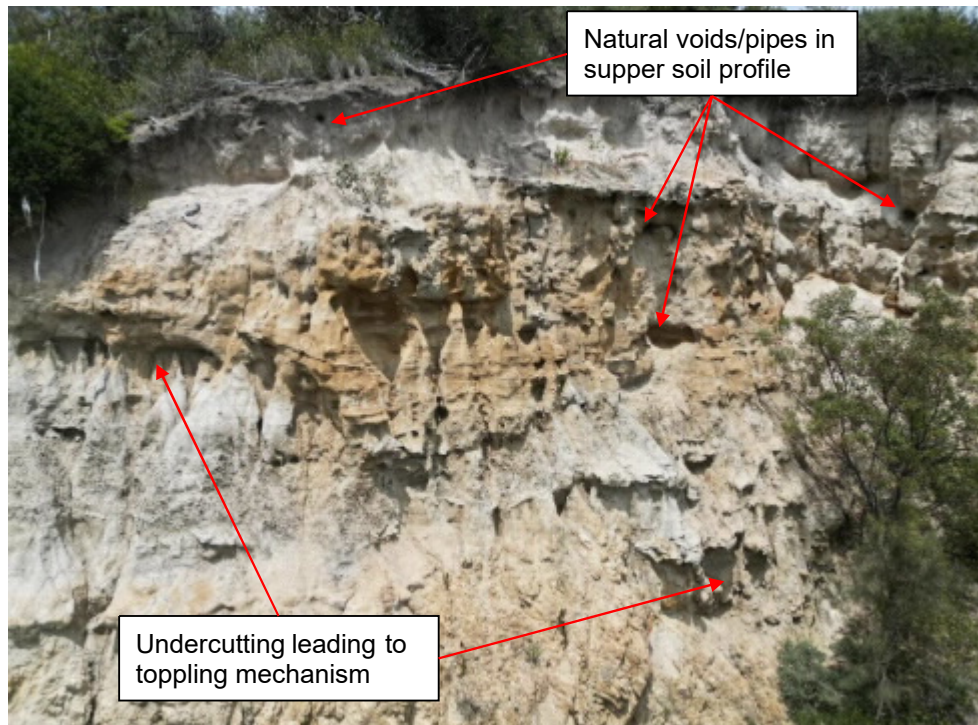
- iii. Granite rock is exposed in shore platform below the road.
    - iv. Steep to sub-vertical upper slopes are inferred to fail by undercutting and erosion of the lower slope leading to toppling style failures, Photo 12 Appendix C.

Photo 12 - Natural cliff profile near Anthony's Nose
