# Expert Opinion Report - Rectification

10-12 View Point Road, McCrae

PSM5226-005R 11 June 2024

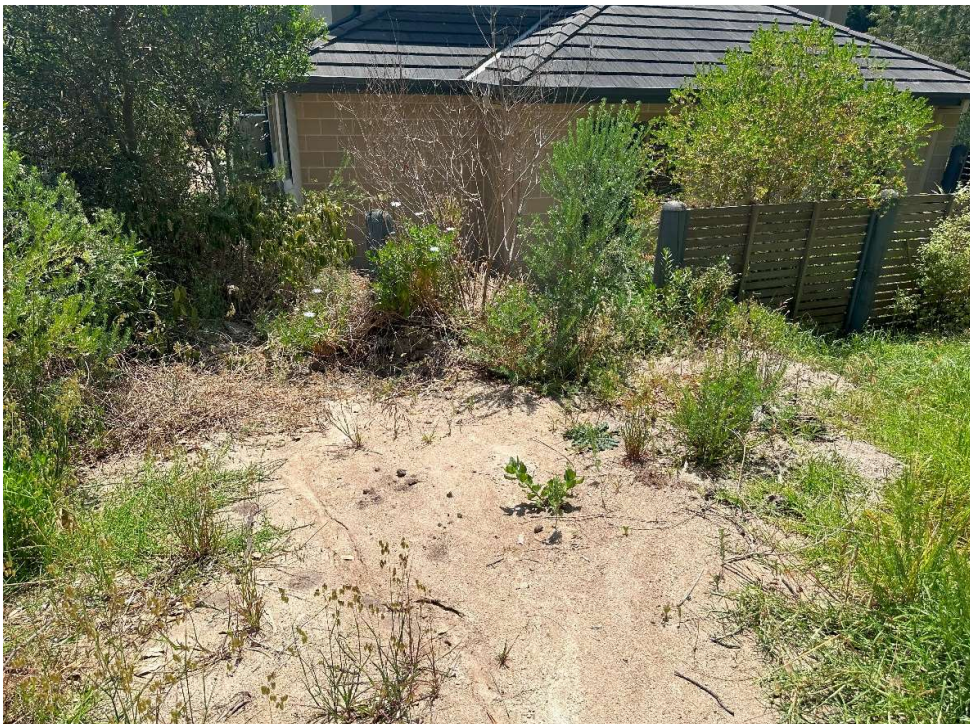
- (b) It was inferred to have initiated as a translational slide followed by mobilisation of failed material into a debris flow which was deposited at the toe of the slope, Photo 2 Appendix C.

Photo 2 - Debris flow runout area, Property P2 visible in background

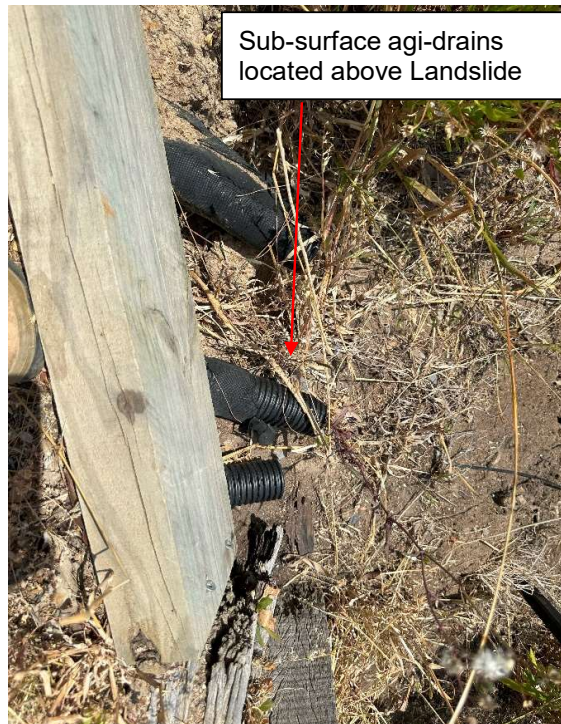
Damaged connection to downslope water pipes and taps

Sub-surface agi-drains located above Landslide

Photo 7 - Water infrastructure including water pipes (on left), and subsurface 'agi drains' (on right)
