PROPOSED RESIDENTIAL DWELLING
14 VIEW POINT ROAD
McCRAE VIC

PREPARED FOR
FASHAM JOHNSON PTY LTD

JOB NO: 1624-8-R
27 MAY 2011

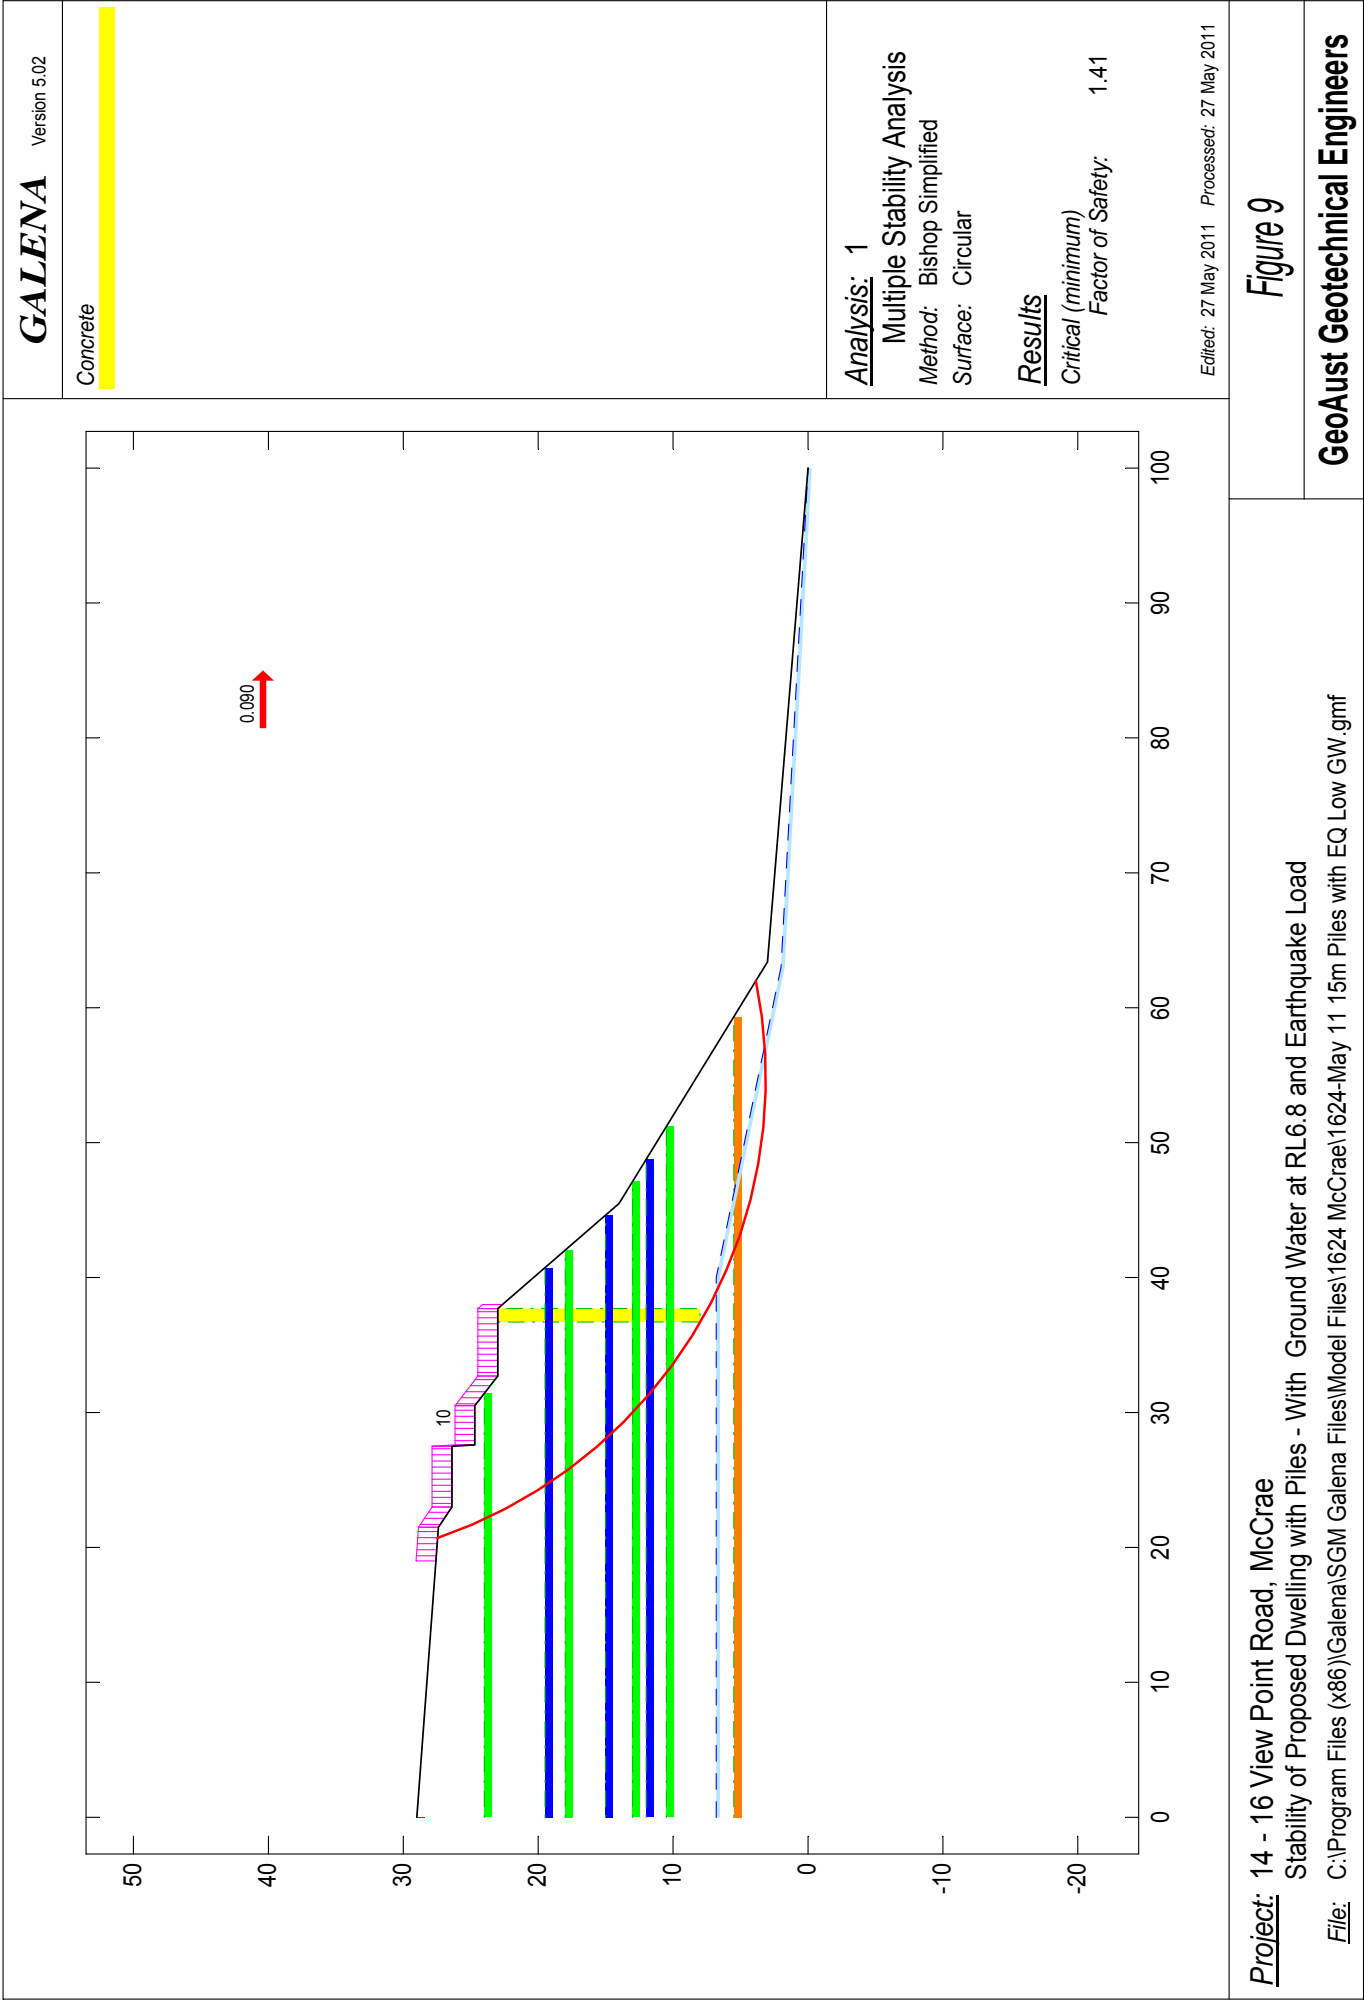
Project: 14 - 16 View Point Road, McCrae
Stability of Proposed Dwelling with Piles - With Ground Water at RL6.8 and Earthquake Load
File: C:\Program Files (x86)\Galena\SGM Galena Files\Model Files\1624 McCrae\1624-May 11 15m Piles with EQ Low GW.gmf

Figure C-9 is the graphical result of the critical stability analysis for the following conditions:

The analysis, which examined the stability of the proposed dwelling at the top of the escarpment, including earthquake loading, returned a factor of safety against failure of 1.41. Whilst this factor of safety is below 1.5 it is considered to be acceptable, given the short duration for which an earthquake load is anticipated to apply.

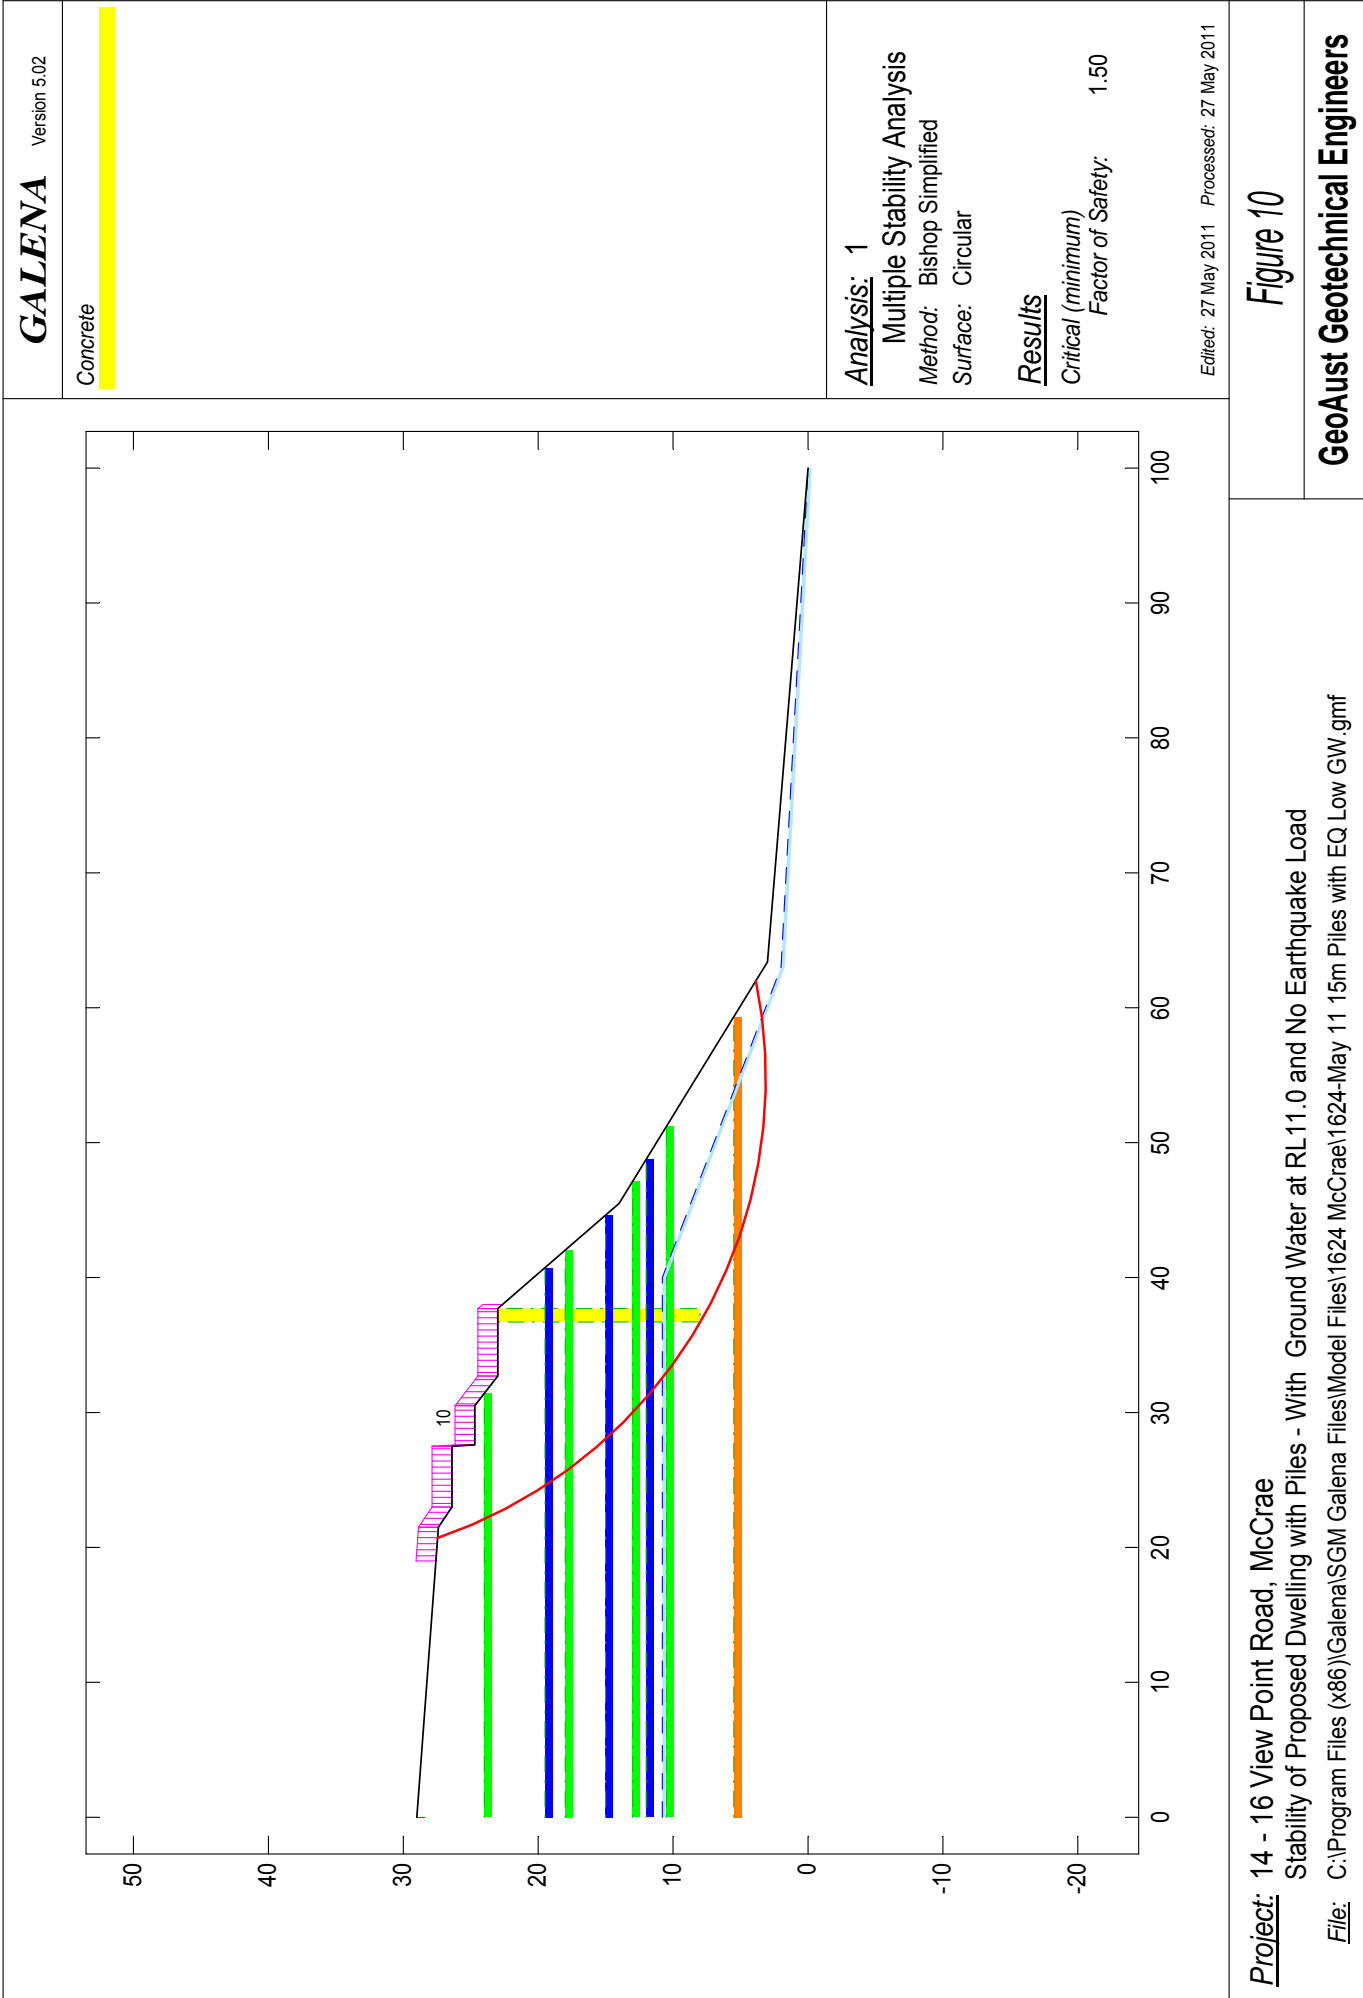
Project: 14 - 16 View Point Road, McCrae
Stability of Proposed Dwelling with Piles - With Ground Water at RL 11.0 and No Earthquake Load
File: C:\Program Files (x86)\Galena\SGM Galena Files\Model Files\1624 McCrae\1624-May 11 15m Piles with EQ Low GW.gmf

Figure C-10 is the graphical result of the critical stability analysis for the following conditions:

The analysis, which examined the stability of the proposed dwelling at the top of the escarpment, assuming a significant increase in the ground water level (4.2 metres) underlying the site, returned a factor of safety against failure of 1.50. This factor of safety is considered to be acceptable for the proposed development.

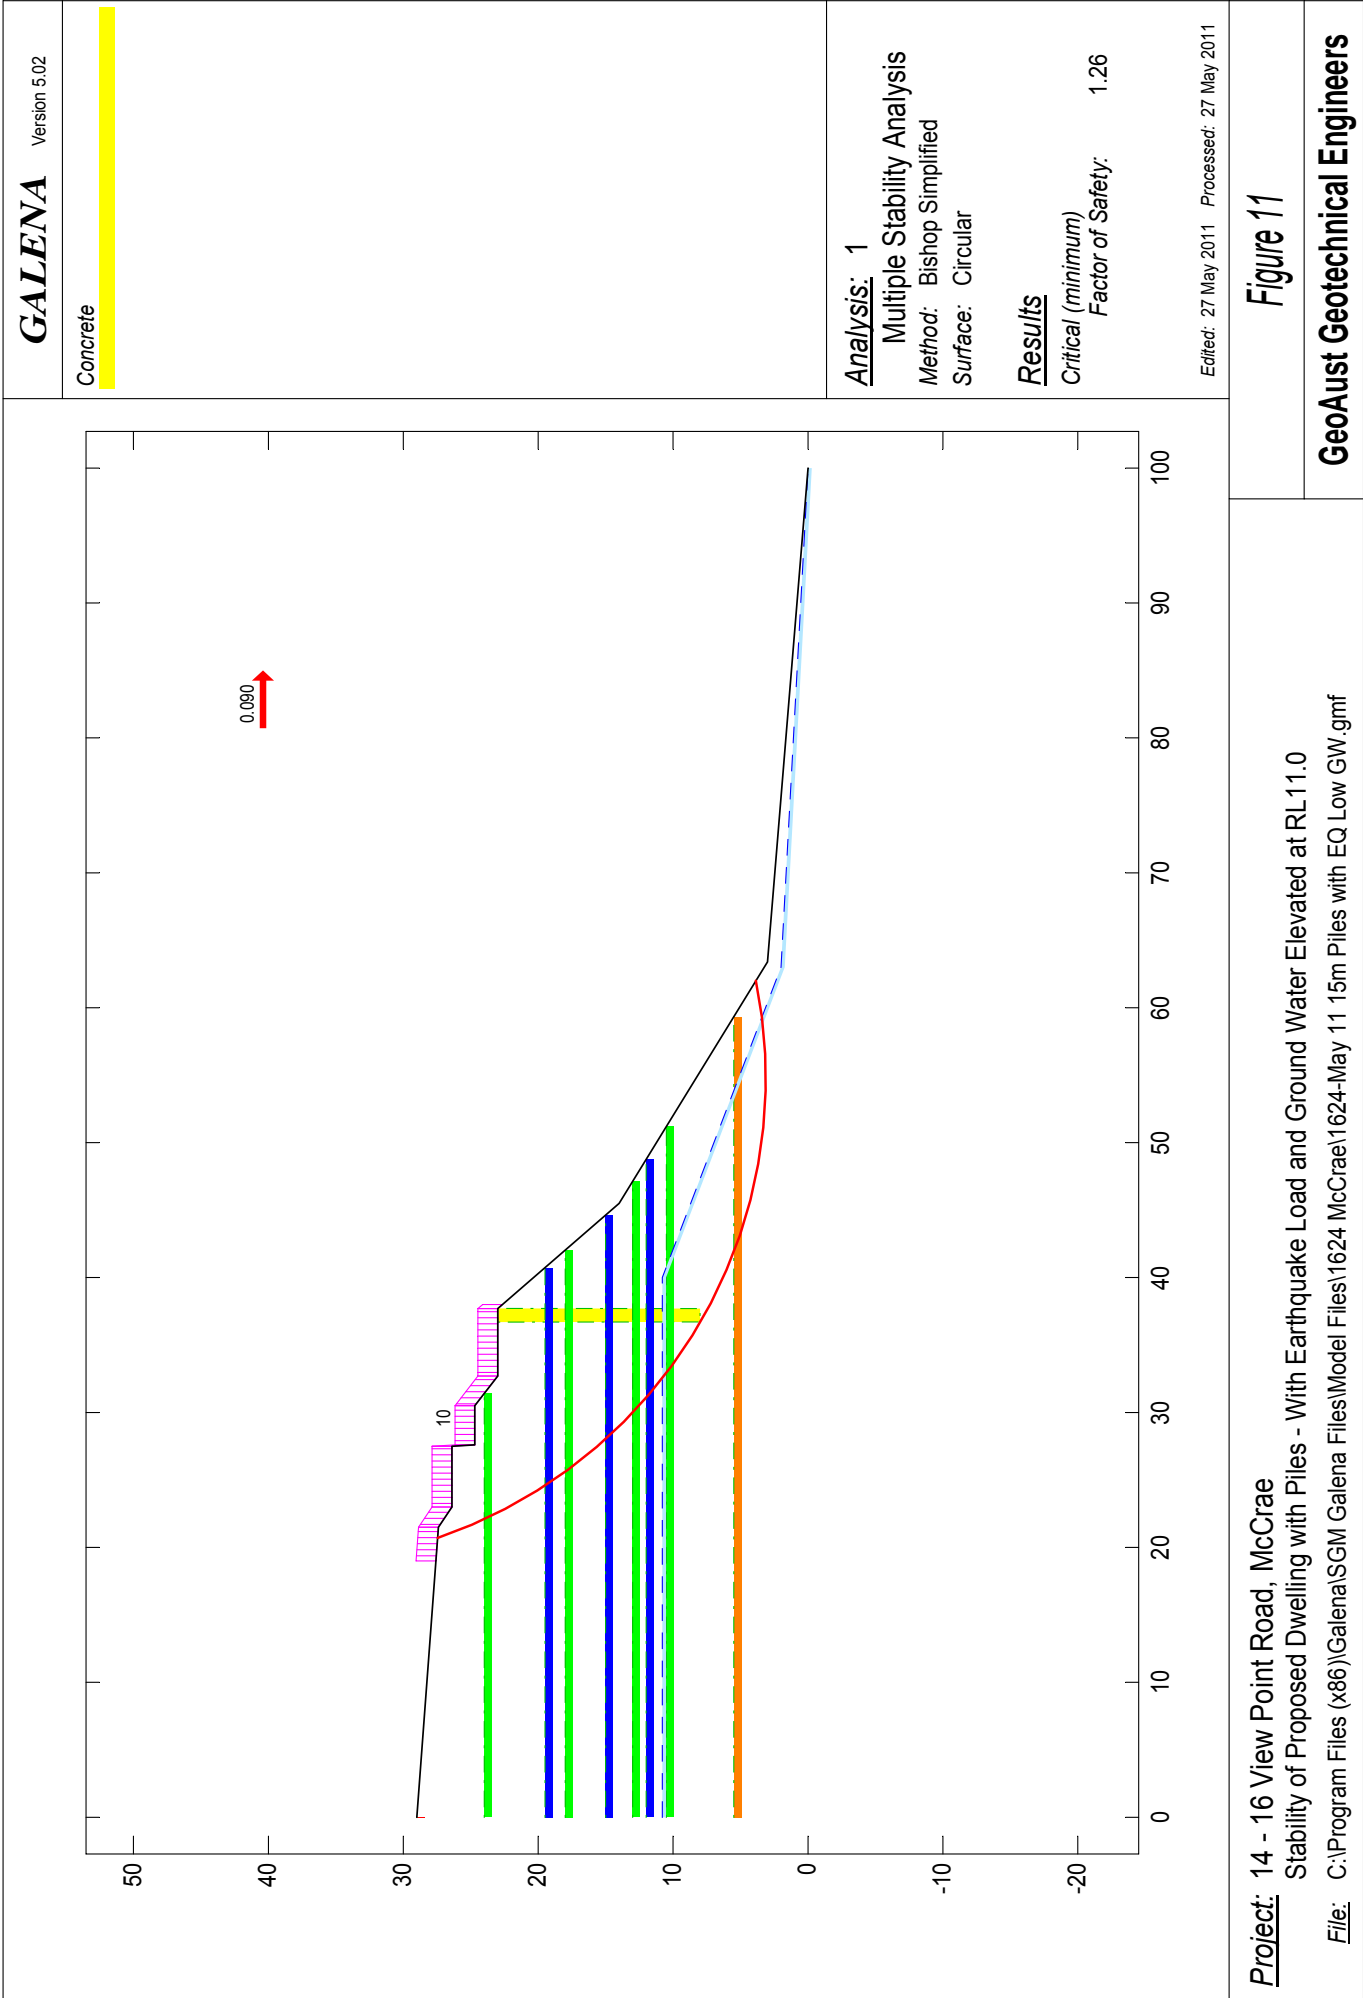
Project: 14 - 16 View Point Road, McCrae
Stability of Proposed Dwelling with Piles - With Earthquake Load and Ground Water Elevated at RL11.0
File: C:\Program Files (x86)\Galena\SGM Galena Files\Model Files\1624 May 11 15m Piles with EQ Low GW.gmf

Figure C-11 is the graphical result of the critical stability analysis for the following conditions:

The analysis, which examined the stability of the proposed dwelling at the top of the escarpment, assuming a significant increase the ground water level (4.2 metres) and included earthquake loading, returned a factor of safety against failure of 1.26. Whist this factor of safety is considerably below 1.5, it is considered to be acceptable, given the short duration for which an earthquake load is anticipated to apply and the highly improbable coincidence of both and an earthquake occurring and a substantial increase in elevation of the ground water table underling the site.
