GEOTECHNICAL INVESTIGATION OF
STABILITY OF GULLY BETWEEN
THE EYRIE & POINT NEPEAN ROAD,
MCCRAE

MORNINGTON PENINSULA SHIRE
COUNCIL

SEPTEMBER 2007

REF NO: 207141Report01.1.doc

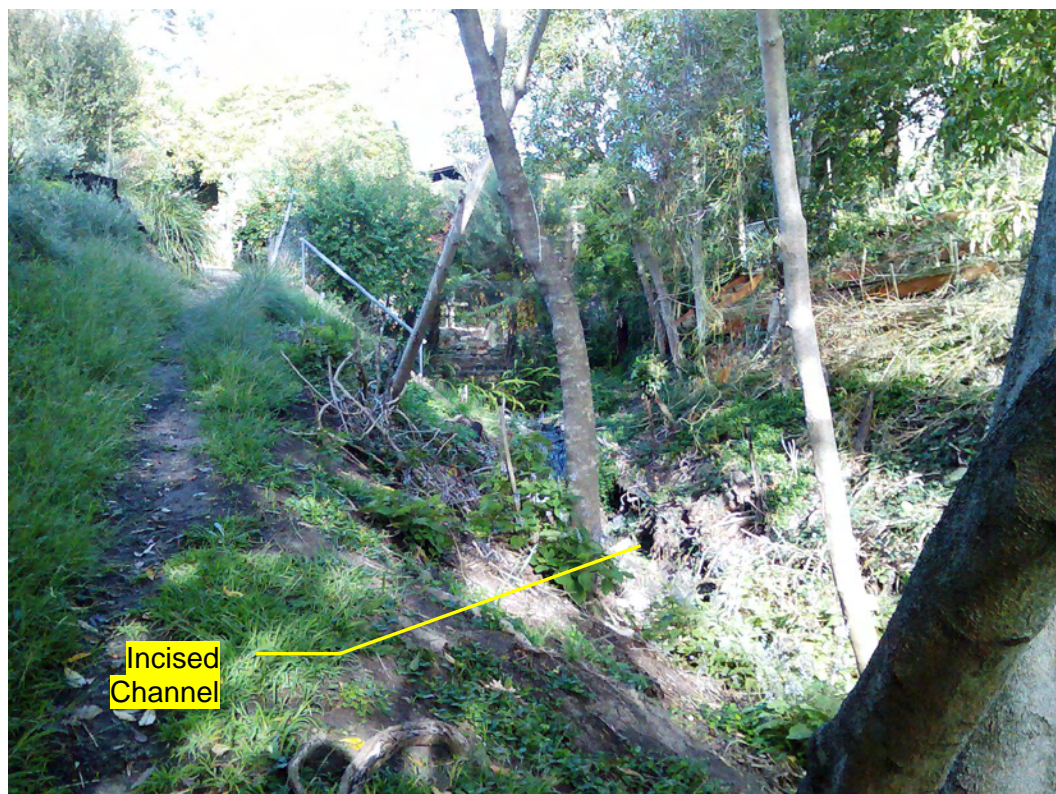
Plate 3.B: Upstream view in vicinity of Section D-D'

The water course in this area appears to run in an incised channel at the base of the gully, although at the time of the investigation the water course was not running. The channel is incised up to 1.0m below the general base of the gully.

This section of the gully appears relatively stable with the exception of some possible soil creep in the upper soils.

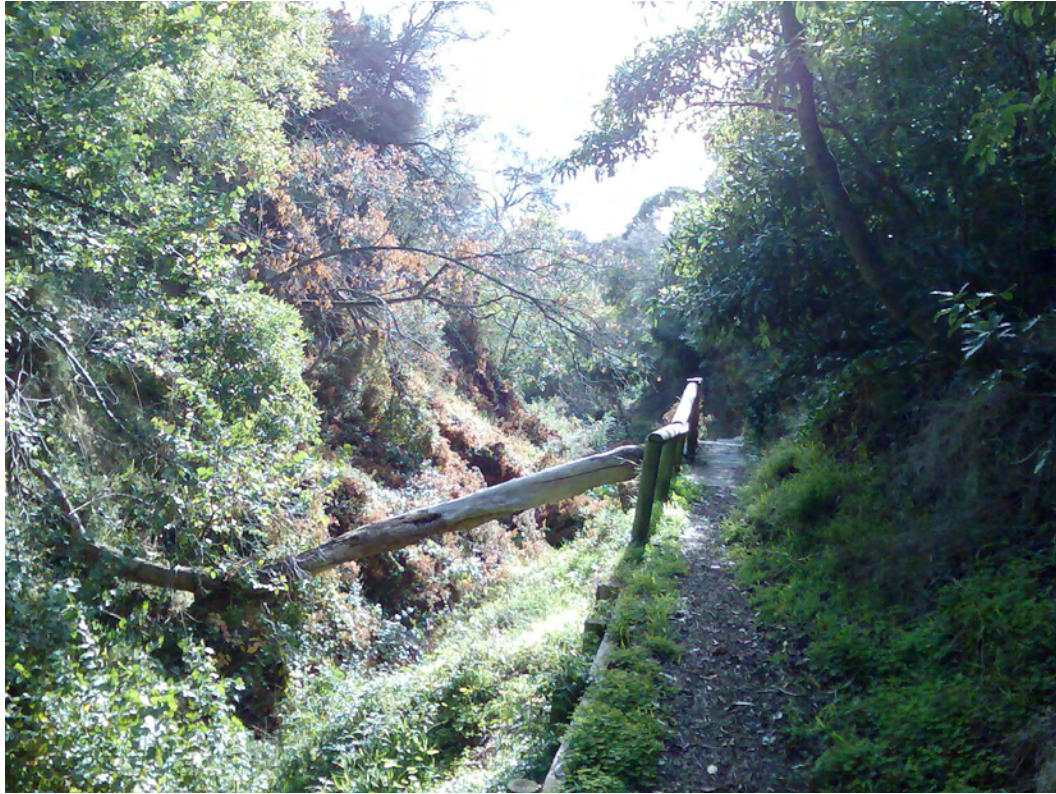
Plate 3.C: Downstream view looking towards Section C-C'

Downstream of the sewer pipe the gully significantly deepens to greater than 10m depth and the base of the gully widens to several metres. The grade of the gully also significantly increases. (Plate 3.C) The gully banks also have a slope of approximately 1V:1H. Significant erosion of the toe slope banks is occurring in this section resulting in the banks being undermined (Plate 3.D) and resultant collapses are occurring. In addition the walking path has been undermined in areas. This required the construction of a boardwalk. The boardwalk has subsequently collapsed. (Plate 3.E)

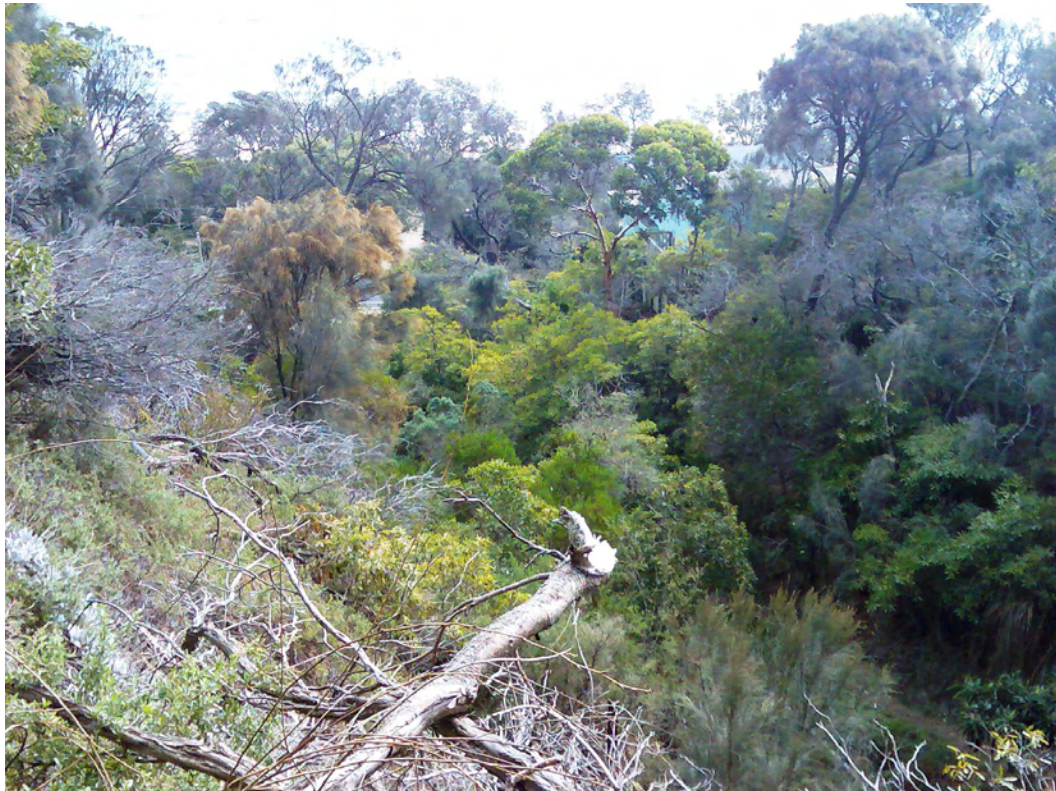
Plate 3.F: View from south side of gully looking down towards Section B-B'

The banks of the gully are well vegetated with trees and a general groundcover. However there are numerous trees that are leaning or have fallen. (Plate 3.F)

It is recommended that the removal of vegetation be minimised. Any unsafe trees such as leaning trees should be removed, but grubbing of the stump should not be carried out.

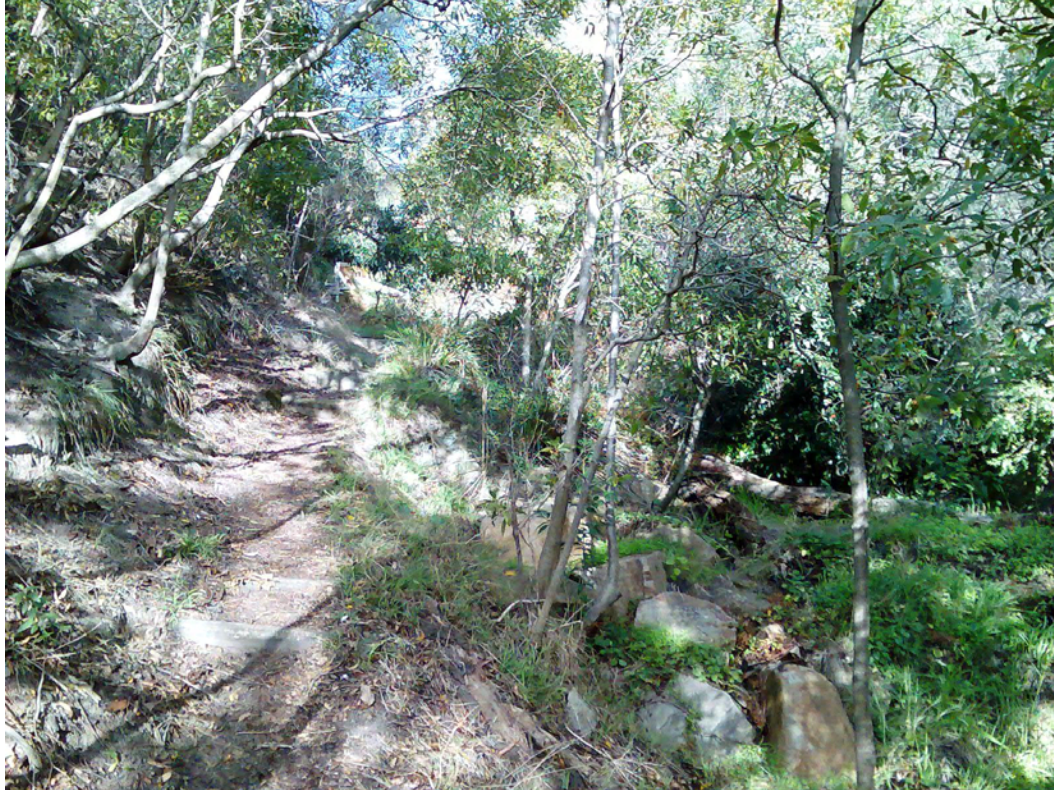
Plate 3.G: Upstream view between Sections A-A' and B-B' showing rock beaching

In the vicinity of Section B-B' the base of the gully begins to broaden and the slopes of the banks decrease to approximately 4V:5H. (Plate 3.G) The rock beaching starts in this area. Leaning trees in this area indicate that creep movement is occurring.

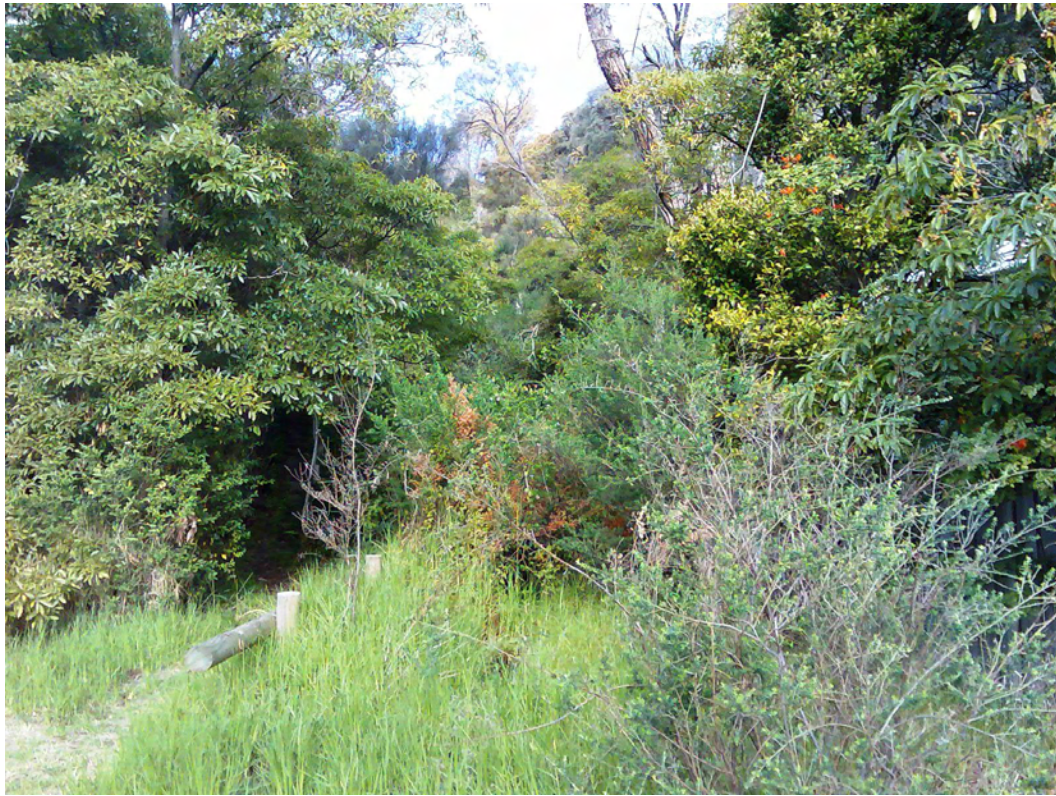
Plate 3.H: Upstream view from Point Nepean Road

Below Section A-A' the gully begins to flatten out and the banks merge with the escarpment. At Point Nepean Road the grade becomes almost flat with a slight slope down towards the beach. (Plate 3.H)

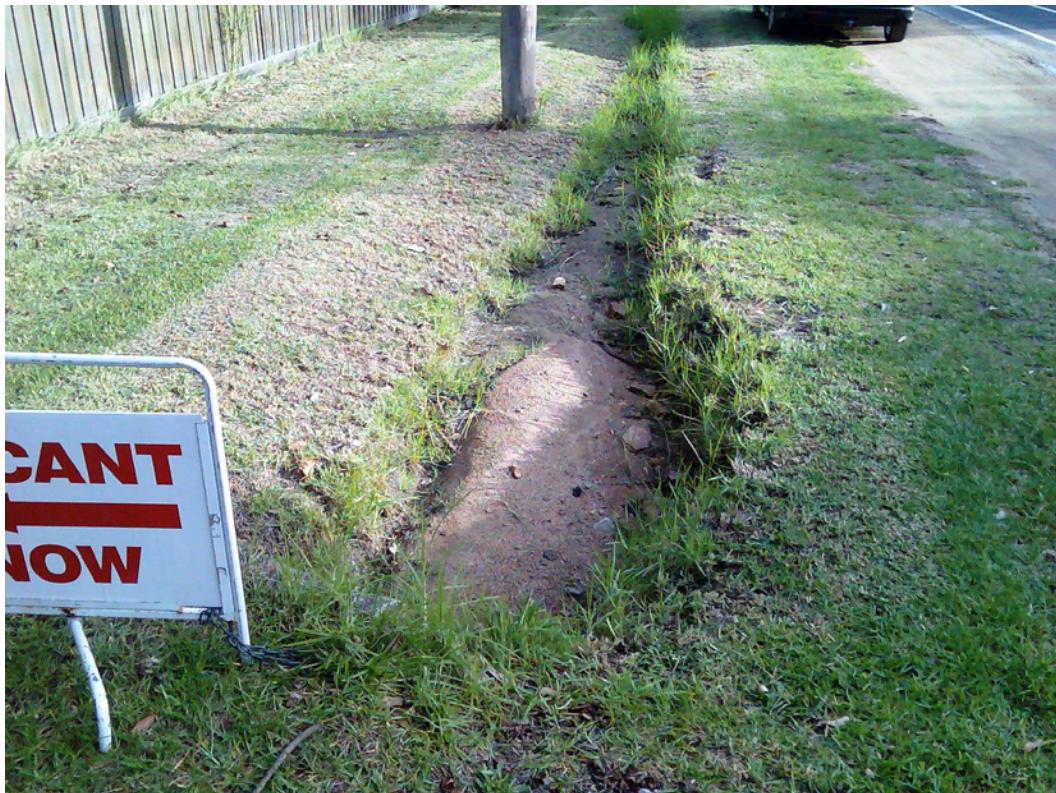
Plate 3.I: Blocked street drainage on Point Nepean Road

At Point Nepean Road the watercourse has a right angle bend to the south and joins the street drainage. The street drain often becomes blocked with soil washed down from the gully. (Plate 3.I) This, in combination with high water flow during significant storm events, can result in overflow of the drainage channel and water flow over the road.

It is recommended that the velocity dissipation structure near Point Nepean Road incorporate a sand and waste trap.
