Landslip McCrae Jan 25 3 Penny Lane and 10-12 View Point

The Council consulting Engineer (PSM) has completed a preliminary risk assessment of the affected dwellings which includes:

- 10-12 View Point Road (Above the Landslide, source of the Landslide) referred to herein as Property "P1".
- 3 Penny Lane (impacted by debris) – Property "P2"
- 607-609 Point Nepean Road (downstream of potential landslide activity – Property "P3".

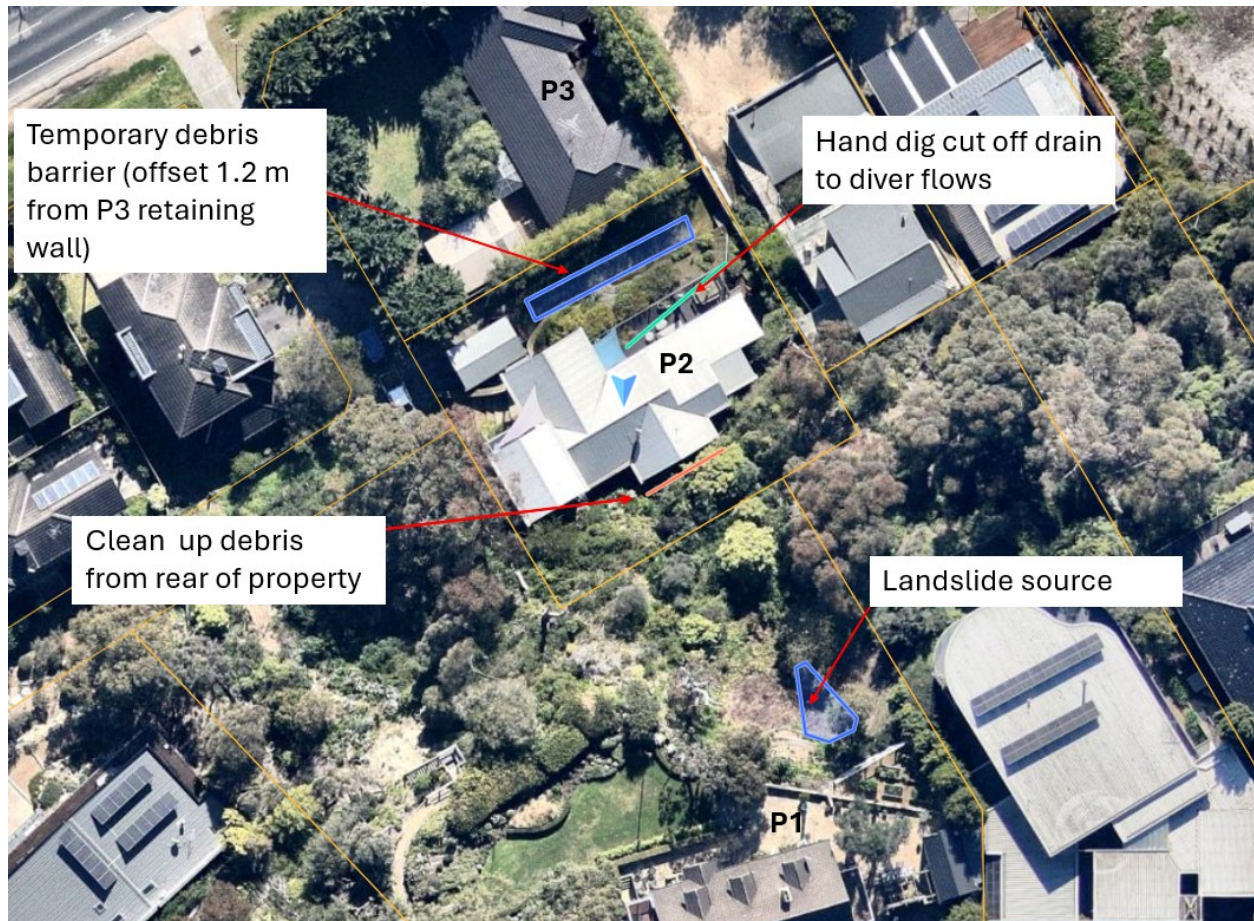
- Initiated from in front of a recently constructed retaining wall on P1 and has impacted the rear of P2, Photo 1.
- The Landslide was initiated on the night of Sunday, 5th January 2025, following two days of dry, hot weather. Rainfall **followed** the event.
- Translational slide which has evacuated materials down to the natural granitic soils at the base of the Landslide.
- A sub-vertical head scarp up to 1.5 m high, Photo 2.
- A significant portion of the headscarp was saturated and with measurable flow of water (0.15-0.2 L/s) flowing along the base and down the hill. The seepage was observed at the contact with surficial soils (fills/ancient landslide debris) and the underlying natural soils.
- Volume in the range of 15 to 20 m³.

P1	<ul style="list-style-type: none"> • Monitor slopes immediately behind the failure for signs of change and or deterioration. • Cease all garden watering in the vicinity of the Landslide. • Surficial cut off bund with Coir logs or sandbags behind the retaining wall to direct surface water away from the head scarp. • Seek advice from their engaged Geotechnical engineer to make safe as best as is practical.
P2	<ul style="list-style-type: none"> • Monitor slopes immediately behind the house for signs of change and or deterioration. • Remove mud from between the house and the rear retaining wall. Do not disturb mud upslope of the retaining wall unless cutting temporary cut off drains. If the retaining wall has collapsed, seek further advice. Caution in areas of potentially unstable walls of the dwelling. This may require a spotter to monitor uphill slope behaviour. • Divert surface water around the dwelling (use hand cut off drains, Coir logs/sand bags). • Install a secondary cut off drain under the deck (hand dig, divert to east, Figure 1 • Install weep holes in northern most retaining wall as required (following installation and assessment of hand dug cut off drains/Coir logs) • Install one to two x ballasted shipping containers (2 x 20 ft or 1 x40 ft containers), 2.44 m wide) in the northern most section of lawn, Figure 1. These should be offset from the P3 retaining wall by at least the height of that retaining wall (~1.2m) and be aligned to protect P3. Ballast may be soil, F type barriers or plastic crash barriers filled with water. Temporary tie downs may be required (screw piles or equivalent). The containers should be back tilted into the slope without undercutting the existing retaining walls. This may require local cut/fill to achieve a 5 to 10% back tilt. Where bulk earthworks or retaining wall loading constraints apply, the containers may need to sit on screw piles or equivalent. Further advice should be sought to detail the design.
