PSM5665-047E Monitoring update 26 February 2025

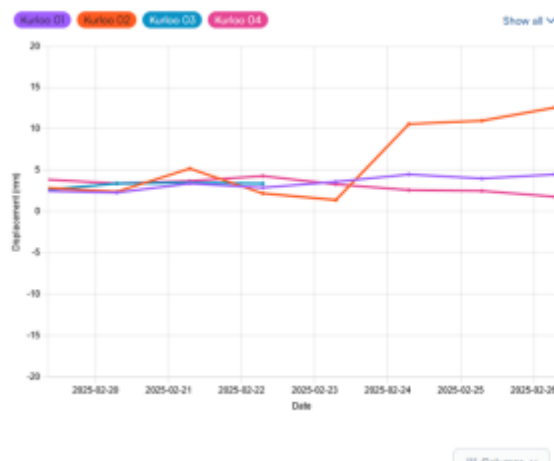
Inset 1 – Excerpt from GPS sensor system

- ☐ * Creep of the landslide head scarp on 6 and 10 to 12 View Point Road is ongoing. i.e. the landslide is active. The rate of relative creep measured with the radar has decreased from late January 2025 when we observed up to 10 mm/day to approximately 3 mm/day in late February 2025. These numbers are relative to the radar and need to be calibrated with regards to ongoing prism monitoring.
- ☐ * The GPS sensor immediately adjacent to the retaining wall on 10-12 View Point road supports that localised creep is occurring, Inset 1. However, it indicates the movements are increasing in this area (accelerating trend rather than a slowing trend observed on the radar). Note this area is in a blind spot of the radar.
- ☐ * Radar, tilt and GPS sensors all support that the immediate vicinity of the landslide headscarp is subject to creep.

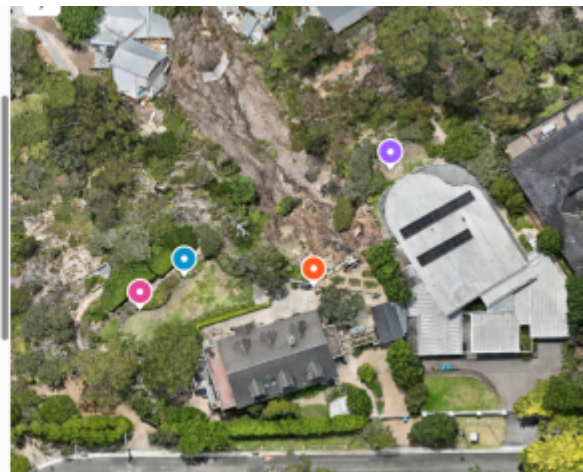
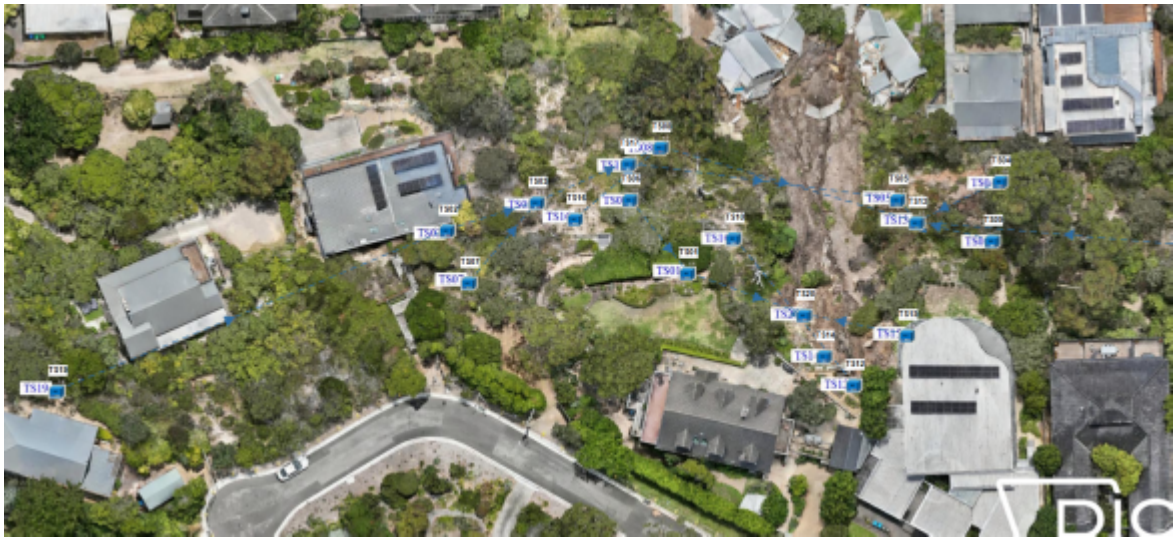
Inset 2 – Excerpt from Tilt sensor system

Tilt sensor locations are provided in Inset 2.

- ☐ * Tilt monitoring systems on other properties are in the process of being calibrated against total station surveys of a prism array that has been installed. This is expected to take a further two weeks as repeat weekly surveys are conducted. This calibration does not stop the tilt sensors from being useful to inform temporary access under the current risk assessed proposal from MPSC
