25/03/2025 – 10-12 Viewpoint Road MCCRAE inspections

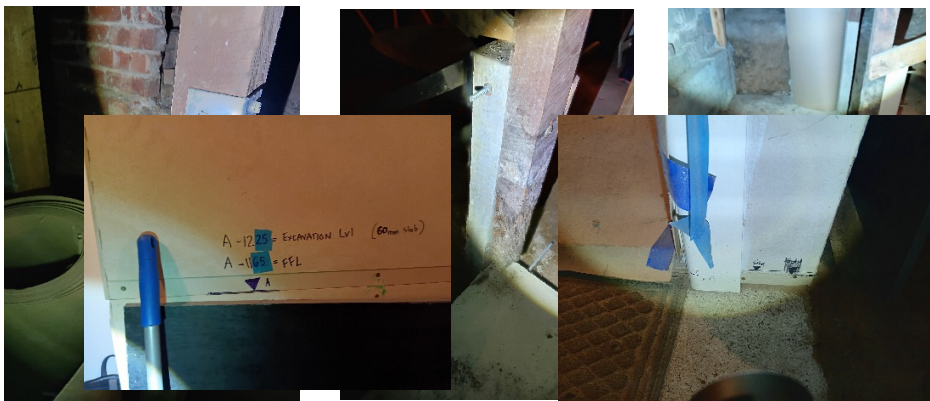
- 7 Altered stumps
- 5 brand new
- 3 steel beams supporting 3 missing stumps
- Plans to put a 60mm concrete slab in the excavated area can be seen on the wall.

Figure 4 - Notes regarding proposed floor levels for concrete and excavation

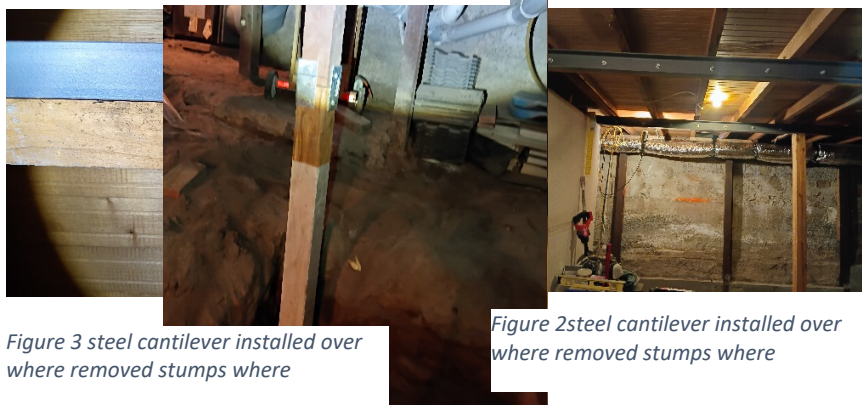
Q – what about the restumping

A – Around the same time, with concrete pads.

Figure 3 steel cantilever installed over where removed stumps where

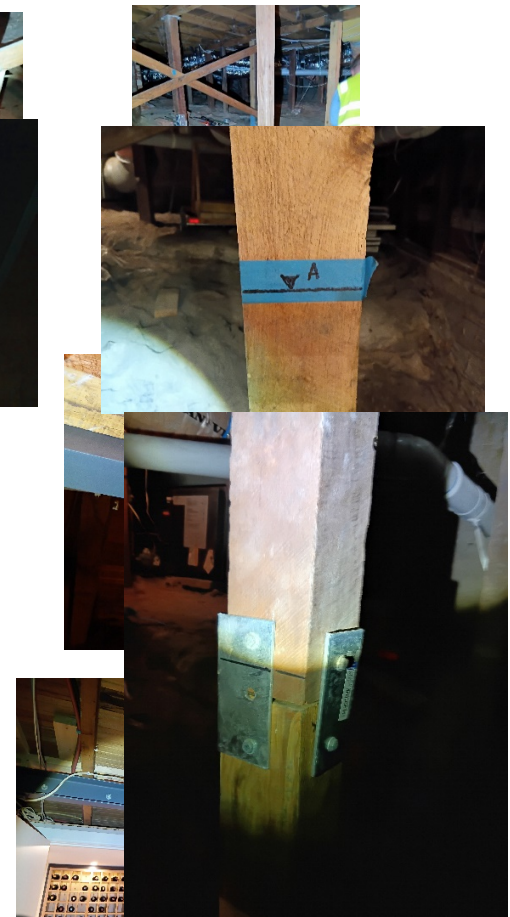
Figure 2 steel cantilever installed over where removed stumps where
