4 April 2025

**Our Ref:** 1222044-15  
**WR:** 21958

**RE: 10-12 View Point Road MCCRAE**

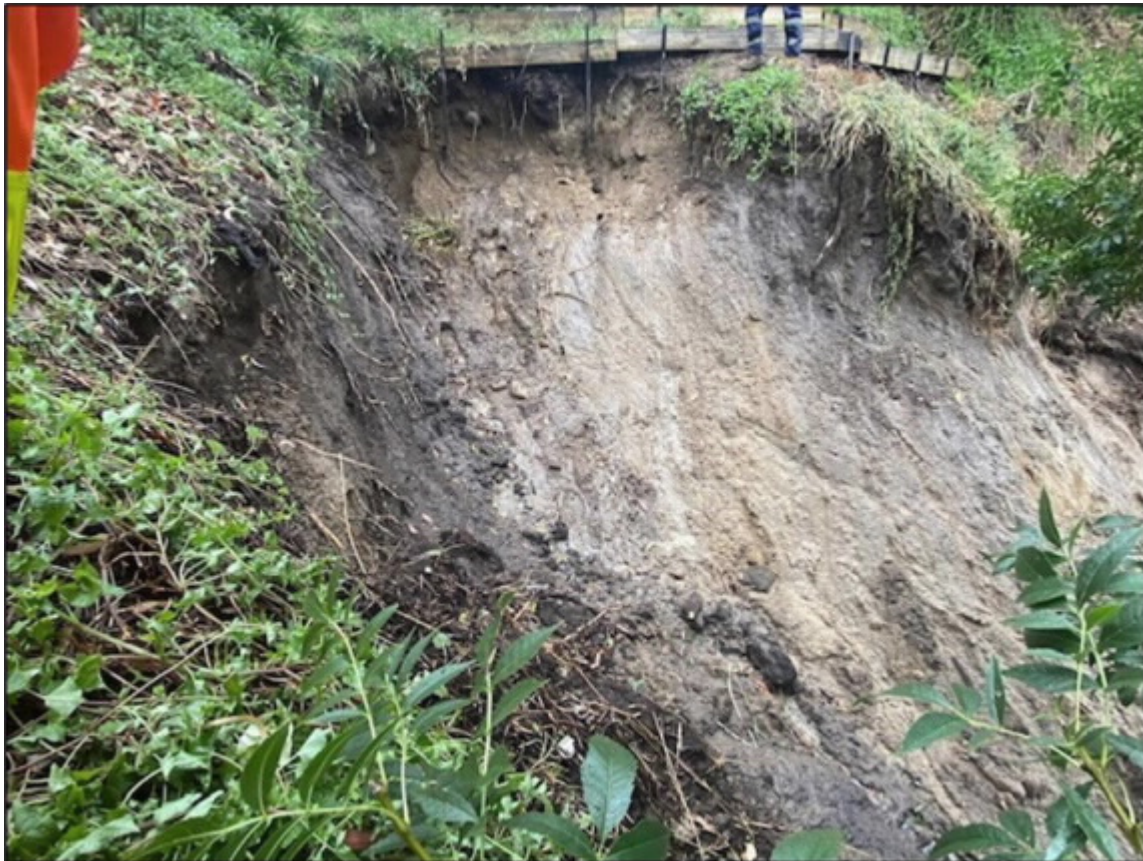
Upon inspection of the site, it was observed that the location of the landslide appears to be a natural gully, perhaps even a very old landslide site based on the concave shape of the surrounding topography. The landslide location has a steep angle of repose, although not dramatically steeper than the rest of the surrounding area. At the time of inspection on 6 January 2025, the existing retaining wall appeared stable after the landslide, although this would end up collapsing the following week during the second landslide on 14 January 2025.

**Photograph 1:** Conditions at the time of the site visit on 6 January 2025

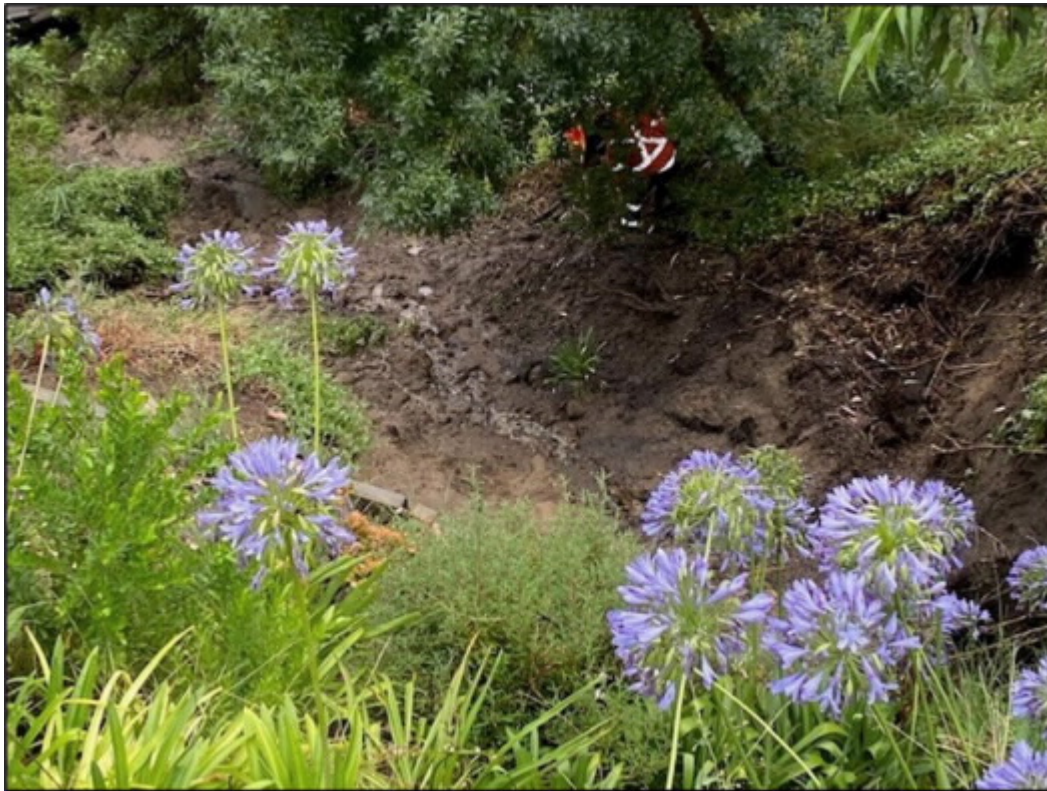
**Photograph 2:** Water flow observed downslope of 6 January 2025 landslide, originating from base of landslide headscarp

At the time of the 6 January inspection, a steady stream of groundwater was observed to be emanating from the lower section of the headscarp, approximately 15-20 litres per minute (not directly measured) downstream flow, shown in Photograph 2. The base of the headscarp was observed to be approximately 4-5 metres below the ground surface level behind the retaining wall. The soils in the immediate vicinity of the base of the headscarp were observed to be moist or wet, and the soils above the level where the groundwater was emanating were observed to be dry.

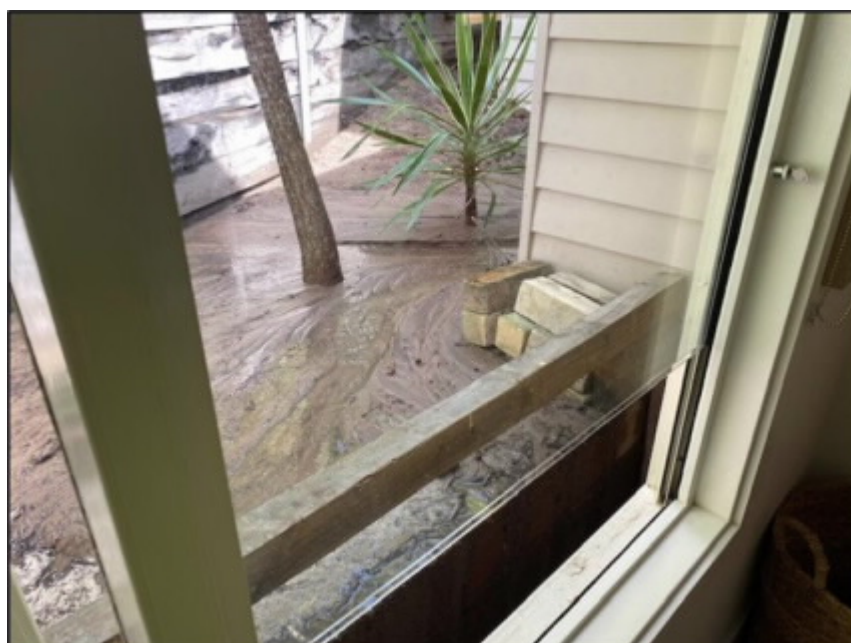
The streamflow was making its way down to the property at 3 Penny Lane (Photograph 3), which at the time was only partially damaged (Photograph 4).

**Photograph 3:** Streamflow from scarp (photograph taken from inside 3 Penny Lane)

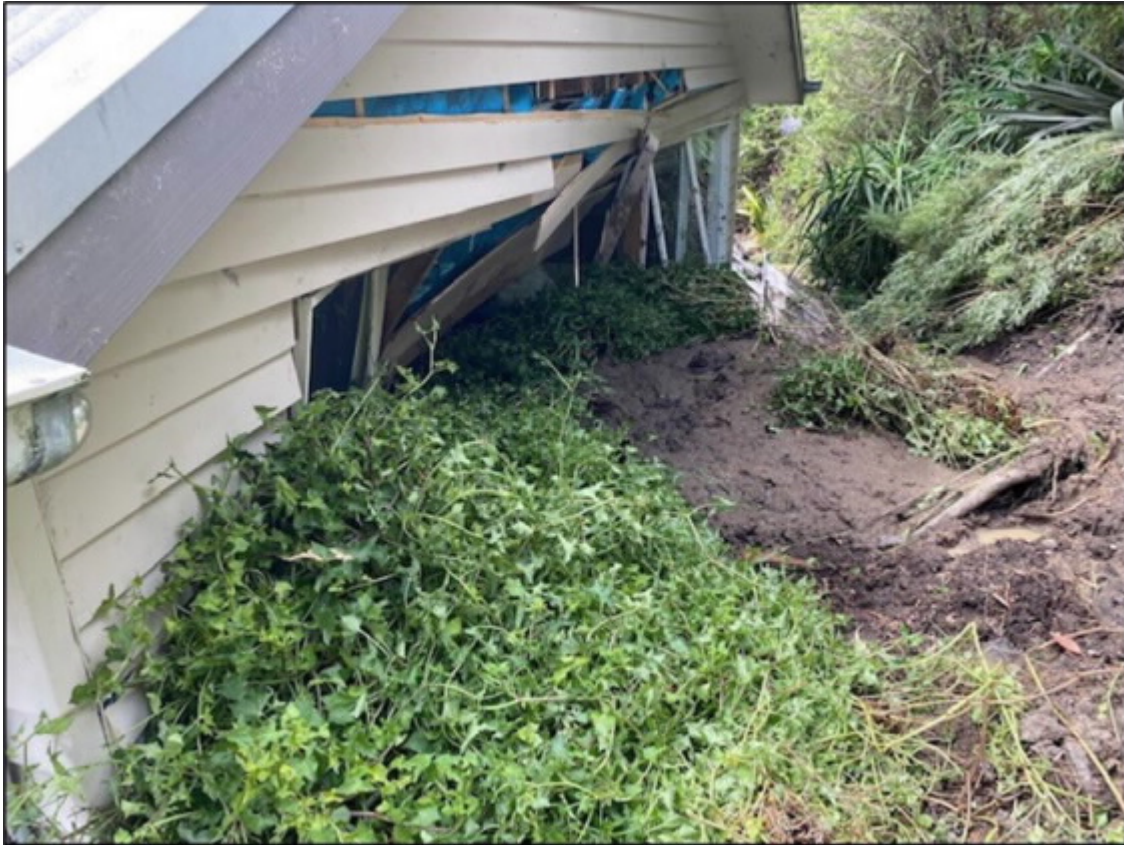
**Photograph 4:** Damage to 3 Penny Lane property from 6 January 2025 landslide

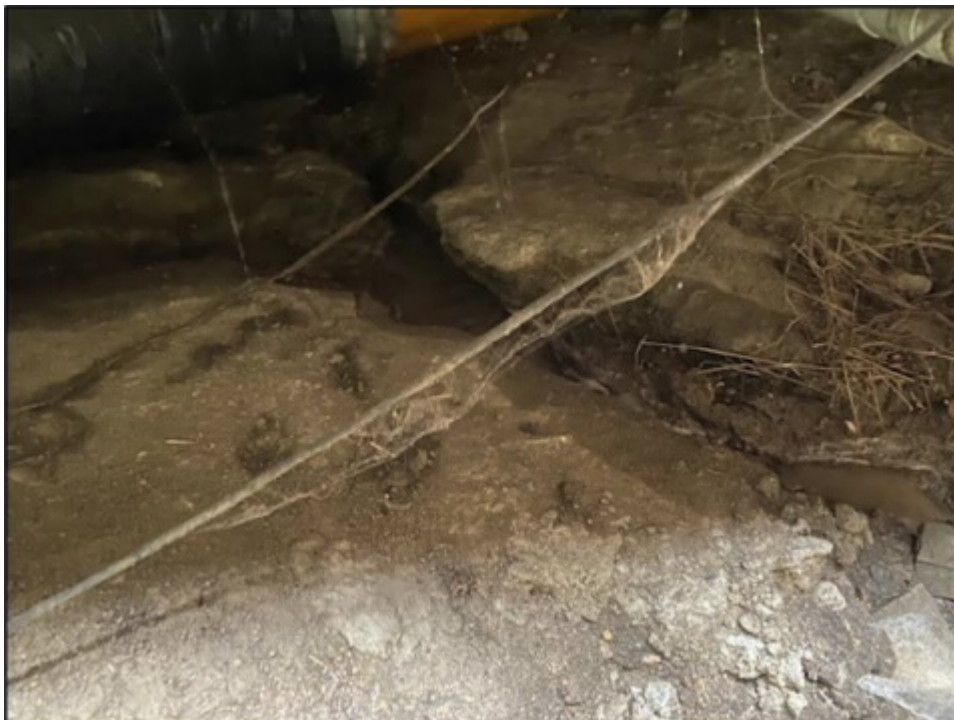
The streamflow made its way under the house at 3 Penny Lane, as shown in Photographs 5 and 6. The apparent erosion grooves on the soil surface under the house indicate that water had been flowing before the 6 January landslide occurred, perhaps for weeks or much longer, although it is hard to determine exact timeframes. The erosion could also have occurred in stages over a much longer timeframe, as a result of intermittent streamflow occurring during periods where larger volumes of water are introduced to the channel upslope that ended up causing the landslide.

**Photograph 5:** Grooves observed in the surface underneath 3 Penny Lane

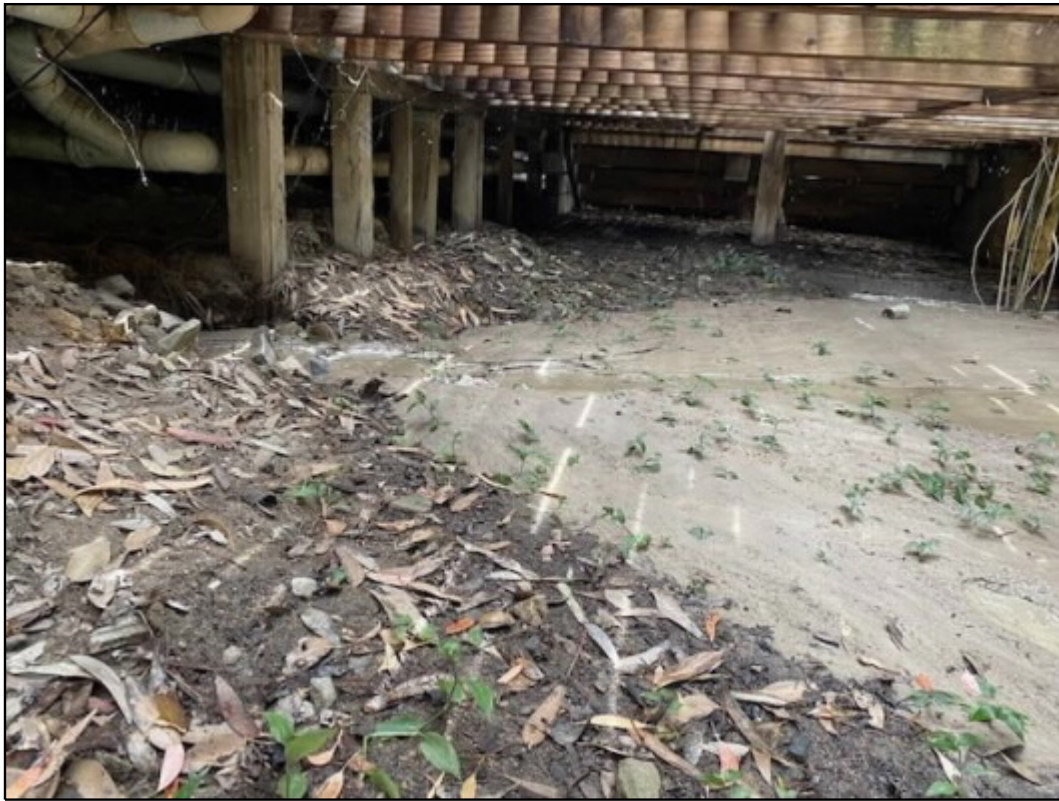
**Photograph 6:** Deposited sediment under 3 Penny Lane from streamflow

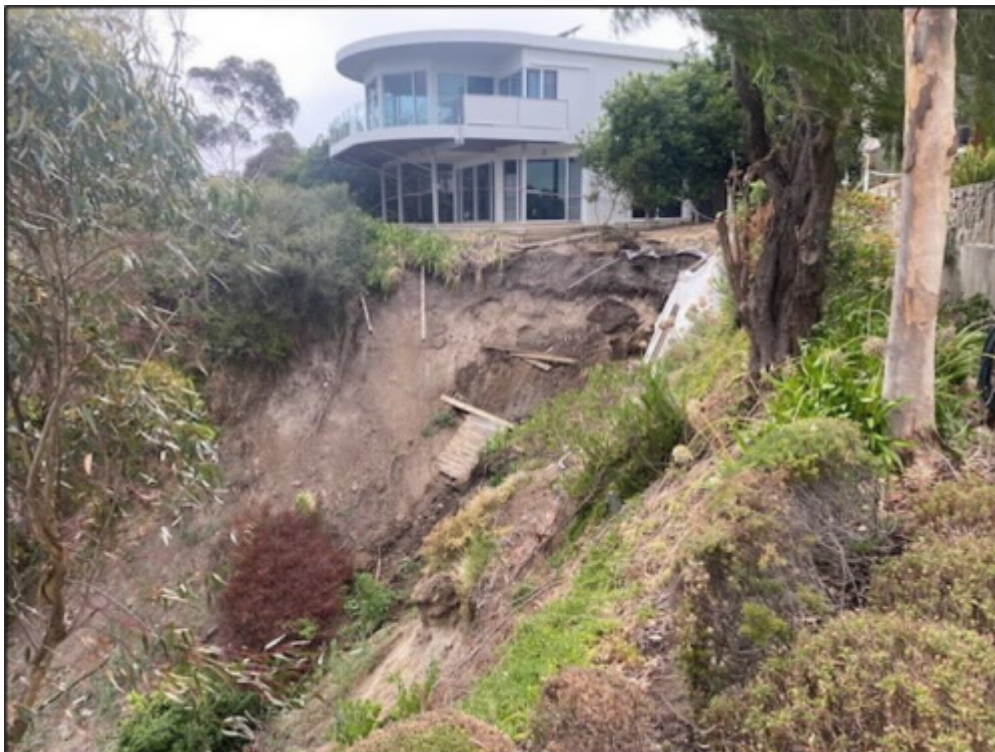
The site was visited again ten weeks later on 20 March 2025. The headscarp at this time (after the second landslide) is shown in Photograph 7. A close inspection could not be conducted due to access/safety issues. The scarp was observed from the adjacent garden area. No streamflow was observed downstream of the headscarp at the time of inspection, and the client indicated that the streamflow had subsided to around 12 litres per minute at most.

**Photograph 7:** Site conditions on 20 March 2025

After observing the site on 6 January 2025 and 20 March 2025, it is evident that elevated pore pressure in the subsurface soils in the location of the landslide is a major contributing factor to the two landslides that have occurred in this area. Based on the natural contours of the landslide location and surrounding area, it appears that the landslide location acts as a natural gully to which groundwater is directed. This would include sub-surface spring water, infiltrated stormwater, and damaged water assets and services as potential sources of groundwater being directed to the gully. The ongoing landslide risk in the area will be highly dependent on the volume of groundwater that is introduced to the gully at any given time. Additionally, the existence of loose soil and lack of deep rooted trees in the gully could facilitate the right conditions for elevated groundwater flow to trigger landslips. Due to the depth of groundwater seepage, trees that are large with deep strong roots would have been required to make a meaningful difference to the landslide risk of the gully.
