File Note**Planning Compliance Investigation****Officer: Matt Smith****Property:** 37 Cook Street MCCRAE VIC 3938**Reference Number:** PE0661/20

**Planning Compliance Offence Assessment**

Sediment control / surface water run-off on to neighbouring land

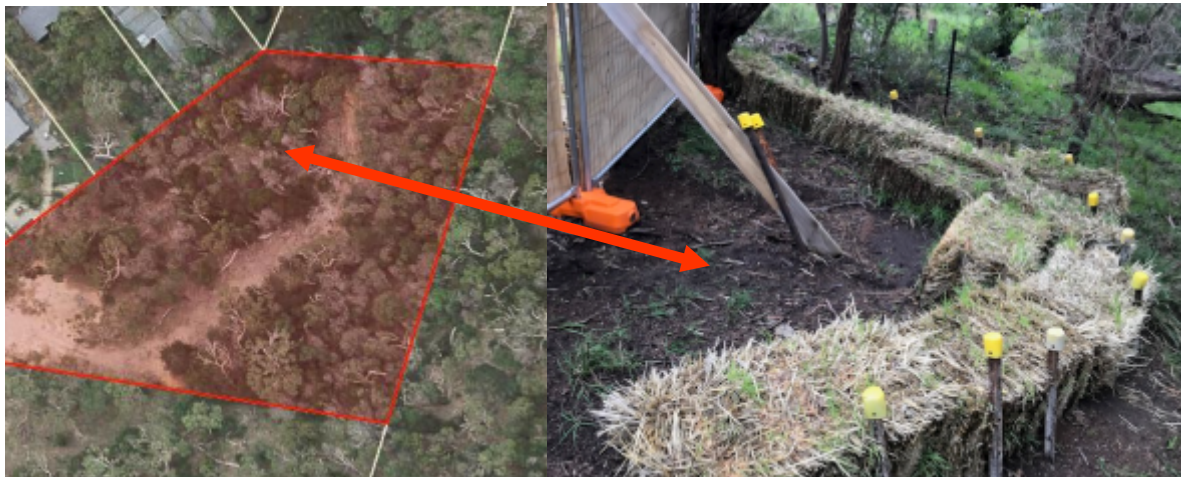
I observed:

- haybales (multiple sections)
- tiered levels
- retaining walls
- temporary gulley / channels
- temp fencing with solid addition at bottom
- small rock barriers

David highlighted an area behind the temp fencing (where there is natural channel due to low point), where further haybales had been implemented as a retention measure, to target a problematic area.

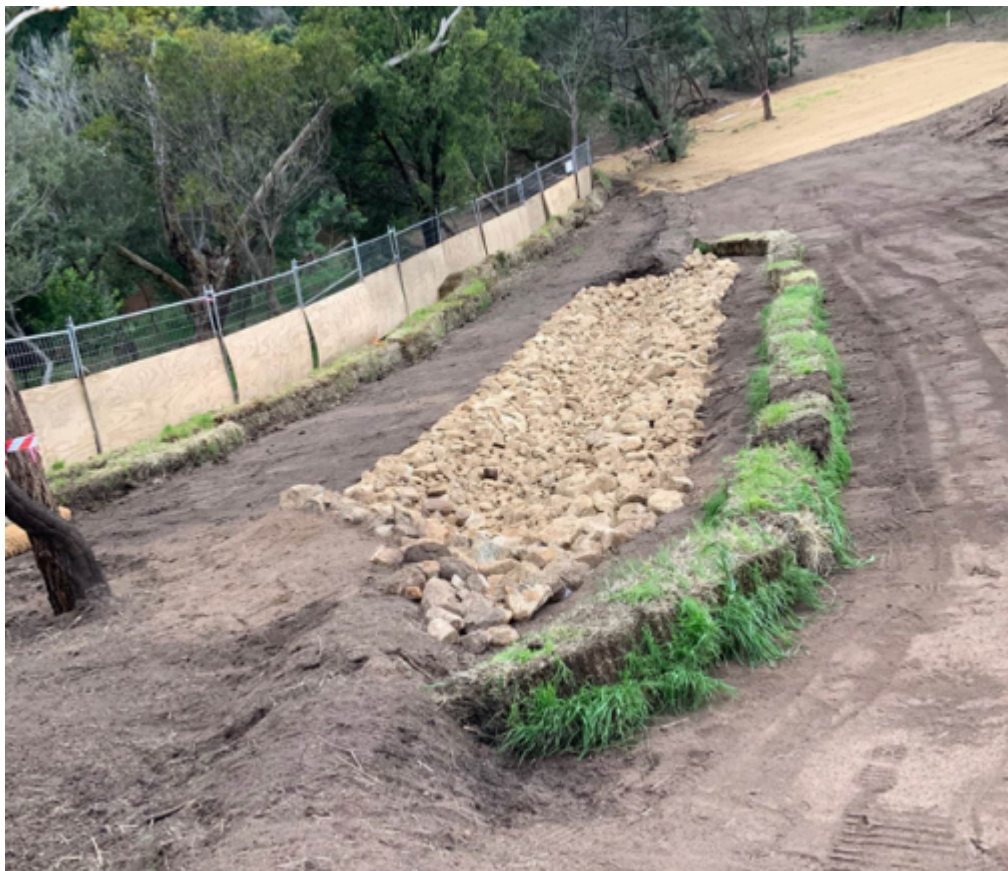
David advised they had implemented a water / sediment catchment area, which he explained was seemingly doing a good job trapping the sediment and slowing the waterflow.

David advised he would send me a photo of the above (photo below).
