04/06/2025

4 View Point Road – 10:30am

14-16 View Point 12pm

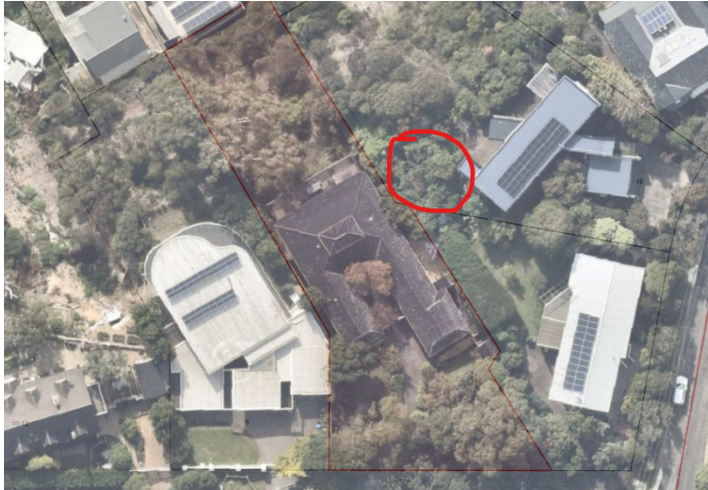
- Richard states that the circled area is not fill, contrary to the Geotech report.
- Richard shows us videos from a flood in 2017, a very large amount of water comes along the side of his property and over his retaining walls in the circled area. Retaining walls are still in great shape
