**PROPOSED RESIDENTIAL DWELLING  
14 VIEW POINT ROAD  
McCRAE VIC**

**PREPARED FOR  
FASHAM JOHNSON PTY LTD**

**JOB NO: 1624-9-R  
14 SEPTEMBER 2011**

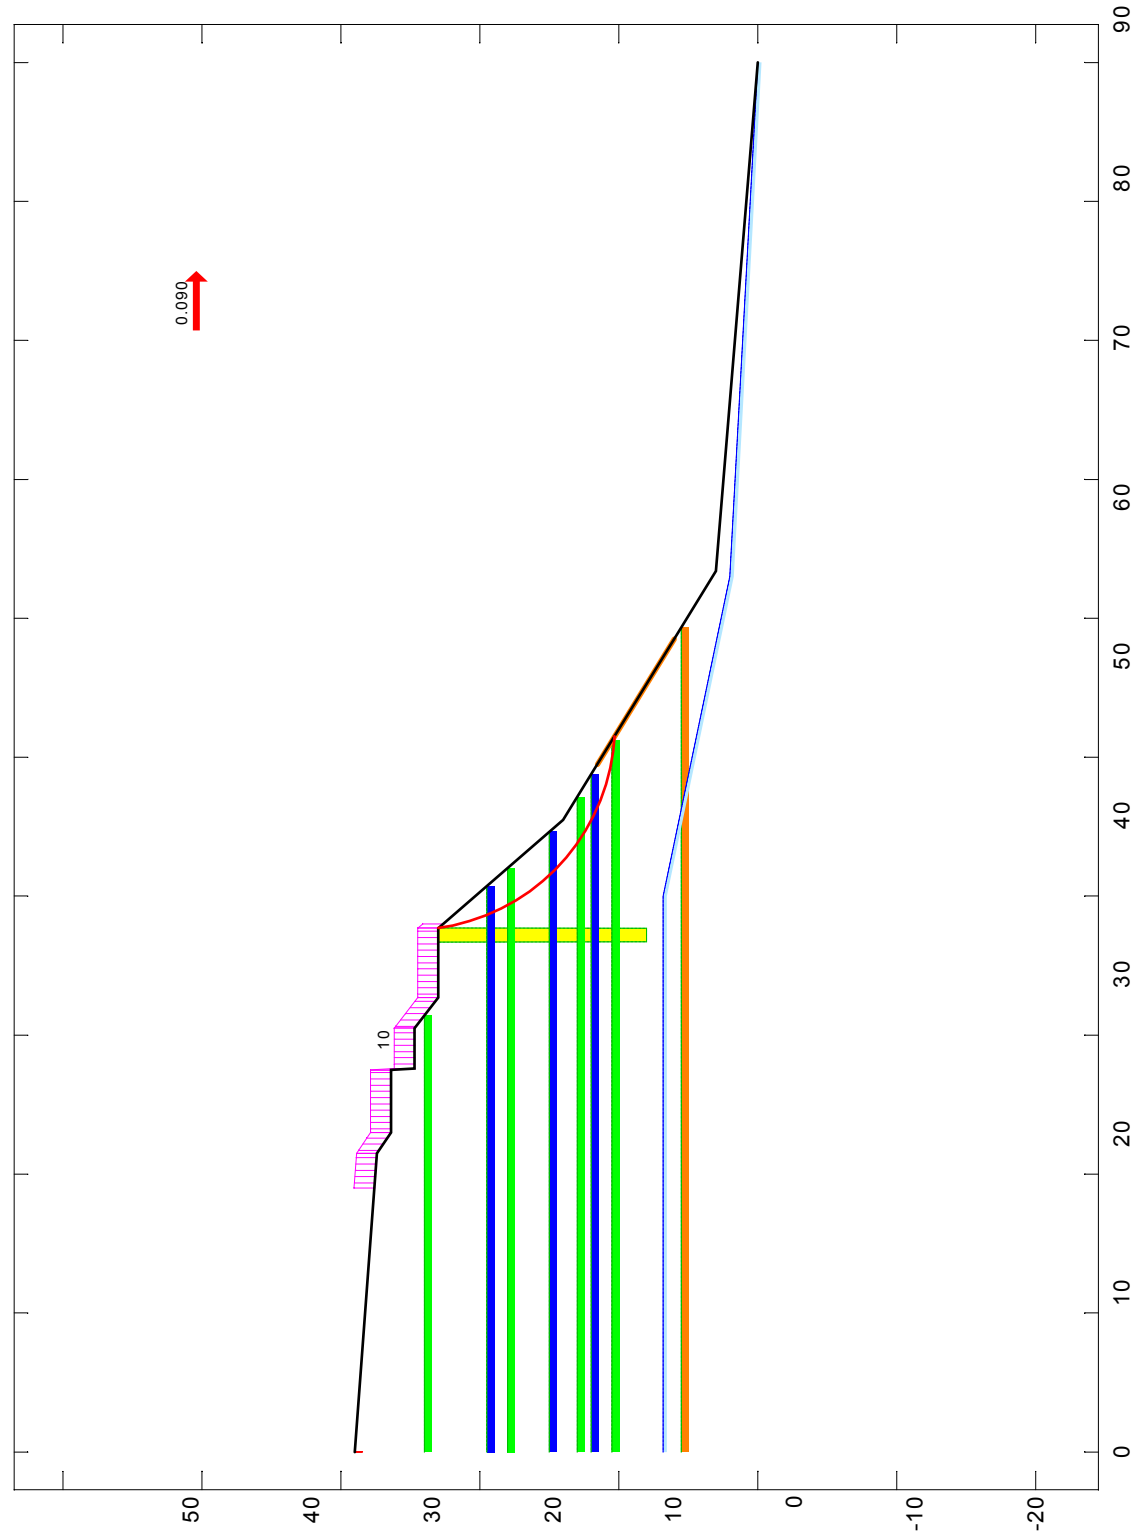
Figure C7

**Figure C-7** is the graphical result of the critical stability analysis for the following conditions:

By applying earthquake loading to the analysis, which examined the stability of the face of the escarpment to the north of the row of 15 metre deep reinforced piles, the factor of safety against failure was reduced to 1.02. This factor of safety is marginally greater than the factor of safety against failure given in Figure C-3 (1.02 c.f. 0.98), which represented the factor of safety against failure for the existing site condition with earthquake loading. This is significant in that it confirms that the proposed development will not adversely affect the stability of the face of the escarpment below the proposed development.
