McCrae Landslide

Causation

PSM5665-075R 21 July 2025

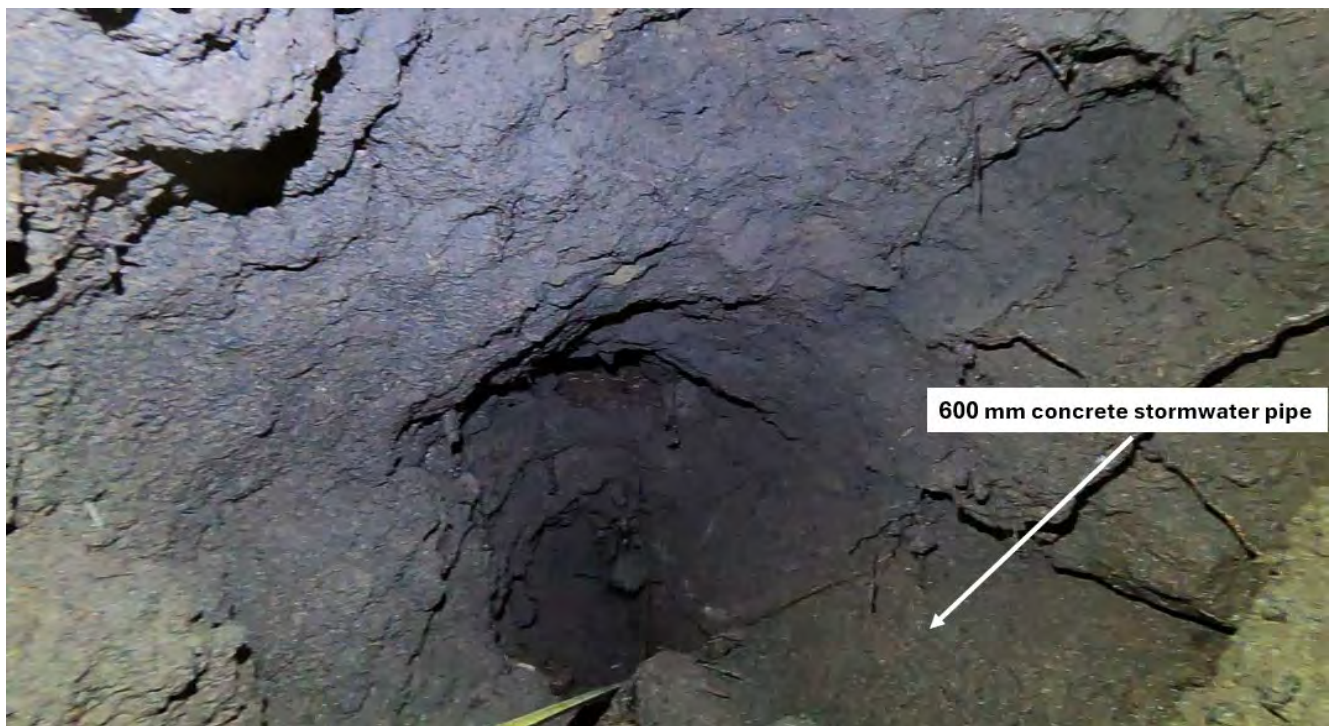
62. My colleague Oliver Stirzaker inspected the Void on the afternoon of the 6 May 2025. I have reviewed his site records and photographs and note:
- (a) The Void depth was difficult to determine due to partial backfill undertaken by the NDD contractor.
 - (b) Approximately 0.4 m cover was present between top of the Void and road surface.
 - (c) The Void was probed to greater than 1.5 m length subparallel to the stormwater pipe in the upstream direction.
 - (d) The concrete stormwater pipe was visible in a down hole video on the southern edge of the Void, Inset 30.

Inset 30: Screen shot of down hole video on the northern edge of the Void

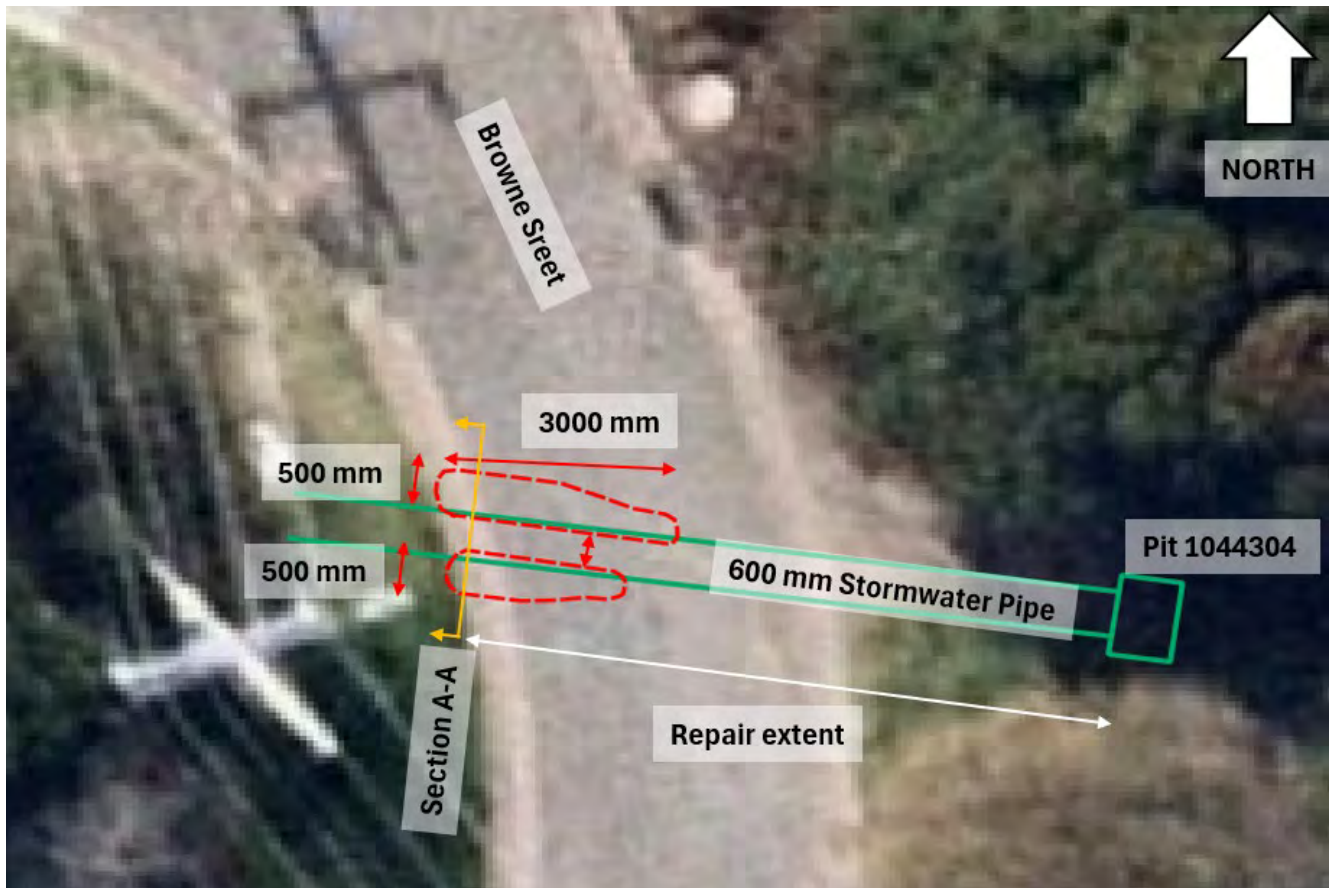
Inset 31: Approximate extents of the Void

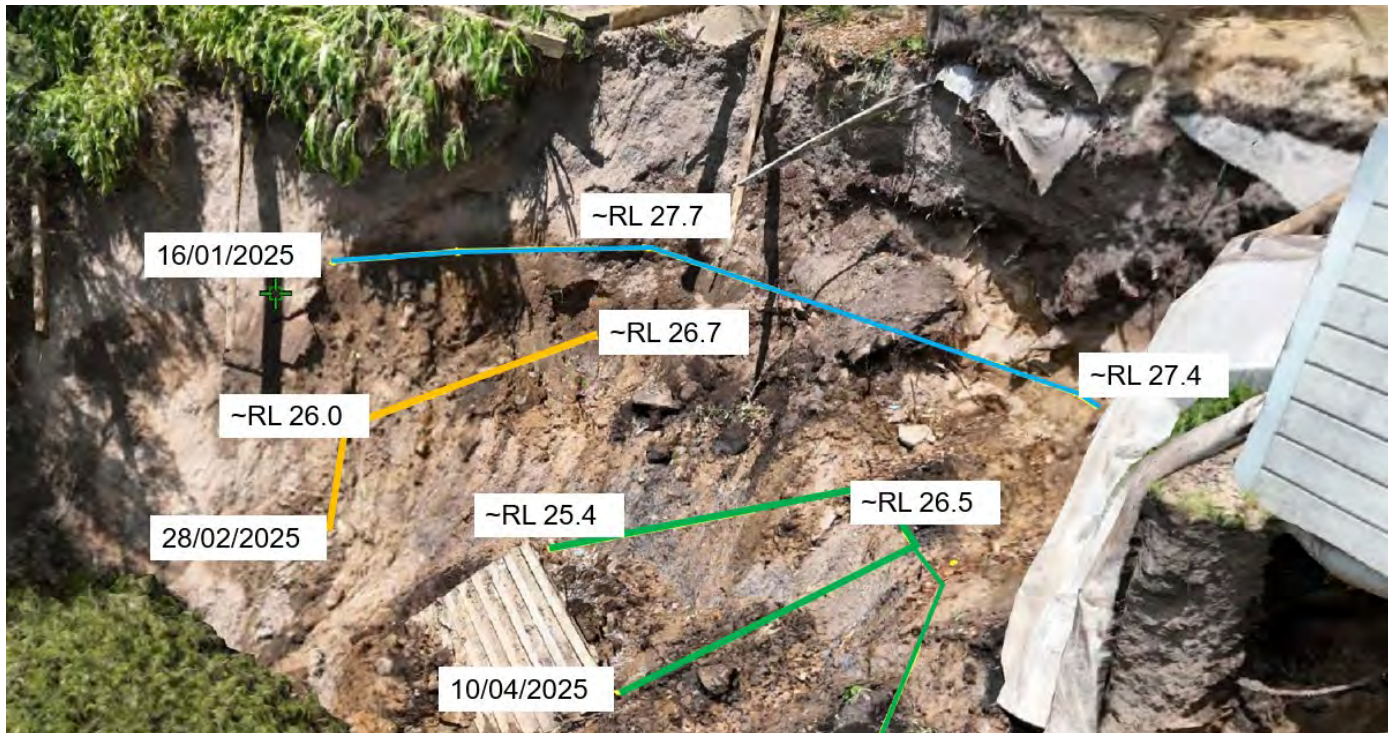
103. I measured flow rates of the seepage from the 2025 Landslide:
- (a) 6 January 2025 – no less than 0.15 to 0.2 litres per second measured with a 600 mL bottle. This approximates to 13,000 to 17,000 litres per day.
 - (b) 16 June 2025 – no less than 50 litres per day. I note that I had to use a 12 mL syringe to measure this rate.
104. I note that neither of these seepage measurements represent the maximum seepage at those times. These rates represent what was practical to measure at those times.
105. My routine photographs of seepage points in the 2025 Landslide headscarp progressively show a decrease in the elevation of the seepage points with time. The seepage lines are discussed further in Section 6.3. This change is illustrated on the Pointerra Reality Model on the eastern flank of the 2025 Landslide, Inset 46 and the western flank of the 2025 Landslide, Inset 47.

Inset 46: Eastern flank of the 2025 Landslides with interpretation on Pointerra Reality Model of the change in levels of seepage points with time

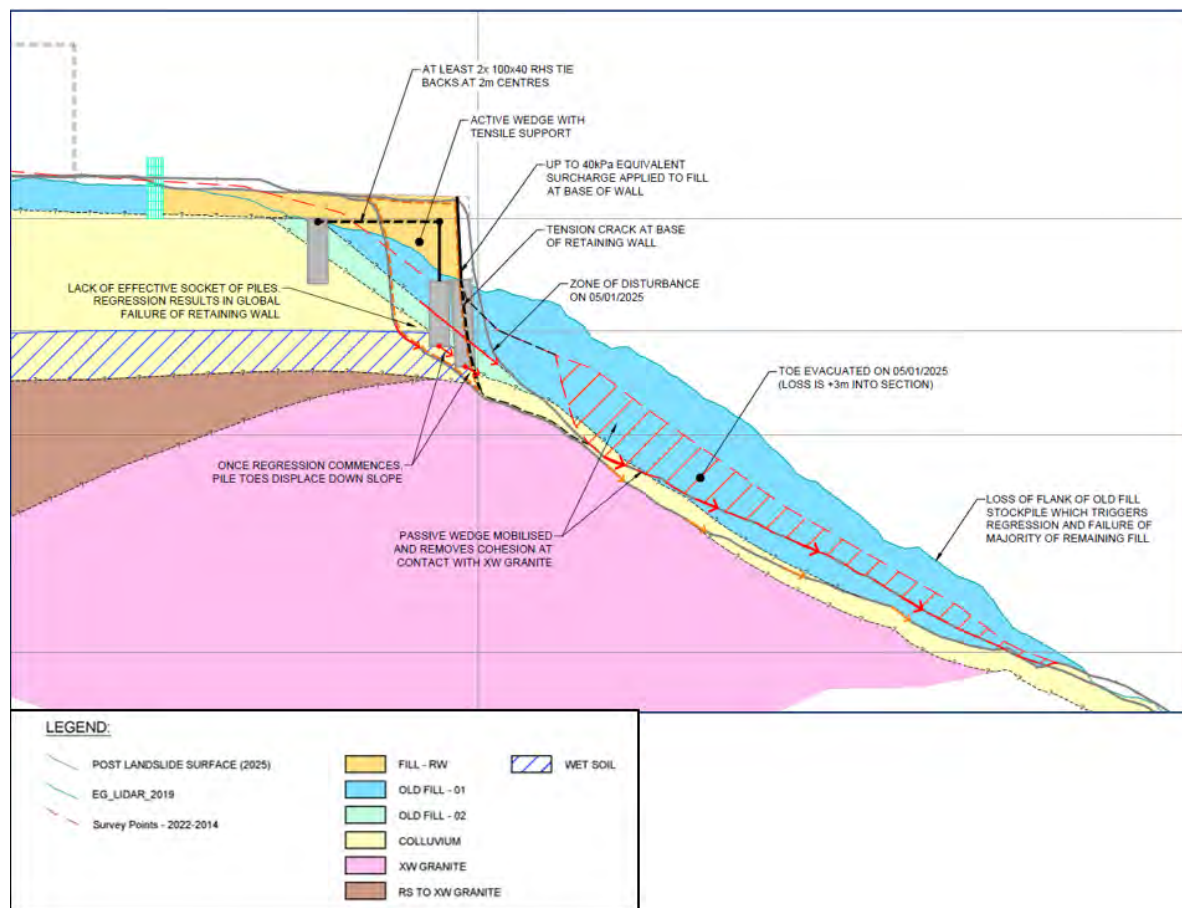
Inset 49: Inferred mechanism of failure

115. With regards to modelling of the 2024 RW failure, the observed tension crack was immediately adjacent to the sub-vertical panels of the RW, Inset 49. To ensure that the failure initiated at this location, I adopted the equivalent horizontal stresses developed by the soils above this point and applied this as an equivalent horizontal force, Inset 53.

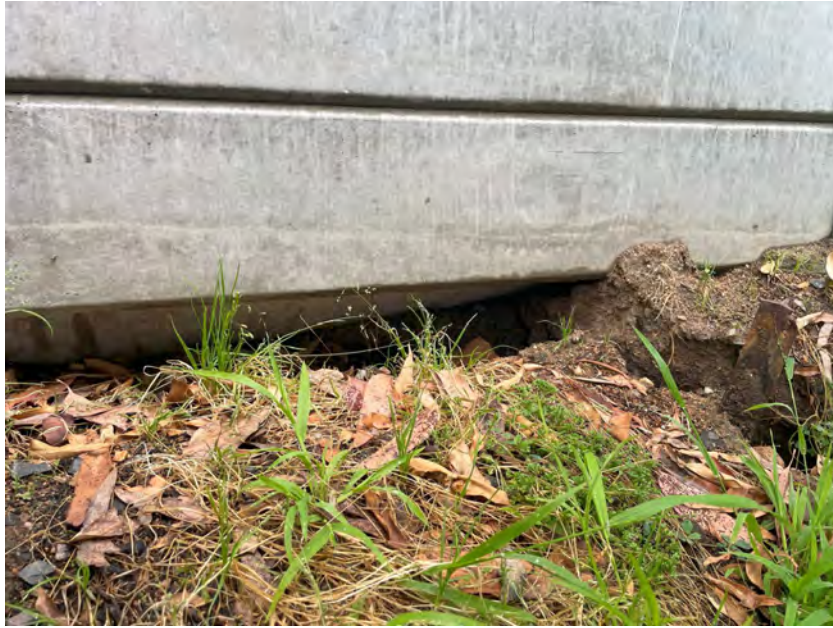
Inset 50: 2024 RW on 6 January 2025. Refer to Figure 9 for tension crack location in plan. I note that the concrete panels are 200 mm in height

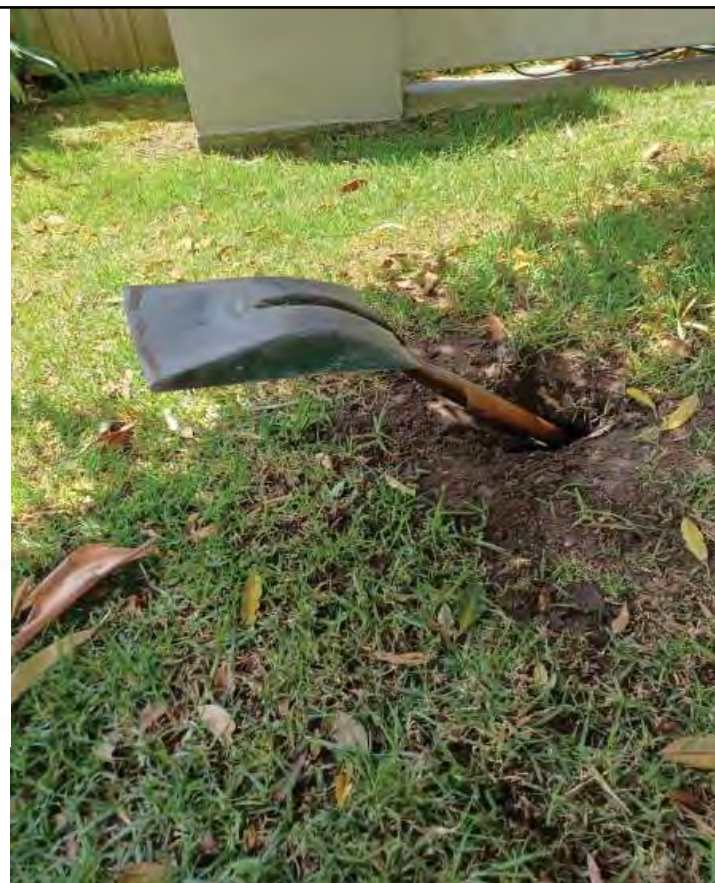
Collapse settlement repaired in sewer trench in front of 6 View Point Road pedestrian gate. Source: SEW FOI Request (2025, June 6) pp. 28 and 39.

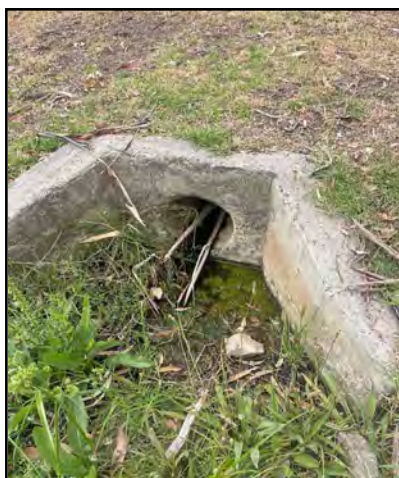
Photo 18 - Inferred base flows in reserve near 44 The Boulevard (30/01/2025)

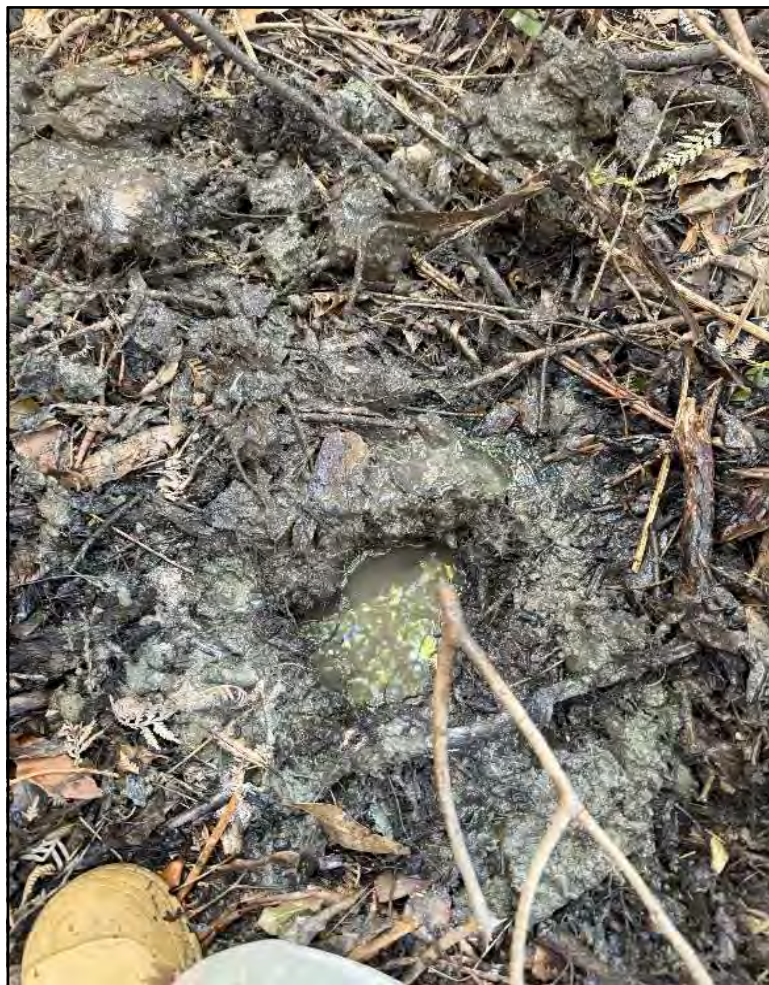
Photo 24 - Saturated pipe adjacent to SEW water main failure on Outlook Road (21/02/2025)

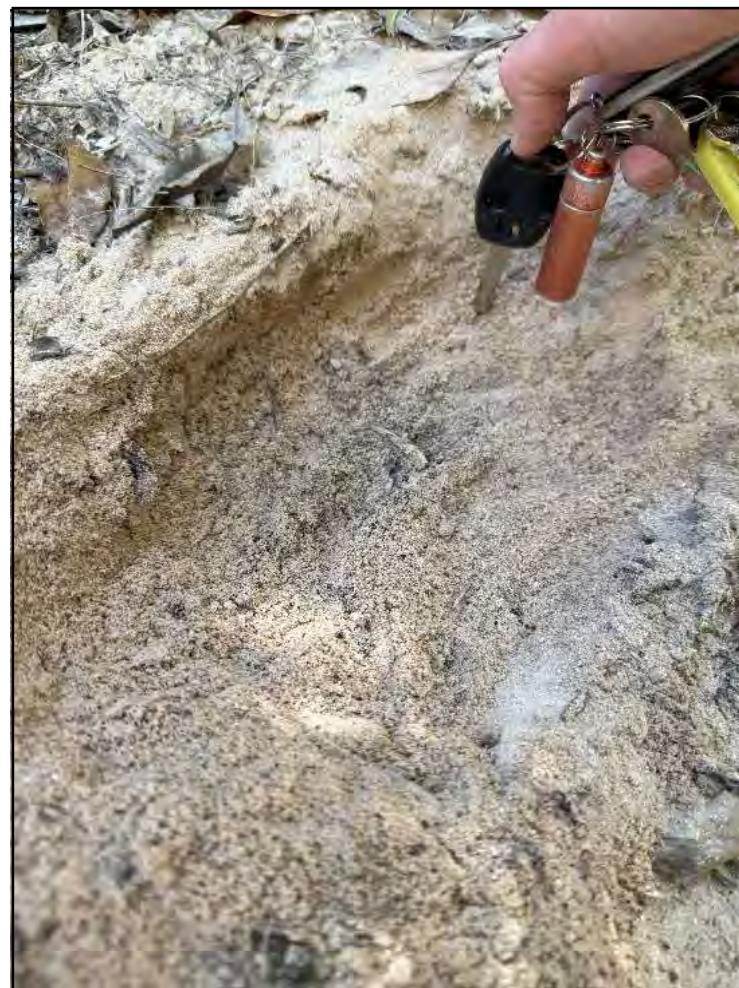
Photo 25 - Sandy sediment plume inferred from Outlook Road Water Main Failure (21/02/2025)

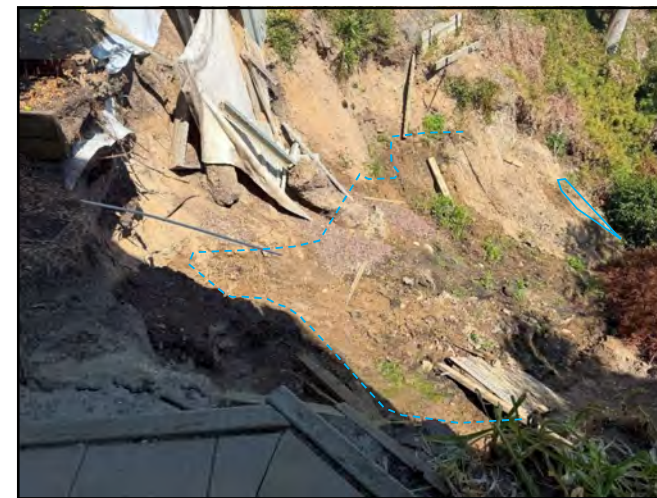
Photo 30- Seepage lines (07/03/2025)

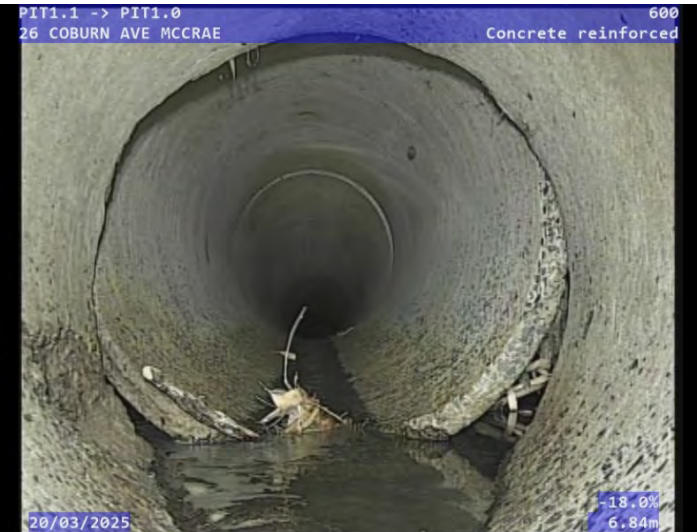
| Defect ID | Asset ID | Pipe Diameter (mm) | Location | Defect Description | Photograph |
|---|---|---|---|---|--|
| 1 | 1044313 | 600 | Intersection of Browne Street and Coburn Avenue | Joint displaced radially, radial displacement. Void visible through defect. | |

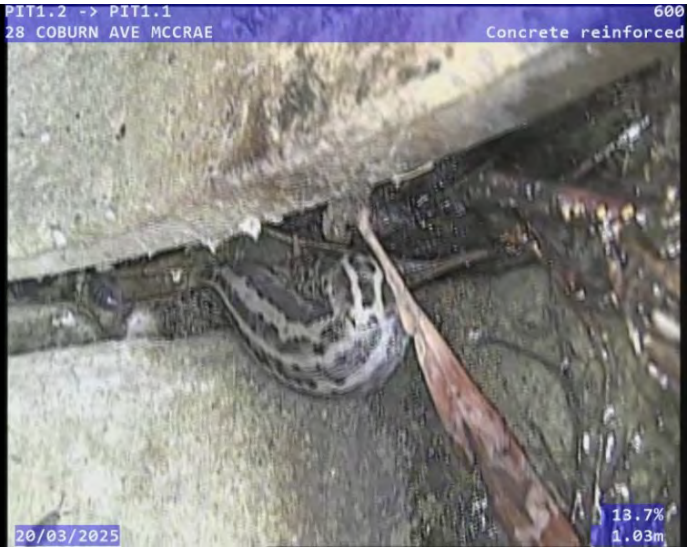
| Defect ID | Asset ID | Pipe Diameter (mm) | Location | Defect Description | Photograph |
|---|---|---|---|---|--|
| 2 | 548709 | 600 | Intersection of Browne Street and Coburn Avenue | Joint displaced radially, radial displacement. Soil visible through defect. | |

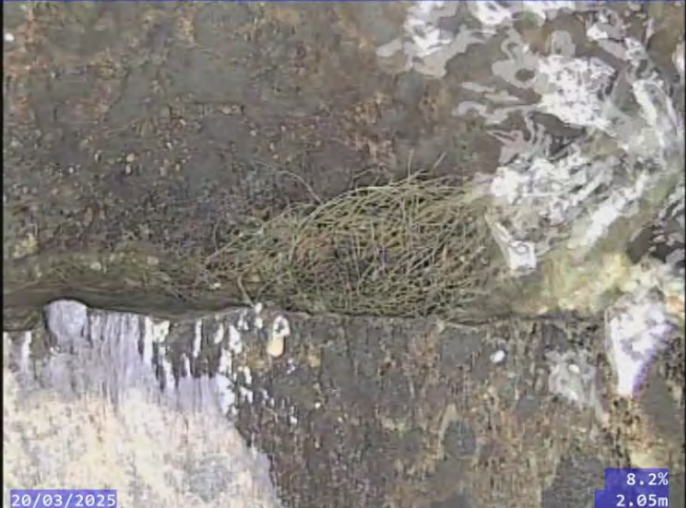
| Defect ID | Asset ID | Pipe Diameter (mm) | Location | Defect Description | Photograph |
|---|---|---|---|--|--|
| 3 | 548722 | 600 | 4 Waller Place | Joint displaced longitudinally. Soil visible through defect. | <div><div>PIT1.3 -> PIT1.2 3A WALLER PLACE MCCRAE</div><div>Concrete reinforced</div><div>600</div><div>8.2% 2.05m</div><div>20/03/2025</div></div> |

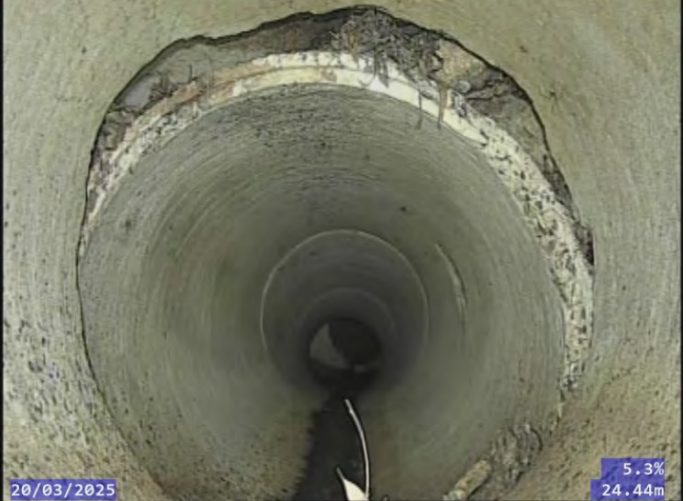
| Defect ID | Asset ID | Pipe Diameter (mm) | Location | Defect Description | Photograph |
|---|---|---|---|--|--|
| 4 | 1044313 | 600 | Intersection of Browne Street and Coburn Avenue | Joint displaced radially. Soil visible through defect. | <div><div>PIT1.1 -> PIT1.0 26 COBURN AVE MCCRAE</div><div>Concrete reinforced</div><div>600</div><div>5.3% 24.44m</div><div>20/03/2025</div></div> |

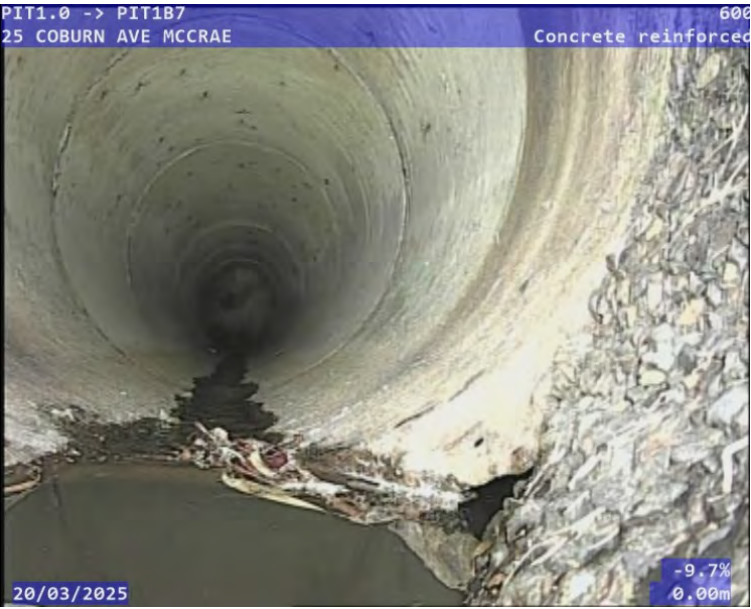
| Defect ID | Asset ID | Pipe Diameter (mm) | Location | Defect Description | Photograph |
|---|---|---|---|--|---|
| 5 | 1035993 | 600 | 26 Coburn Avenue | Hole in invert. Void visible through defect. | |

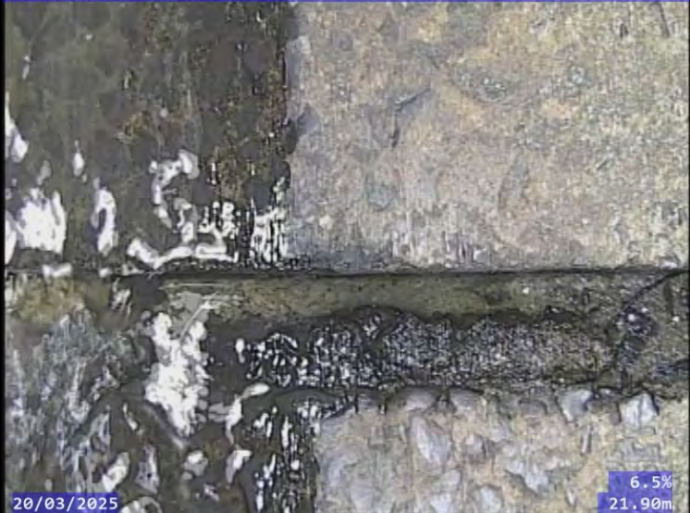
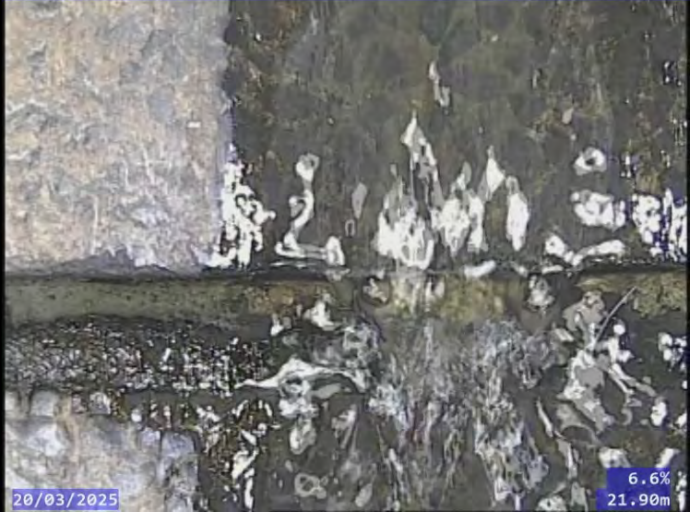
| Defect ID | Asset ID | Pipe Diameter (mm) | Location | Defect Description | Photograph |
|---|---|---|--|--|--|
| 6 | 1036004 | 600 | Intersection of Coburn Avenue and Prospect Hill Road | Joint displaced longitudinally. Soil visible through defect. | <div><div>PIT1B7 -> PIT1B6 25 COBURN AVE MCCRAEConcrete reinforced600</div><div>20/03/20256.5%21.90m</div></div> <div><div>PIT1B7 -> PIT1B6 25 COBURN AVE MCCRAEConcrete reinforced600</div><div>20/03/20256.6%21.90m</div></div> |

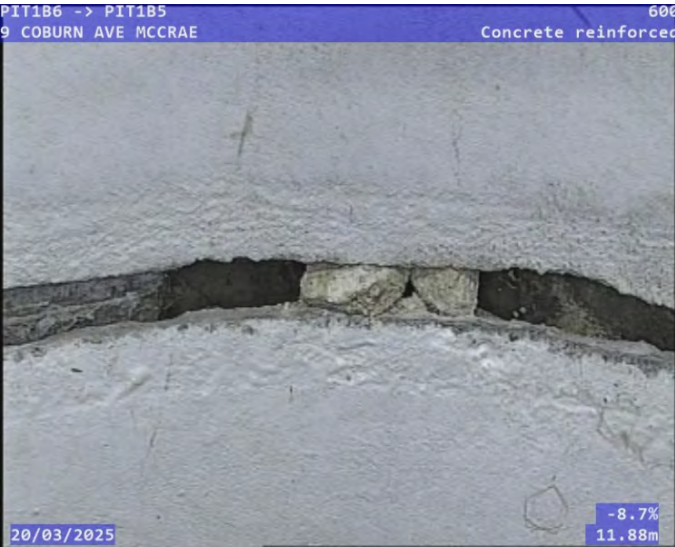
| Defect ID | Asset ID | Pipe Diameter (mm) | Location | Defect Description | Photograph |
|---|---|---|---|--|--|
| 7 | 1036005 | 600 | 22 Coburn Avenue | Joint displaced longitudinally. Soil visible through defect. | |

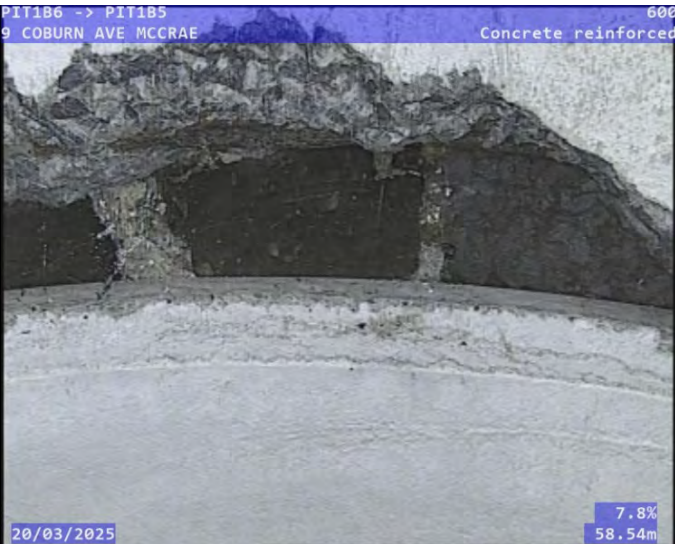
| Defect ID | Asset ID | Pipe Diameter (mm) | Location | Defect Description | Photograph |
|---|---|---|---|--|--|
| 8 | 1036005 | 600 | 12 Coburn Avenue | Hole at Joint. Soil visible through defect. | |

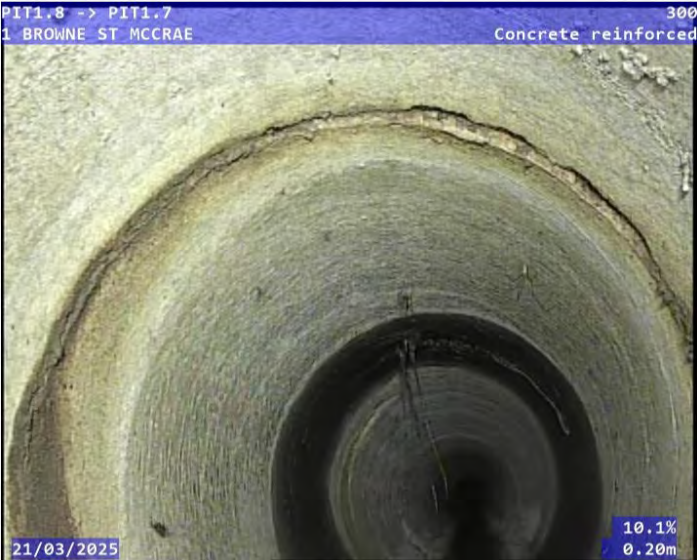
| Defect ID | Asset ID | Pipe Diameter (mm) | Location | Defect Description | Photograph |
|---|---|---|---|--|--|
| 9 | 570333 | 300 | 9 Browne Street | Circumferential cracking. Soil visible through defect. | |

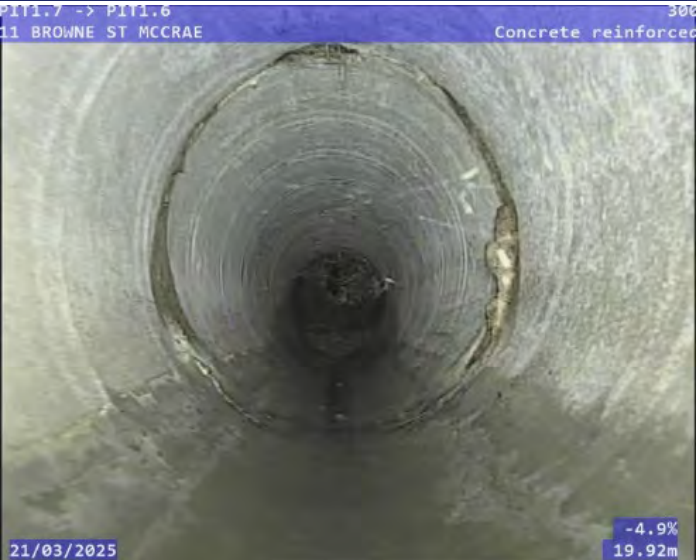
| Defect ID | Asset ID | Pipe Diameter (mm) | Location | Defect Description | Photograph |
|---|---|---|---|--|--|
| 10 | 570332 | 300 | 11 Browne Street | Circumferential cracking. Soil visible through defect. | |

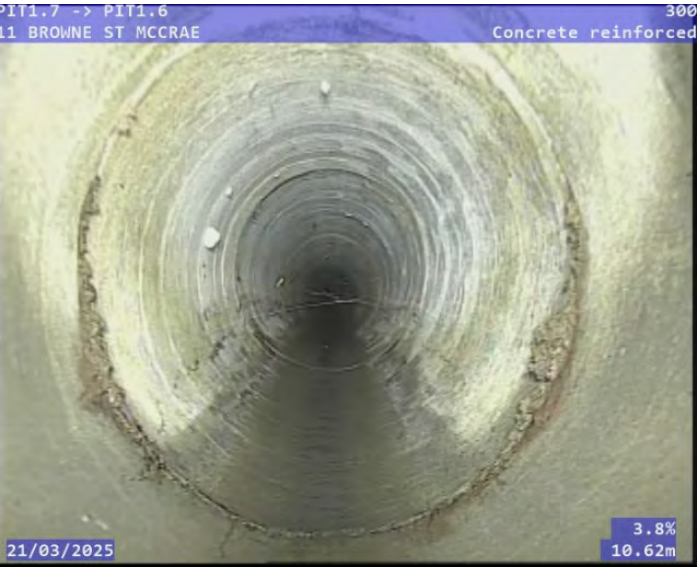
| Defect ID | Asset ID | Pipe Diameter (mm) | Location | Defect Description | Photograph |
|---|---|---|---|--|--|
| 11 | 570332 | 300 | 11 Browne Street | Circumferential cracking. Soil visible through defect. | |

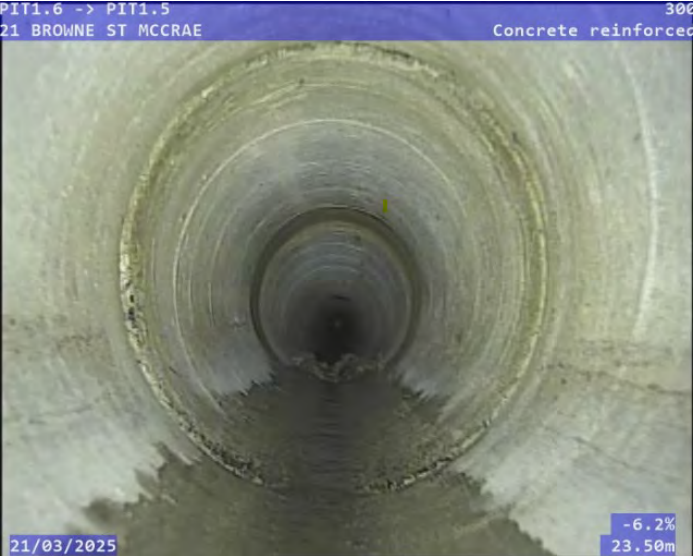
| Defect ID | Asset ID | Pipe Diameter (mm) | Location | Defect Description | Photograph |
|---|---|---|---|--|--|
| 12 | 570331 | 300 | 15 Browne Street | Circumferential cracking. Soil visible through defect. | |

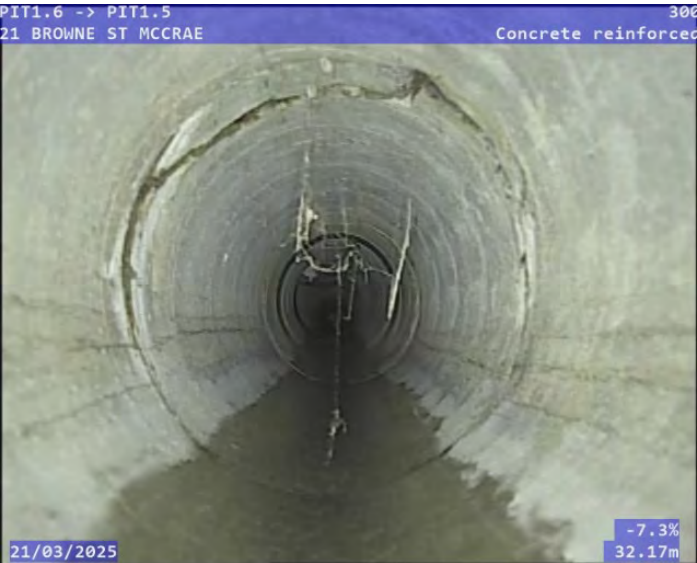
| Defect ID | Asset ID | Pipe Diameter (mm) | Location | Defect Description | Photograph |
|---|---|---|---|--|--|
| 13 | 570331 | 300 | 15 Browne Street | Circumferential cracking. Soil visible through defect. | |

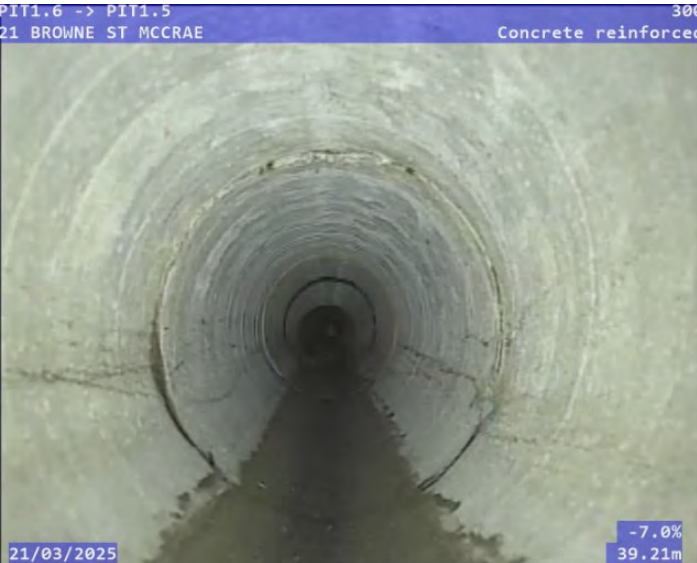
| Defect ID | Asset ID | Pipe Diameter (mm) | Location | Defect Description | Photograph |
|---|---|---|---|--|--|
| 14 | 570331 | 300 | 17 Browne Street | Circumferential cracking. Soil visible through defect. | |

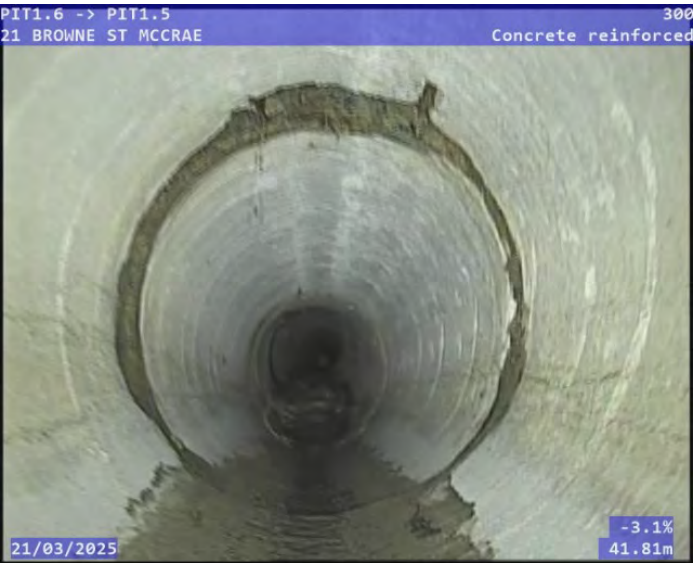
| Defect ID | Asset ID | Pipe Diameter (mm) | Location | Defect Description | Photograph |
|---|---|---|---|--|--|
| 15 | 570331 | 300 | 17 Browne Street | Circumferential cracking. Soil visible through defect. | |

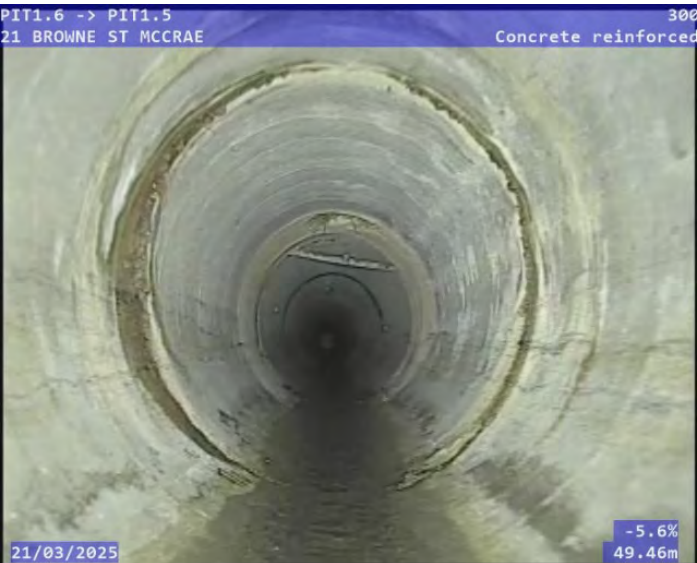
| Defect ID | Asset ID | Pipe Diameter (mm) | Location | Defect Description | Photograph |
|---|---|---|---|--|--|
| 16 | 570331 | 300 | 17 Browne Street | Circumferential cracking. Soil visible through defect. | |

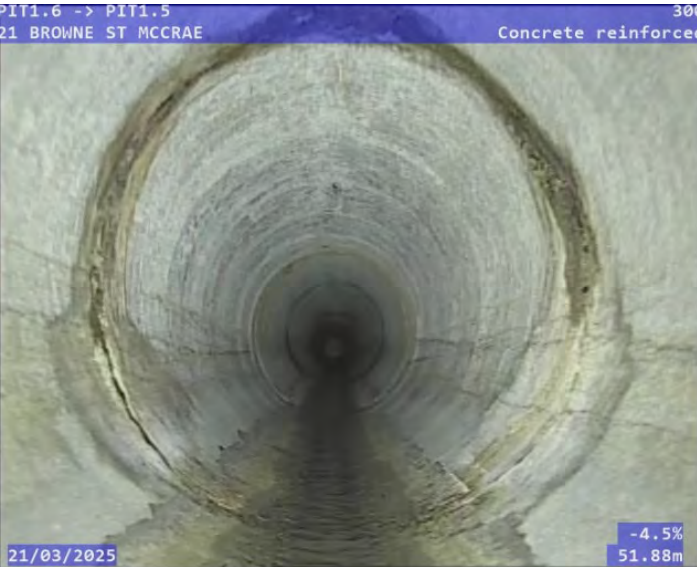
| Defect ID | Asset ID | Pipe Diameter (mm) | Location | Defect Description | Photograph |
|---|---|---|---|--|--|
| 17 | 570331 | 300 | 17 & 19 Browne Street | Circumferential cracking. Soil visible through defect. | |

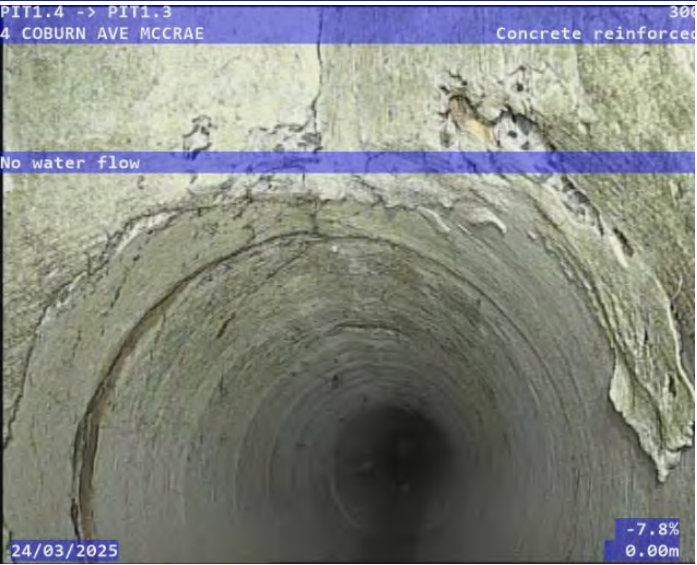
| Defect ID | Asset ID | Pipe Diameter (mm) | Location | Defect Description | Photograph |
|---|---|---|---|--|--|
| 18 | 570329 | 300 | 21 Browne Street | Circumferential cracking. Soil visible through defect. | |

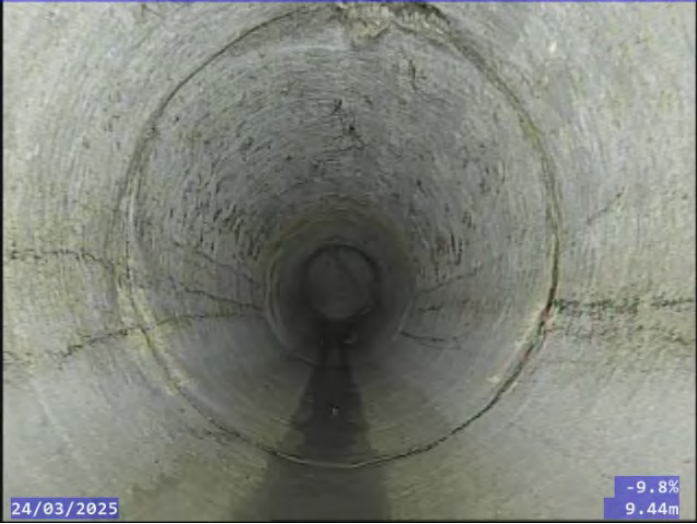
| Defect ID | Asset ID | Pipe Diameter (mm) | Location | Defect Description | Photograph |
|---|---|---|--|--|--|
| 19 | 570329 | 300 | Corner of Browne Street and Corbens Lane | Circumferential cracking. Soil visible through defect. | <div><div>PIT1.4 -> PIT1.3 4 COBURN AVE MCCRAE</div><div>Concrete reinforced</div><div></div><div><div>24/03/2025</div><div>-9.8% 9.44m</div></div></div> |

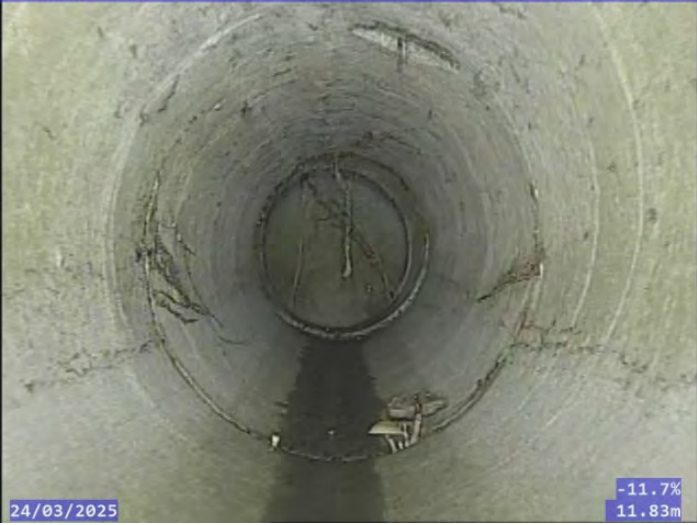
| Defect ID | Asset ID | Pipe Diameter (mm) | Location | Defect Description | Photograph |
|---|---|---|--|--|--|
| 20 | 570329 | 300 | Corner of Browne Street and Corbens Lane | Circumferential cracking. Soil visible through defect. | <div><div>PIT1.4 -> PIT1.3 4 COBURN AVE MCCRAE</div><div>Concrete reinforced</div><div></div><div><div>24/03/2025</div><div>-11.7% 11.83m</div></div></div> |

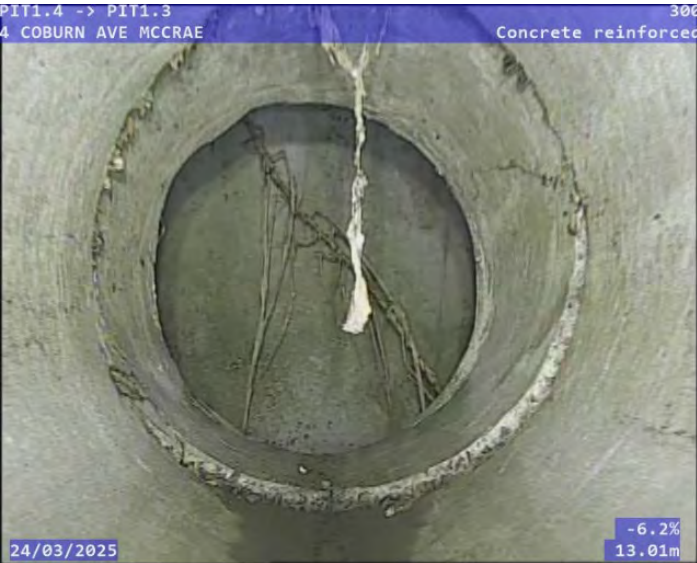
| Defect ID | Asset ID | Pipe Diameter (mm) | Location | Defect Description | Photograph |
|---|---|---|--|--|--|
| 21 | 570329 | 300 | Corner of Browne Street and Corbens Lane | Circumferential cracking. Soil visible through defect. | <p>PIT1.4 -> PIT1.3 4 COBURN AVE MCCRAE Concrete reinforced -6.2% 13.01m 24/03/2025</p> |

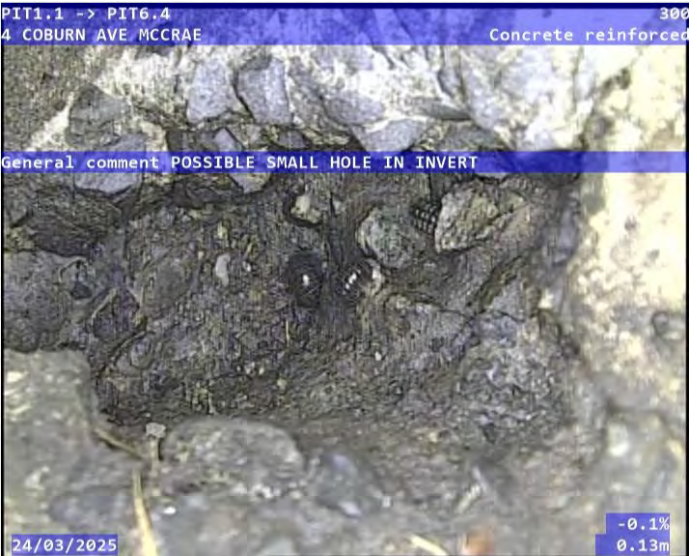
| Defect ID | Asset ID | Pipe Diameter (mm) | Location | Defect Description | Photograph |
|---|---|---|--|--|--|
| 22 | 570339 | 300 | Corner of Coburn Avenue and Corbens Lane | Possible small hole in invert. | <p>PIT1.1 -> PIT6.4 4 COBURN AVE MCCRAE Concrete reinforced General comment POSSIBLE SMALL HOLE IN INVERT -0.1% 0.13m 24/03/2025</p> |

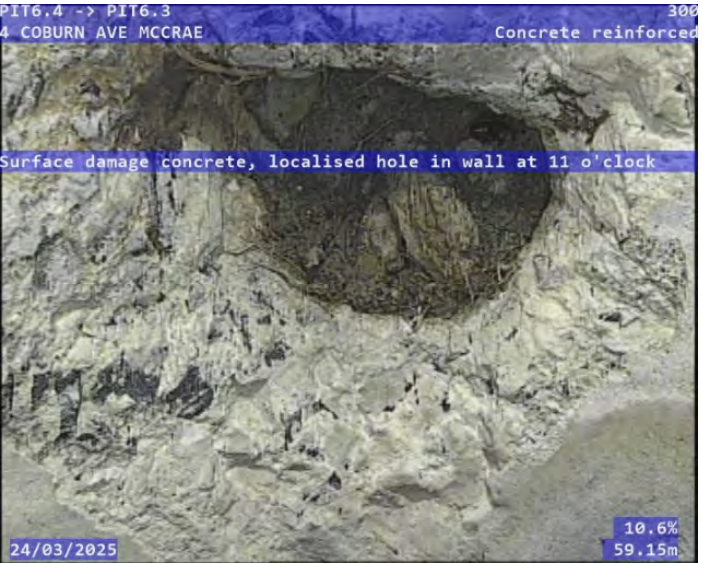
| Defect ID | Asset ID | Pipe Diameter (mm) | Location | Defect Description | Photograph |
|---|---|---|--|--|--|
| 23 | 570338 | 300 | Corner of Coburn Avenue and Corbens Lane | Localised hole. Soil visible through defect. | |

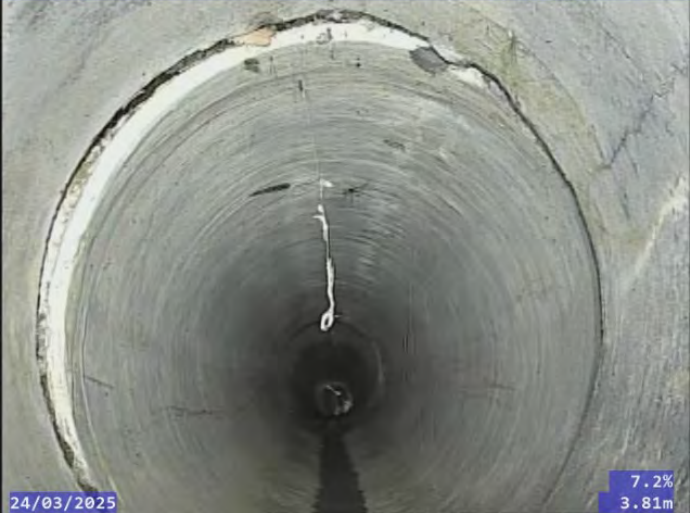
| Defect ID | Asset ID | Pipe Diameter (mm) | Location | Defect Description | Photograph |
|---|---|---|---|---|---|
| 25 | 546872 | 300 | 1 Burrell Street | Radial displacement. Soil/void visible through defect at joint. | <div><div>PIT3 -> PIT2 1 BURRELL ST MCCRAE</div><div>Concrete reinforced</div><div>7.2% 3.81m</div></div> |

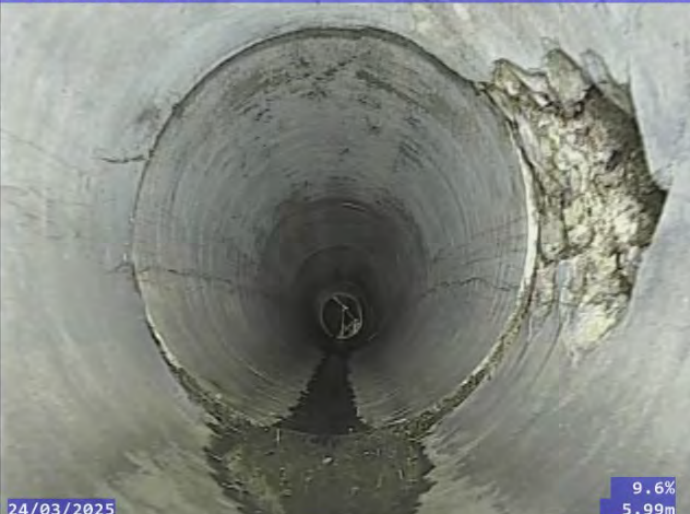
| Defect ID | Asset ID | Pipe Diameter (mm) | Location | Defect Description | Photograph |
|---|---|---|---|---|---|
| 26 | 546872 | 300 | 1 Burrell Street | Localised hole in wall. Soil/void visible through defect. | <div><div>PIT3 -> PIT2 1 BURRELL ST MCCRAE</div><div>Concrete reinforced</div><div>9.6% 5.99m</div></div> |

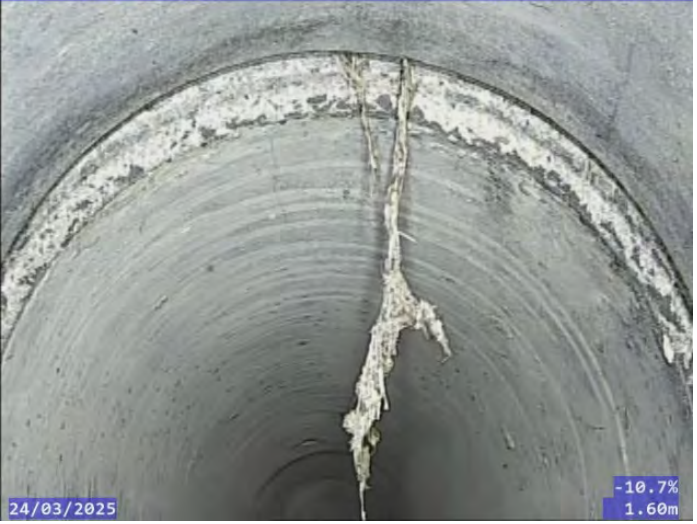
| Defect ID | Asset ID | Pipe Diameter (mm) | Location | Defect Description | Photograph |
|---|---|---|---|--|---|
| 27 | 927918 | 300 | 2 Burrell Street | Joint displaced radially. Soil/void visible through defect. | <div><div>PIT4 -> EW 2 BURRELL ST MCCRAE</div><div>Concrete reinforced</div><div></div><div>24/03/2025</div><div>-10.7% 1.60m</div></div> |

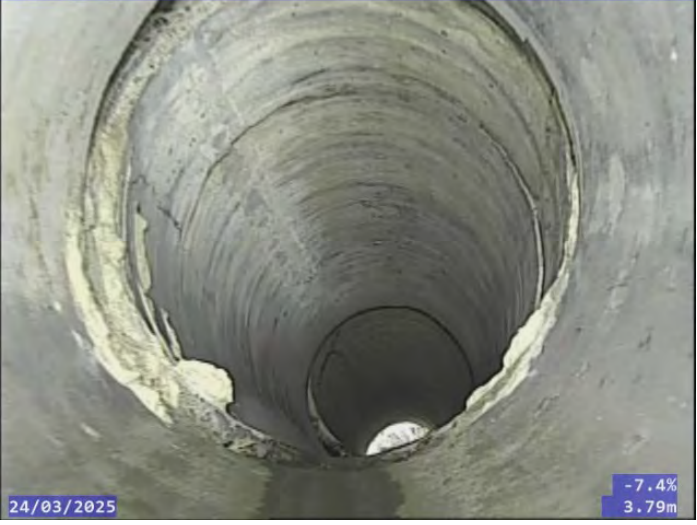
| Defect ID | Asset ID | Pipe Diameter (mm) | Location | Defect Description | Photograph |
|---|---|---|---|--|---|
| 28 | 927918 | 300 | 2 Burrell Street | Joint displaced radially. Soil/void visible through defect at joint. | <div><div>PIT4 -> EW 2 BURRELL ST MCCRAE</div><div>Concrete reinforced</div><div></div><div>24/03/2025</div><div>-7.4% 3.79m</div></div> |
