BOARD OF INQUIRY INTO THE McCRAE LANDSLIDE

Witness Statement

WITNESS STATEMENT OF MATHEW HOPWOOD-GLOVER

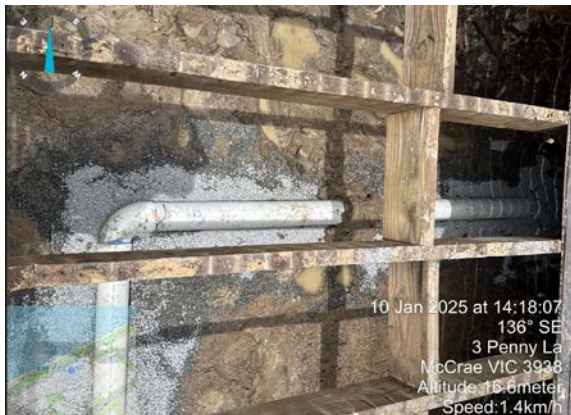
18. I recall that contractors (builders/carpenters and plumbers) were on site at 3 Penny Lane the day after I provided the Actions List to the Moran's. The contractors installed a pipe under the house to divert the water. The pipe experienced silting overtime, which meant water could not properly pass through the pipe. Photo 1 below, which I took on 10 January 2025, shows the initial drainage diversion using the pipe. The contractors later installed upgraded hand cutoff drains, plastic traps and sandbags under the house at 3 Penny Lane to divert the water. Photo 2, which I took during my inspection on 14 January 2025, shows the upgraded diversion with some silting (discussed further below). That photograph shows the tarps and sandbags diverting the water. In the background of the photograph, a scour line can be seen as indicated at red arrow.

Photo 1: Initial Drainage diversion

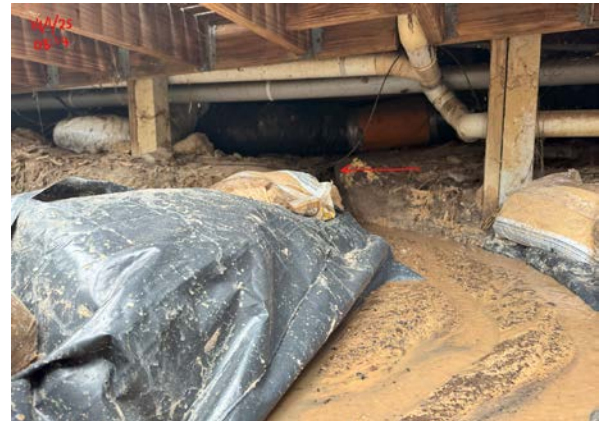
Photo 2: Upgraded Drainage Diversion System

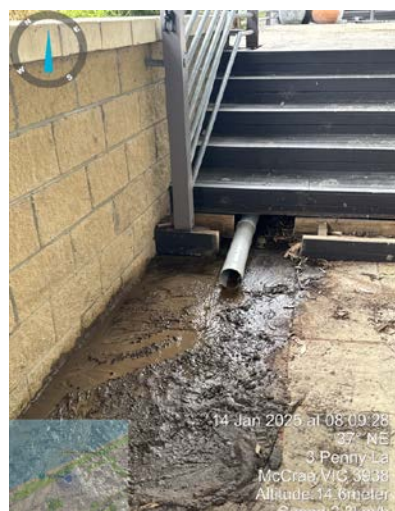
19. Photo 3 below, which I took of 14 January 2025, shows the discharge from the pipe, which was present for both the initial and upgraded diversion works.

Photo 3: Discharge PVC pipe for both initial and upgrade

20. The water was being directed out to the pedestrian access to the dwelling to the concrete driveway and down Penny Lane via a PVC stormwater pipe along the pedestrian entrance to the dwelling. This is shown in Photo 3.

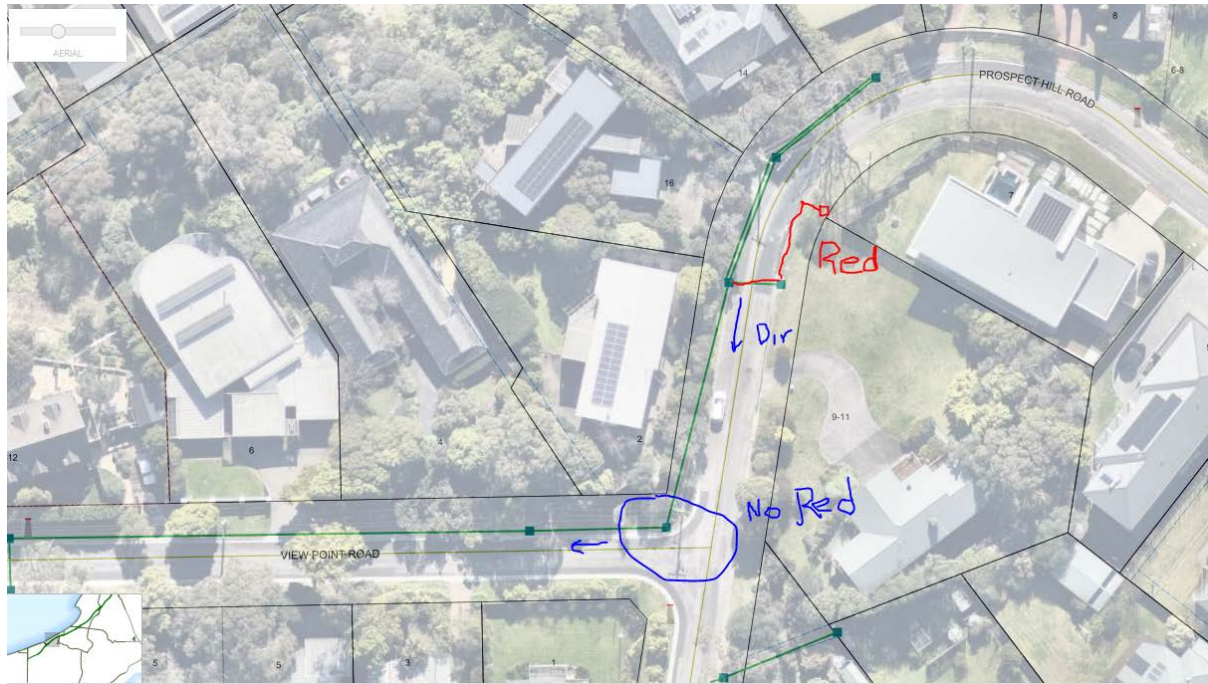
28. I provided a copy of Map 1 (below) to Mr Smith on 13 January 2025 showing where red trace-dye commenced and finished.

Map 1: Shire GIS Drainage mapping (Prospect Hill Road and View Point Road) with markings showing the trace-dye start and end points.

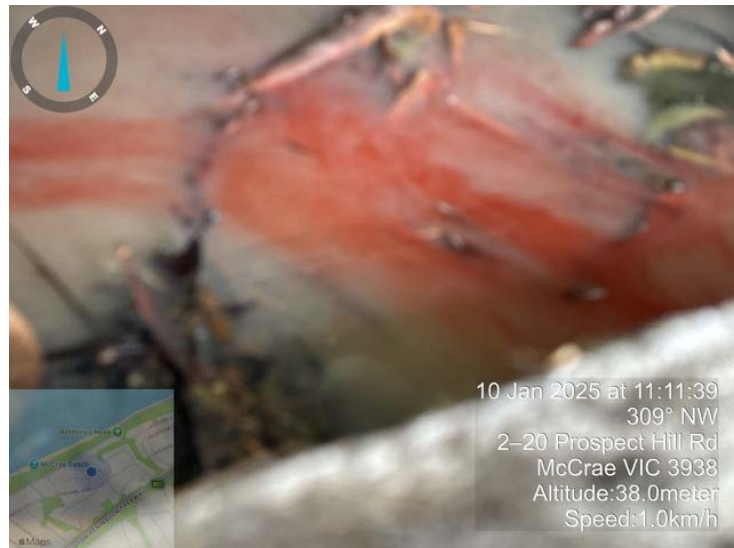
- (ii) Trace-dye testing was conducted by me and Mr Thomas McMahon (student building surveyor and Administration Officer) on 10 January 2025. I observed that the road curb collector at Prospect Hill Road was silted with debris (photo 10 Jan 2025) and the red dye did not flow via the stormwater drain to the corner pit of Prospect Hill and View Point Road. This made me consider there was a potential damaged pipe allowing water to flow subterraneously or within the trench void; and

29. Photo 4 below, which I took 10 January 2025, shows a silted and debris drain where the trace-dye stopped.

Photo 4: road curb collector drain (2 Viewpoint Road
along Prospect Hill Road (Trace-dye stopping))

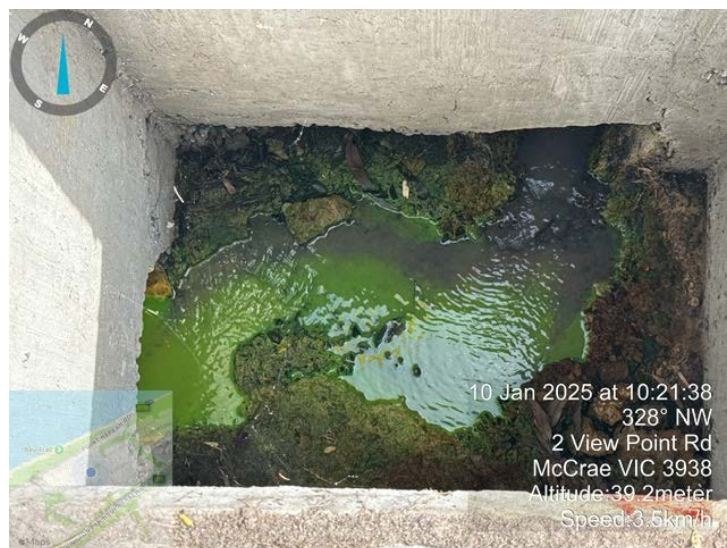
Photo 5: Inspection Pit Corner Prospect Hill Road and
View Point Road waiting for red trace dye to appear.

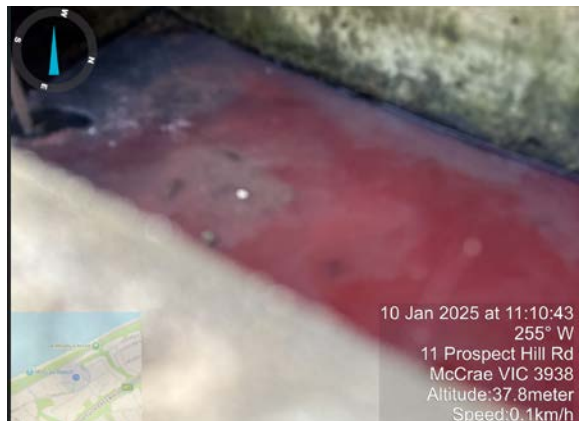
Photo 6: Stormwater curb collector: 9-11 Prospect Hill Road.

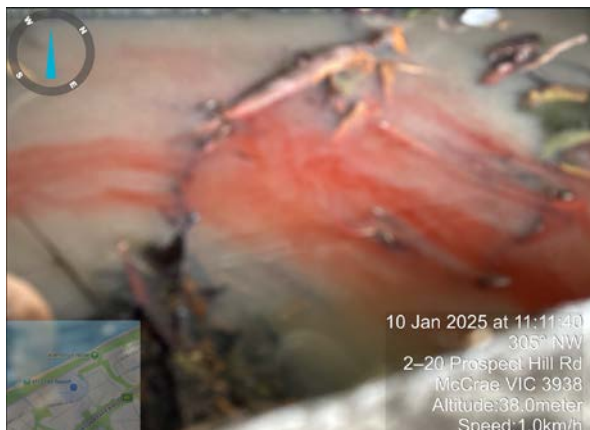
Photo 7: 2 View Point Road Stormwater curb collector facing Prospect Hill Road across from 9-11 Prospect Hill Road.

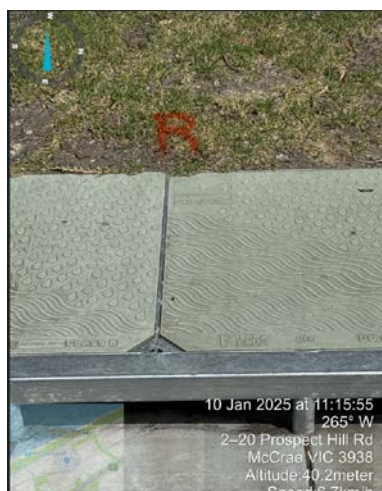
Photo 8: 2 View Point Road Stormwater curb collector

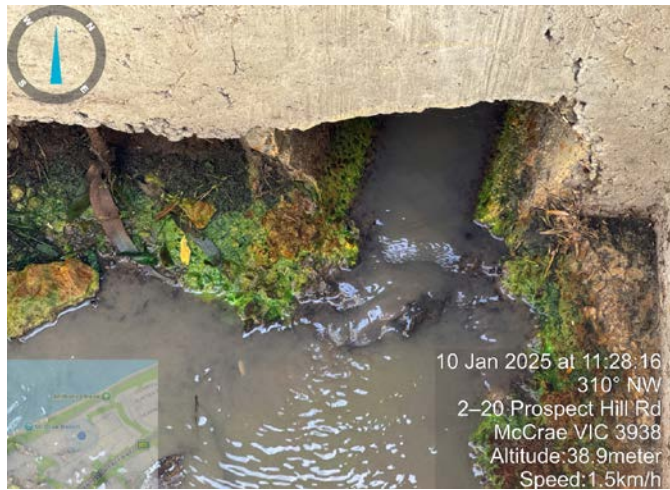
Photo 9: Corner of View Point road and Prospect Hill Road stormwater pit no red dye.

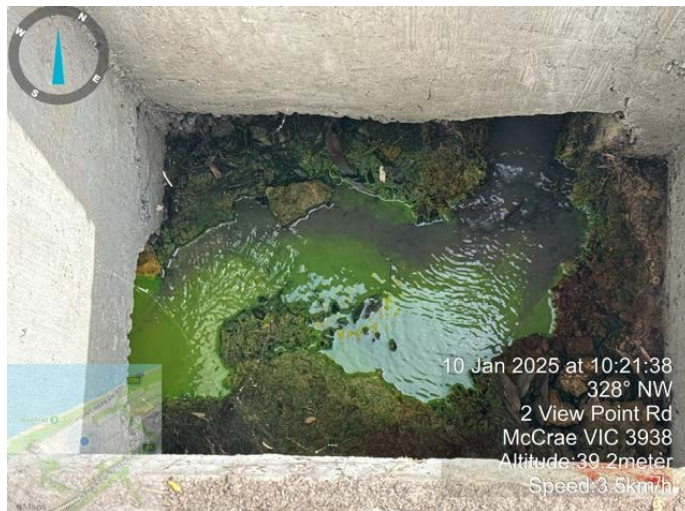
Photo 10: Lime-green dye from Corner of Prospect Hill and View Point roads

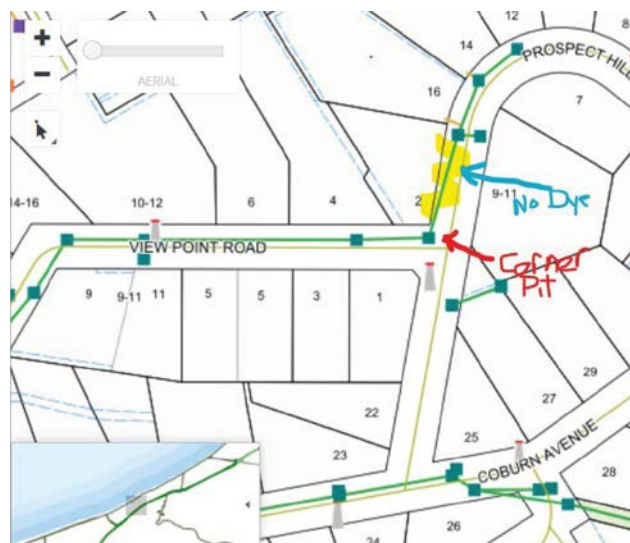
Map 2: The location in yellow highlights where the red dye was lost and did not enter the corner pit.

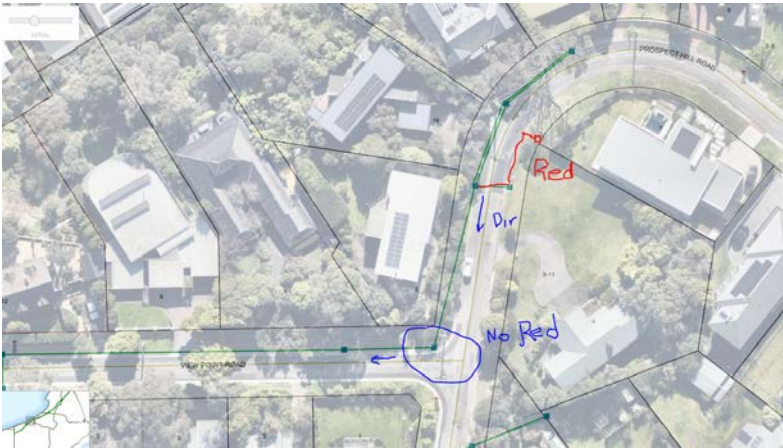
Map 3: Start location of the red dye
