**IN THE MATTER OF THE BOARD OF INQUIRY
INTO THE MCCRAE LANDSLIDES**

**ANNEXURES TO
WITNESS STATEMENT OF GERRARD RAYMOND BORGHESI**

RE: 10-12 View Point Road MCCRAE - Technical Memorandum

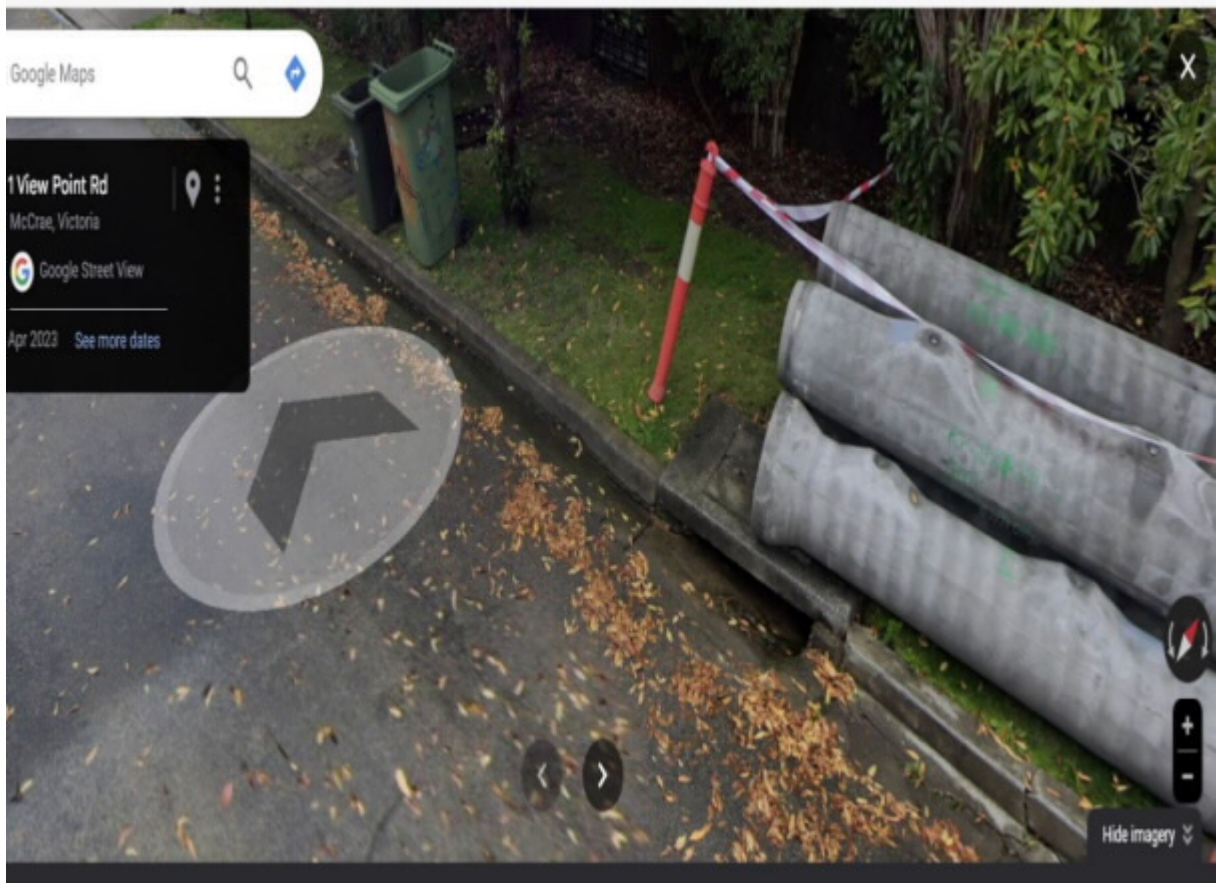
GB-2

“Photo of the Culvert”

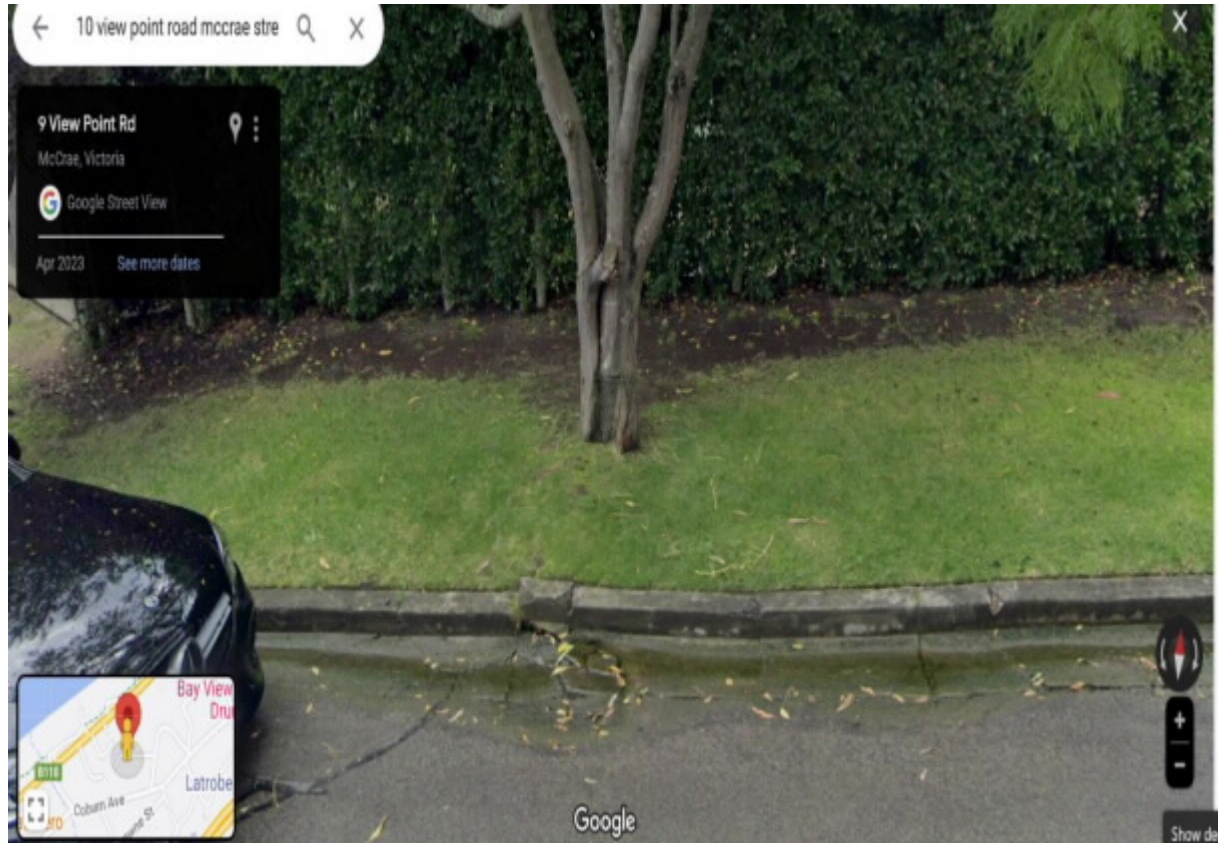
GB-3

“Image of the cracked northern kerb of View Point Road”

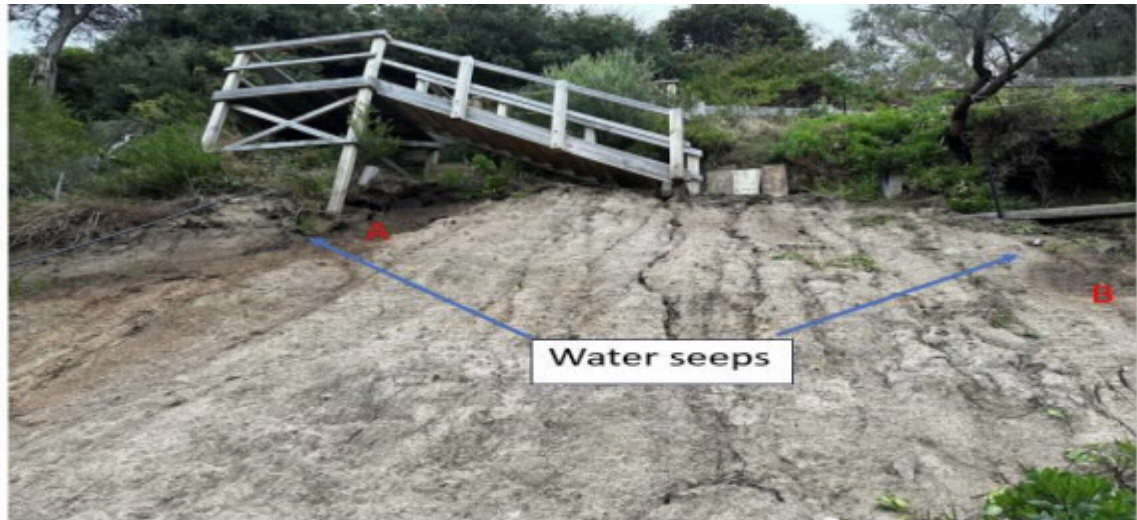
GB-4

“Seeps on Hillside”

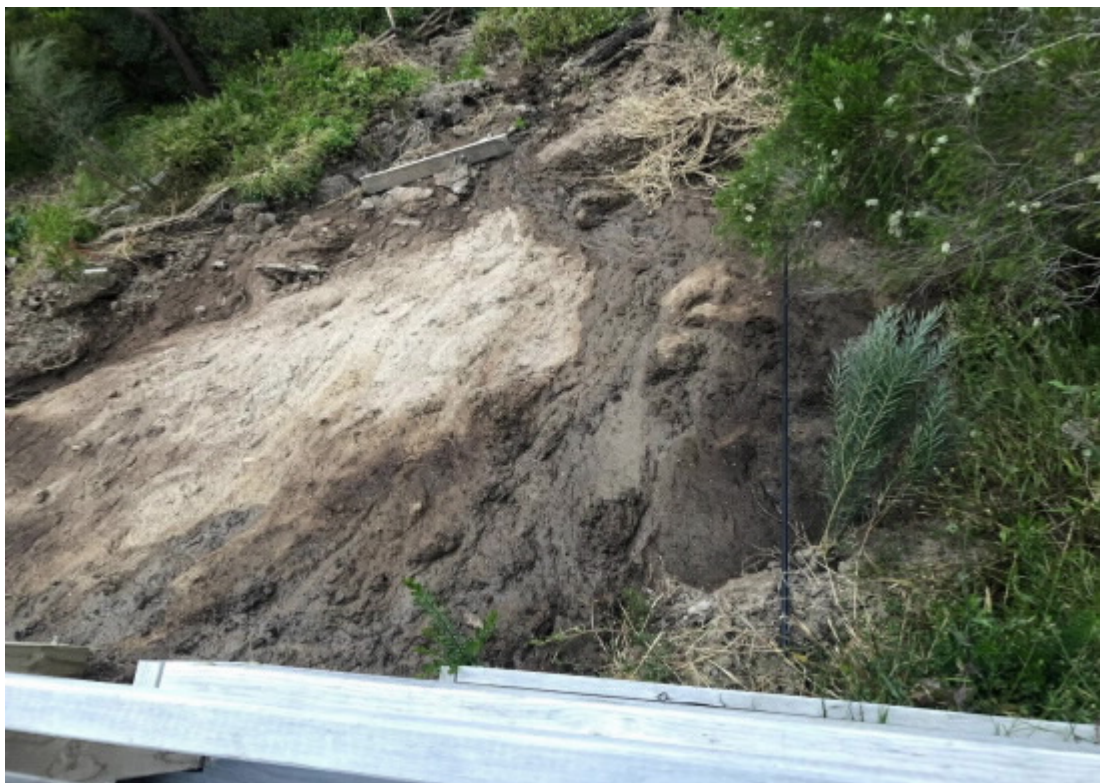
Picture 7 – looking South over landslide showing seeps A and B flanking the landslide

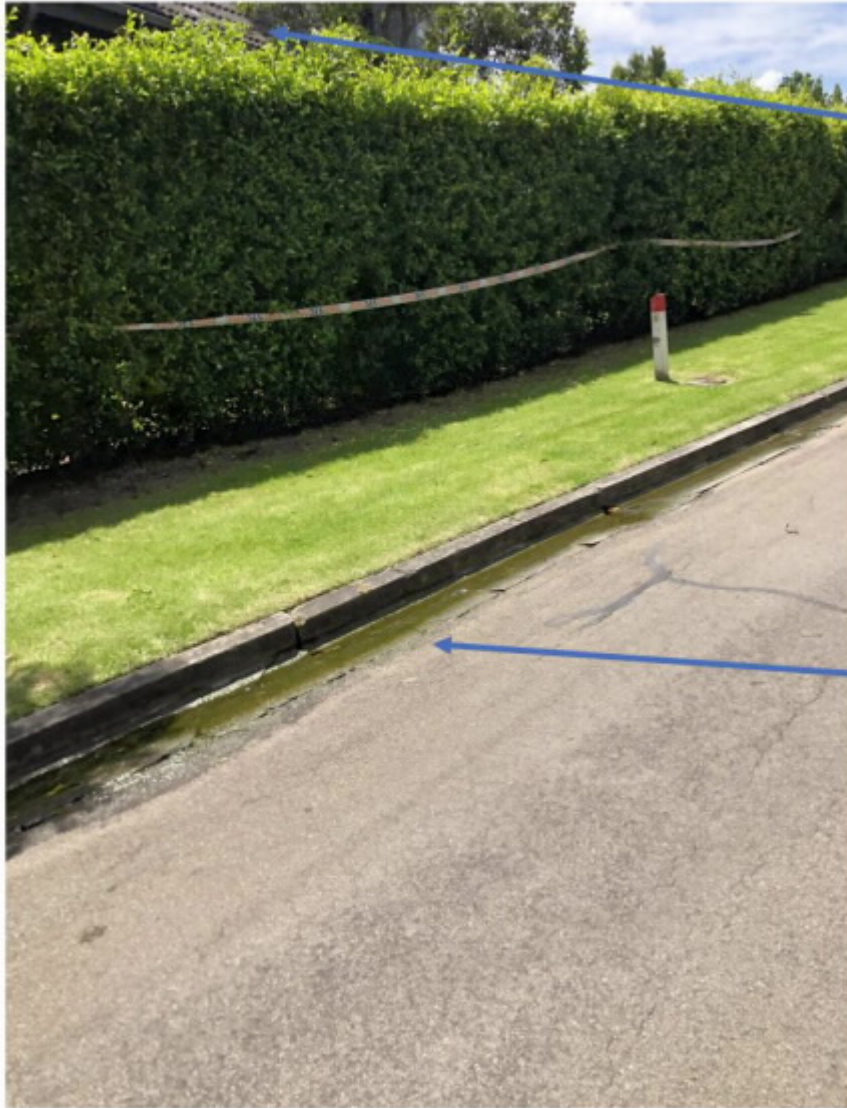
GB-5

"Moss and Algae"

Moss/Algae

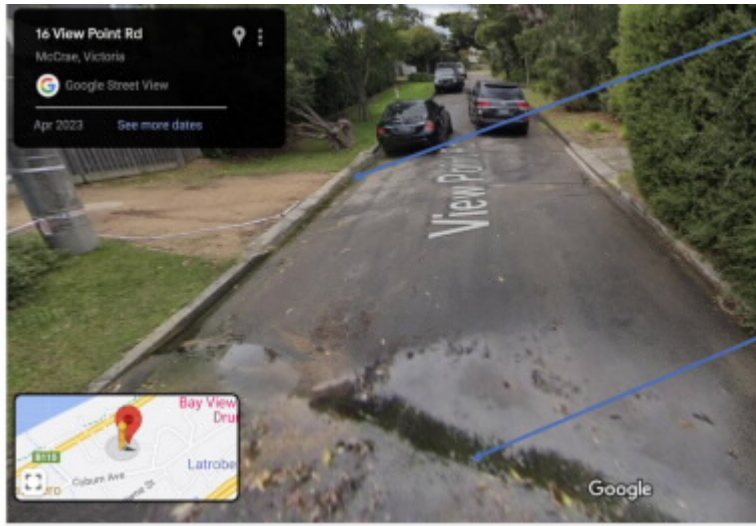
GB-6

Google image of the speedhump with my notations

void (picture 8) discovered
under cracked kerb

'Speed hump' installed by Council
to direct continuous water flow
to South side of View Point road

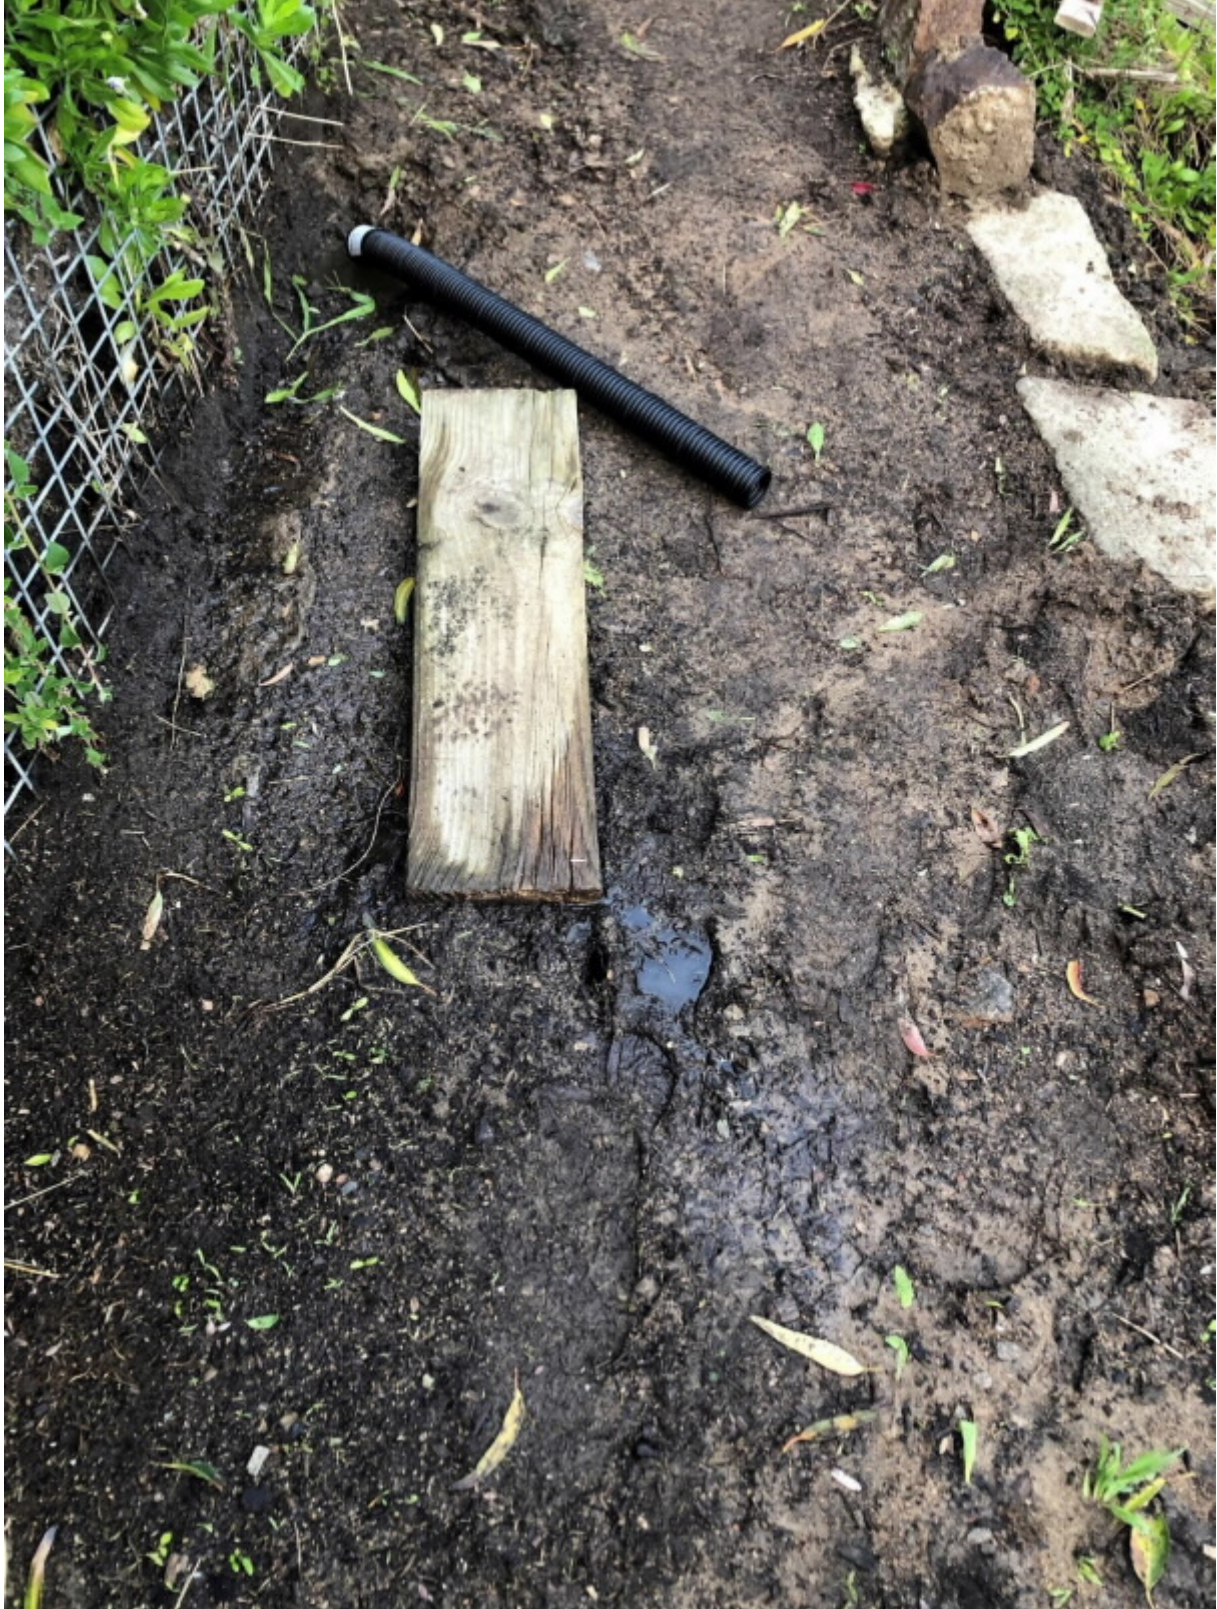
GB-7

“Saturated hillside where the aggie drains were installed”

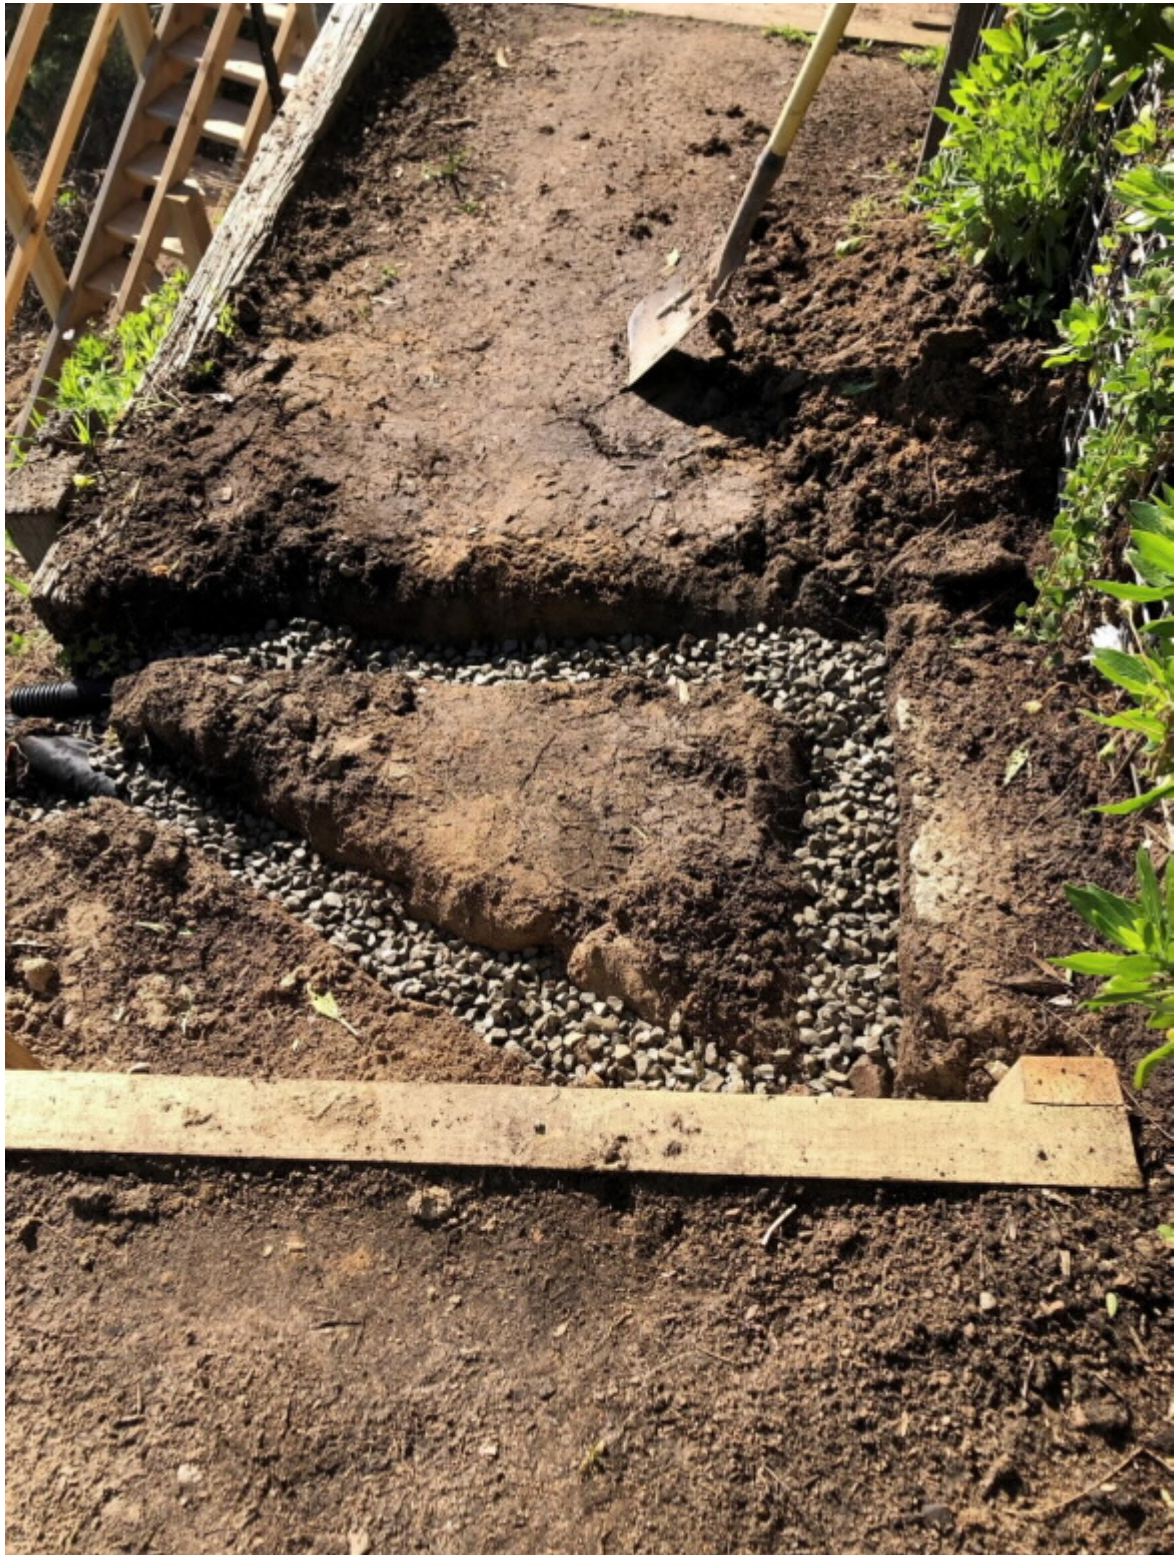
GB-8

“Aggie drains”

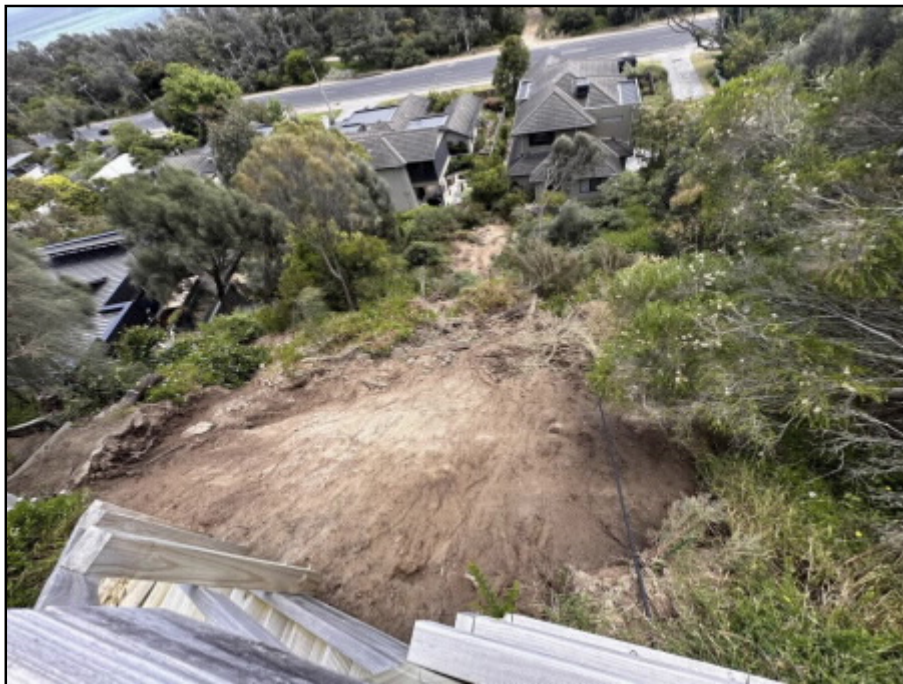
Figure 3: View looking down on the landslide

The inspected landslide can be classified as a Translational Earth FLOW, and this consisted of moist to wet sandy material and fine topsoil, which occurred along a distinctive planar surface of weakness. This planar surface of weakness is likely to be the interface of the upper Aeolian sandy material and the granitic residual soil, where the residual soil would be clayey and have lower permeability. Perched water could form at the abovementioned sandy material and granitic soil interface, which significantly reduces the shear strength of the material and forms a weak shear plane. The client has reported “three natural seeps” on the slope. The exposed batter near the top of the slide still showed moisture ingress at the surface at the time of the site inspection on 29 November 2022, which was conducted on a dry day. This is strong evidence of perched water forming at the materials interface due to the soil profile and topography of the area.

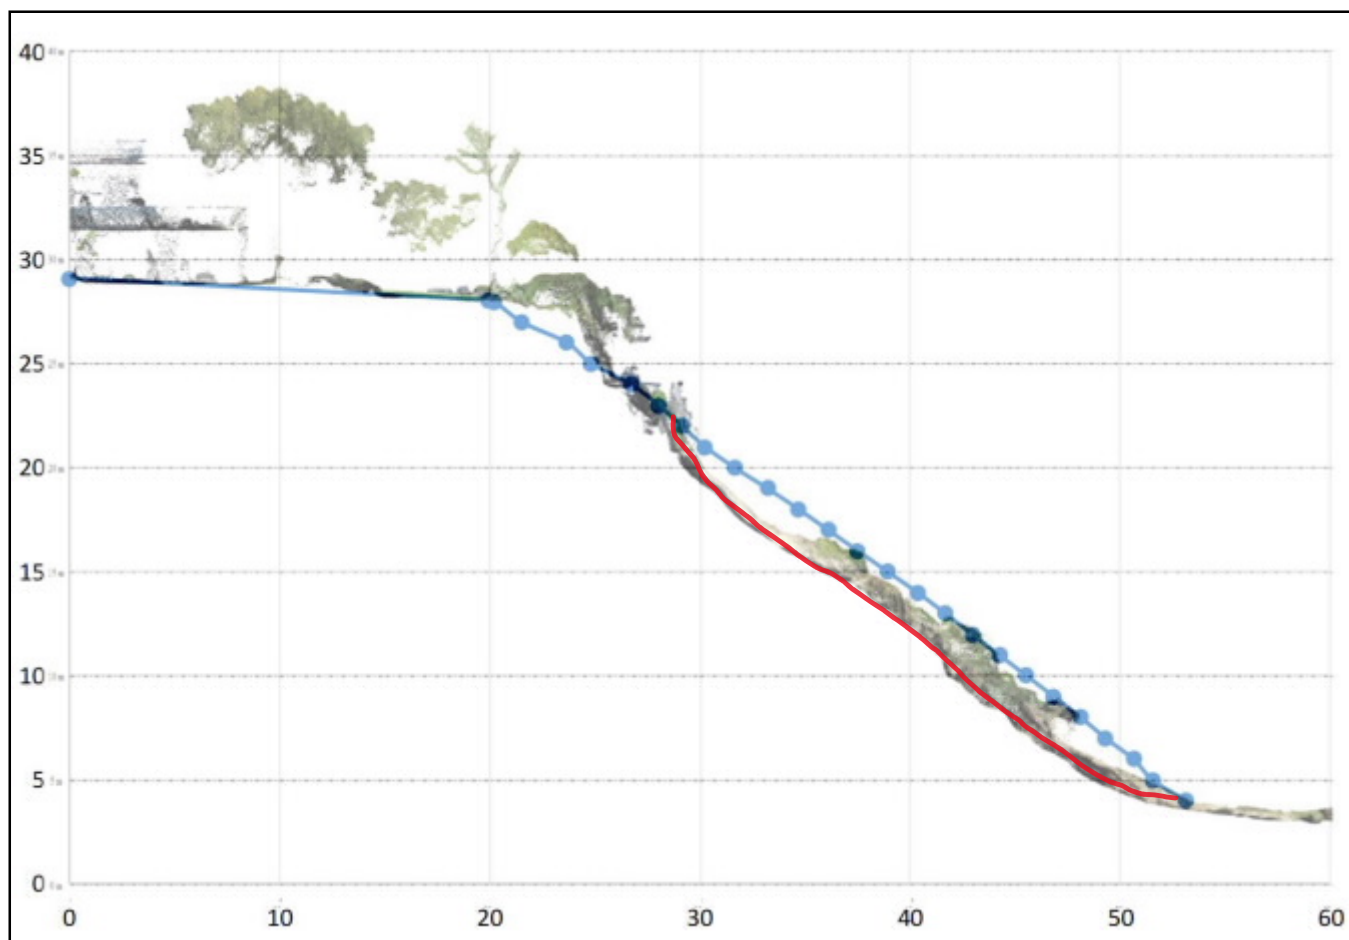
Figure 5: Before and After the Landslide, Section Comparison

The two surveys have been overlaid and a section (A-A) cutting through the location of the landslide has been obtained from both surveys to estimate the extent of the Earth FLOW. The section overlay is shown on **Figure 5** above. The blue dotted line represents the ground levels before the landslide. The background image showing trees represents the surface levels after the landslide event. The red line represents the estimated extent of the Translational Earth FLOW. The width of the section is approximately 8m from the top and the width varies with distance from the top. The material between the red line and blue dotted line is the residual disturbed earth that stopped moving at the middle to lower section of the slope, which did not flow down to the base of the slope. It should be noted that the contours provided in the abovementioned feature survey are at 1m intervals. The owner suggested the original slope was uniform, which is reflected in the feature survey. The original slope was approximately 35 degrees with the horizontal. It is possible that the feature survey has produced higher than actual ground levels due to the previous vegetation cover in the area and the steepness of the site, causing access issues for the Surveyor to survey the slope. Also, 1m contour intervals on the feature survey drawing would indicate the levels in between the contour lines are estimated. The estimated undisturbed part of the slope after the landslide has similar steepness, except the levels are 1m to 2m lower than the original levels, and the head scarp on the top is now much steeper, approximately 45 degrees.

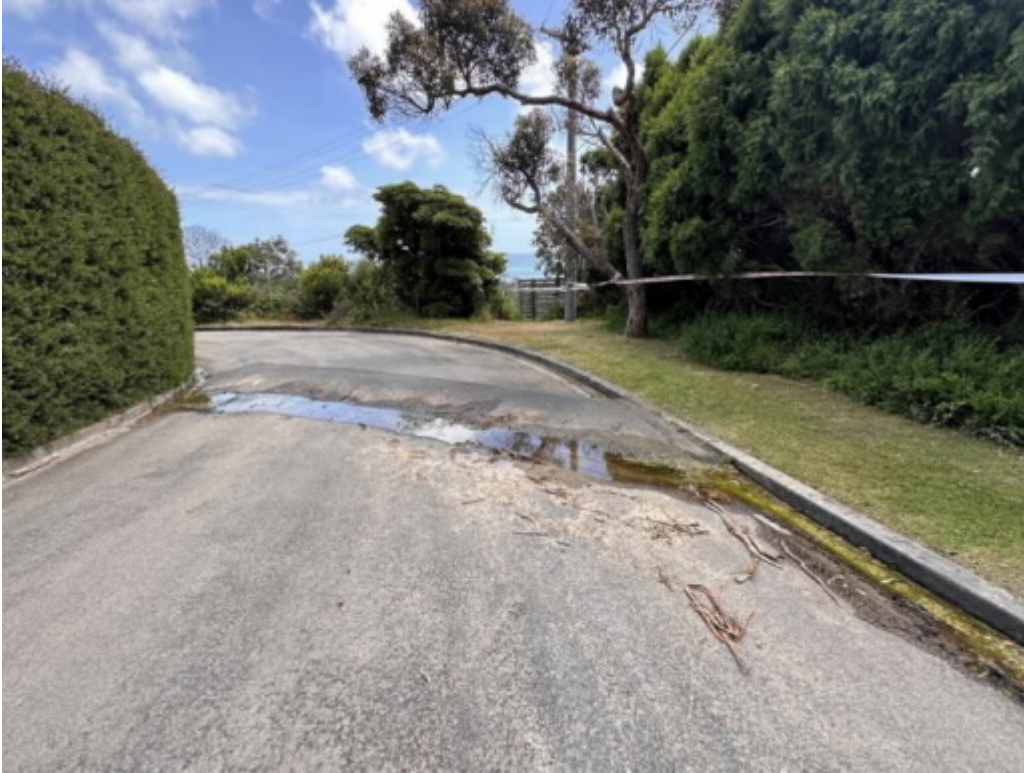
Figure 7: Water running along the kerb on View Point Road

It is noted that on 29 October and 2 November 2022 (both of which were sunny days), there was continuous water flowing along the kerb drain on View Point Road. The point of discharge of the drain is at the end of View Point Road, which is not far from the subject landslide area. A hump was built onto the surface of the road to divert water from one side of the kerb on View Point Road to the other side. There were signs of cracks and bitumen patching along the kerb on View Point Road. The diverted runoff would then seep into the nature strip and flow at/along the interface of the sandy and clayey soils, following gravity, towards the landslide area. This would be the most likely trigger for the landslide, as the road drain collects surface runoff from a much larger catchment area, and the continuous flow through the cracks and possible voids would build up abnormal hydraulic pressure at the sandy and clayey soil interface, especially following the storm event that occurred the day before the landslide.

Based on available Nearmap aerial images, The hump shown in Figure 7 was built around 10 years ago for diverting any surface runoff from the kerb on the northern side of the road to the southern side of the road, so water can flow towards the drainage pit at the end of View Point Road. This intercepts the natural flowpath of water, which in turn led to building up of surface water on the kerb on the northern side of the road.

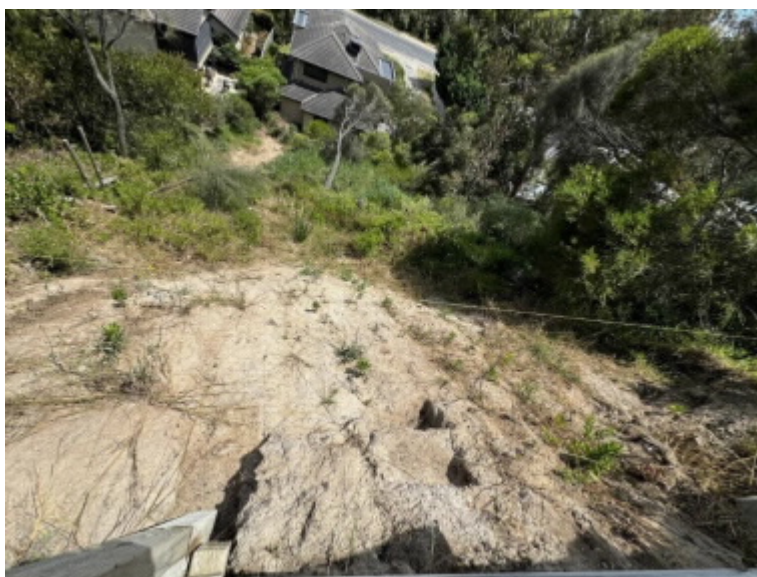
Figure 9: Dried out head scarp (photograph taken 4 December 2023)

On 4 December 2023, a follow up site inspection was conducted by Civiltest and it was noted that further to the renewed road drainage installation conducted by the Council, the continuous seeps on the exposed hillside slope have dried out, as indicated in Figure 9 below.

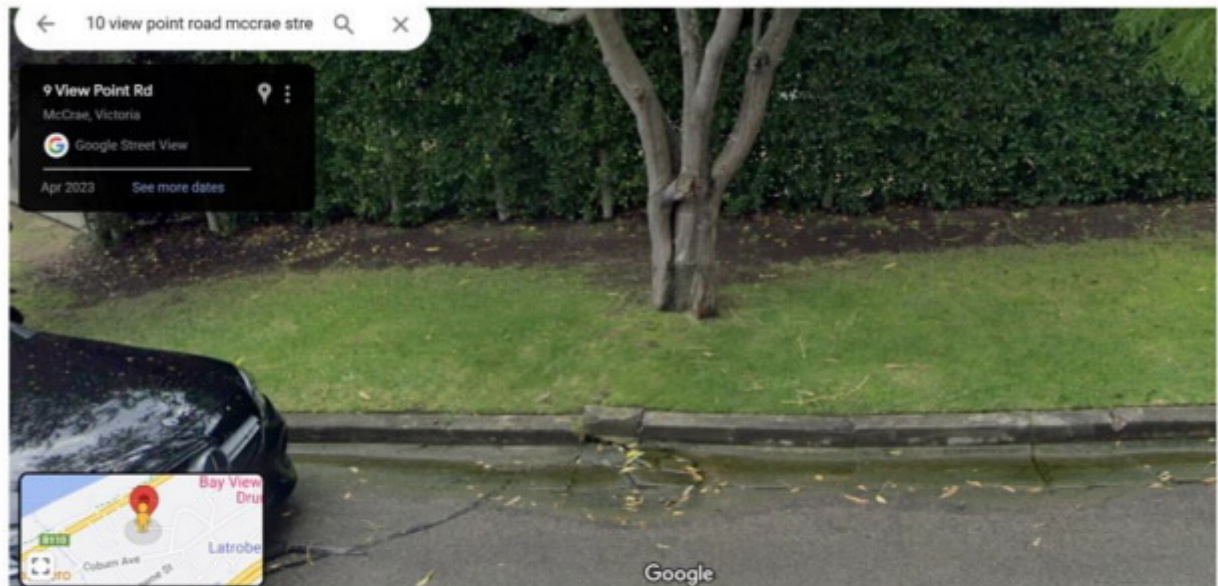
Picture 5 – example of major cracking in View Point road kerb prior mid 2023 drainage works

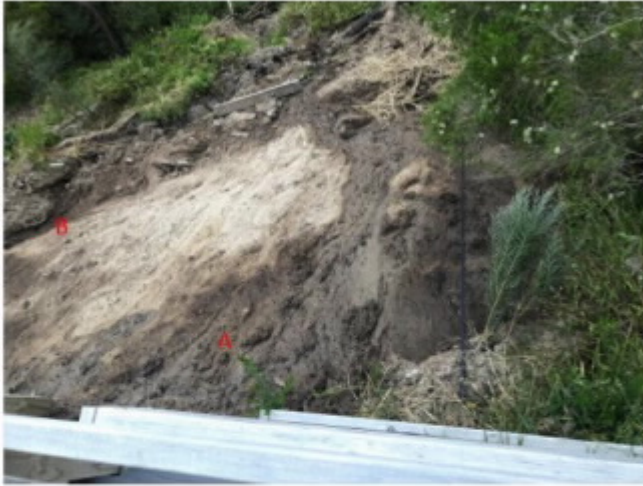
Picture 6 – looking North over timber stairs showing seeps A and B after landslip November 2022

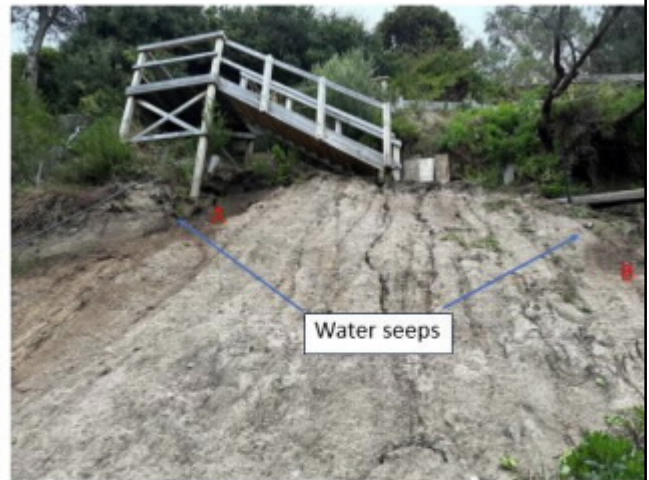
Picture 7 – looking South over landslide showing seeps A and B flanking the landslide

The right hand seep is directly below the void found under the cracked kerb on view point rd (refer to the other photo).

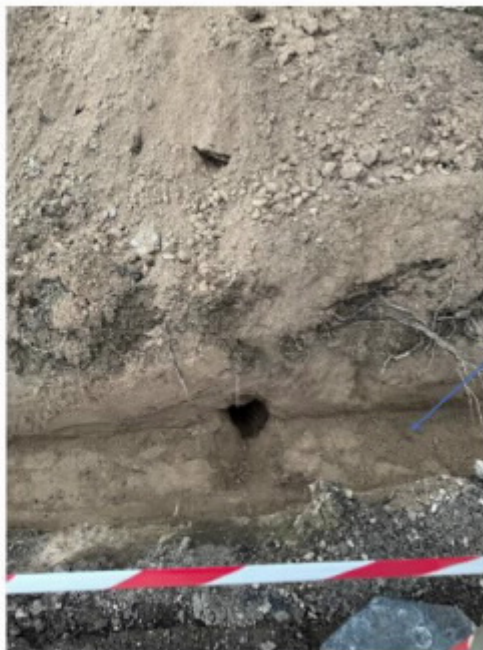
Bottom of excavation for new stormwater pipe, approximately 1.5m below ground

Picture 8 - Void discovered during earthworks to install drainage and new kerb on View Point road

This is the void that proves there was water flowing from the cracked kerb into the hillside where the landslide occurred, for many decades.

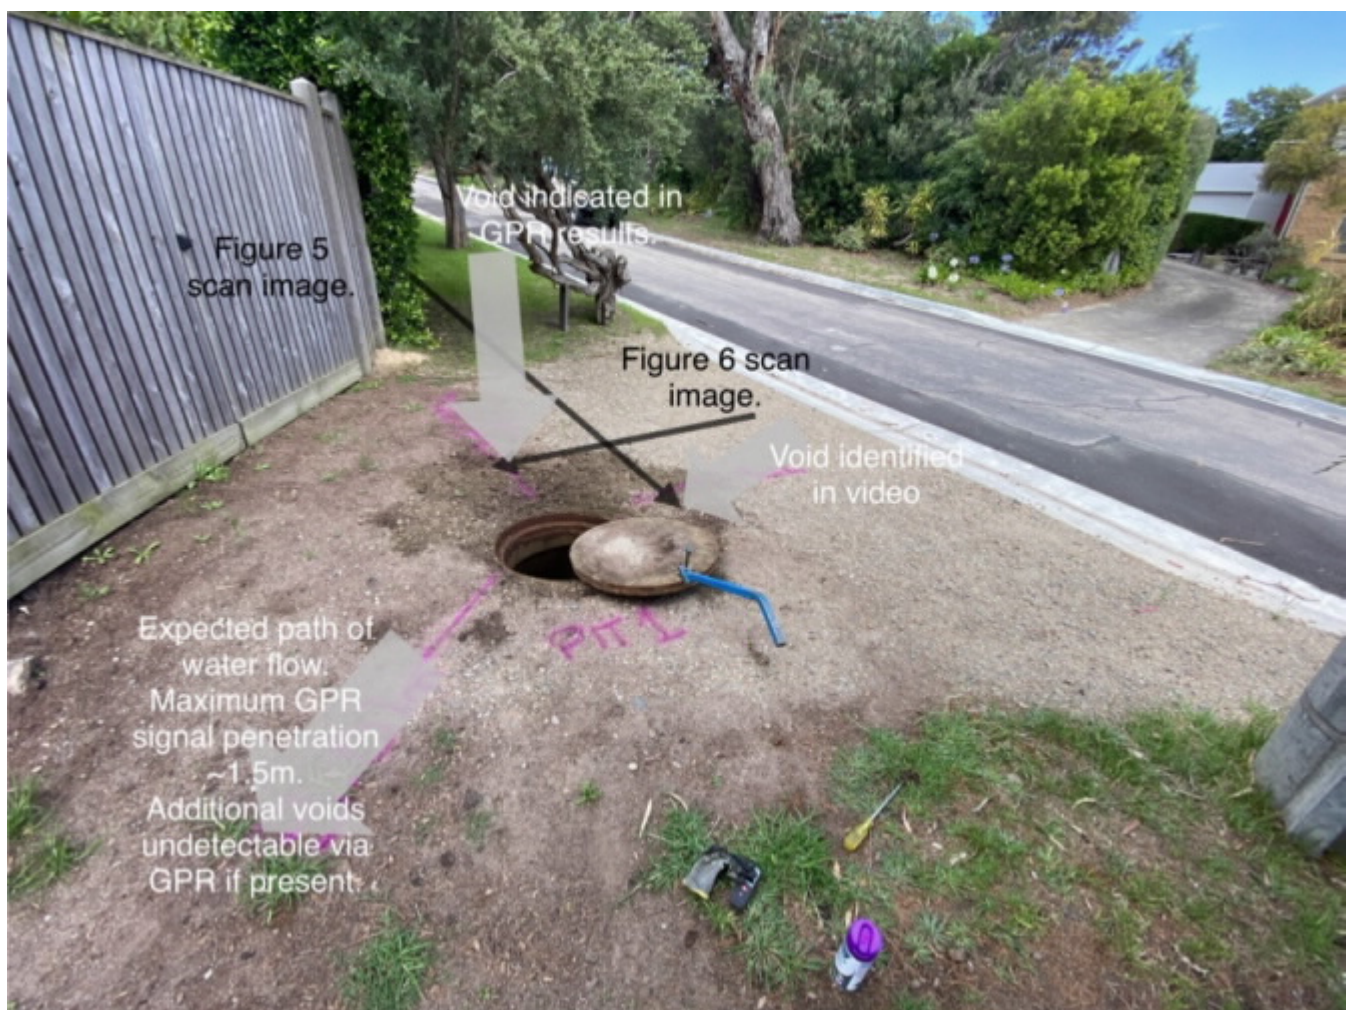
Fig 1 : Recorded scan locations included within the report indicated below.
Identified void locations as marked.
Open sewer pit with invert levels and pipe directions noted in paint.

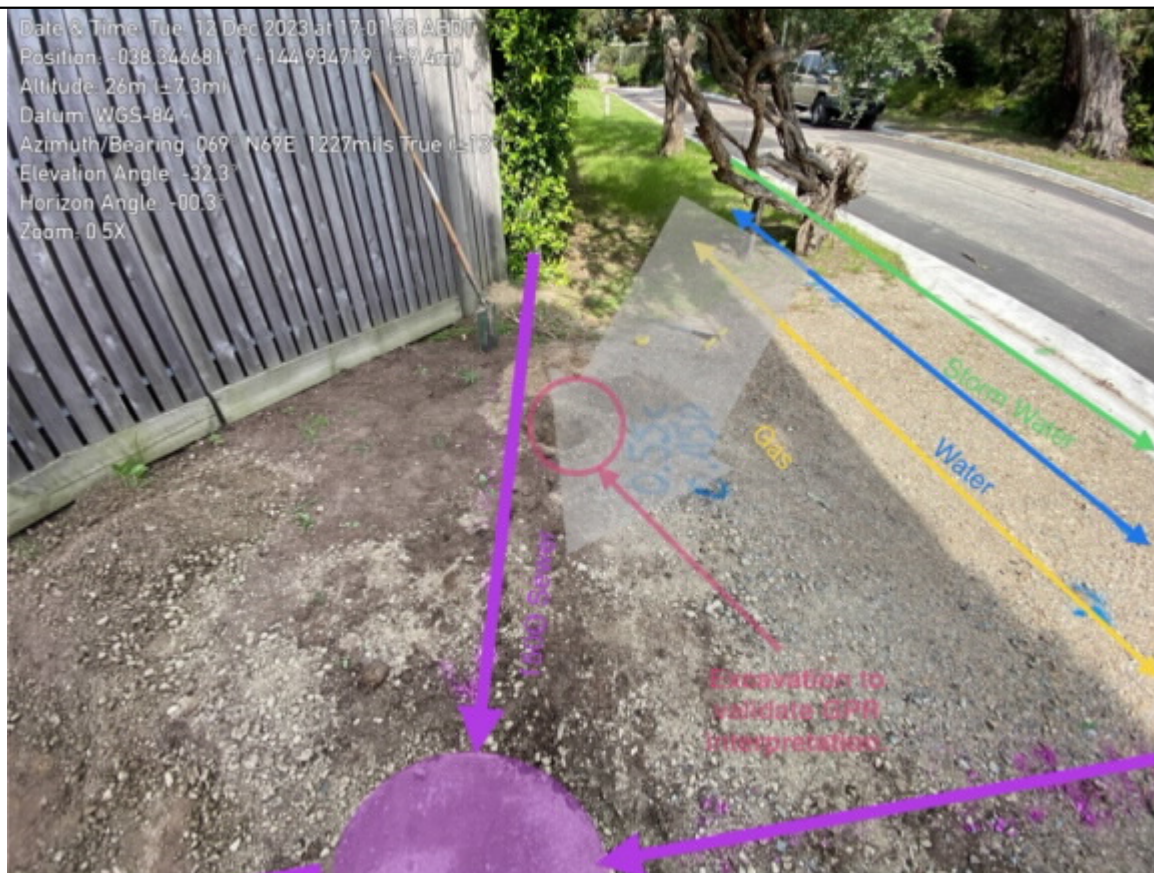
Fig 2: Services identified, along with GPR validation location.

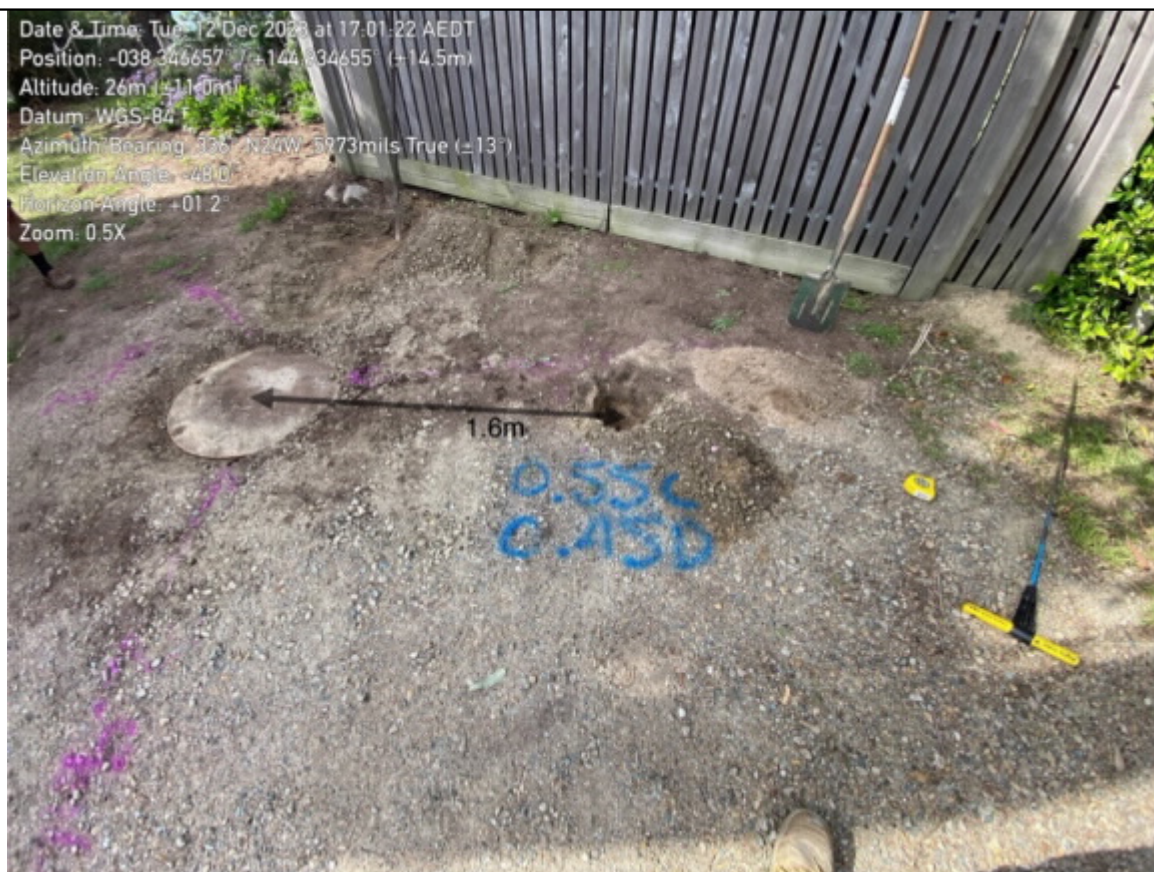
Fig 3: Scan validation location, positioned to avoid underground utilities. Void was proven with 0.55m cover.

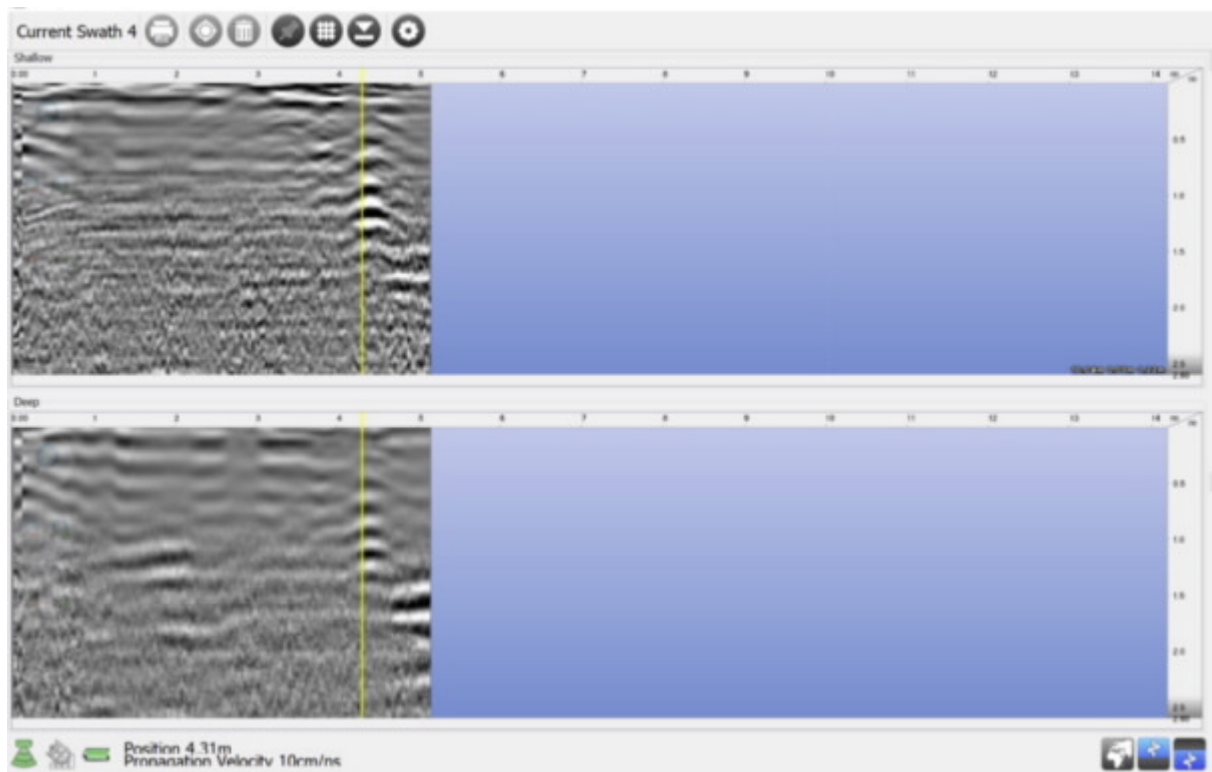
Fig 6: Cross section of identified void in nature strip, physically verified.

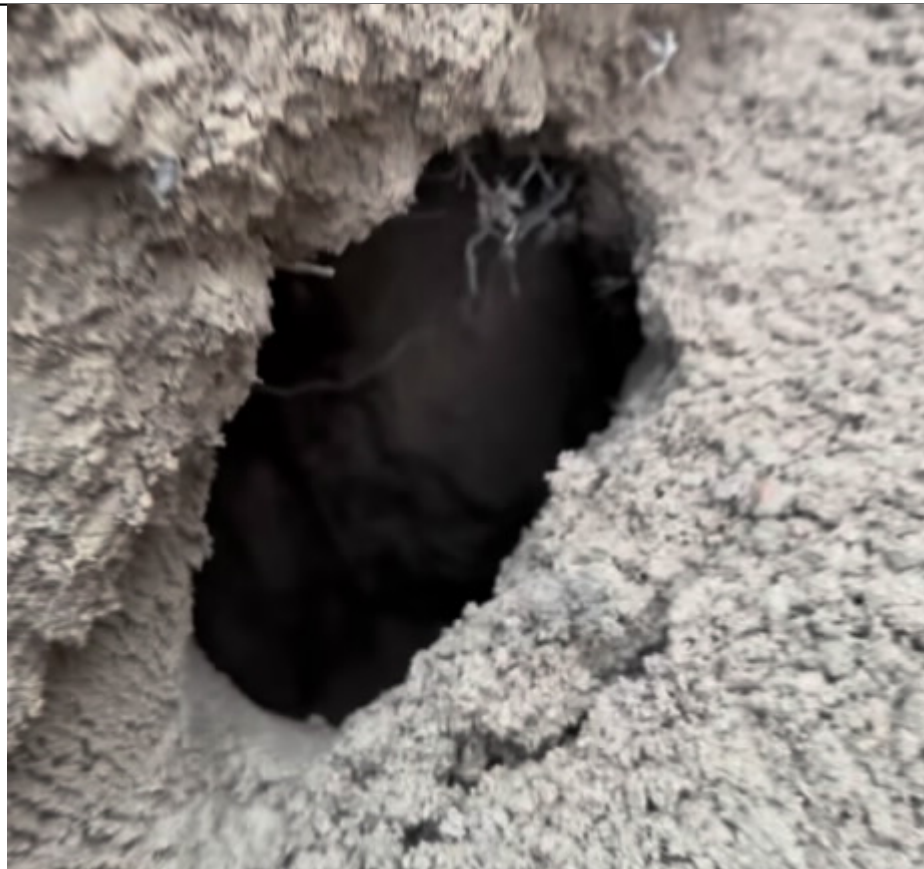
Fig 7: Still image showing void, taken from a video provided by Gerry Borghesi during Storm Water upgrade.
