McCrae landslides

Board of Inquiry (BOI) request for input by August 11, 2025

Landslide Causation Submission

11 August 2025

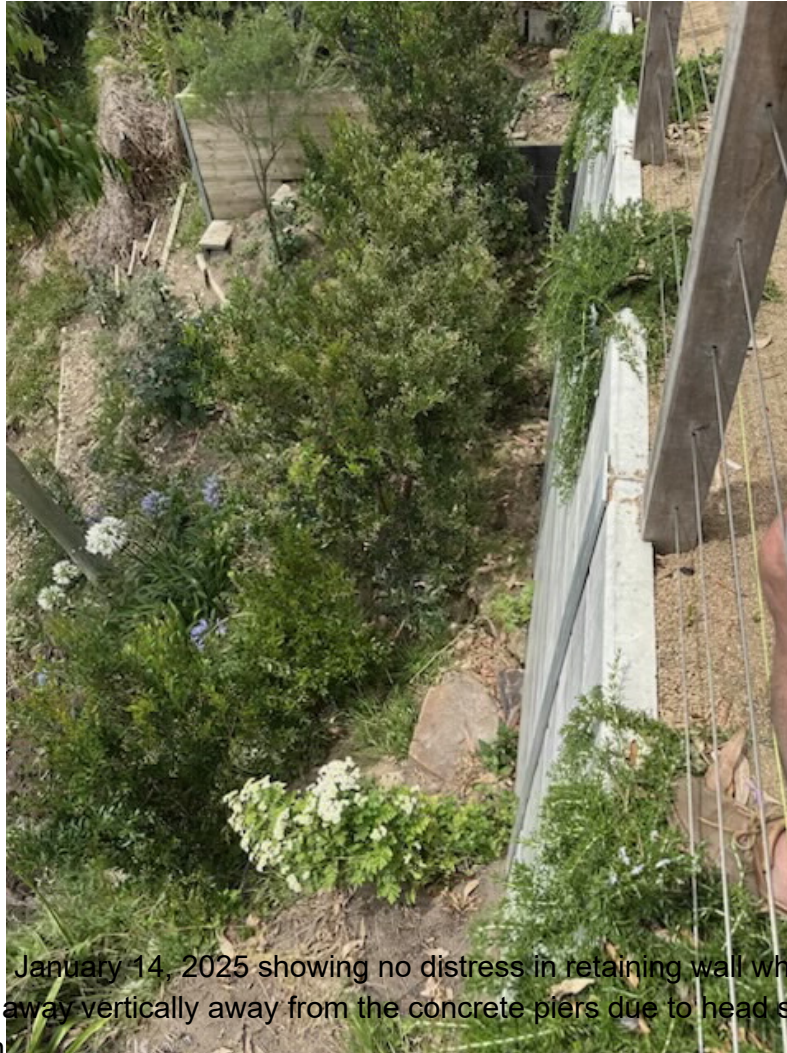
The landslide volume was estimated to be 20-30 cubic meters and described as a translational mud flow (similar to the November 2022 landslide). The property at 3 Penny lane was damaged. Prior to this landslide, there was no visible evidence of water in this gully. The current and previous owners of 3 Penny Lane advise that the area under their house was dry. Photos taken under and along the base of the retaining wall between January 5 and 14 also show that the surface area was dry (ie: there was no surface water near the base of the retaining wall). The retaining wall was not failing due to overturning nor sliding and remained straight with no signs of distress (*refer photo 1 attached*).

Photographic evidence taken between January 5 and 14 shows the soil around the concrete piers 'falling away' from the piers and that the piers remained in place, unmoved until a catastrophic failure. There was no evidence of water capture and pressure build up behind the well-drained retaining wall. Technically, the passive restraining capacity of the soil acting against the front and beneath the concrete piers was being reduced as the head scarp was falling away and receding back toward the retaining wall piers. Additionally, the shear strength of the soil below the piers had been dramatically reduced by the sudden increase in pore pressure, leading to a likely shear plane failure, which was exacerbated by the shortening of the shear plane as the head scarp receded. This is not the usual failure mechanism for a retaining wall, which would typically occur by starting to slide or overturn by being overloaded from behind and above.

Photo 1: January 14, 2025 showing no distress in retaining wall while soil is dropping away vertically away from the concrete piers due to head scarp recession.

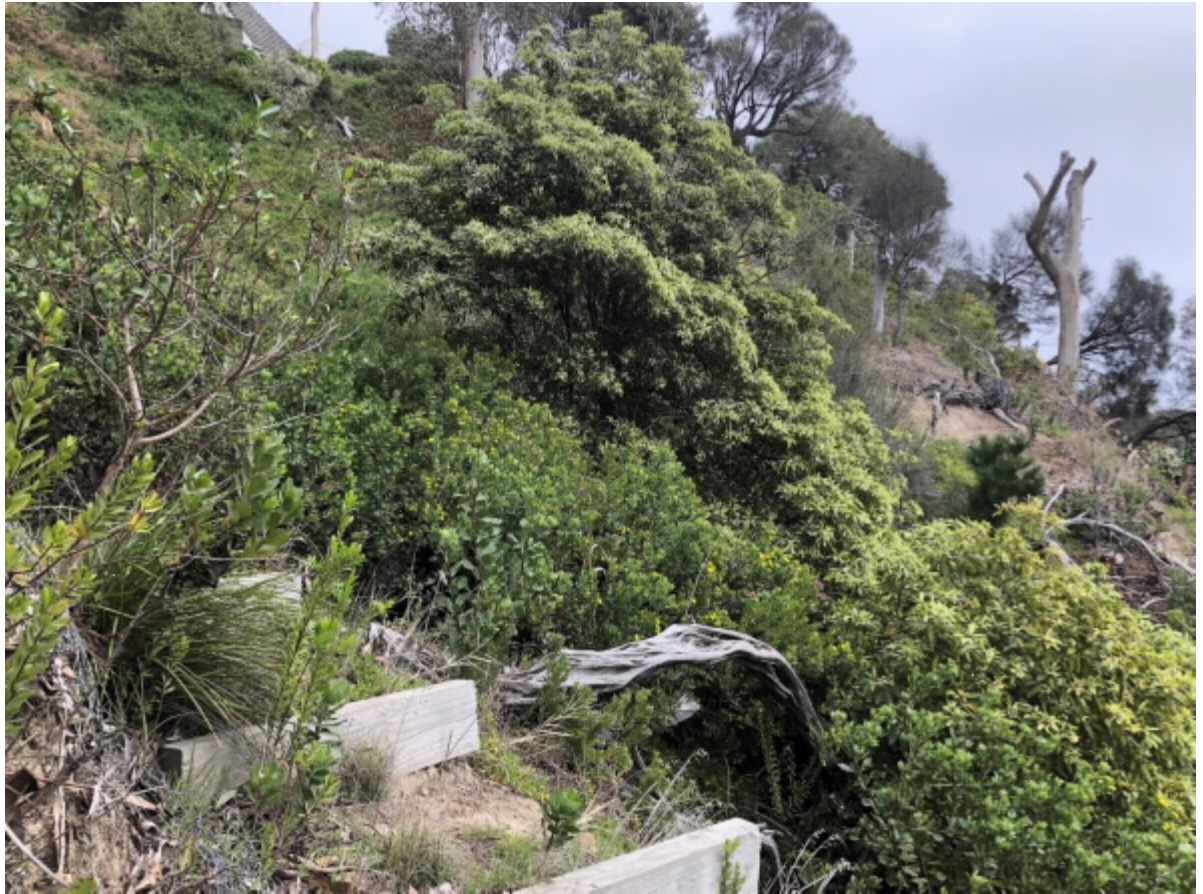
There was no de-vegetation conducted by us in the lower reaches of the 2025 landslide area, except for one pine tree on the boundary with 3 Penny Lane in the 2016 timeframe, as requested by the owners of 3 Penny Lane and in compliance with the bushfire overlay. This area is generally inaccessible, and there is no conceivable motivation as to why this area may have been de-vegetated (*refer photos 2 and 3, attached*).

Photo 2: August 2021 from North East boundary of 3 Penny Lane and 10-12 View Point Road, looking West, showing natural vegetation and extent of inaccessibility (taken from red circle in photo 3)

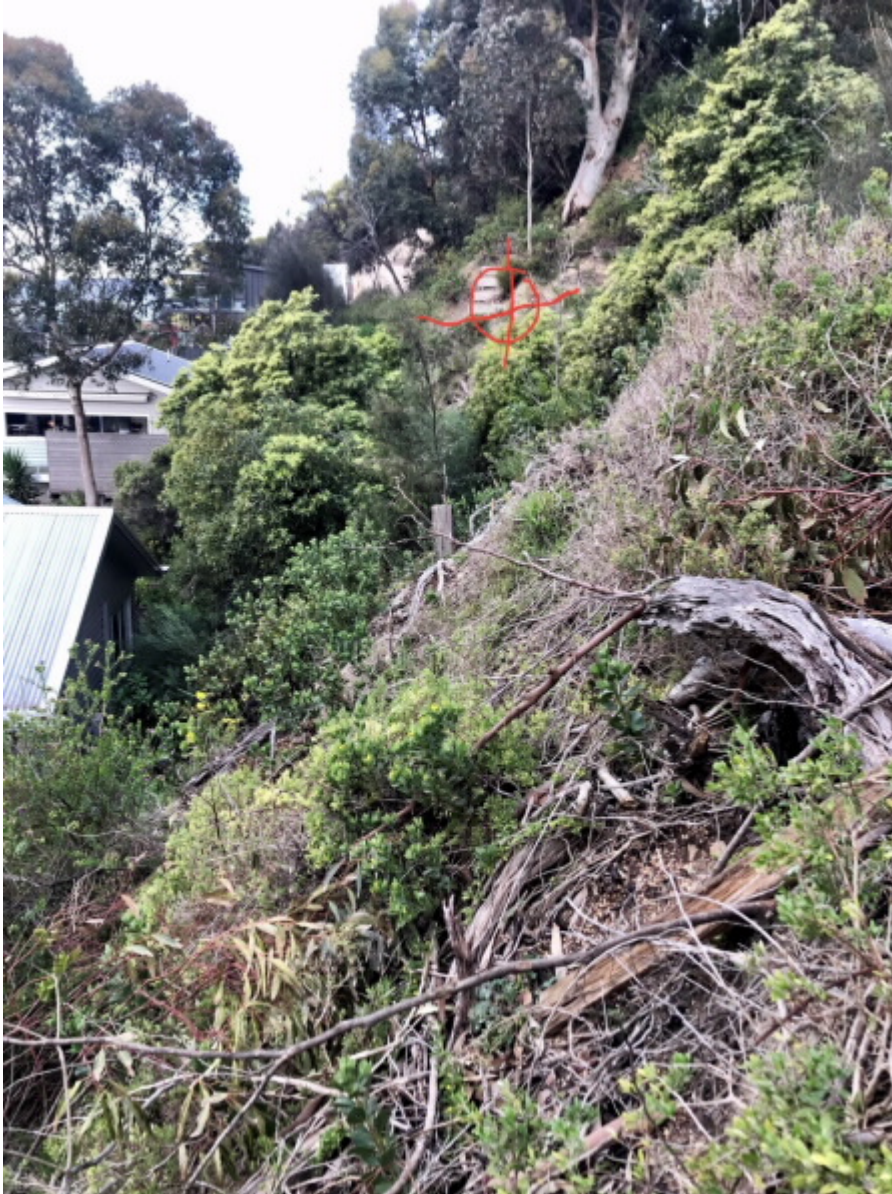
Photo 3: Taken on boundary with 3 Penny Lane, looking East to property corner (marked by red circle) showing state of natural vegetation and degree of inaccessibility

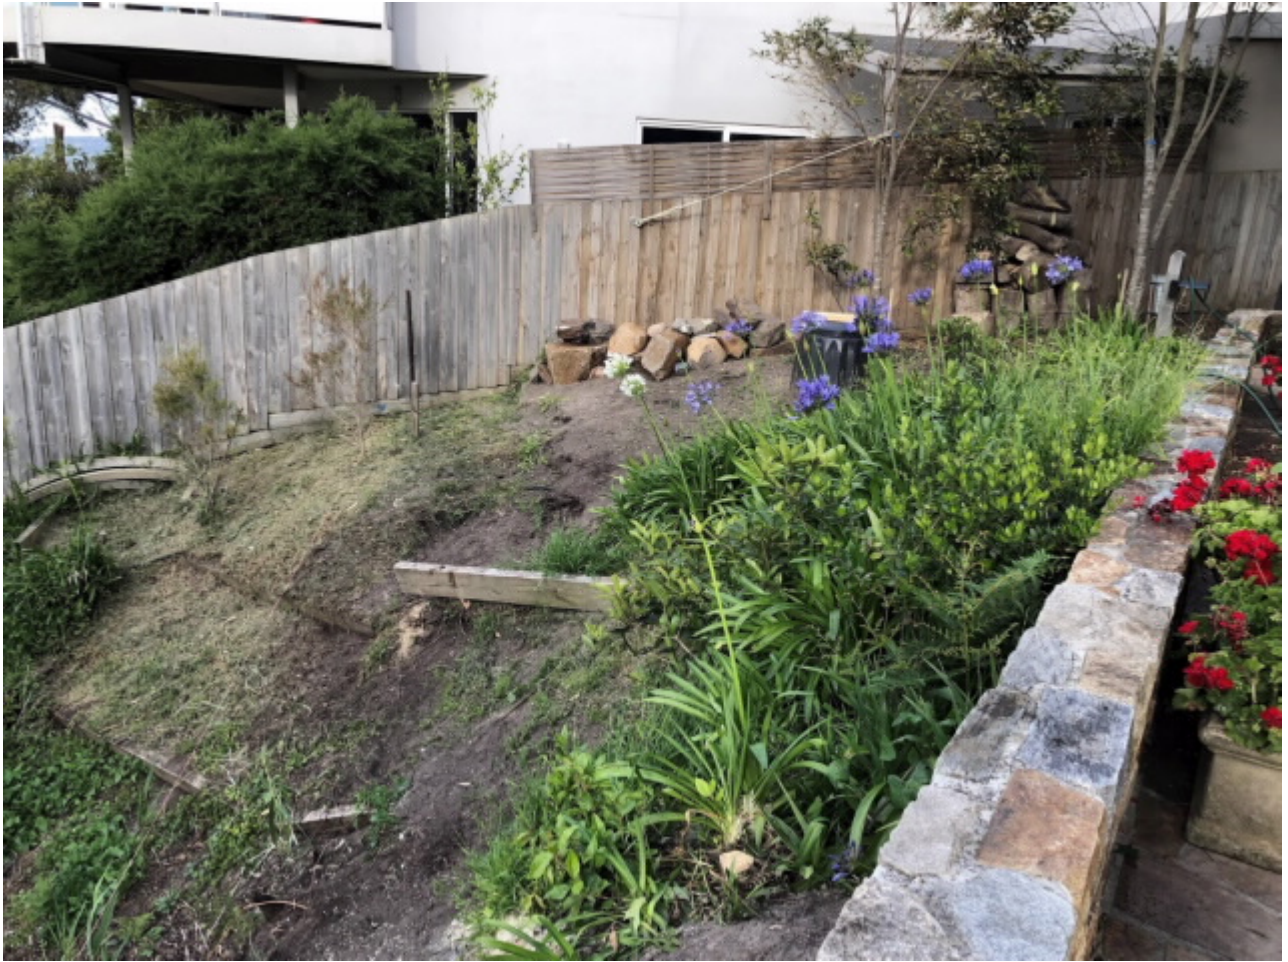
The PSM reports overstate the amount of fill behind the retaining wall (30m3). This can be proven by reviewing photos taken prior to the installation of the retaining walls, and by the photos taken from 6 VPR looking back to the remnants of the retaining wall (*refer photos 4 and 5*).

Photo 4: Area of 2025 landslide prior to construction of retaining walls, showing natural profile before any fill.

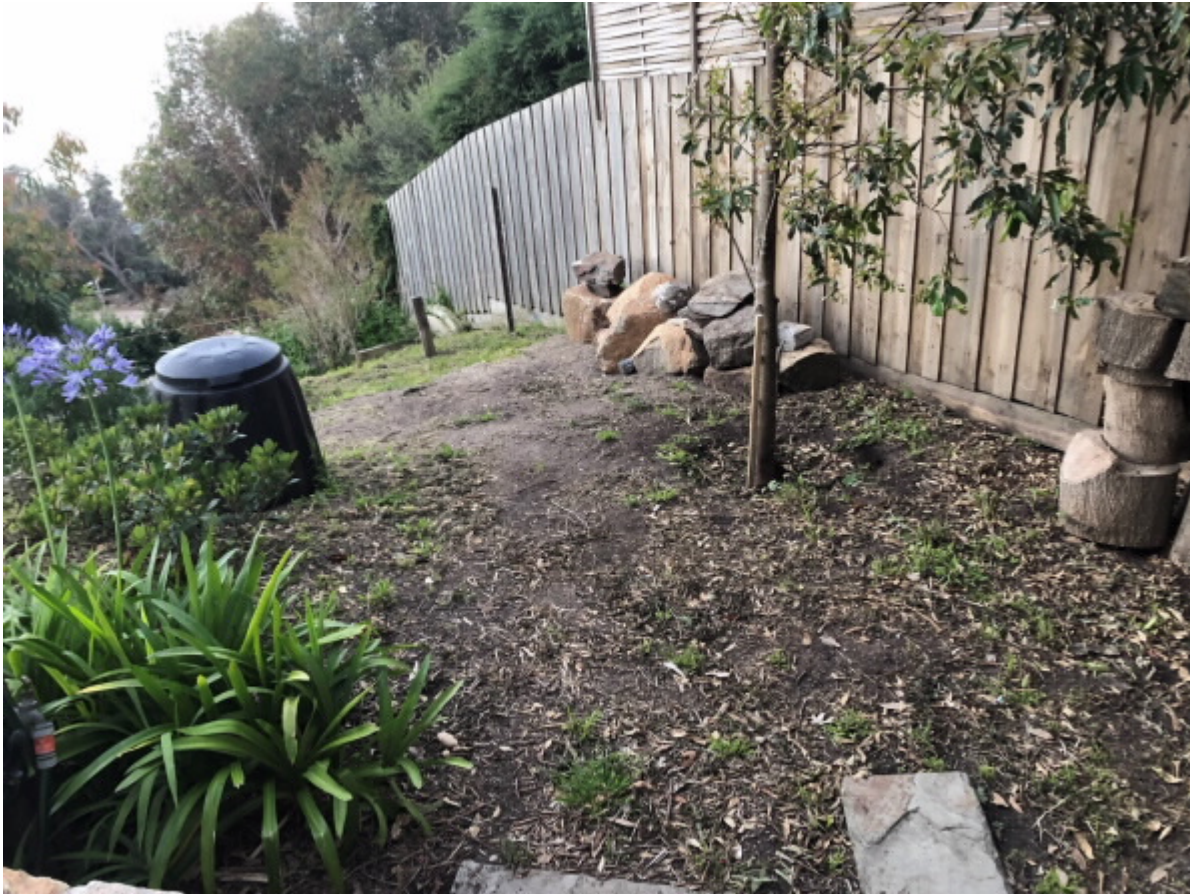
Photo 5: Property boundary in veggie patch area prior to construction of retaining walls, showing natural soil profile. The tree in this photo remains in place today (post 2025 landslide).

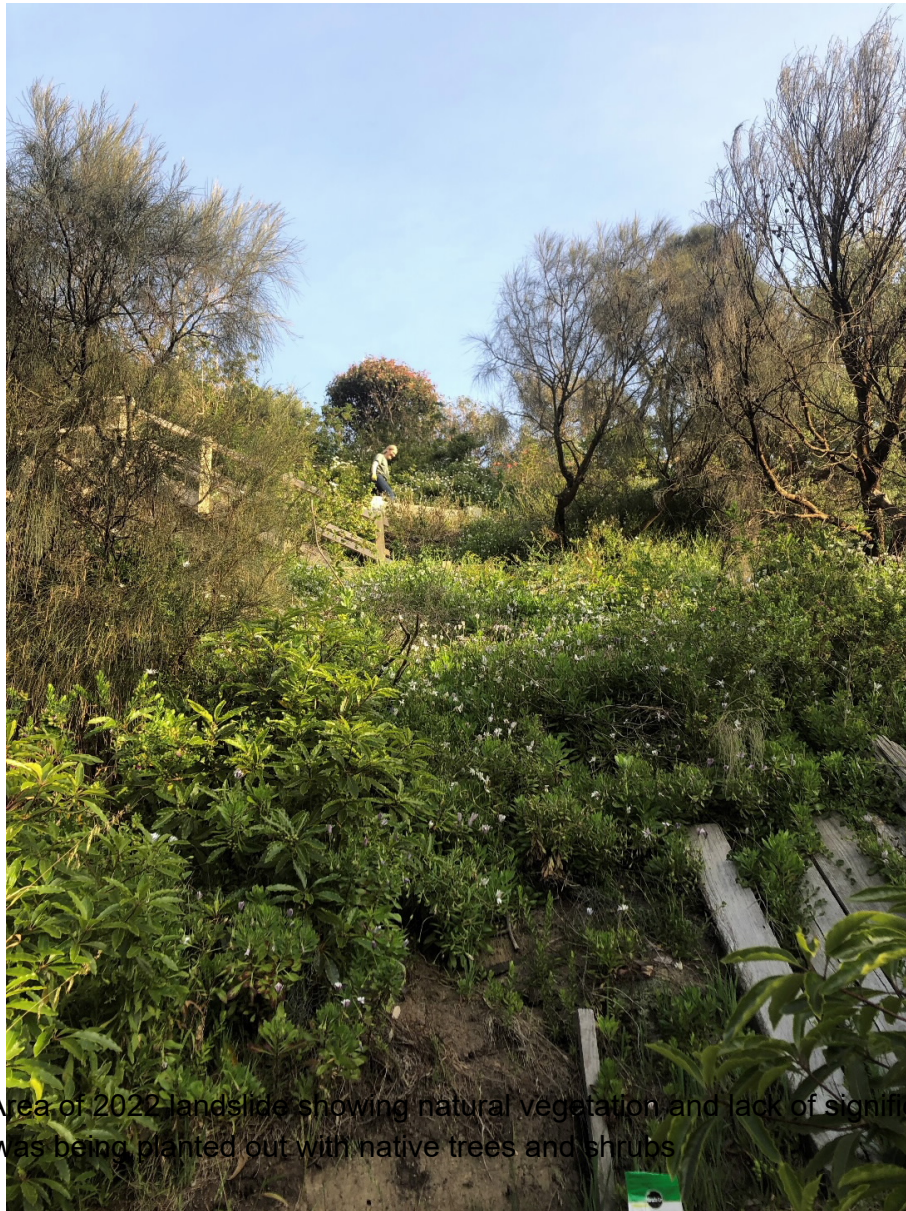
There was no de-vegetation in immediate the area of the landslide, and the area was being planted out with native trees and shrubs (*refer photo 6*).

Photo 6: Area of 2022 landslide showing natural vegetation and lack of significant trees. This area was being planted out with native trees and shrubs
