29 April 2025

**Our Ref:** 1250546-1 Issue 2  
**WR:** 22220

**RE: McCrae Groundwater Investigation MCCRAE**

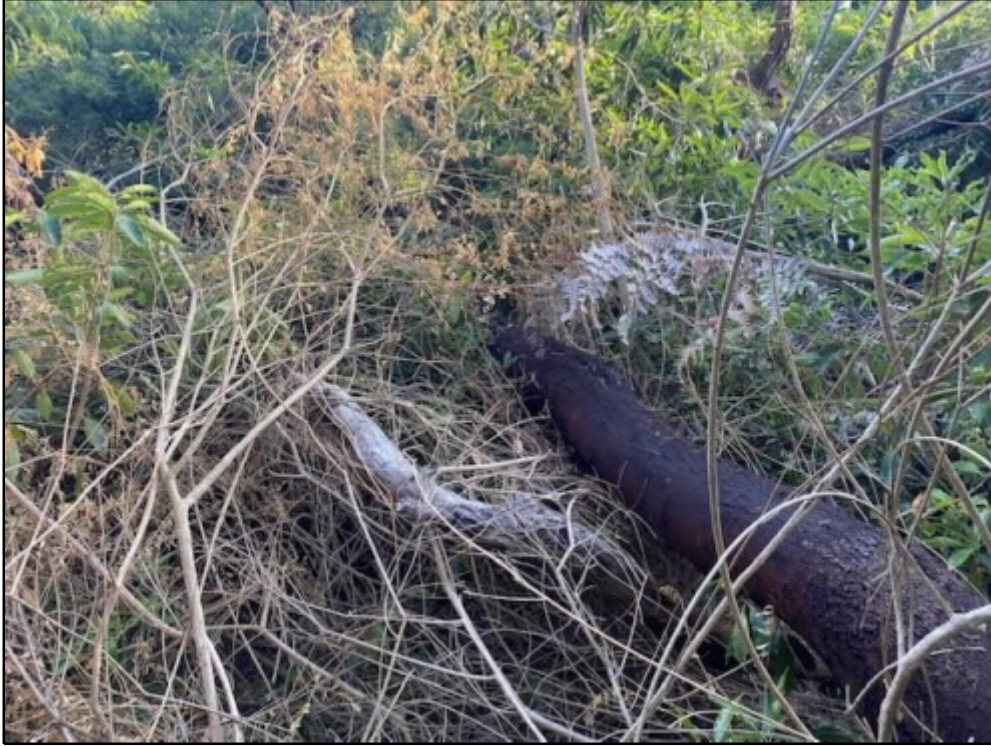
In the vegetated area, the ground surface was dry, but evidence of potential recent disturbance and inundation was noted in the form of collapsed trees that appeared to have fallen recently due to the condition of the attached foliage, and also areas of migrated sediment were present.

**Site photograph 1:** Disturbed vegetation North of the burst pipe location

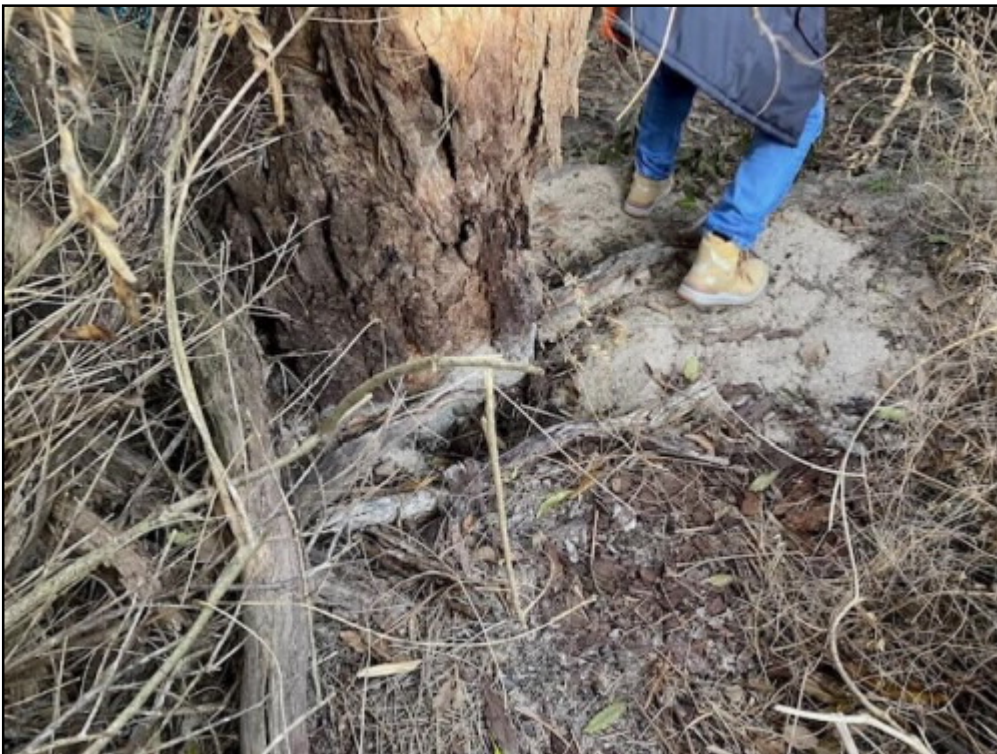
**Site photograph 2:** Example of recently deposited sediment, North of the burst location

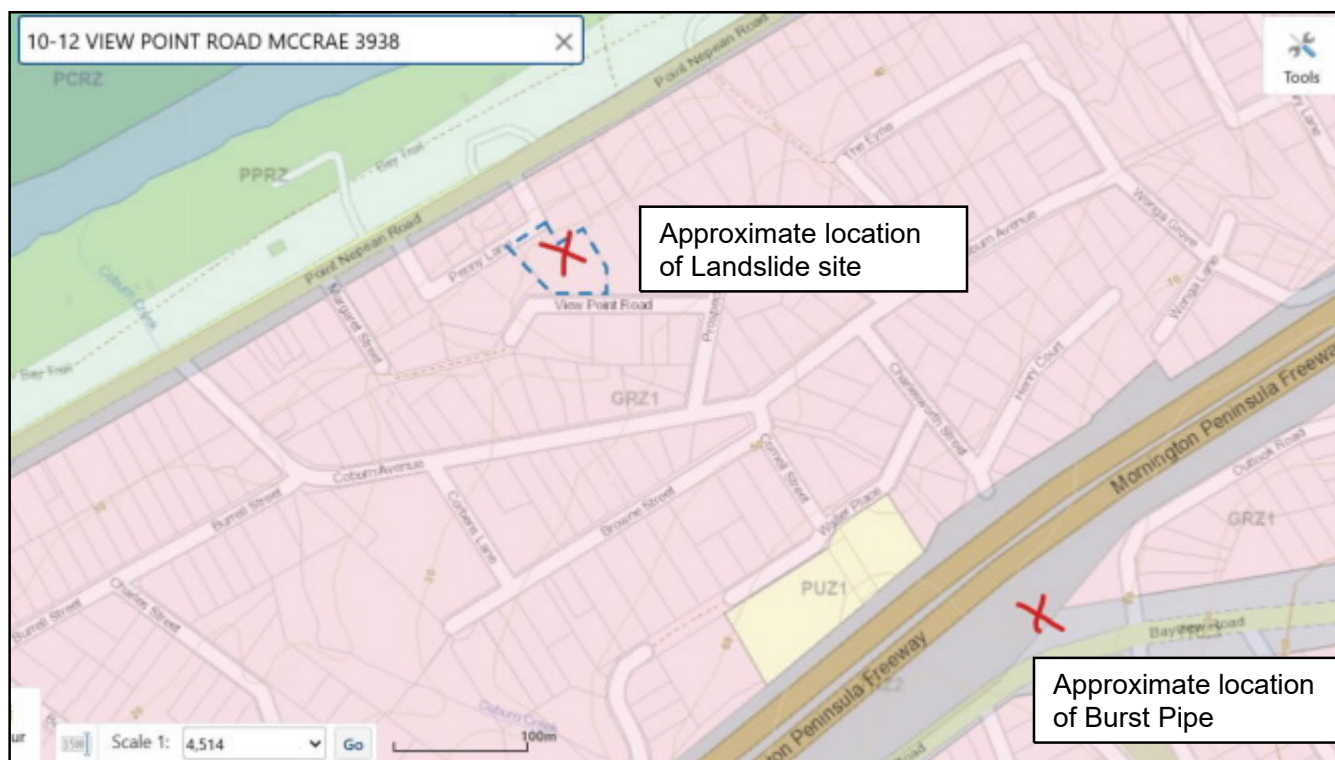
**Image 1:** VicPlan screenshot

The general observation was made that the alleged flow path approximately follows the natural contour of the local area. The following screenshot from VicPlan marks the approximate location of the burst pipe and the approximate location of the Landslide site.

While VicPlan contours should not be used as a precise guide for determining site levels, they can help to provide an understanding of the general topography of the local area. It can be observed that the burst pipe location is located between 70-80 AHD on the map, and the landslide location is located around 30 AHD. Furthermore, the contour generally moves downwards in a North-Westerly direction, or the general direction of the foreshore. Based on the media provided to Civiltest, it appears that the water allegedly originating from the burst water pipe was moving downslope with the natural contour.
