**Task Number:**1295094/001**Task Address:**4 WALLER PLACE, MCCRAE VIC 3938 MapRef : 159B10**Program Name:****Task Work Type:**Planned Maintenance - Repair**Source Of Work:****Facility:****Permit Not Required:**No**Permit Pre Approved:**No**Permit Reason:**Other**Permit Other Reason:**

**Task Address:**4 WALLER PLACE, MCCRAE VIC 3938 MapRef : 159B10

# Leak Report

**Failure Details:**1 Water Main - Longitudinal split - Fatigue

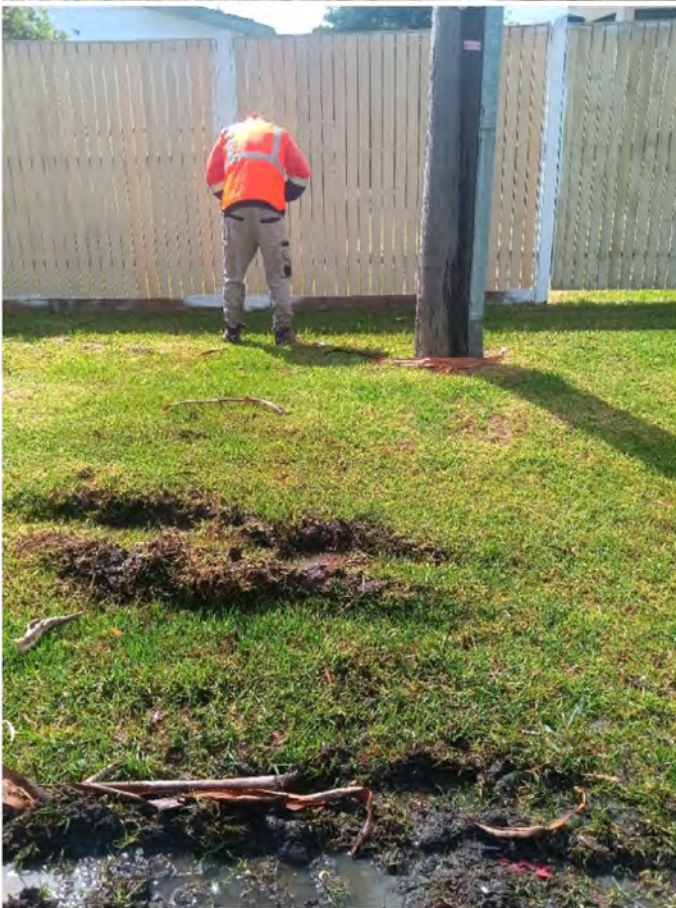
## Identified Leaks

Sounded all assets in the area, followed suspect 300mm main and no leaks were detected. Chlorine sample needs to be taken when rain stops.

We also surveyed Bayview Rd above the Highway with no leak noises detected.

I don't believe there's any leaks on the mains but still some of the smaller pipes really haven't checked out. Jason Marsh will return take samples when it's not raining for a few days.

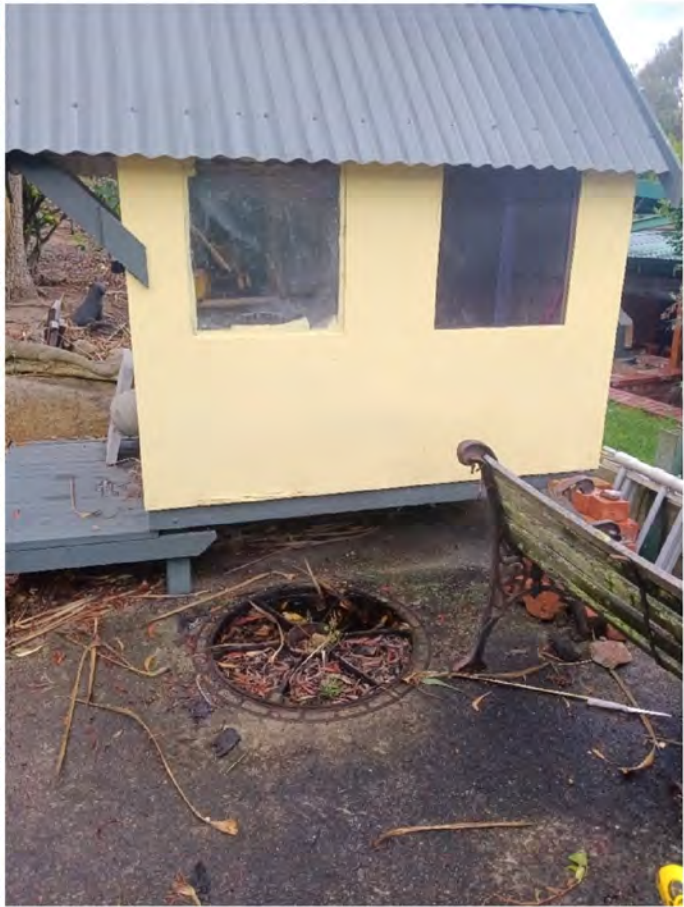
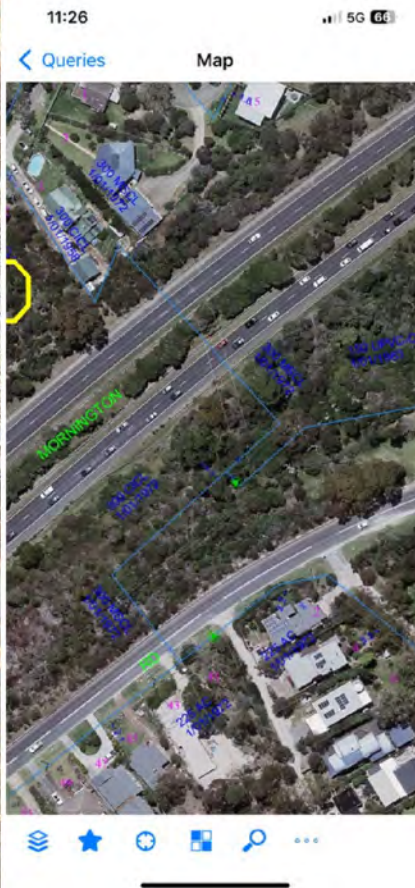
## Identified Leaks

Sounded all assets in the area, followed suspect 300mm main and no leaks were detected. Chlorine sample needs to be taken when rain stops.

We also surveyed Bayview Rd above the Highway with no leak noises detected.

I don't believe there's any leaks on the mains but still some of the smaller pipes really haven't checked out. Jason Marsh will return take samples when it's not raining for a few days.

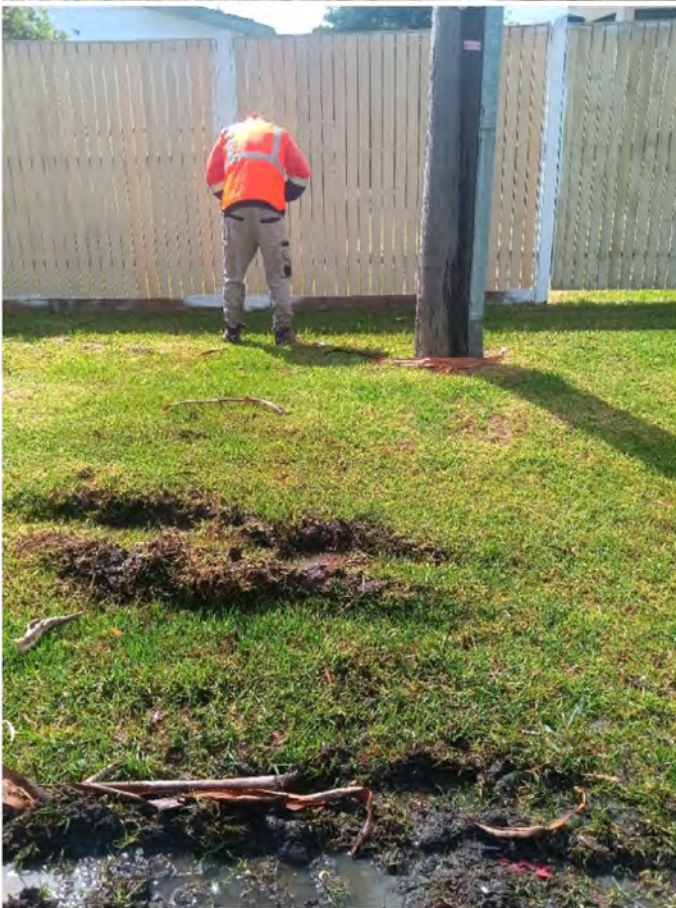
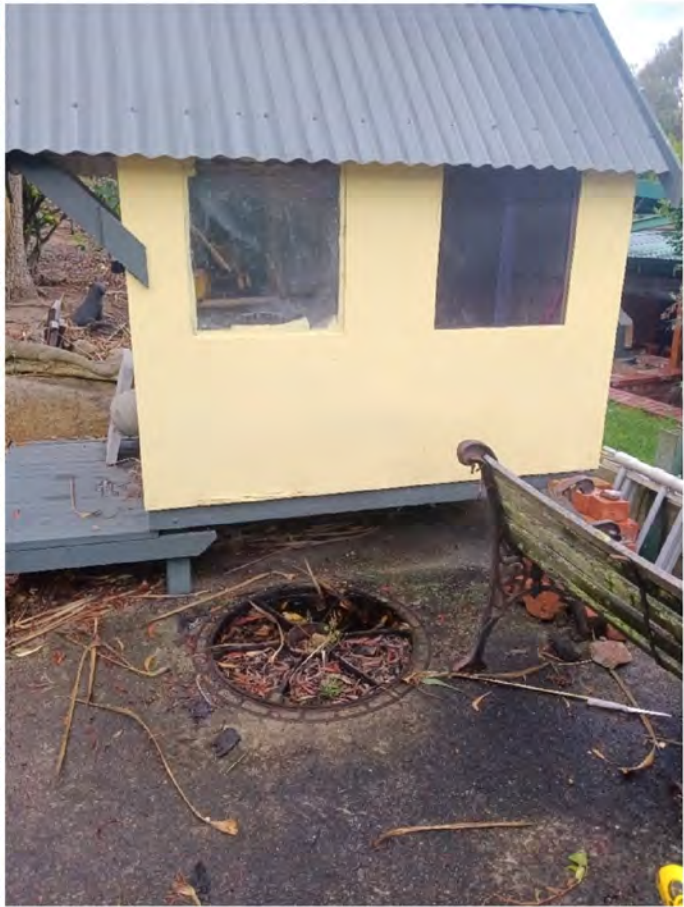
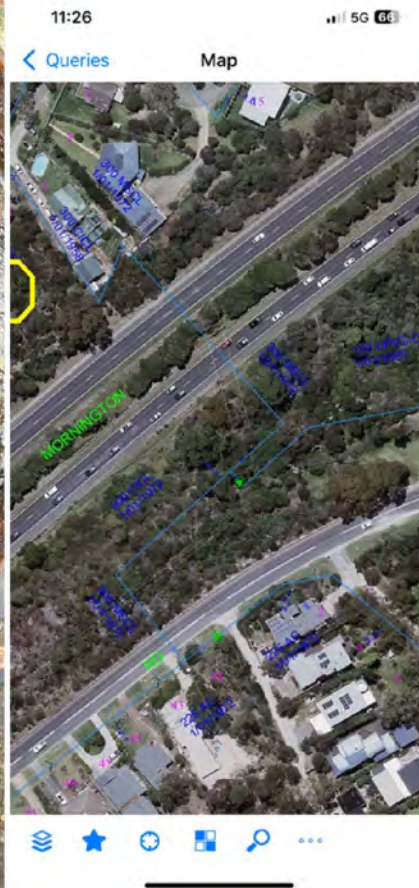
## Identified Leaks

Sounded all assets in the area, followed suspect 300mm main and no leaks were detected. Chlorine sample needs to be taken when rain stops.

We also surveyed Bayview Rd above the Highway with no leak noises detected.

I don't believe there's any leaks on the mains but still some of the smaller pipes really haven't checked out. Jason Marsh will return take samples when it's not raining for a few days.
