Task Number:1295094/001**Task Address:**4 WALLER PLACE, MCCRAE VIC 3938 MapRef : 159B10**Program Name:****Task Work Type:**Planned Maintenance - Repair**Source Of Work:****Facility:****Permit Not Required:**No**Permit Pre Approved:**No**Permit Reason:**Other**Permit Other Reason:**

Task Number:1295094/002

Task Number:1295094/006

Request Details:Burst on the 150UPVC main opp 2 the boulevard. water Ops located leak

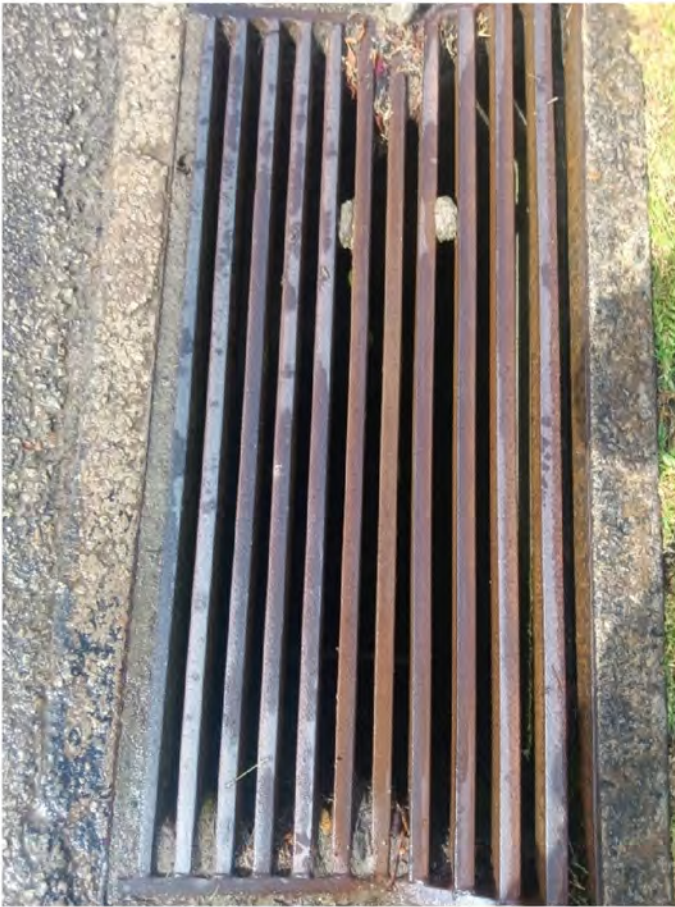
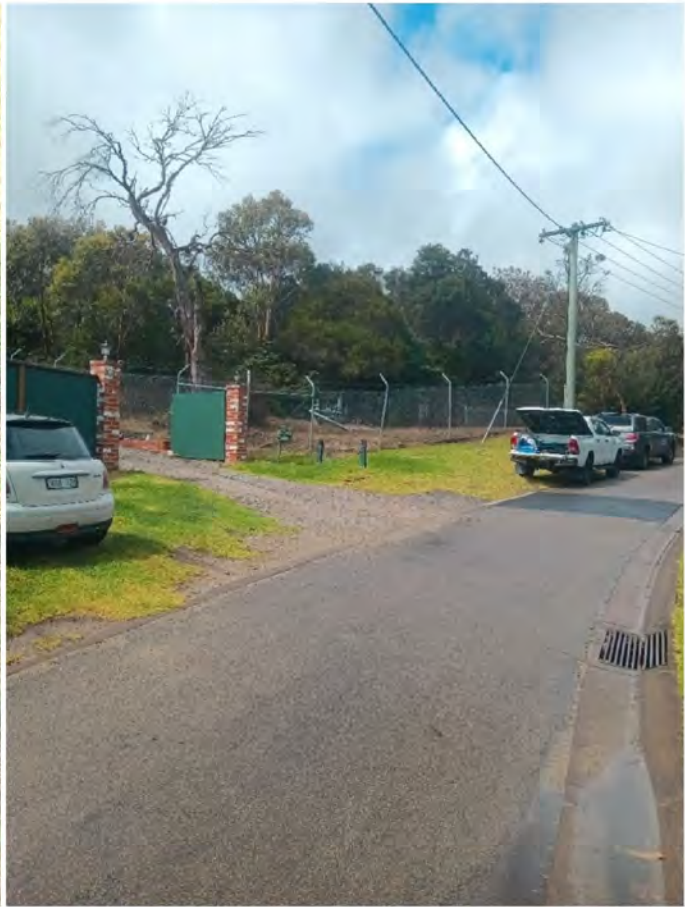
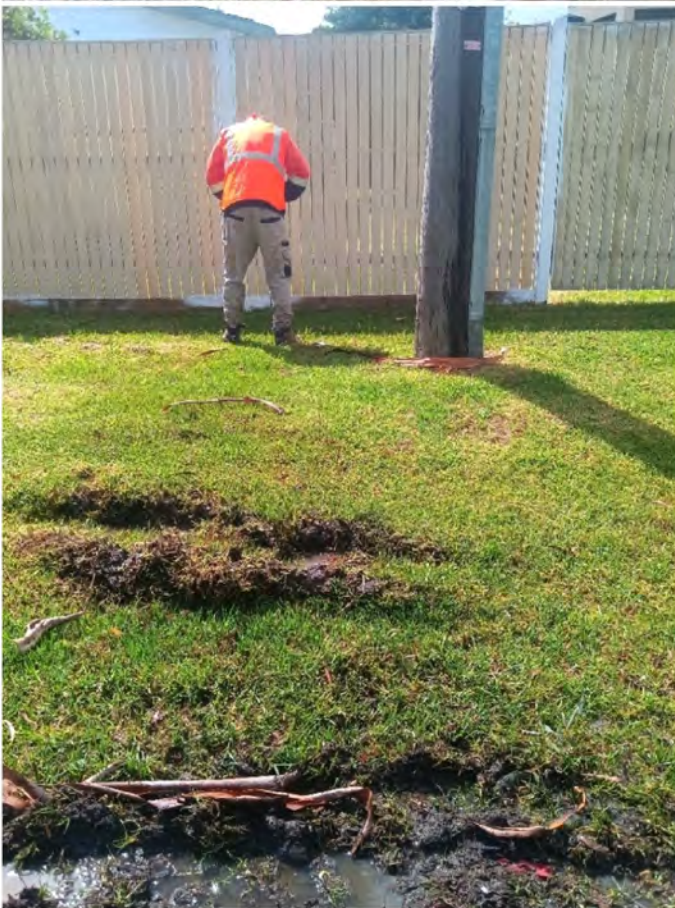
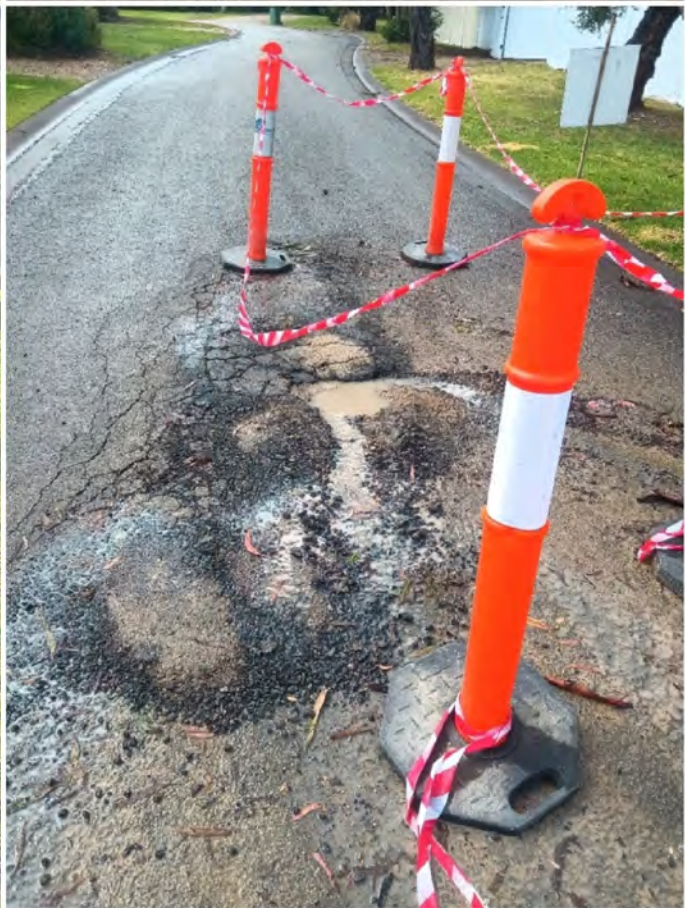
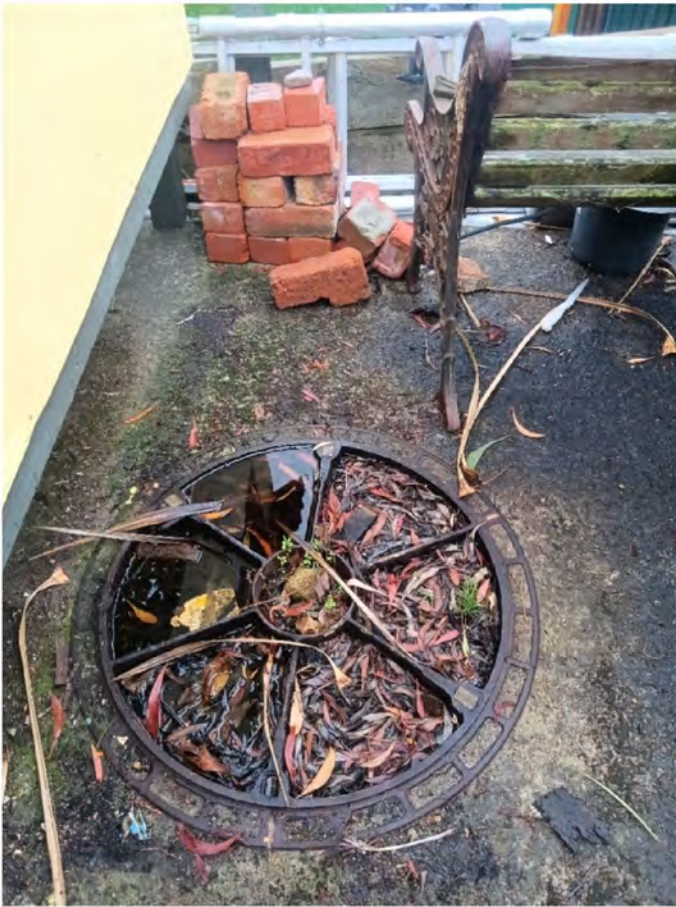
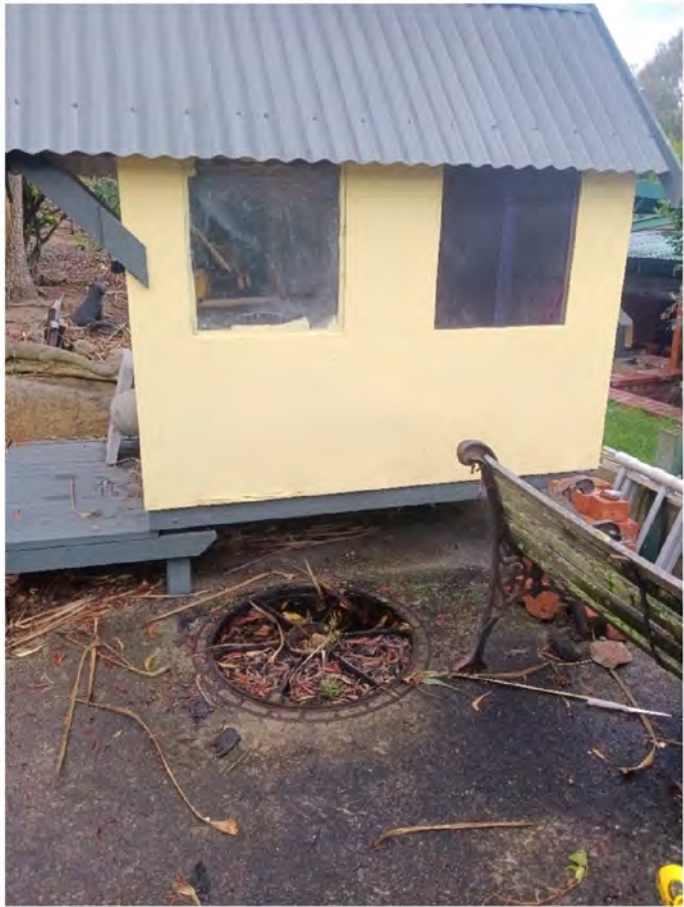
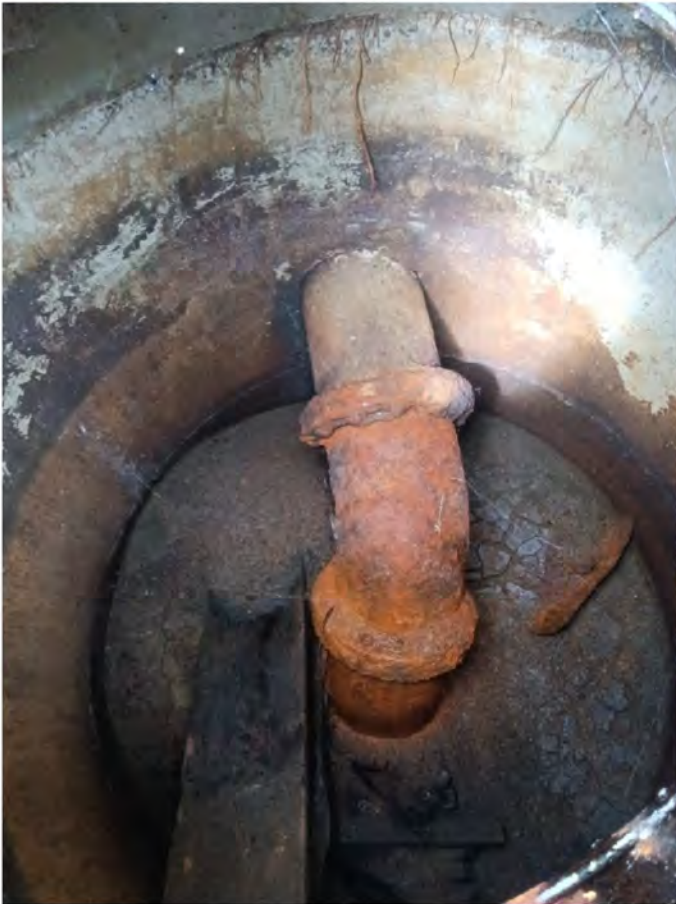
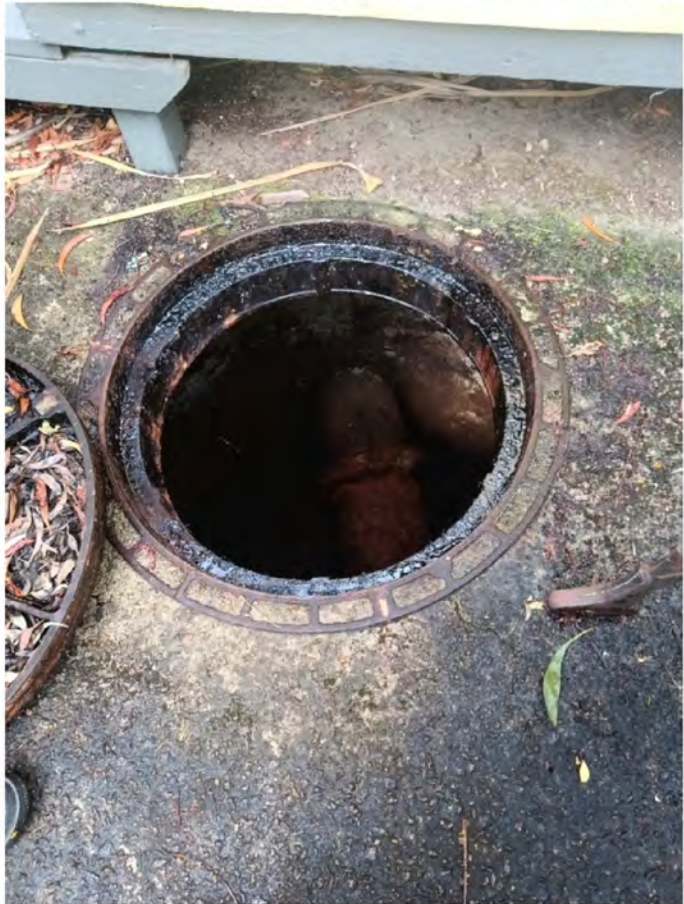
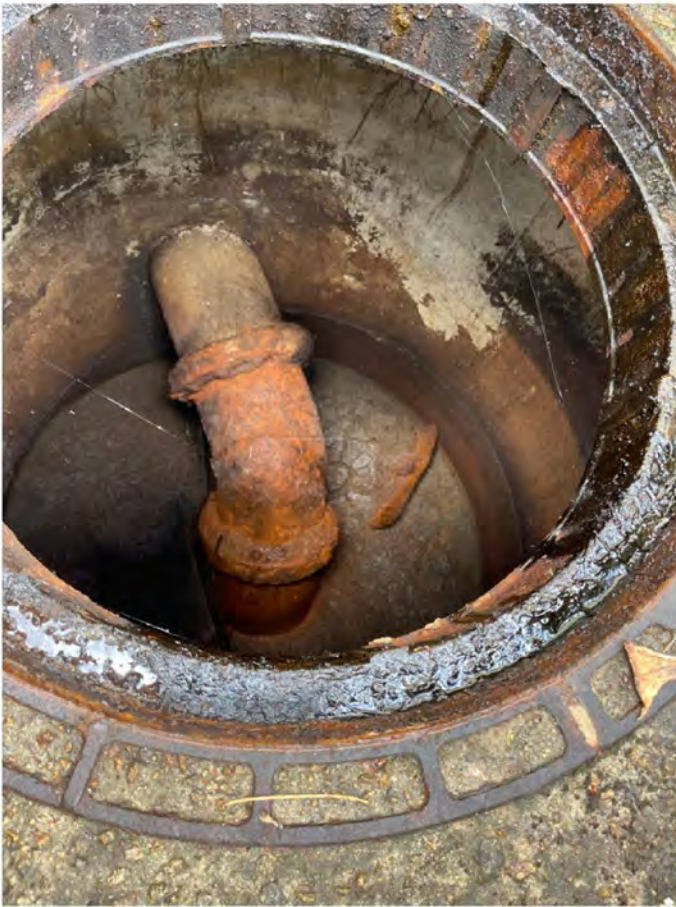
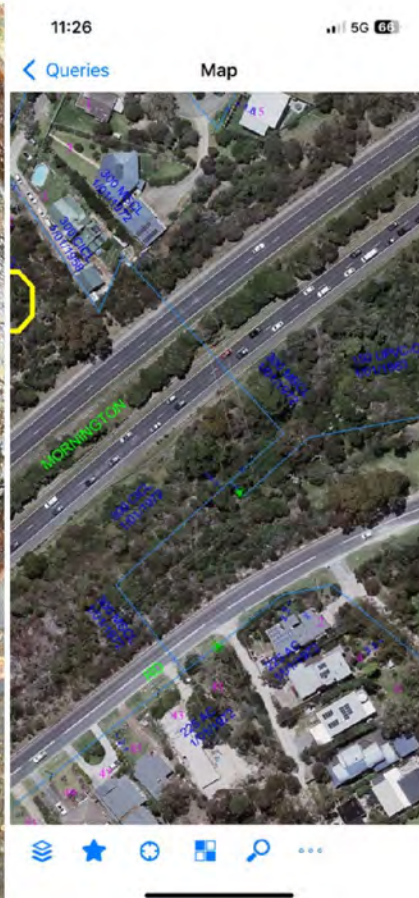
Sounded all assets in the area, followed suspect 300mm main and no leaks were detected. Chlorine sample needs to be taken when rain stops.

We also surveyed Bayview Rd above the Highway with no leak noises detected.

I don't believe there's any leaks on the mains but still some of the smaller pipes really haven't checked out. Jason Marsh will return take samples when it's not raining for a few days.

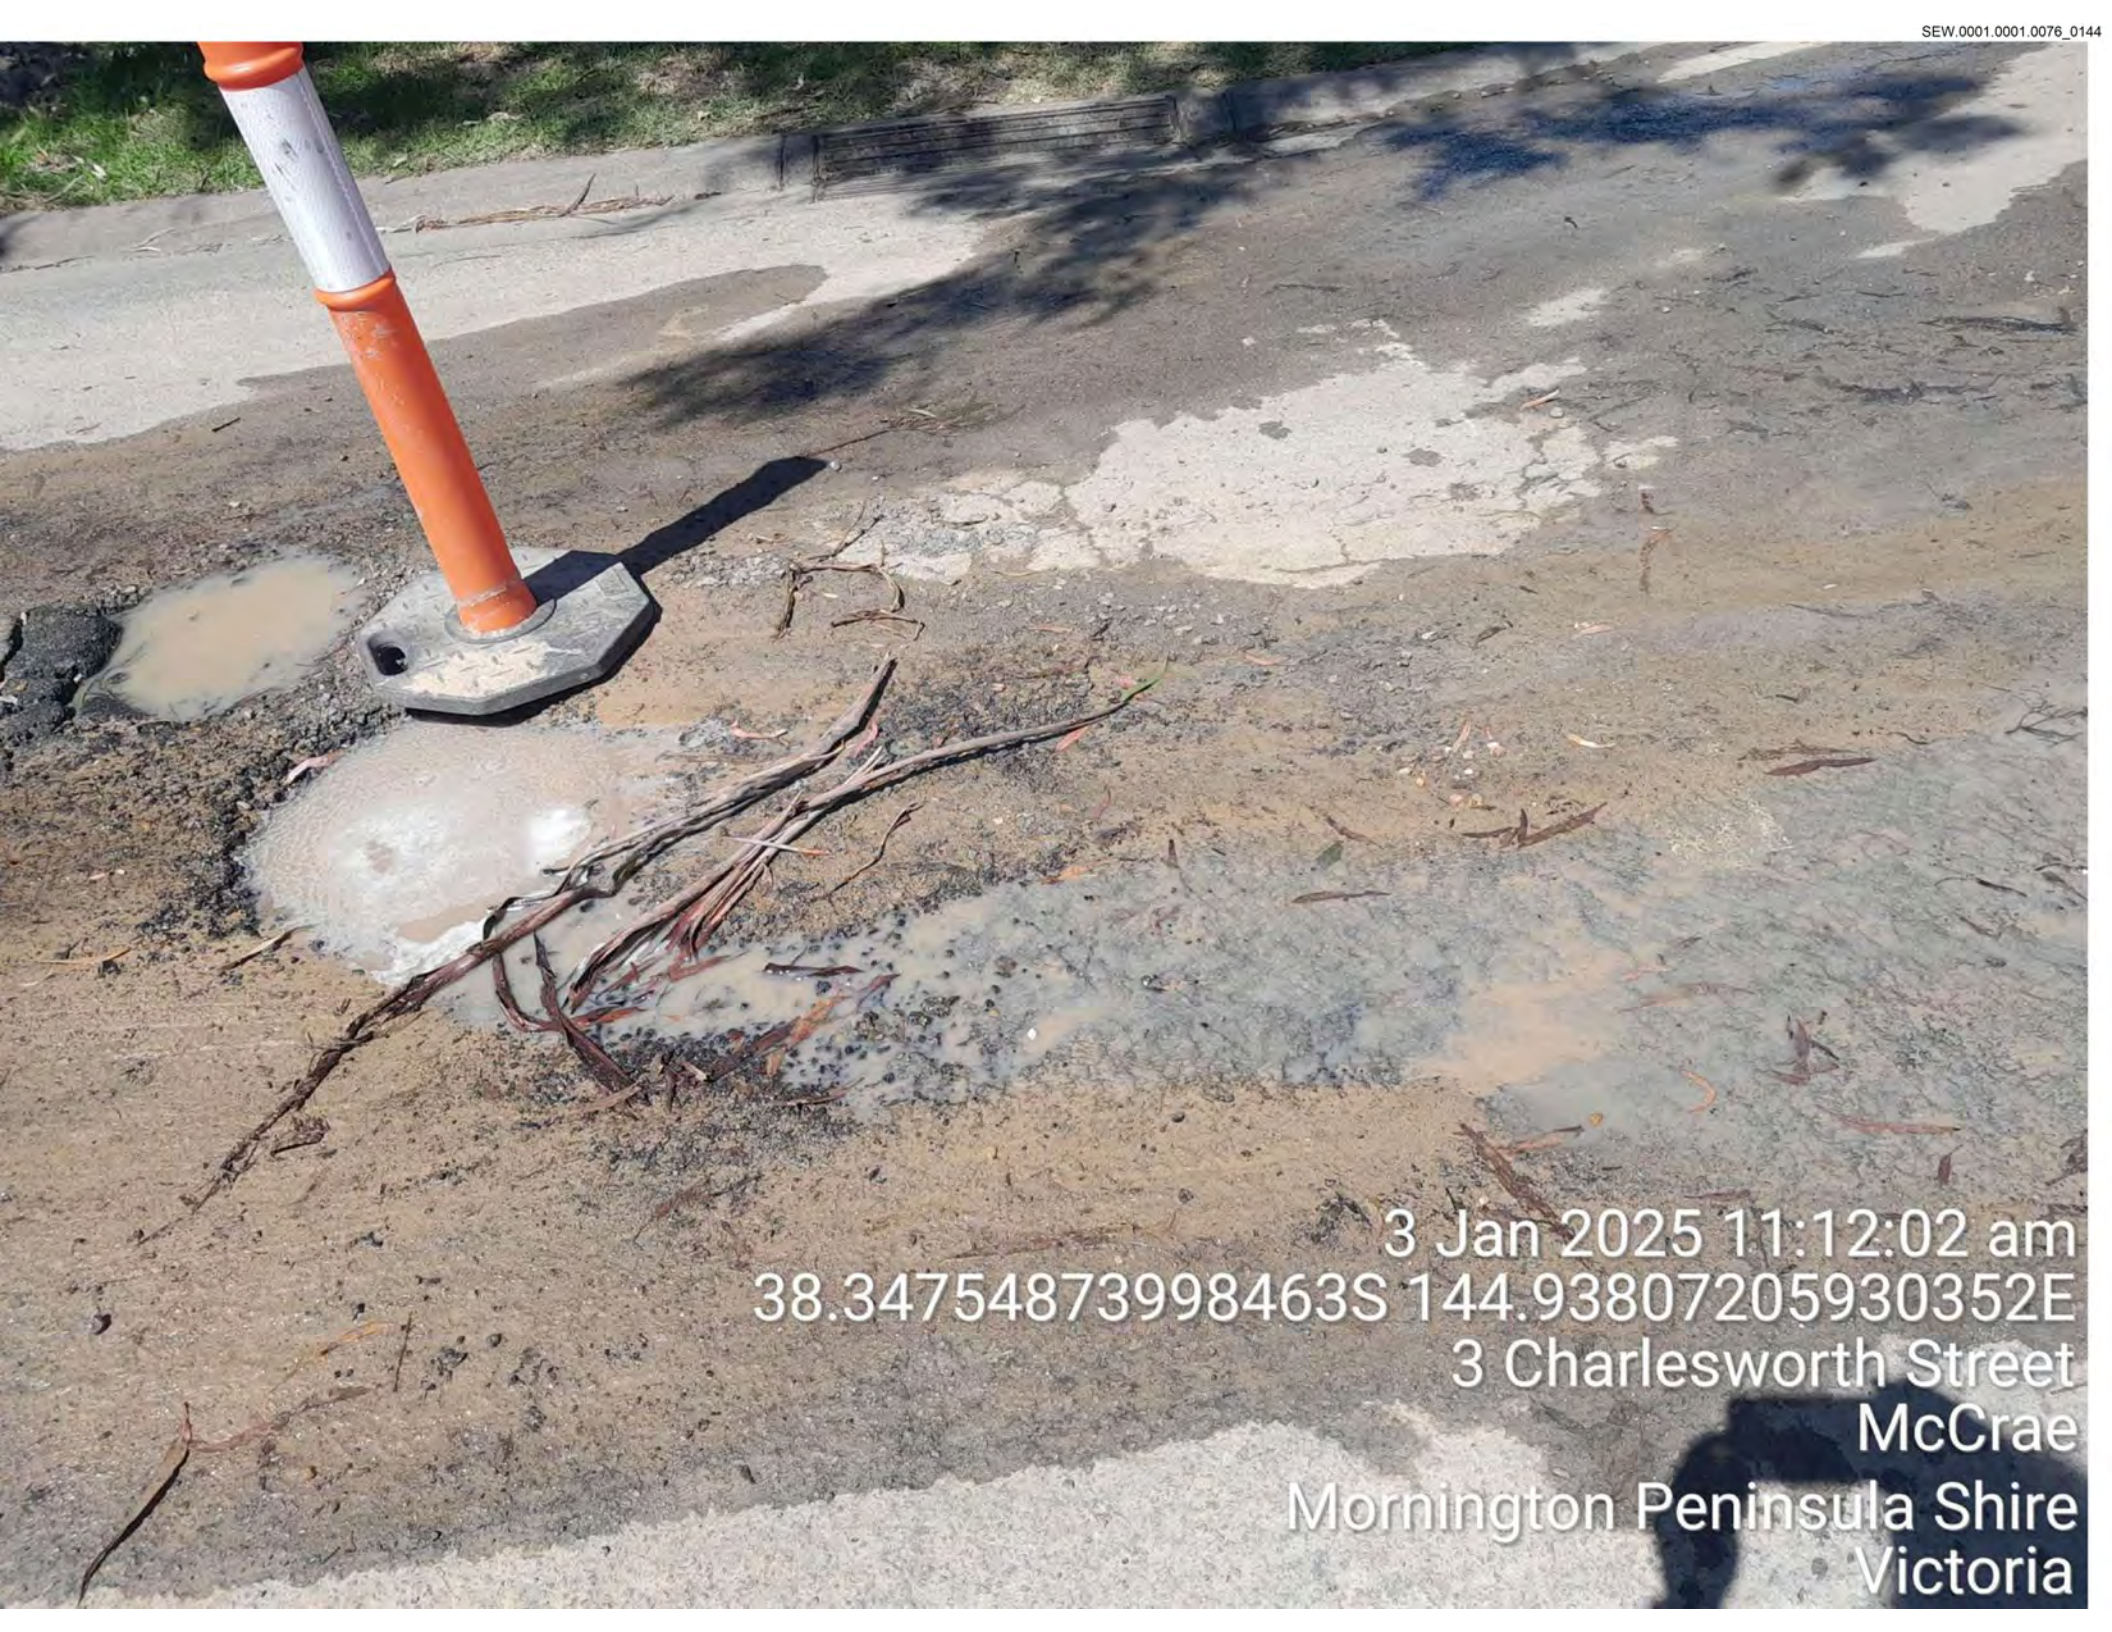
3 Jan 2025 11:12:02 am
38.34754873998463S 144.93807205930352E
3 Charlesworth Street
McCrae
Mornington Peninsula Shire
Victoria

Task Story:[FT] [SSf0010] [2/1/2025 17:56] [ON SITE] Arrived back on site & water is still coming out of the road opp no-3 Charlesworth st & the n/strip at no-1 Waller Pl. I then went to the other side of the freeway to do some leak detection as per Jason Marsh from SEW & found water is seeping out of the middle of the d/way at no-29 Bayview rd & where the d/way meets the road. I tested the water & it did turn pink. There is a 100mm UPVC main that runs along there. I picked up a few faint sounds on nearby service's. Will notify Jason Marsh on my findings. I have spoke to the owner at no-29 Bayview rd & he did report the leak awhile ago. I gave him a calling card. [FT] [SSf0010] [8/1/2025 14:38] [ON SITE] Arrived back on site & water is still coming out of the road opp no-3 Charlesworth st & the n/strip at no-1 Waller Pl. I then went to do some more leak detection & got diverted to another job. [Marsh,Jason] [9/1/2025 07:43] [OFF SITE] Team, Spent the last 2 days checking storm water drains and walking streets sounding services around Waller Pl and BAYVIEW ROAD. Checked WR174 water tank site and all Air valves hydrants ect. I thought I found a good leak, water coming to surface at presser, after probing. Tested at EC 500 and after 10 minuets stopped. It was a backed-up Agi pipe. Hayden and Eathen from operation also assisted checking surveying for leaks yesterday, correlating some sections of the water pipe. Detection services are on site surveying zone from BAYVIEW ROAD up. Took sample on storm water pit outside 6 Waller Pl as requested by Charles, it had a site EC reading over 600. Dropped sample at ALS. Will get results today. Note: this storm water drain has been sampled previously 30-12-24 before repair to water main on Bayview. It still has a good flow 10l per minute, see attached. [Castle,Ken] [9/1/2025 16:09] [OFF SITE] Pulse case 08556065 raised. [FT] [SSf0010] [13/1/2025 11:10] [ON SITE] Arrived on site & water has now stop seeping across the road at no-1 Waller Pl & the front lawn at the fence at no-1 is now not pooling & starting to dry out but water is still coming out of the middle of the road at no-3 Charlesworth st. [Selliah,Sam] [14/1/2025 17:56] [OFF SITE] Caller Debbie Lightfoot from 34 Coburn Ave advised she is currently in the middle of a new build and there is water sitting all over the front. Said she was concerned about the foundations to the property. I have advised customer after discussing this further that we are doing daily tests here and it is still found to be ground water. Council have also been on site. Advised customer to take this up with the council. Looks like she has called several times previously as she was aware of where all the leaks were and testing done. Caller is on PH: PI
