Legally Privileged Multidisciplinary Expert Report

McCrae Landslip Project

5 May 2025

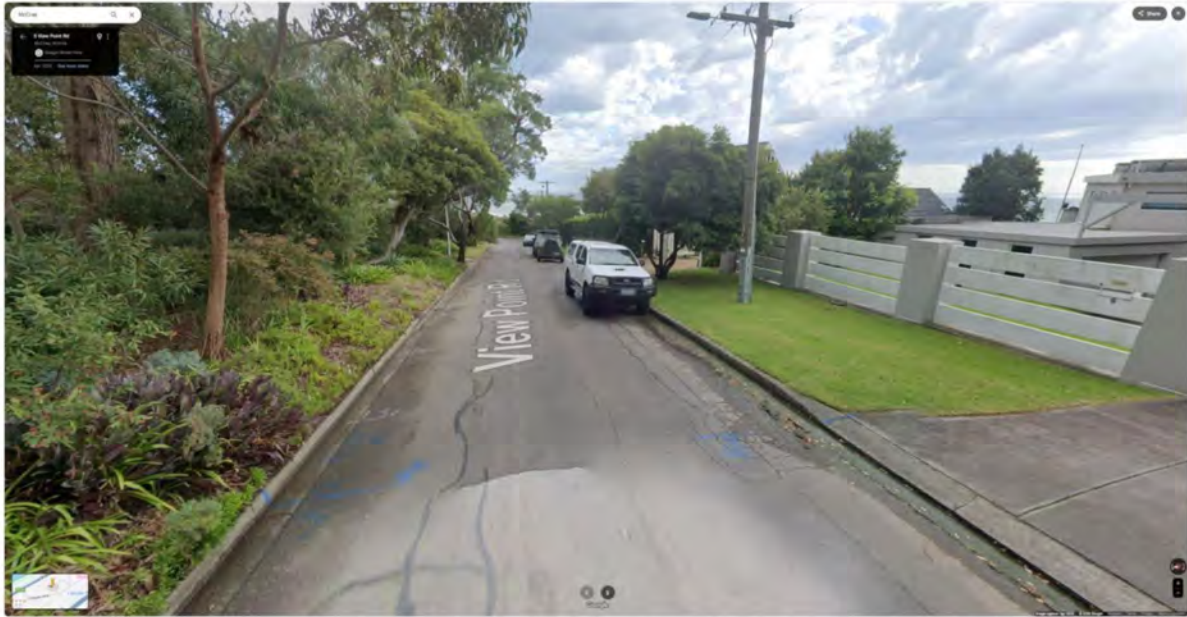
Figure 5, Figure 6 and Figure 7 provide an indication of the condition of View Point Road. The condition of the pavement is characterised by numerous longitudinal cracks (Figure 5) and areas of crocodile cracking and spalling. Such evidence can indicate pavement fatigue or aging, or weak subgrade. Water is noted to be flowing down the eastbound kerb within the photographs. The precise date of the photographs is not known. But we note the greenish tinge of the kerb and channel, compared to the south side, which could indicate vegetation build up due to high levels of moisture content.

Figure 6: Google Streetview image from April 2023 looking west from outside No. 6 View Point Road. Note the localised spalling and crocodile cracking of the pavement adjacent to the driveway of No. 6.

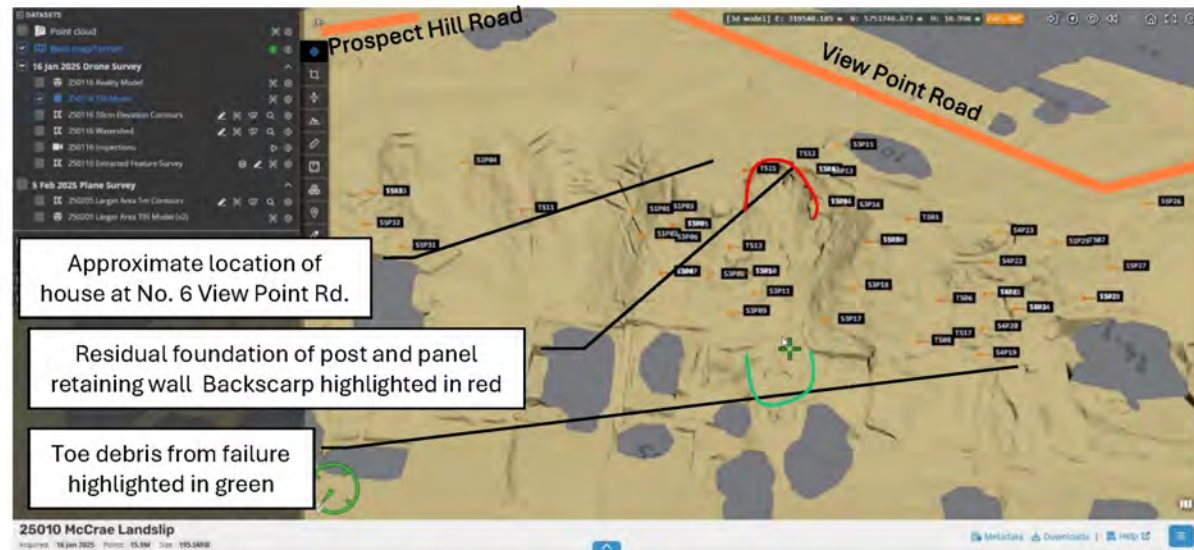
Figure 8: Imagery showing the subject site and adjacent slopes looking south west.

Figure 8 shows an overview of the site topography. The backscarp toe debris of the 14 January 2025 failure is highlighted. Note that the failure is within a clearly defined gully, which is a characteristic of the escarpment within the vicinity of the subject site.

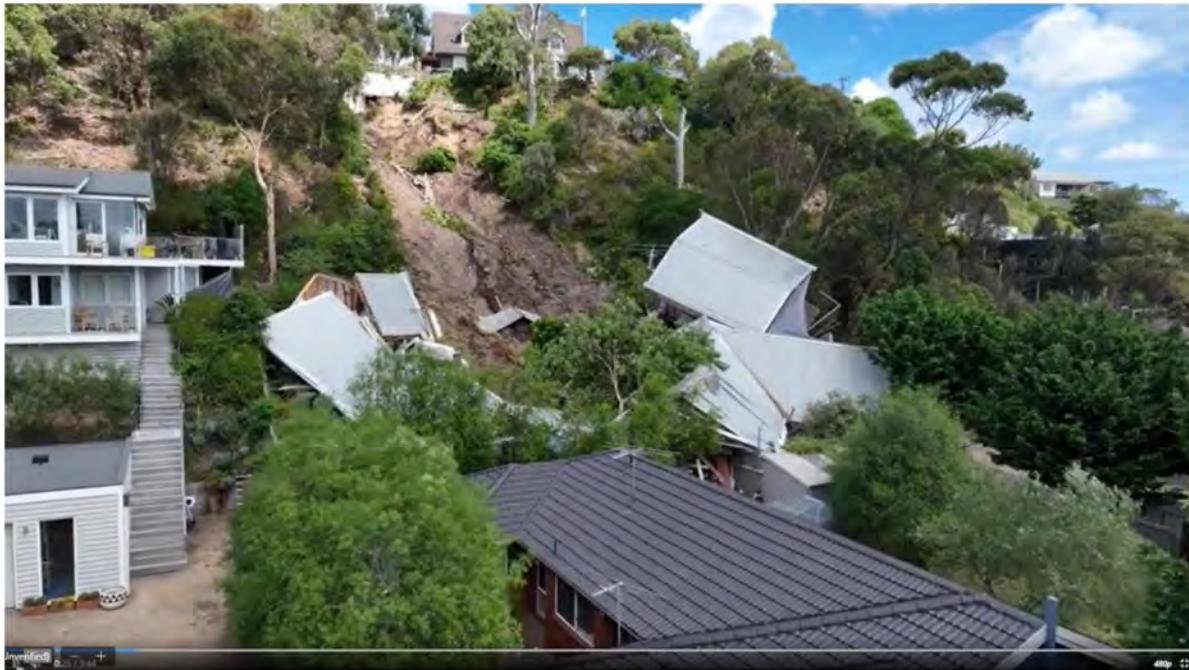
Figure 10: Drone footage taken from toe of slope failure showing the gully, denuded by slipping debris from upslope.

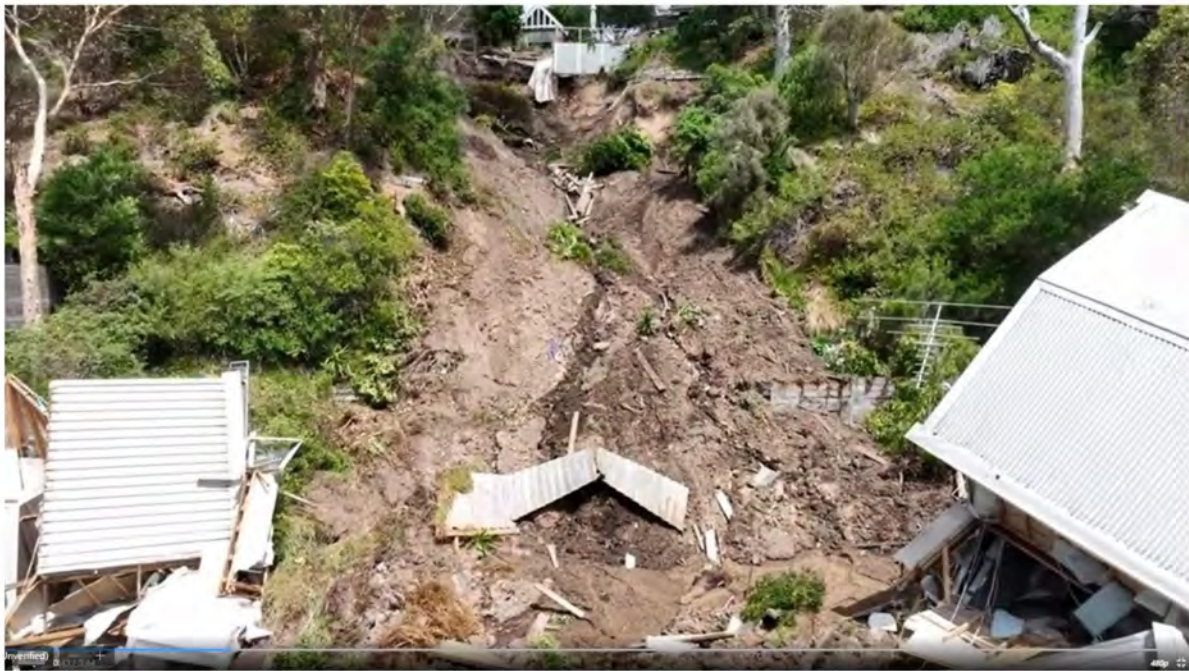
Figure 11: Drone footage taken from toe of failure, illustrating the 'bowl' shaped failure within the upper slope.

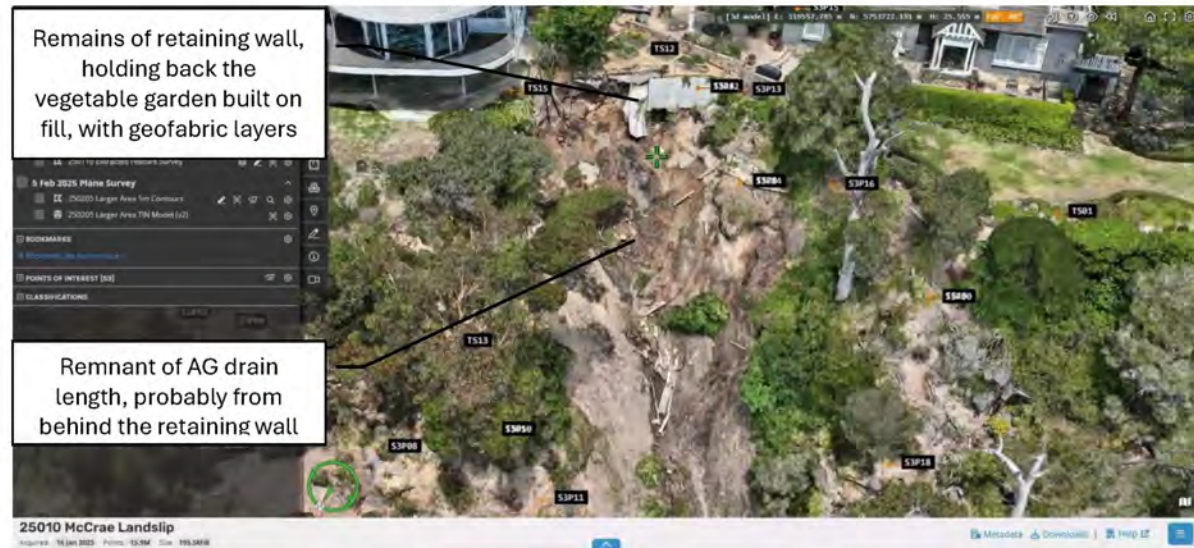
Figure 14: Drone footage showing detail of the failure.

Figure 14 shows the debris field of the failure. We note that a retaining wall at the crest of the site, and the retained platform behind, has been undermined by the slope movement, revealing geotextile layers. Fence panels are also seen in the debris. The varying colouration of the exposed soils suggest varying moisture content, and perhaps running water.

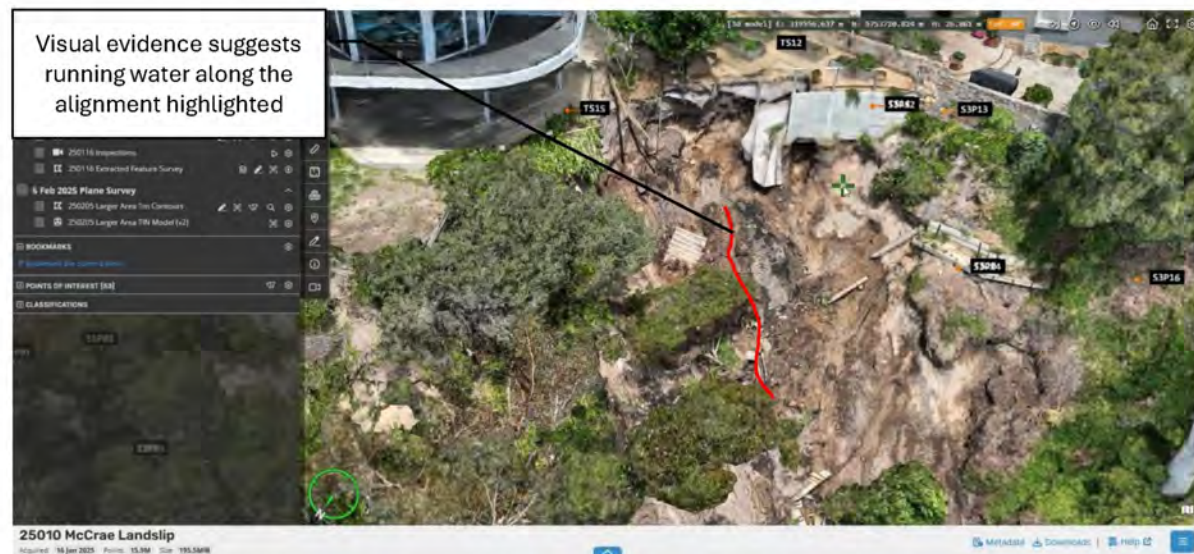
Figure 15: Detail of the presumed slip area with the red line an annotation of possible running water at the time of drone footage.

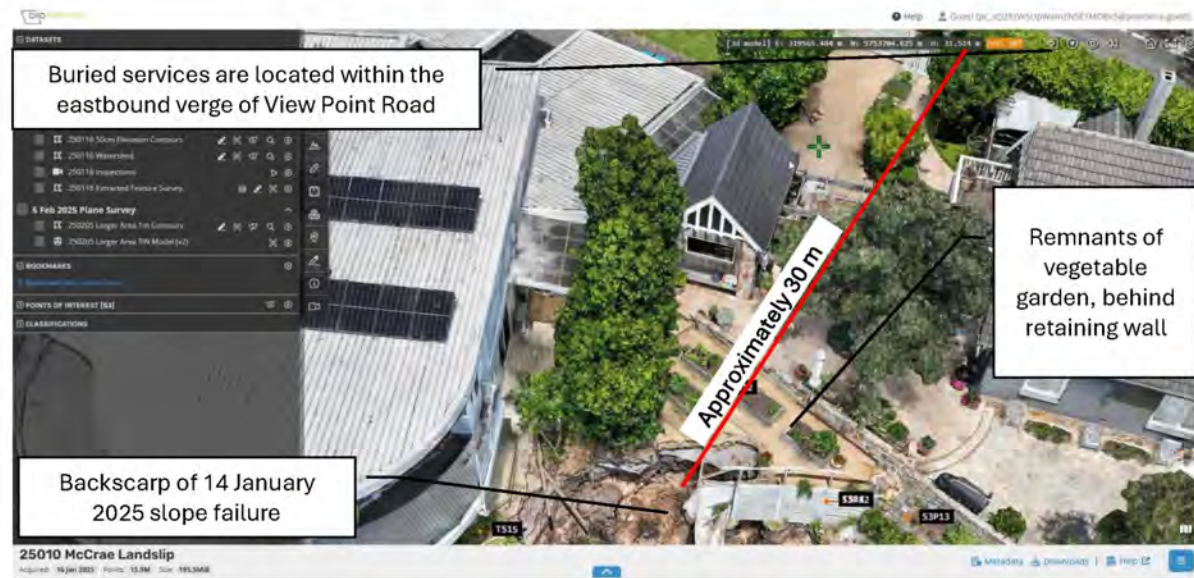
Figure 16: Drone footage showing the infrastructure, buildings vegetation and distance between View Point Road and the failure

The distance between the verge of View Point Road, the location of known SEW assets, and the failure, is approximately 30 m. Figure 16 includes View Point Road and the retaining wall, illustrating the approximate distance. Figure 16 also shows the vegetable garden behind the retaining wall, and mature tree.

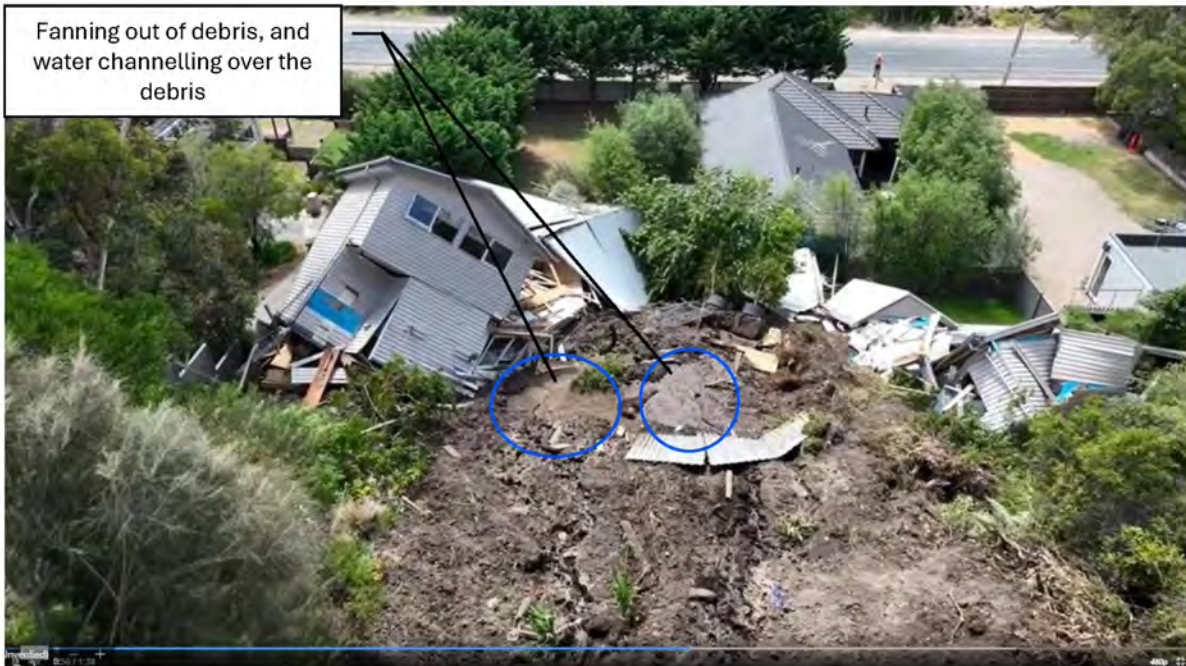
Figure 18: Drone footage, showing the toe debris.

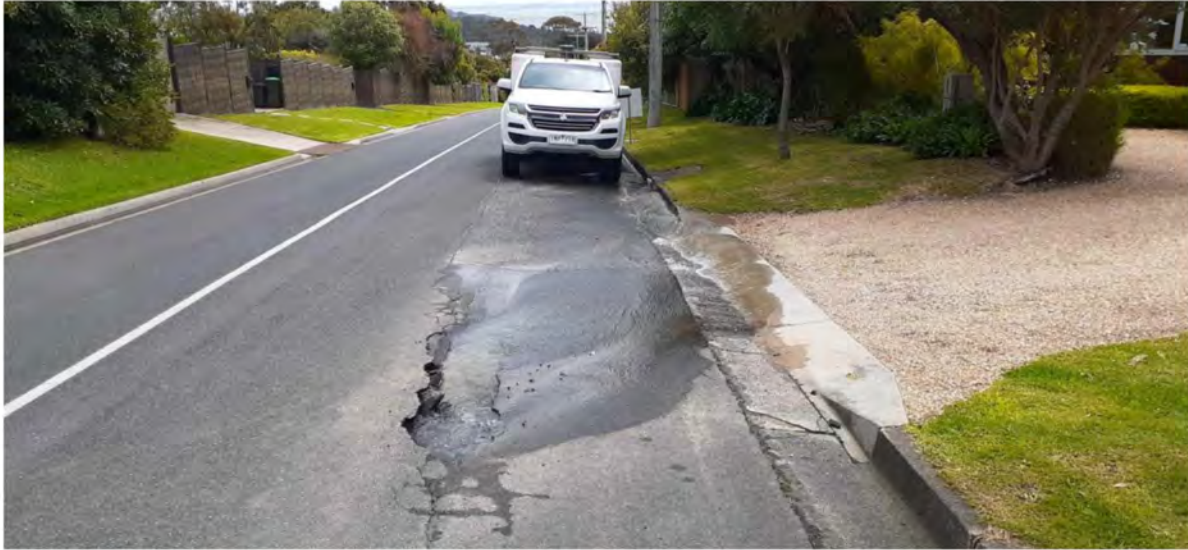
Figure 21: Photograph from SEW taken on 14 November 2022, looking west along Coburn Avenue from junction with Prospect Hill Road showing site conditions.

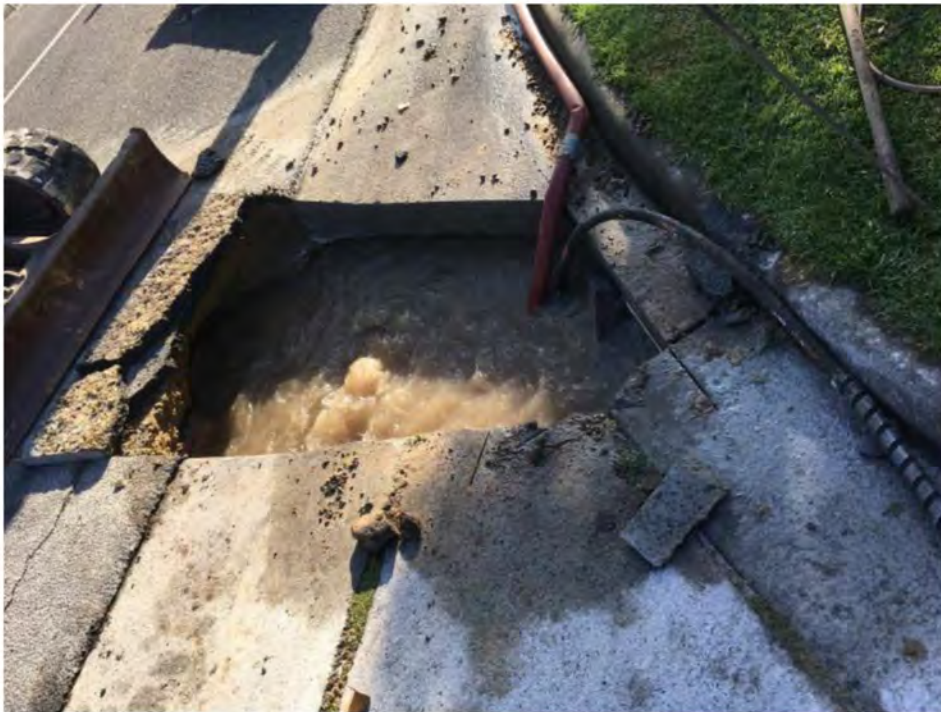
Figure 22: Photograph from SEW taken on 15 November 2022 (approximately), showing detail of water beneath concrete pavement construction prior to repair, being pumped out.

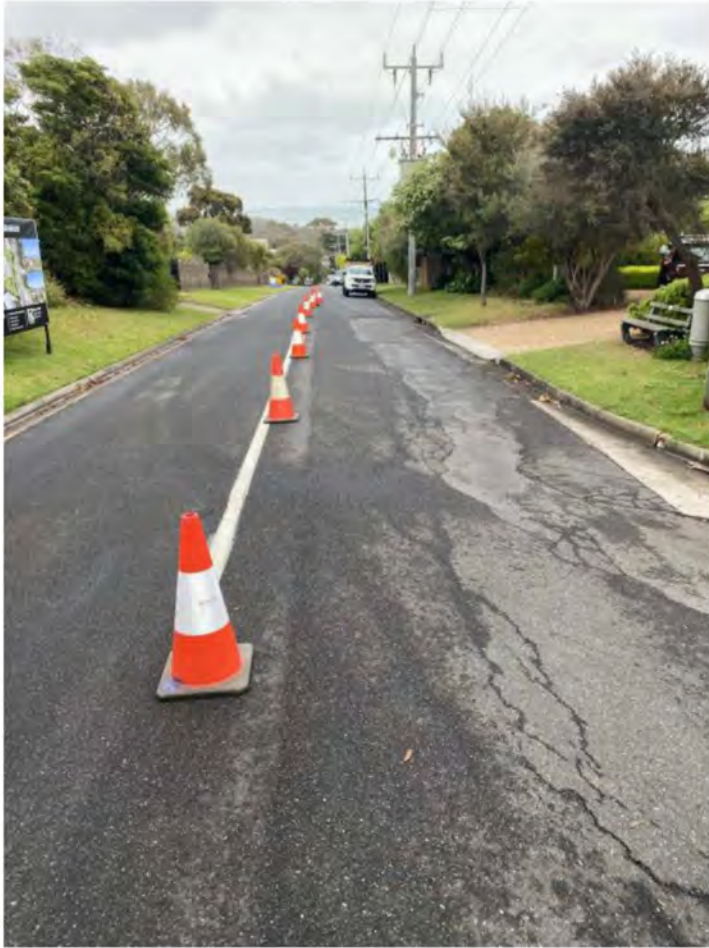
Figure 28: Photograph from SEW taken on 29 November 2023 (approximately), looking west along Coburn Avenue from junction with Prospect Hill Road showing condition of pavement prior to repair works.

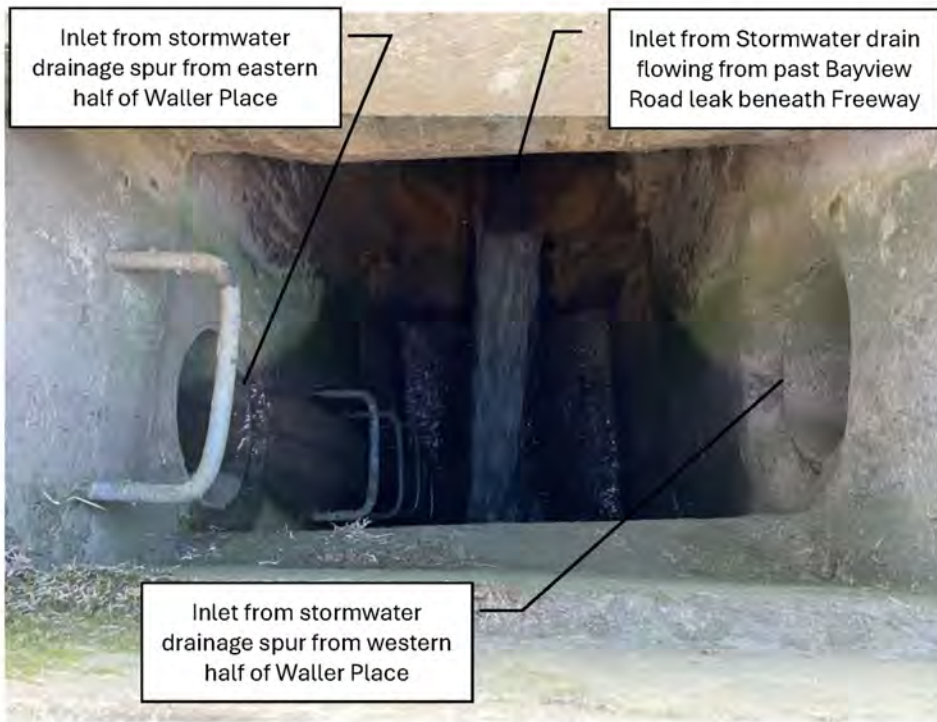
Figure 41: Photograph supplied by SEW, taken on 30 December 2024, showing water flowing into pit opposite 6 Waller Place

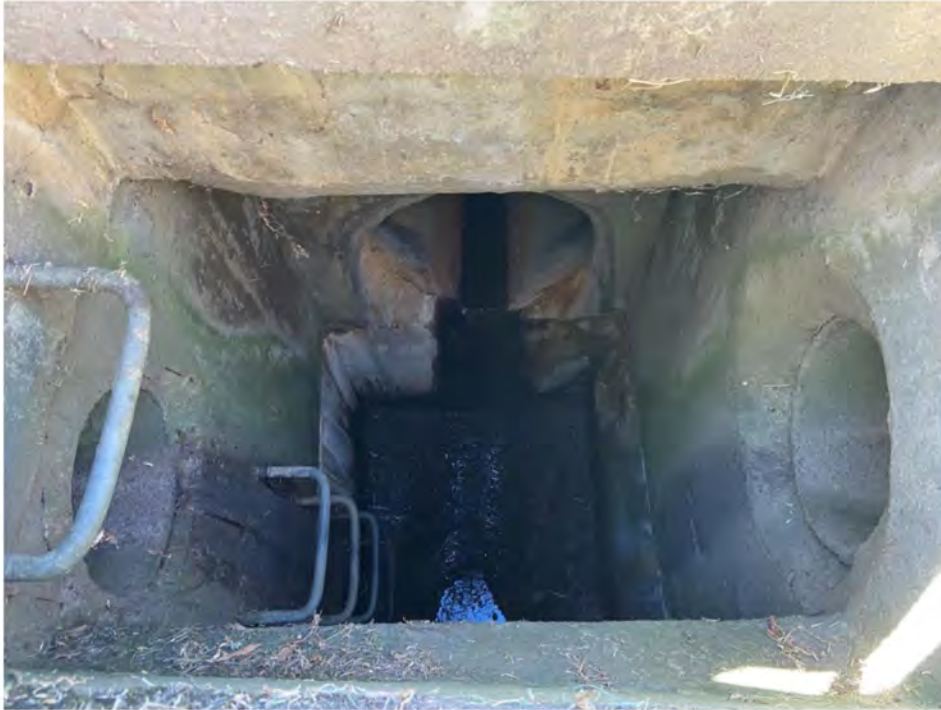
Figure 42: Photograph supplied by SEW, taken on 5 March 2025, showing water flowing into pit opposite 6 Waller Place.

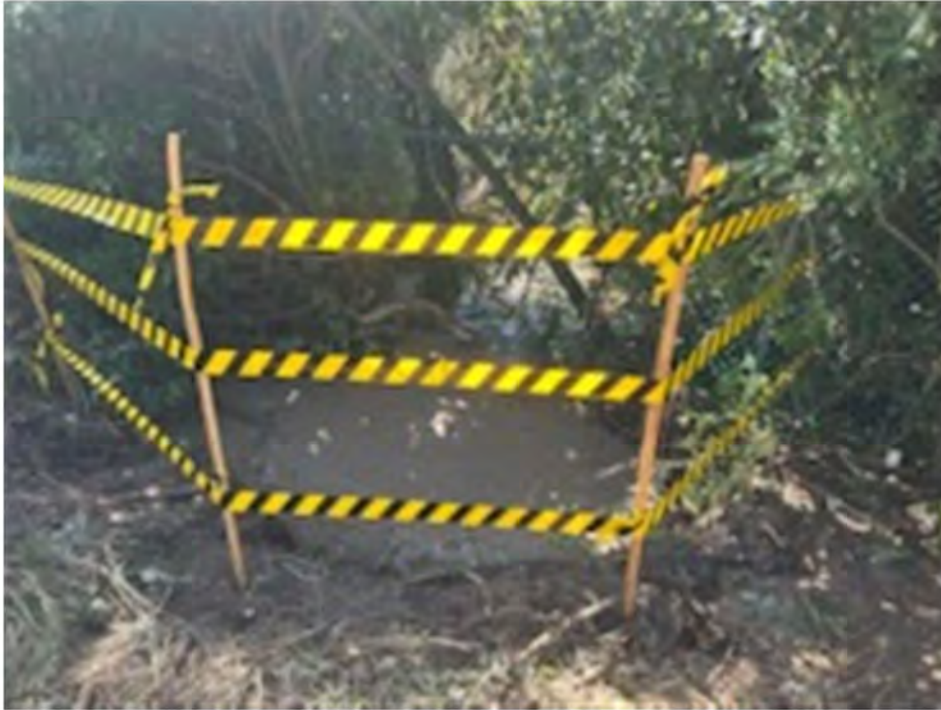
Figure 43: Provided by SEW, understood to have been taken on 31 December 2024, showing site condition upon arrival at the Bayview Road leak site. Note the ponded water, and flowing runoff into the background.

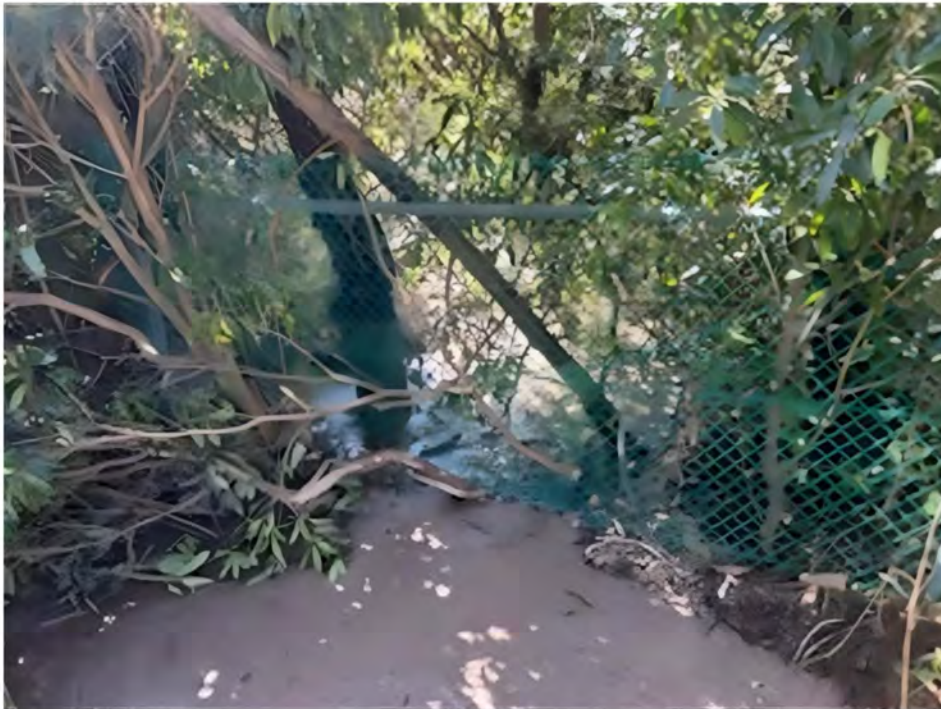
Figure 44: Provided by SEW, understood to have been taken on 31 December 2024, showing detail of ponded and flowing runoff at the Bayview Road leak site

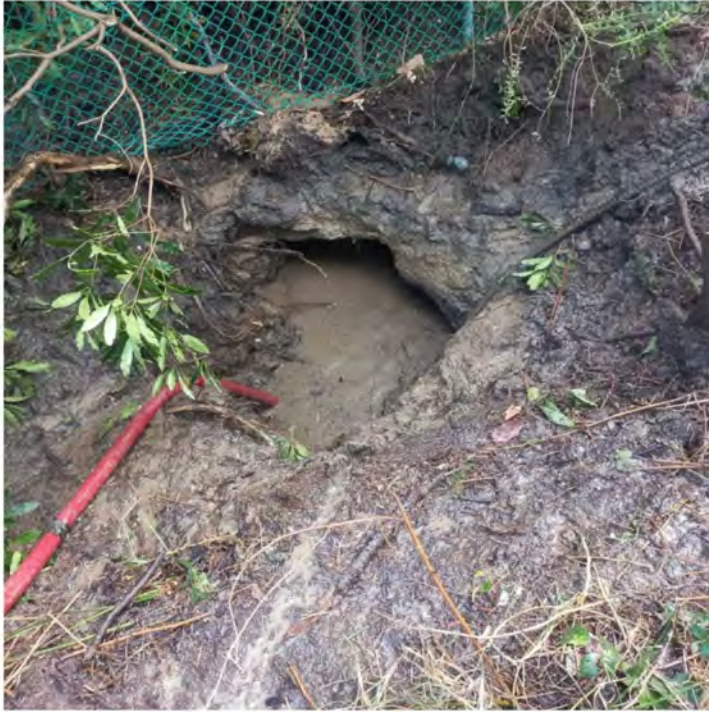
Figure 45: Provided by SEW, understood to have been taken on 31 December 2024, showing the ground collapsing during water pumping at Bayview Road leak site. Hole assumed to have been excavated by small excavator on site at the time.

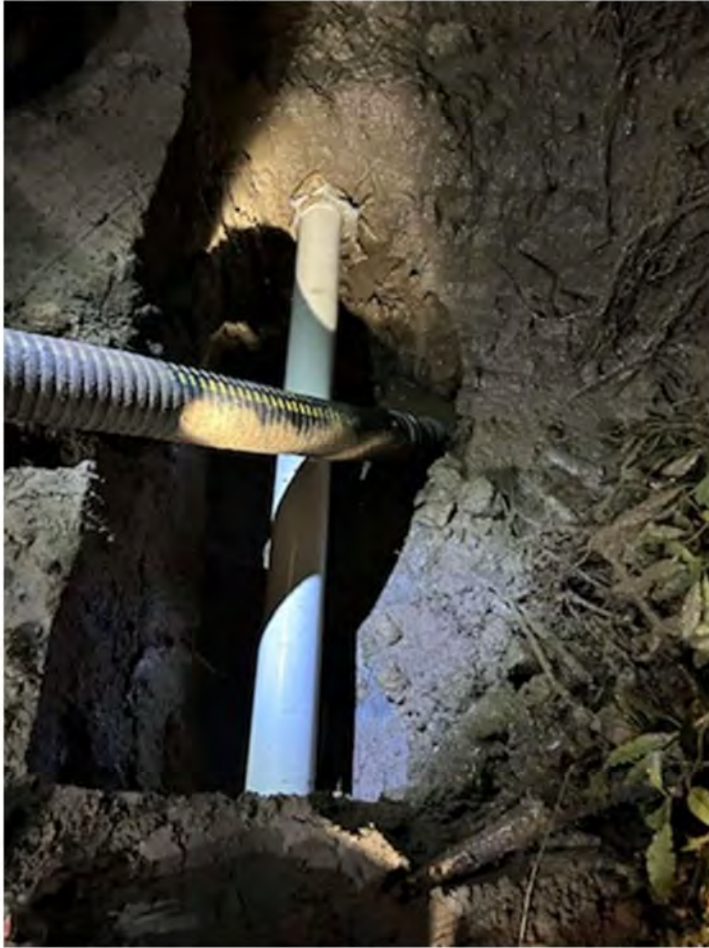
Figure 47: Provided by SEW, understood to have been taken on 1 January 2025, at the Bayview Road leak site showing exposure of pipe. Indicating the fracture is at the bottom of the pipe.

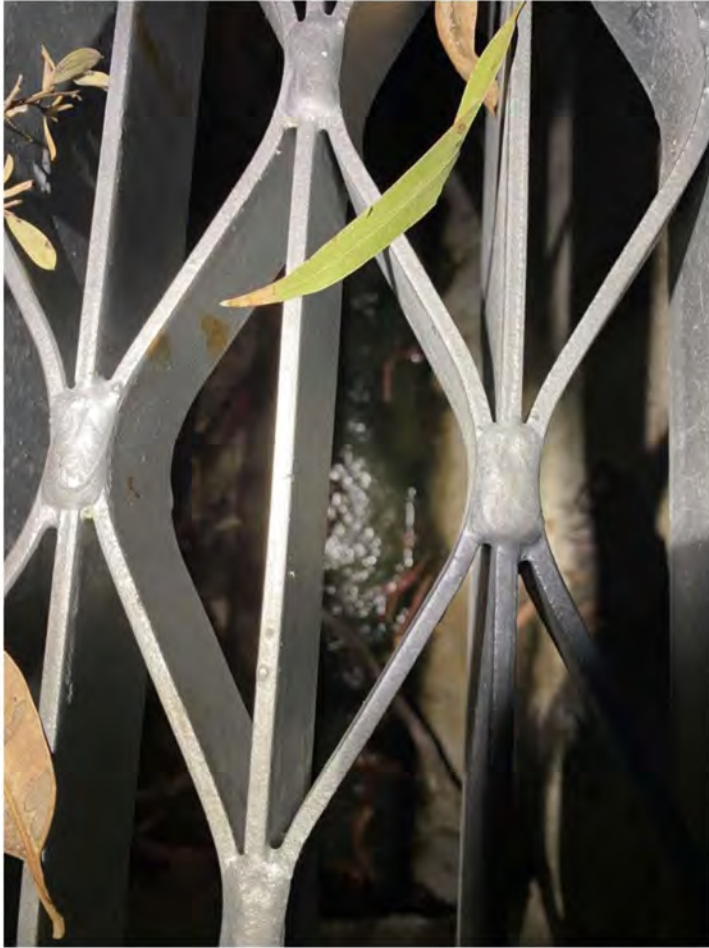
Figure 50: Photograph taken on the night of 5-6 January 2025, Showing flowing water within the stormwater drain shown in Figure 49.

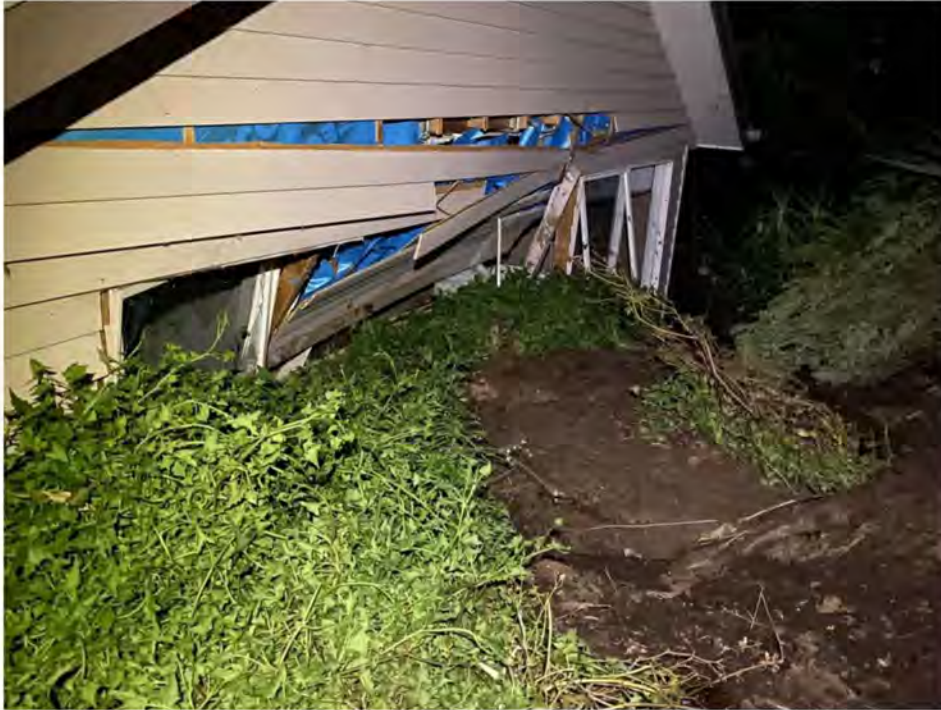
Figure 52: Photograph taken on the night of 5-6 January 2025 showing landslide debris against rear wall of 3 Penny Lane

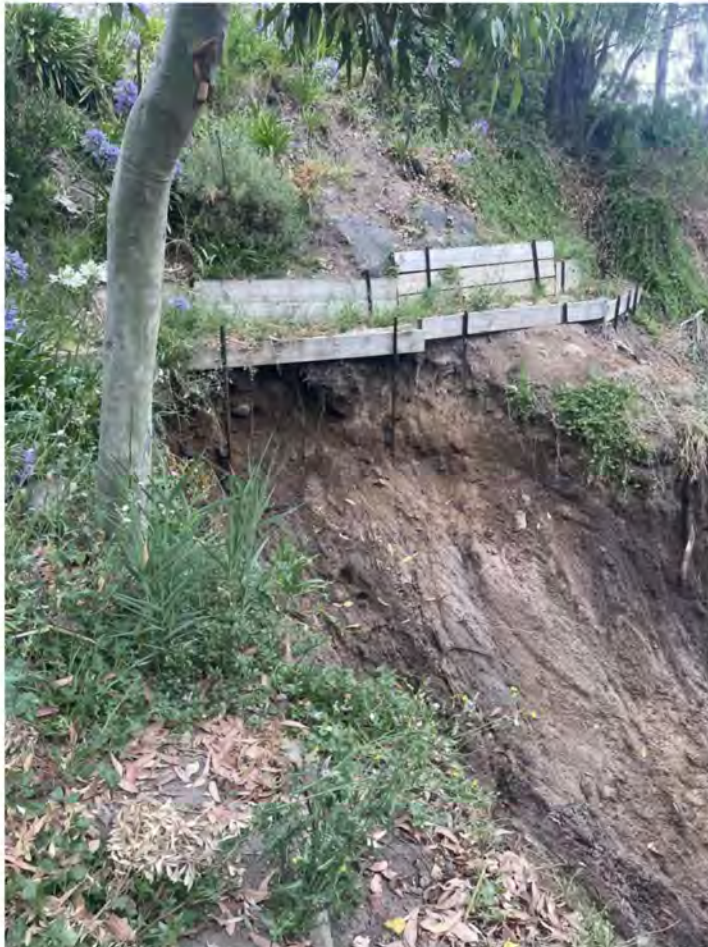
Figure 53: Photograph taken on 6 January 2025 looking west across the backscarp of the failure.

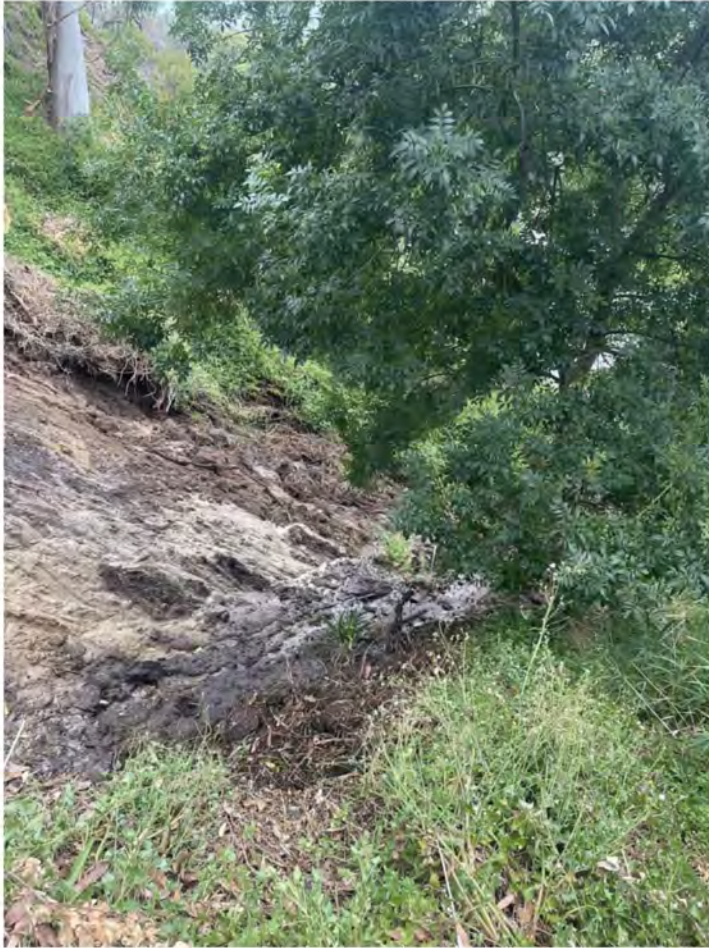
Figure 54: Photograph taken on 6 January 2025, looking downstope showing debris slide below the backscarp.

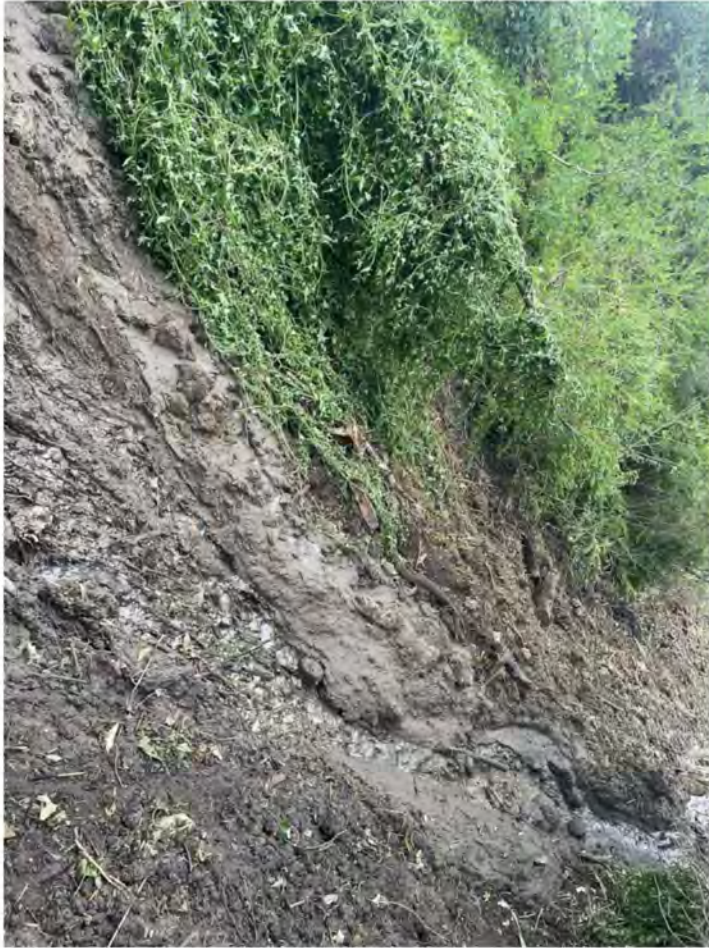
Figure 55: Photograph taken on 6 January 2025, showing slip debris of the 5 January 2025 landslide and water channel cutting through debris. The adjacent vegetation may indicate the original ground level and vegetation cover prior to the failure.

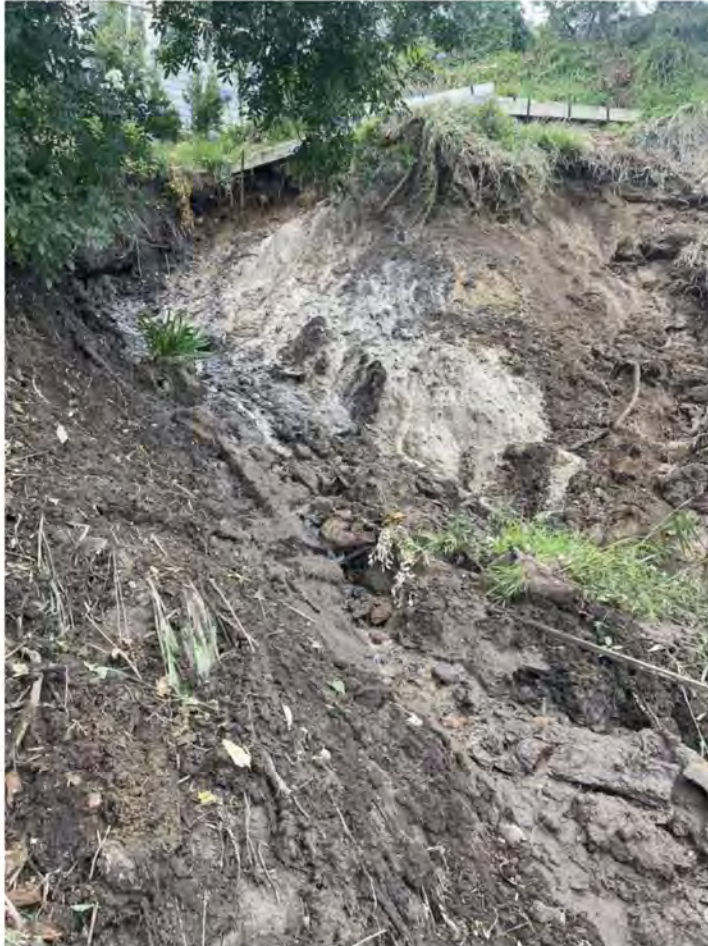
Figure 56: Photograph taken on 6 January 2025, looking up at the landslide, showing saturated debris flow surface with dry soil adjacent. Debris may include some boulders cobbles, but also anthropogenic and vegetation material
