Legally Privileged Multidisciplinary Expert Report

# McCrae Landslip Project

Prepared for: Thomson Geer

5 May 2025

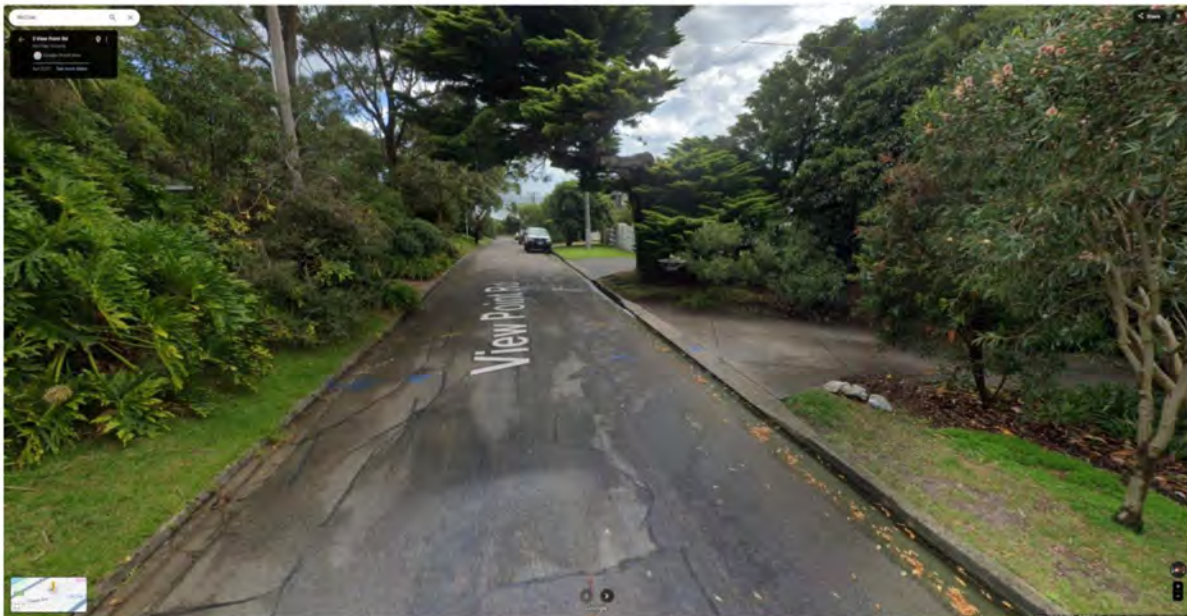
Figure 5, Figure 6 and Figure 7 provide an indication of the condition of View Point Road. The condition of the pavement is characterised by numerous longitudinal cracks (Figure 5) and areas of crocodile cracking and spalling. Such evidence can indicate pavement fatigue or aging, or weak subgrade. Water is noted to be flowing down the eastbound kerb within the photographs. The precise date of the photographs is not known. But we note the greenish tinge of the kerb and channel, compared to the south side, which could indicate vegetation build up due to high levels of moisture content.

Figure 5: Google Streetview image from April 2023 looking west from outside No. 3 View Point Road.

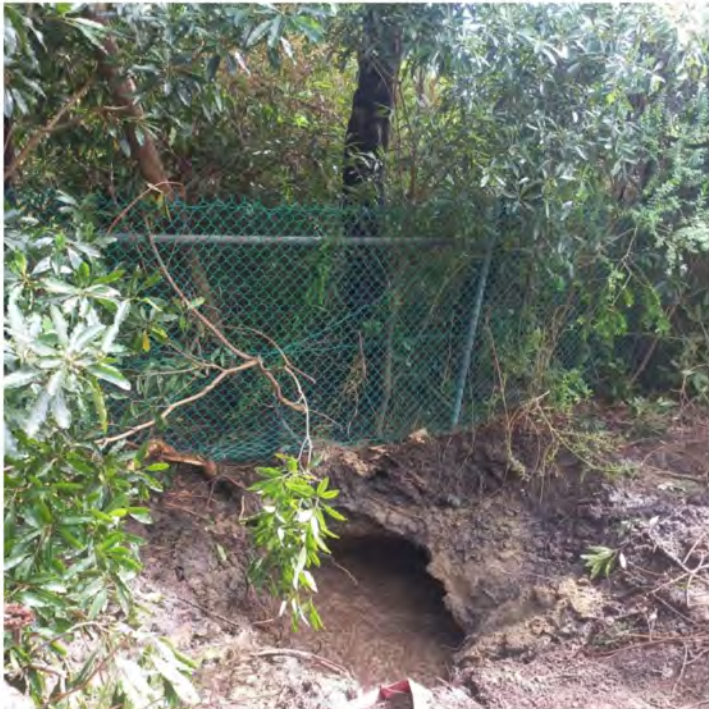
Figure 46: Provided by SEW, understood to have been taken on 31 December 2024, showing the Bayview Road leak site during pumping and excavation works.

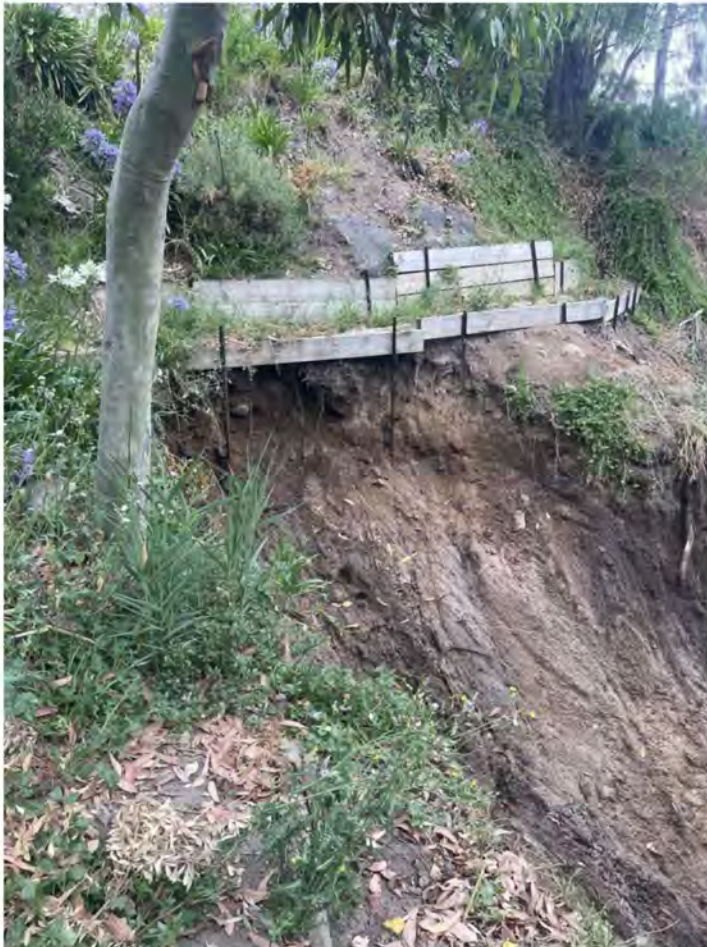
Figure 53: Photograph taken on 6 January 2025 looking west across the backscarp of the failure.

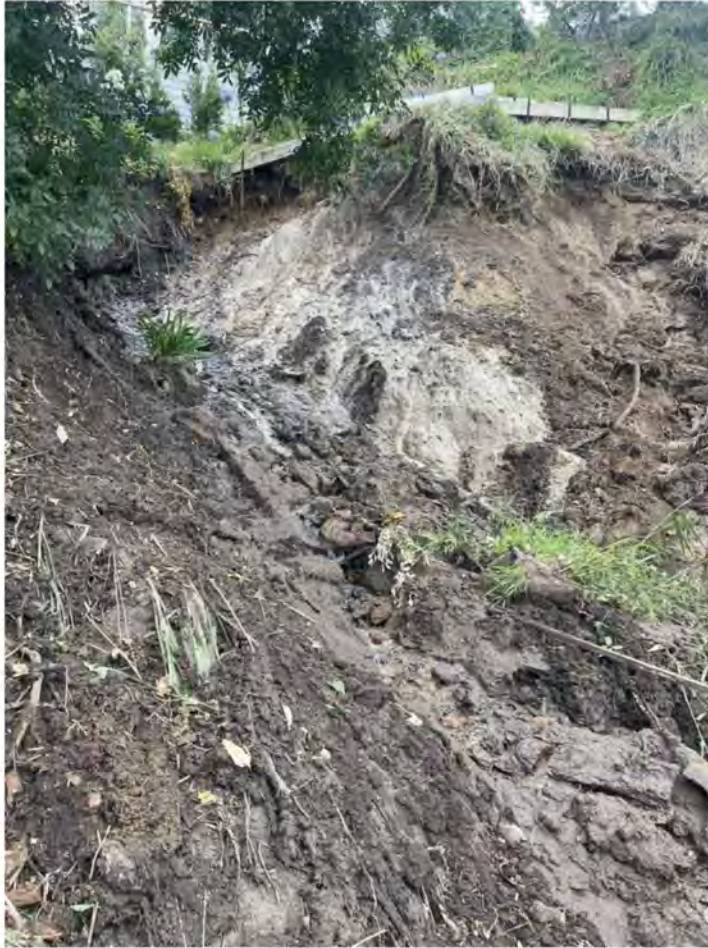
Figure 56: Photograph taken on 6 January 2025, looking up at the landslide, showing saturated debris flow surface with dry soil adjacent. Debris may include some boulders cobbles, but also anthropogenic and vegetation material
