**Task Number:**1295094/001**Task Address:**4 WALLER PLACE, MCCRAE VIC 3938 MapRef : 159B10**Program Name:****Task Work Type:**Planned Maintenance - Repair**Source Of Work:****Facility:****Permit Not Required:**No**Permit Pre Approved:**No**Permit Reason:**Other**Permit Other Reason:**

# Leak Report

**Task Number:**1295094/006

**Request Details:**Burst on the 150UPVC main opp 2 the boulevard. water Ops located leak

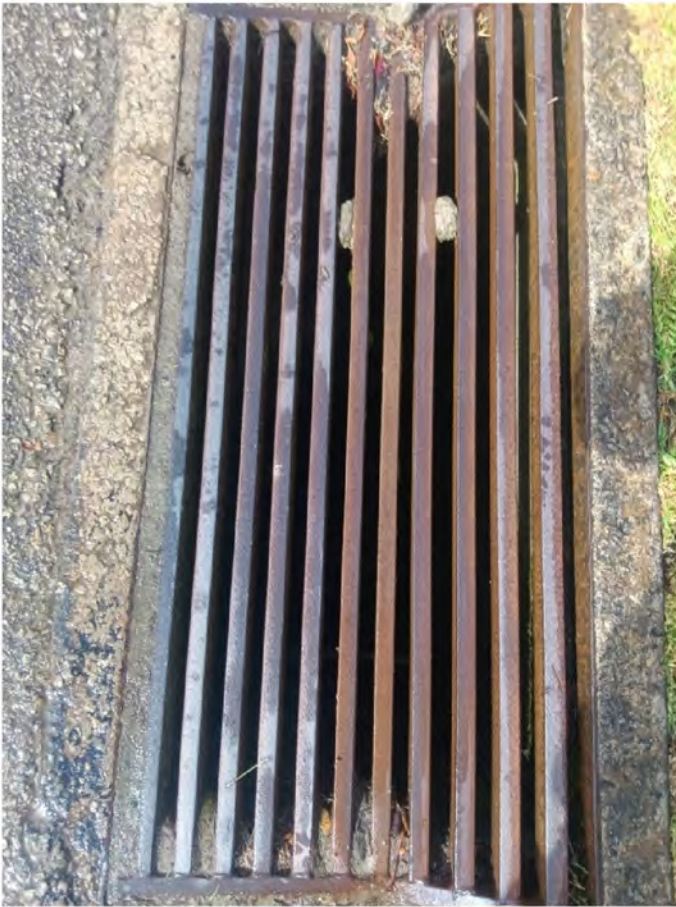
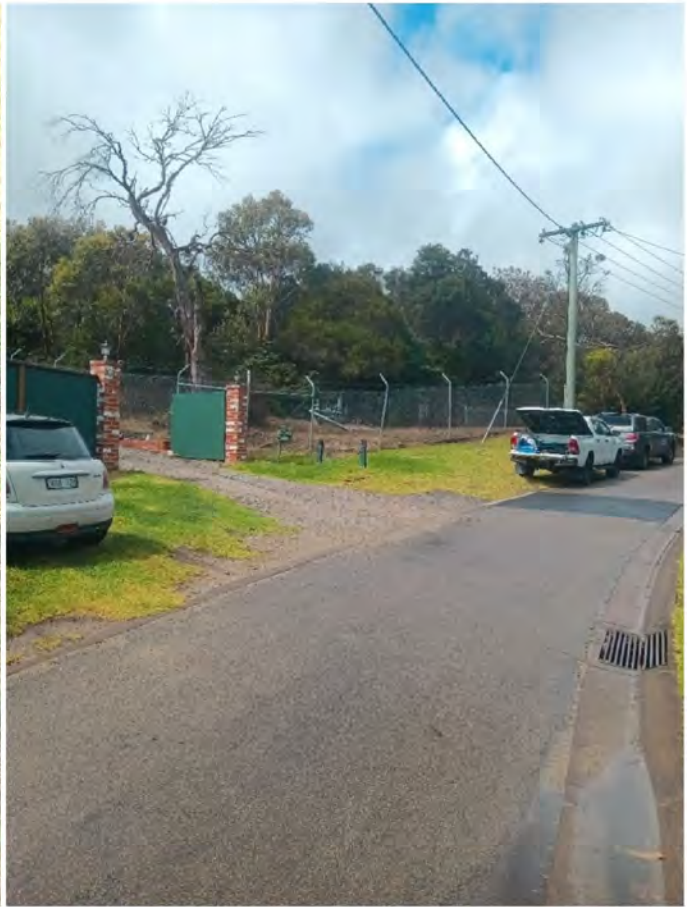
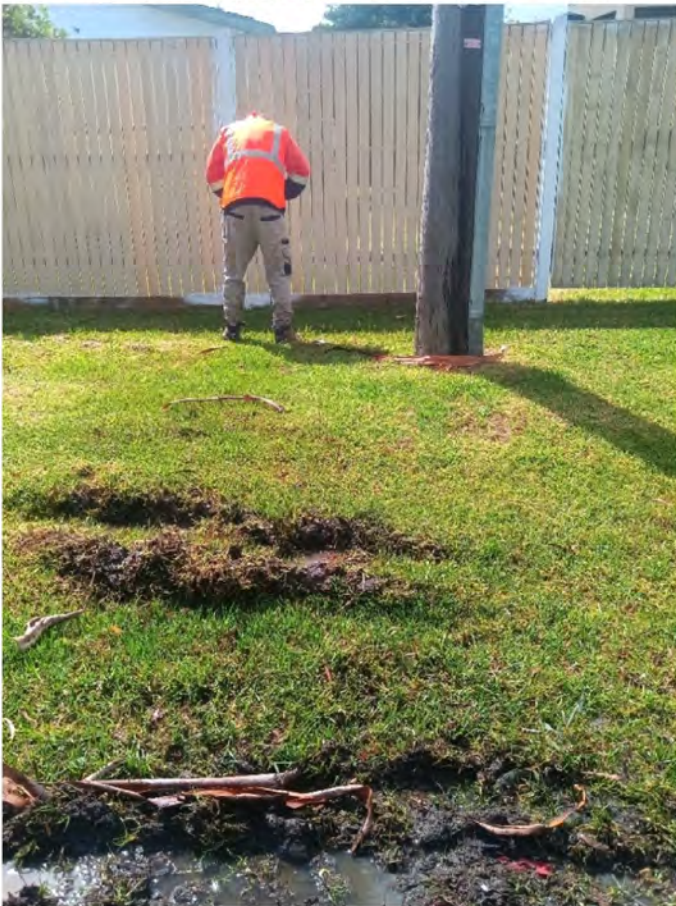
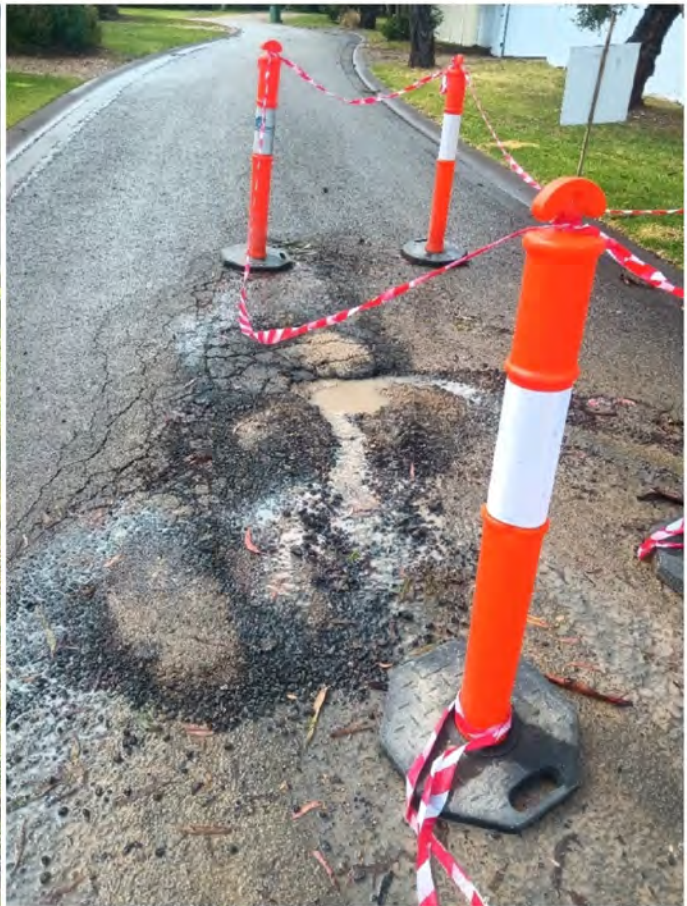
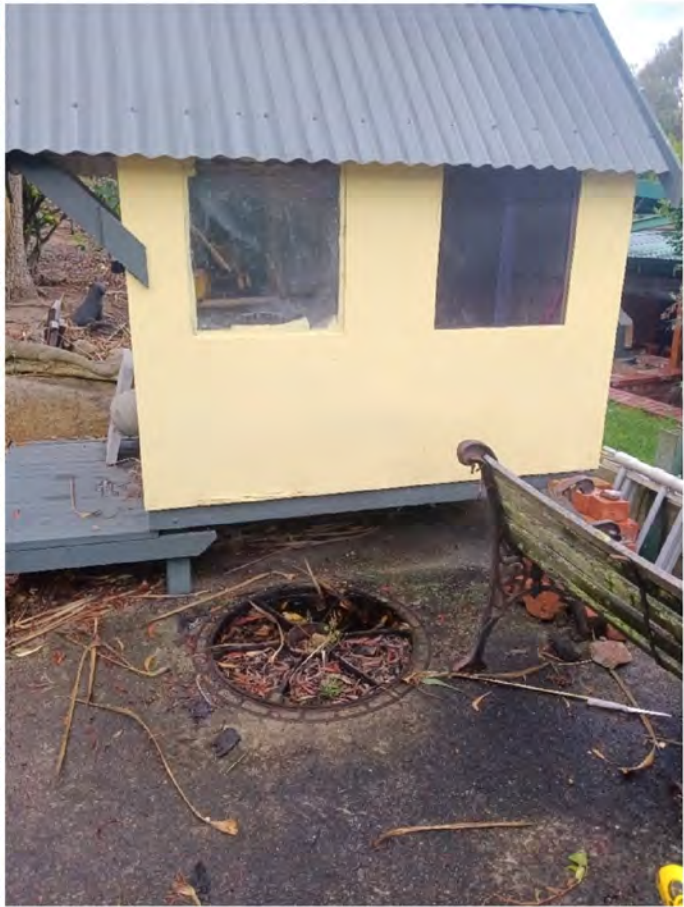
Sounded all assets in the area, followed suspect 300mm main and no leaks were detected. Chlorine sample needs to be taken when rain stops.

We also surveyed Bayview Rd above the Highway with no leak noises detected.

I don't believe there's any leaks on the mains but still some of the smaller pipes really haven't checked out. Jason Marsh will return take samples when it's not raining for a few days.
