**Task Number:**1299529/001**Task Address:**3 PENNY LANE, MCCRAE VIC 3938 MapRef : 159A9**Program Name:****Task Work Type:**Planned Maintenance - Unblock**Source Of Work:****Facility:****Permit Not Required:**No**Permit Pre Approved:**No**Permit Reason:**Other**Permit Other Reason:**

**Task Address:**14 HENRY COURT, MCCRAE 3938 MapRef : 159B10

**Request Details:** Please attempt to open seized MH NEP39 - 582, if unable replace with new heavy precast. MH locate on road but is quiet road.

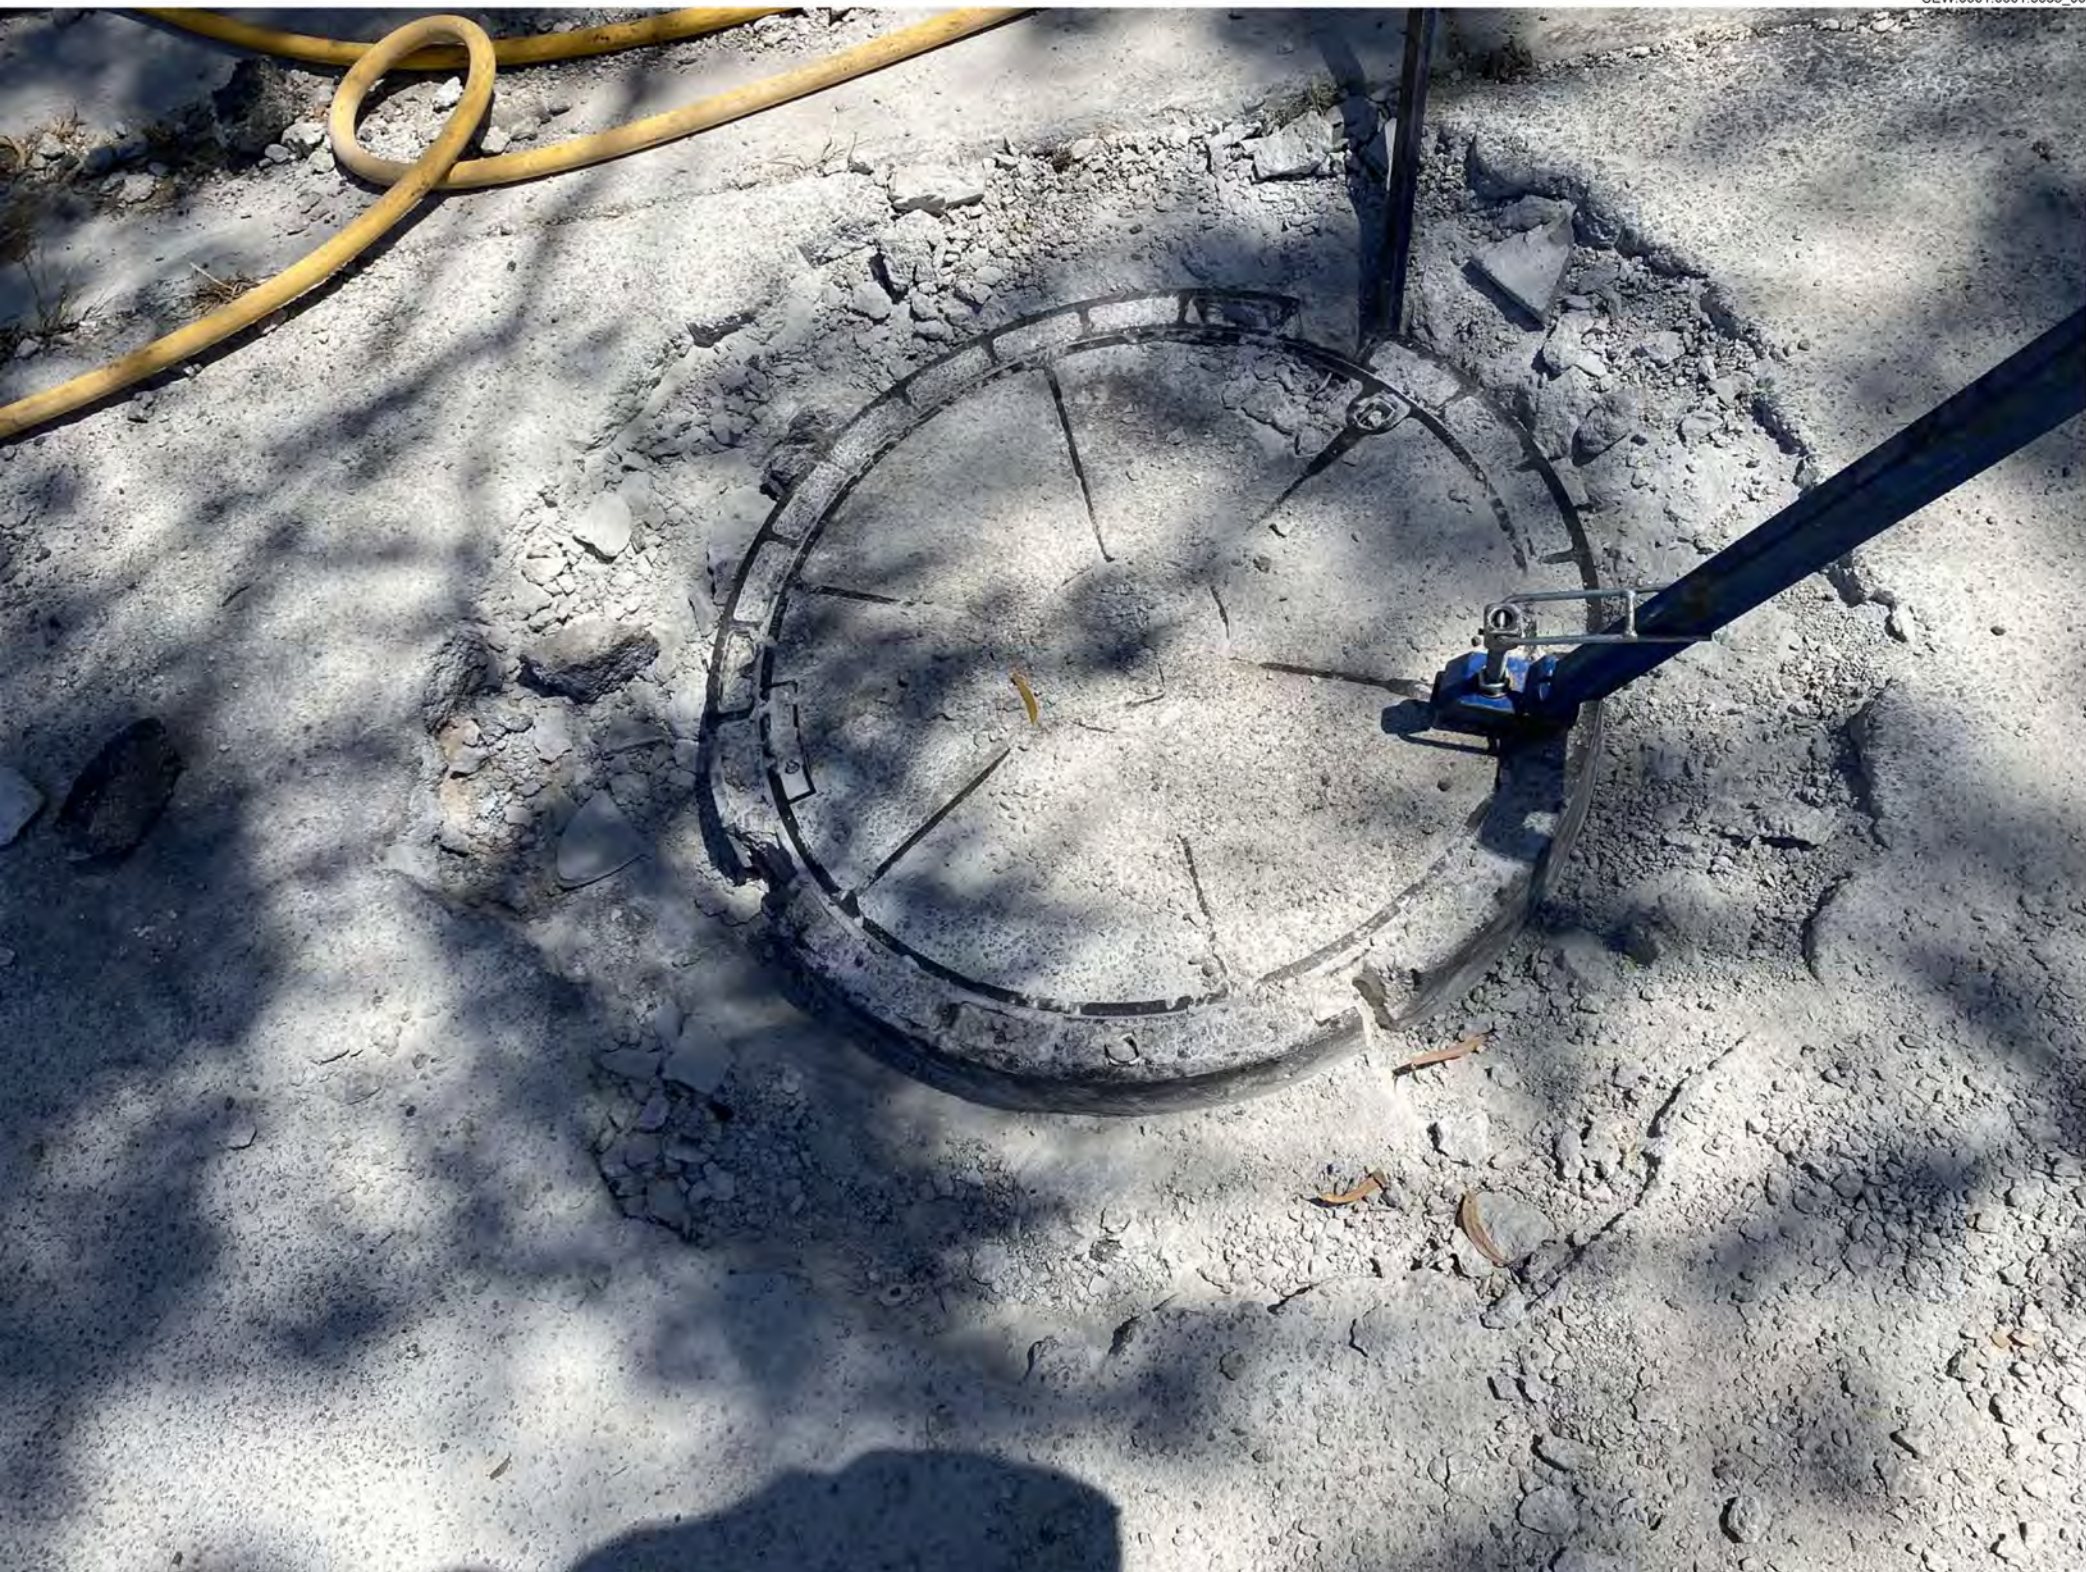
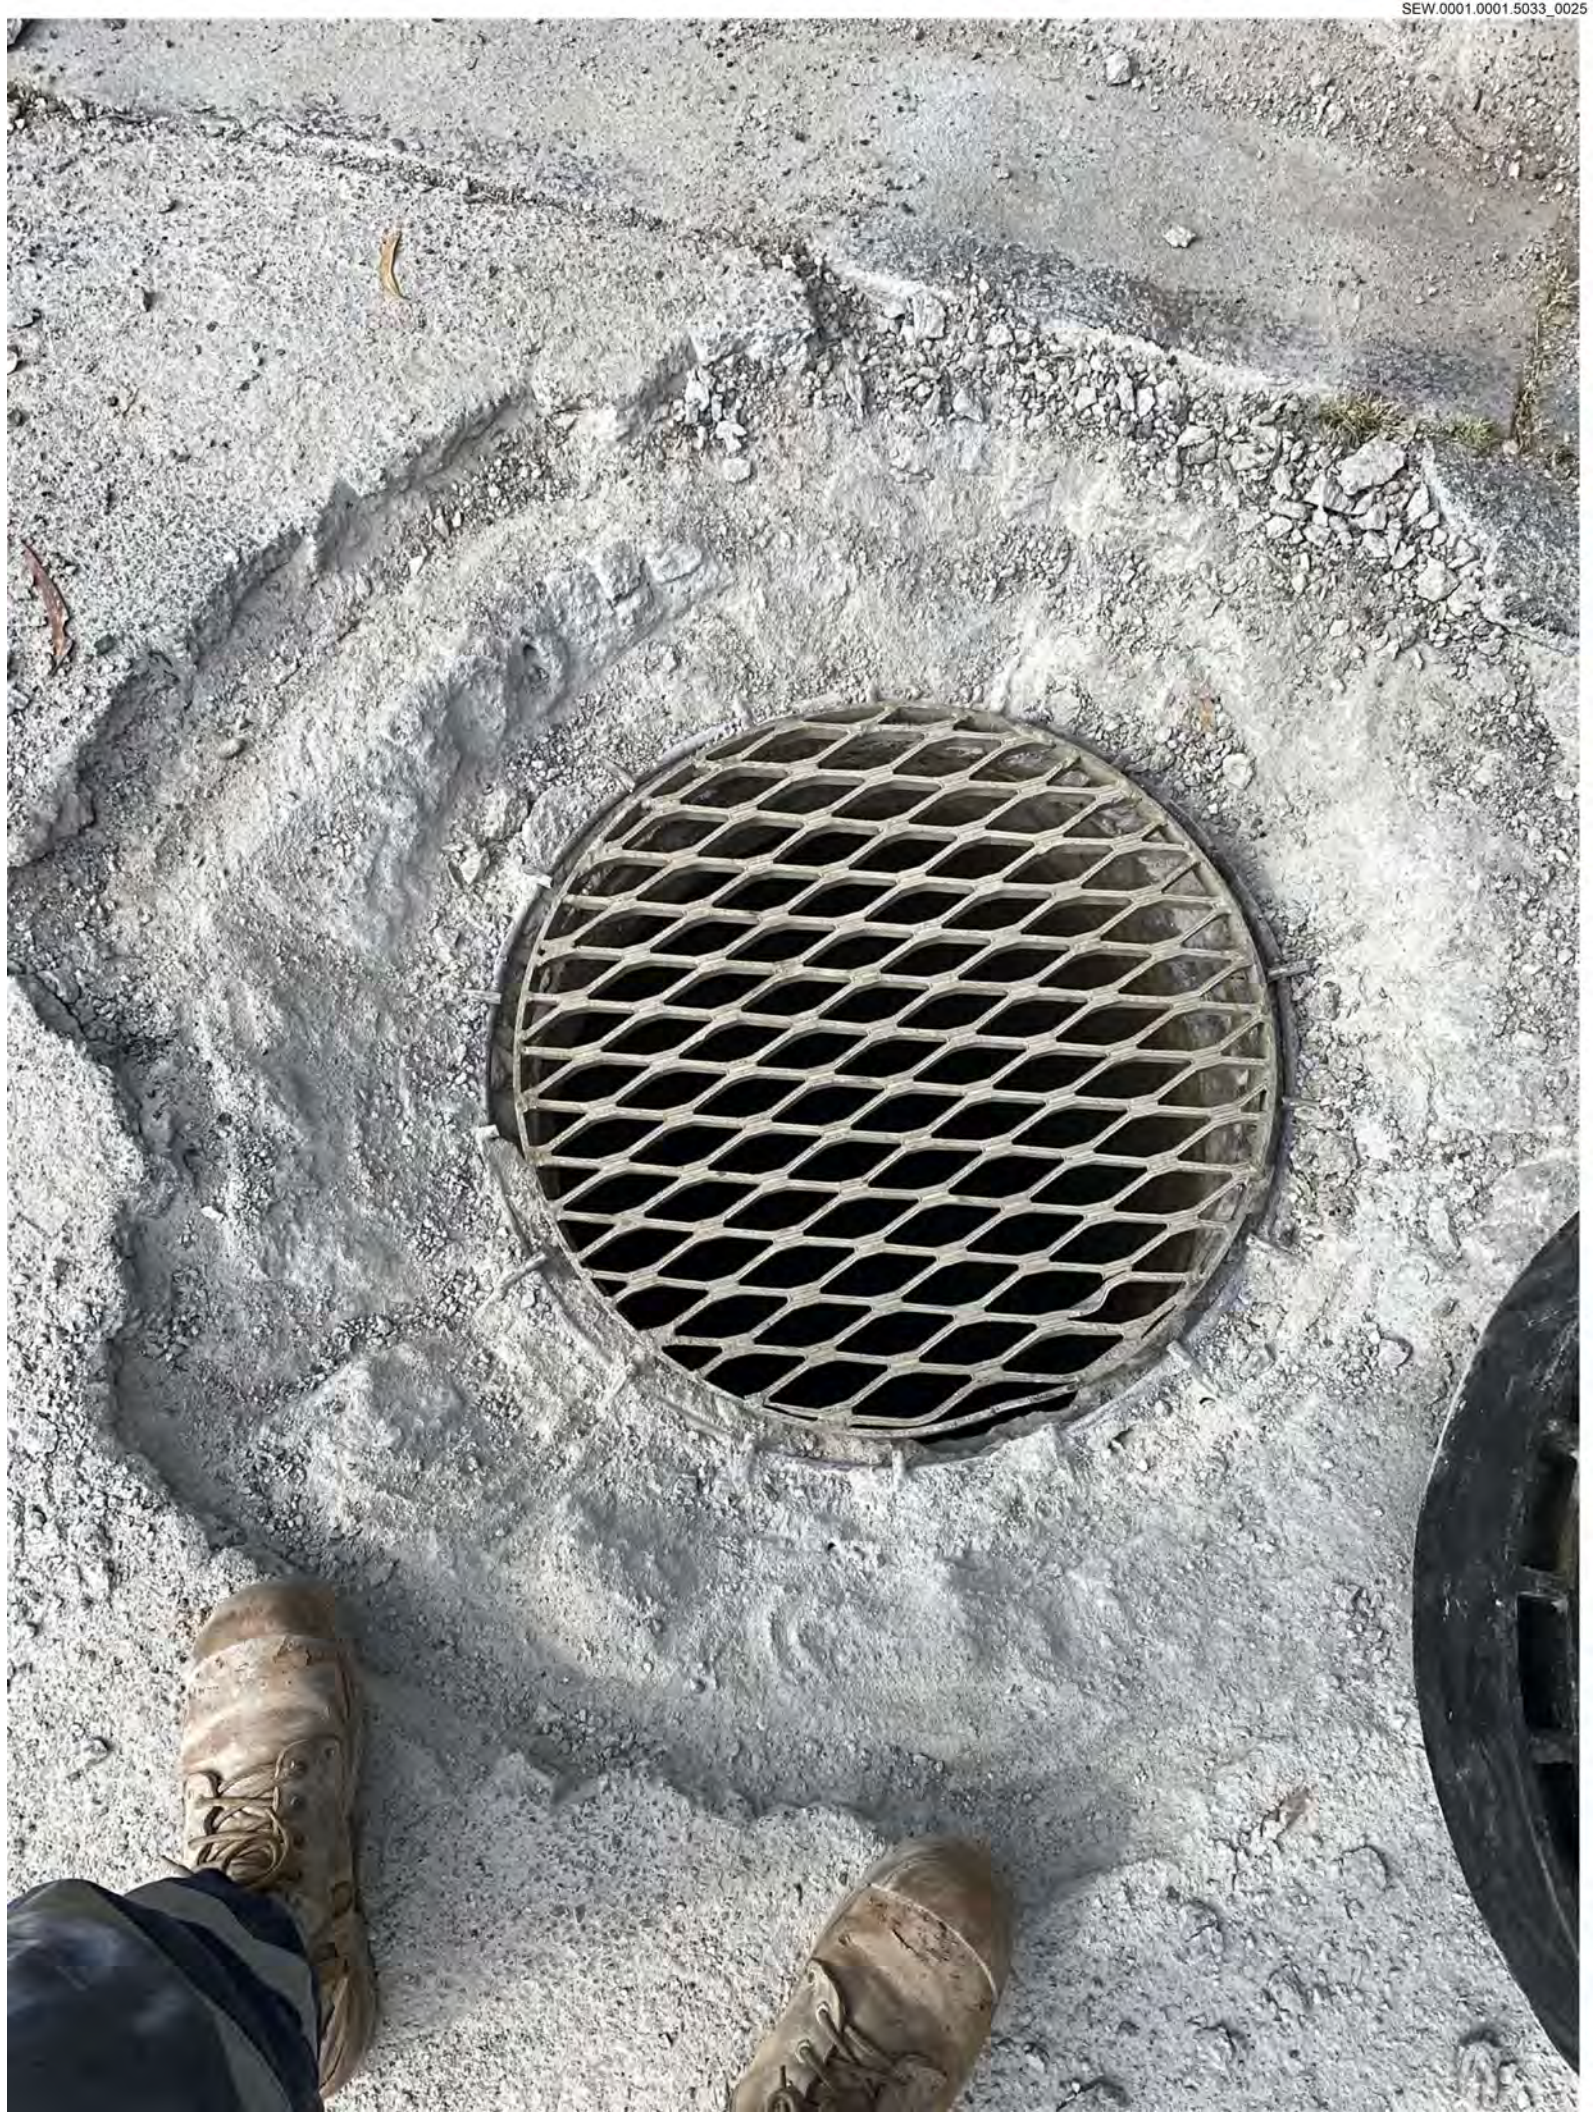
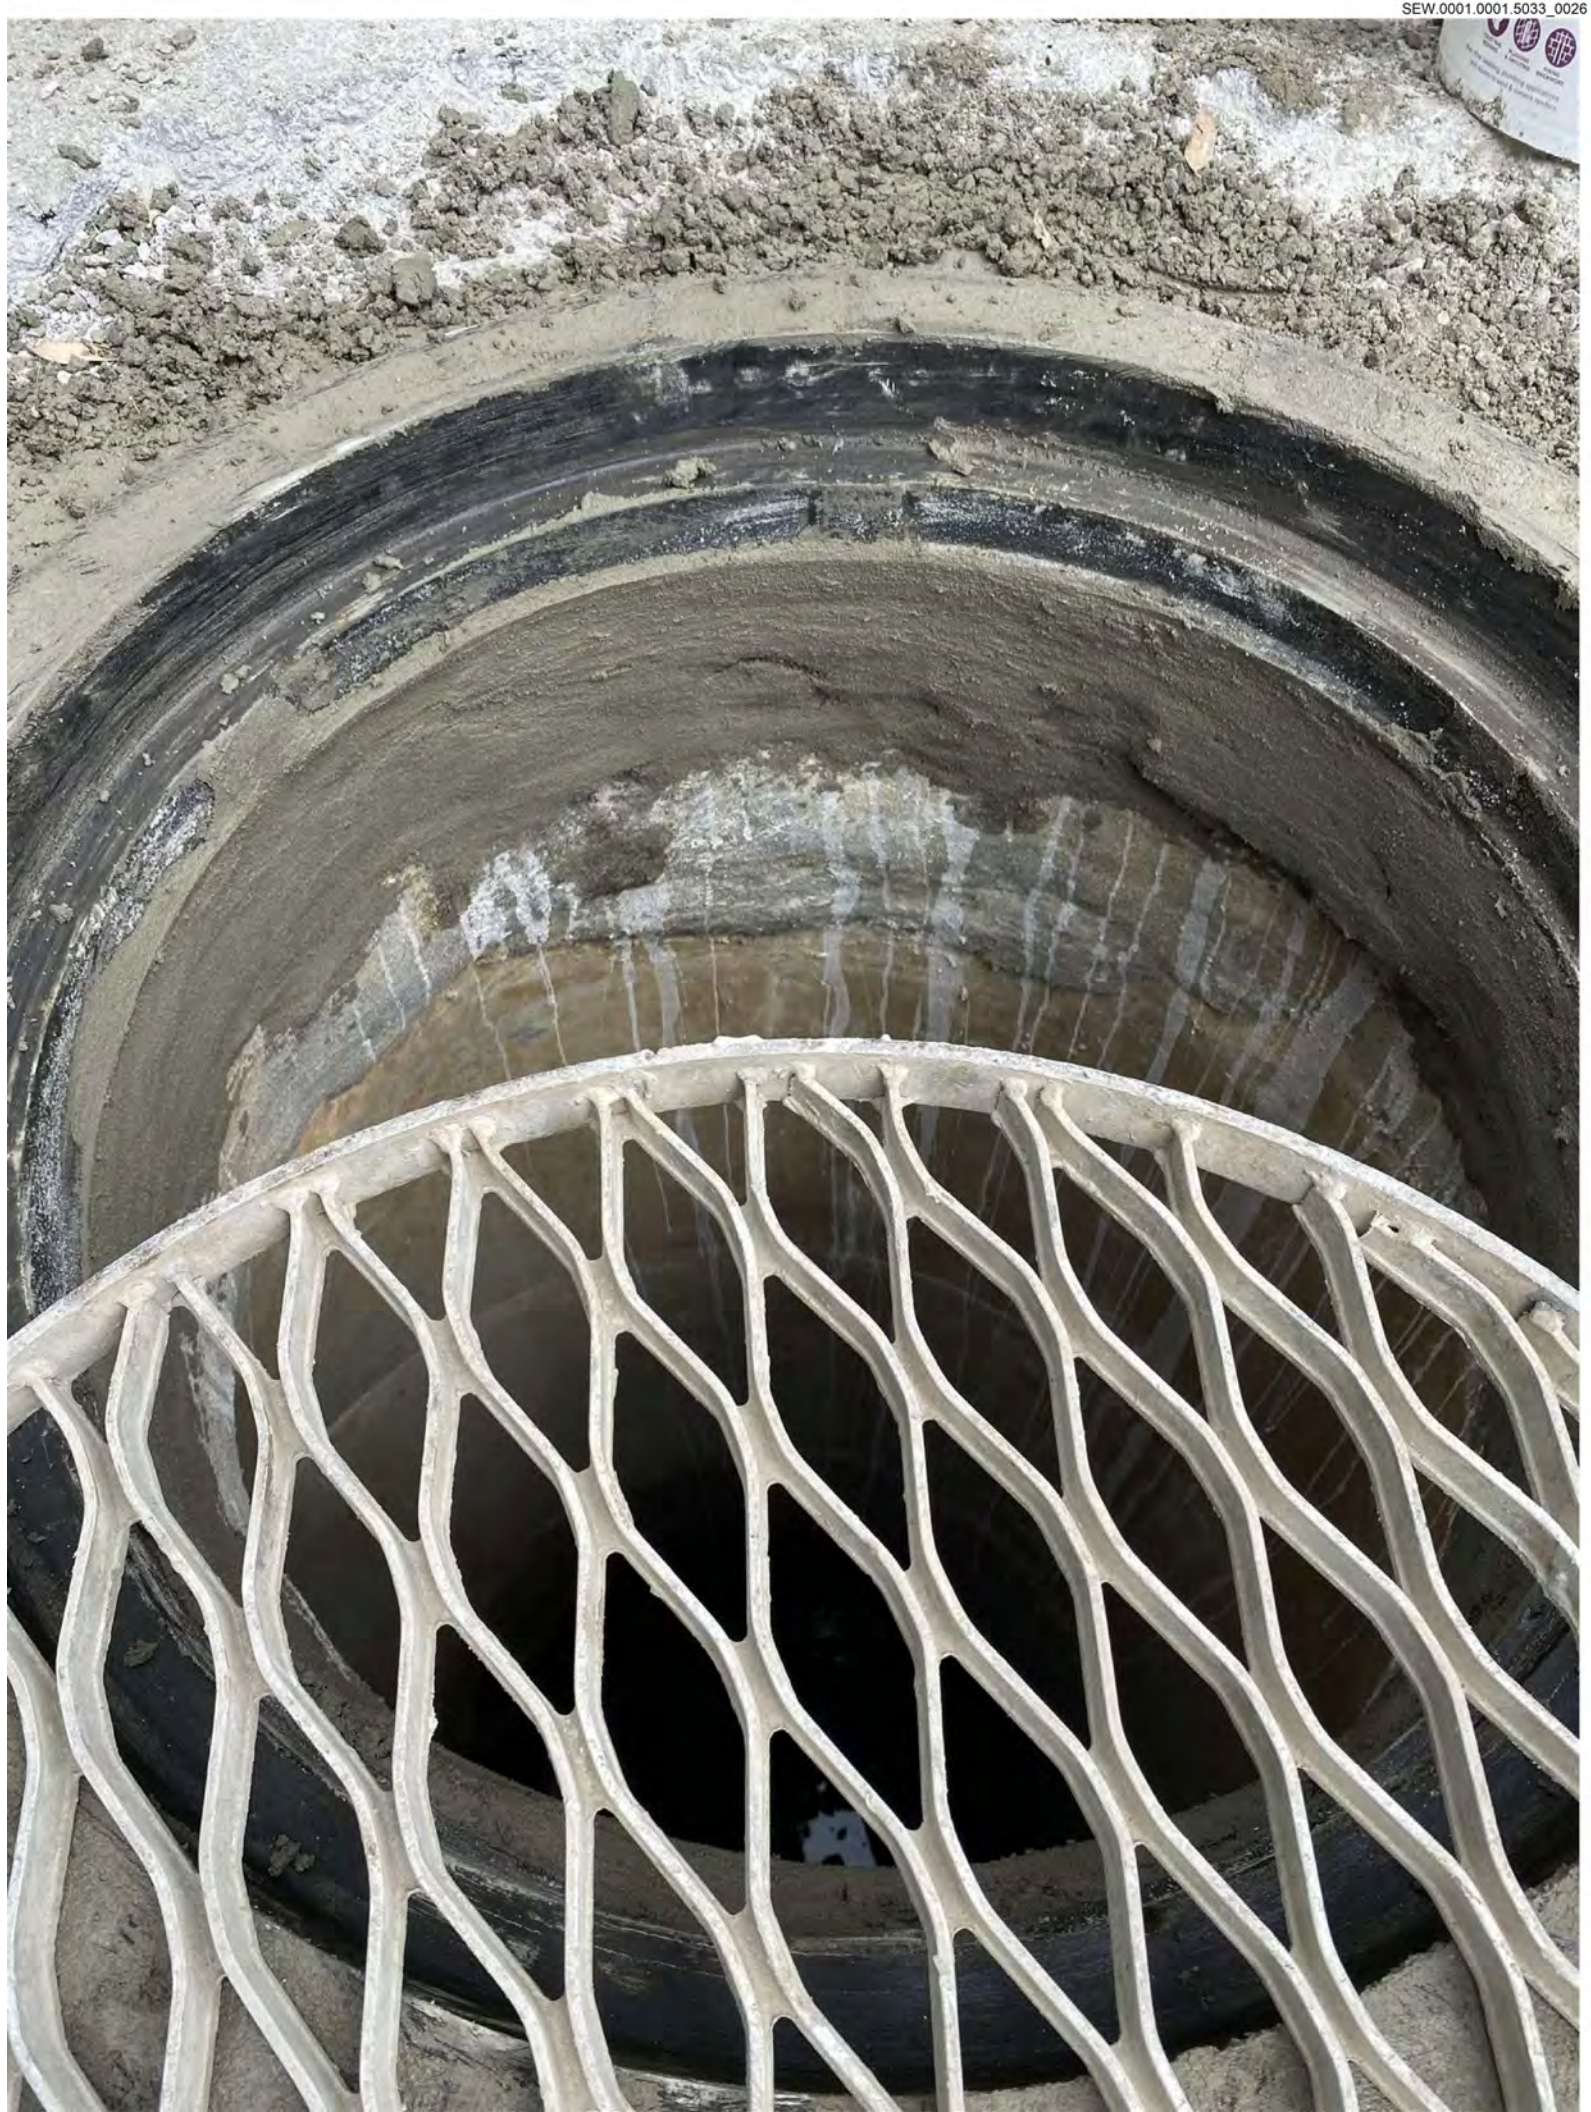
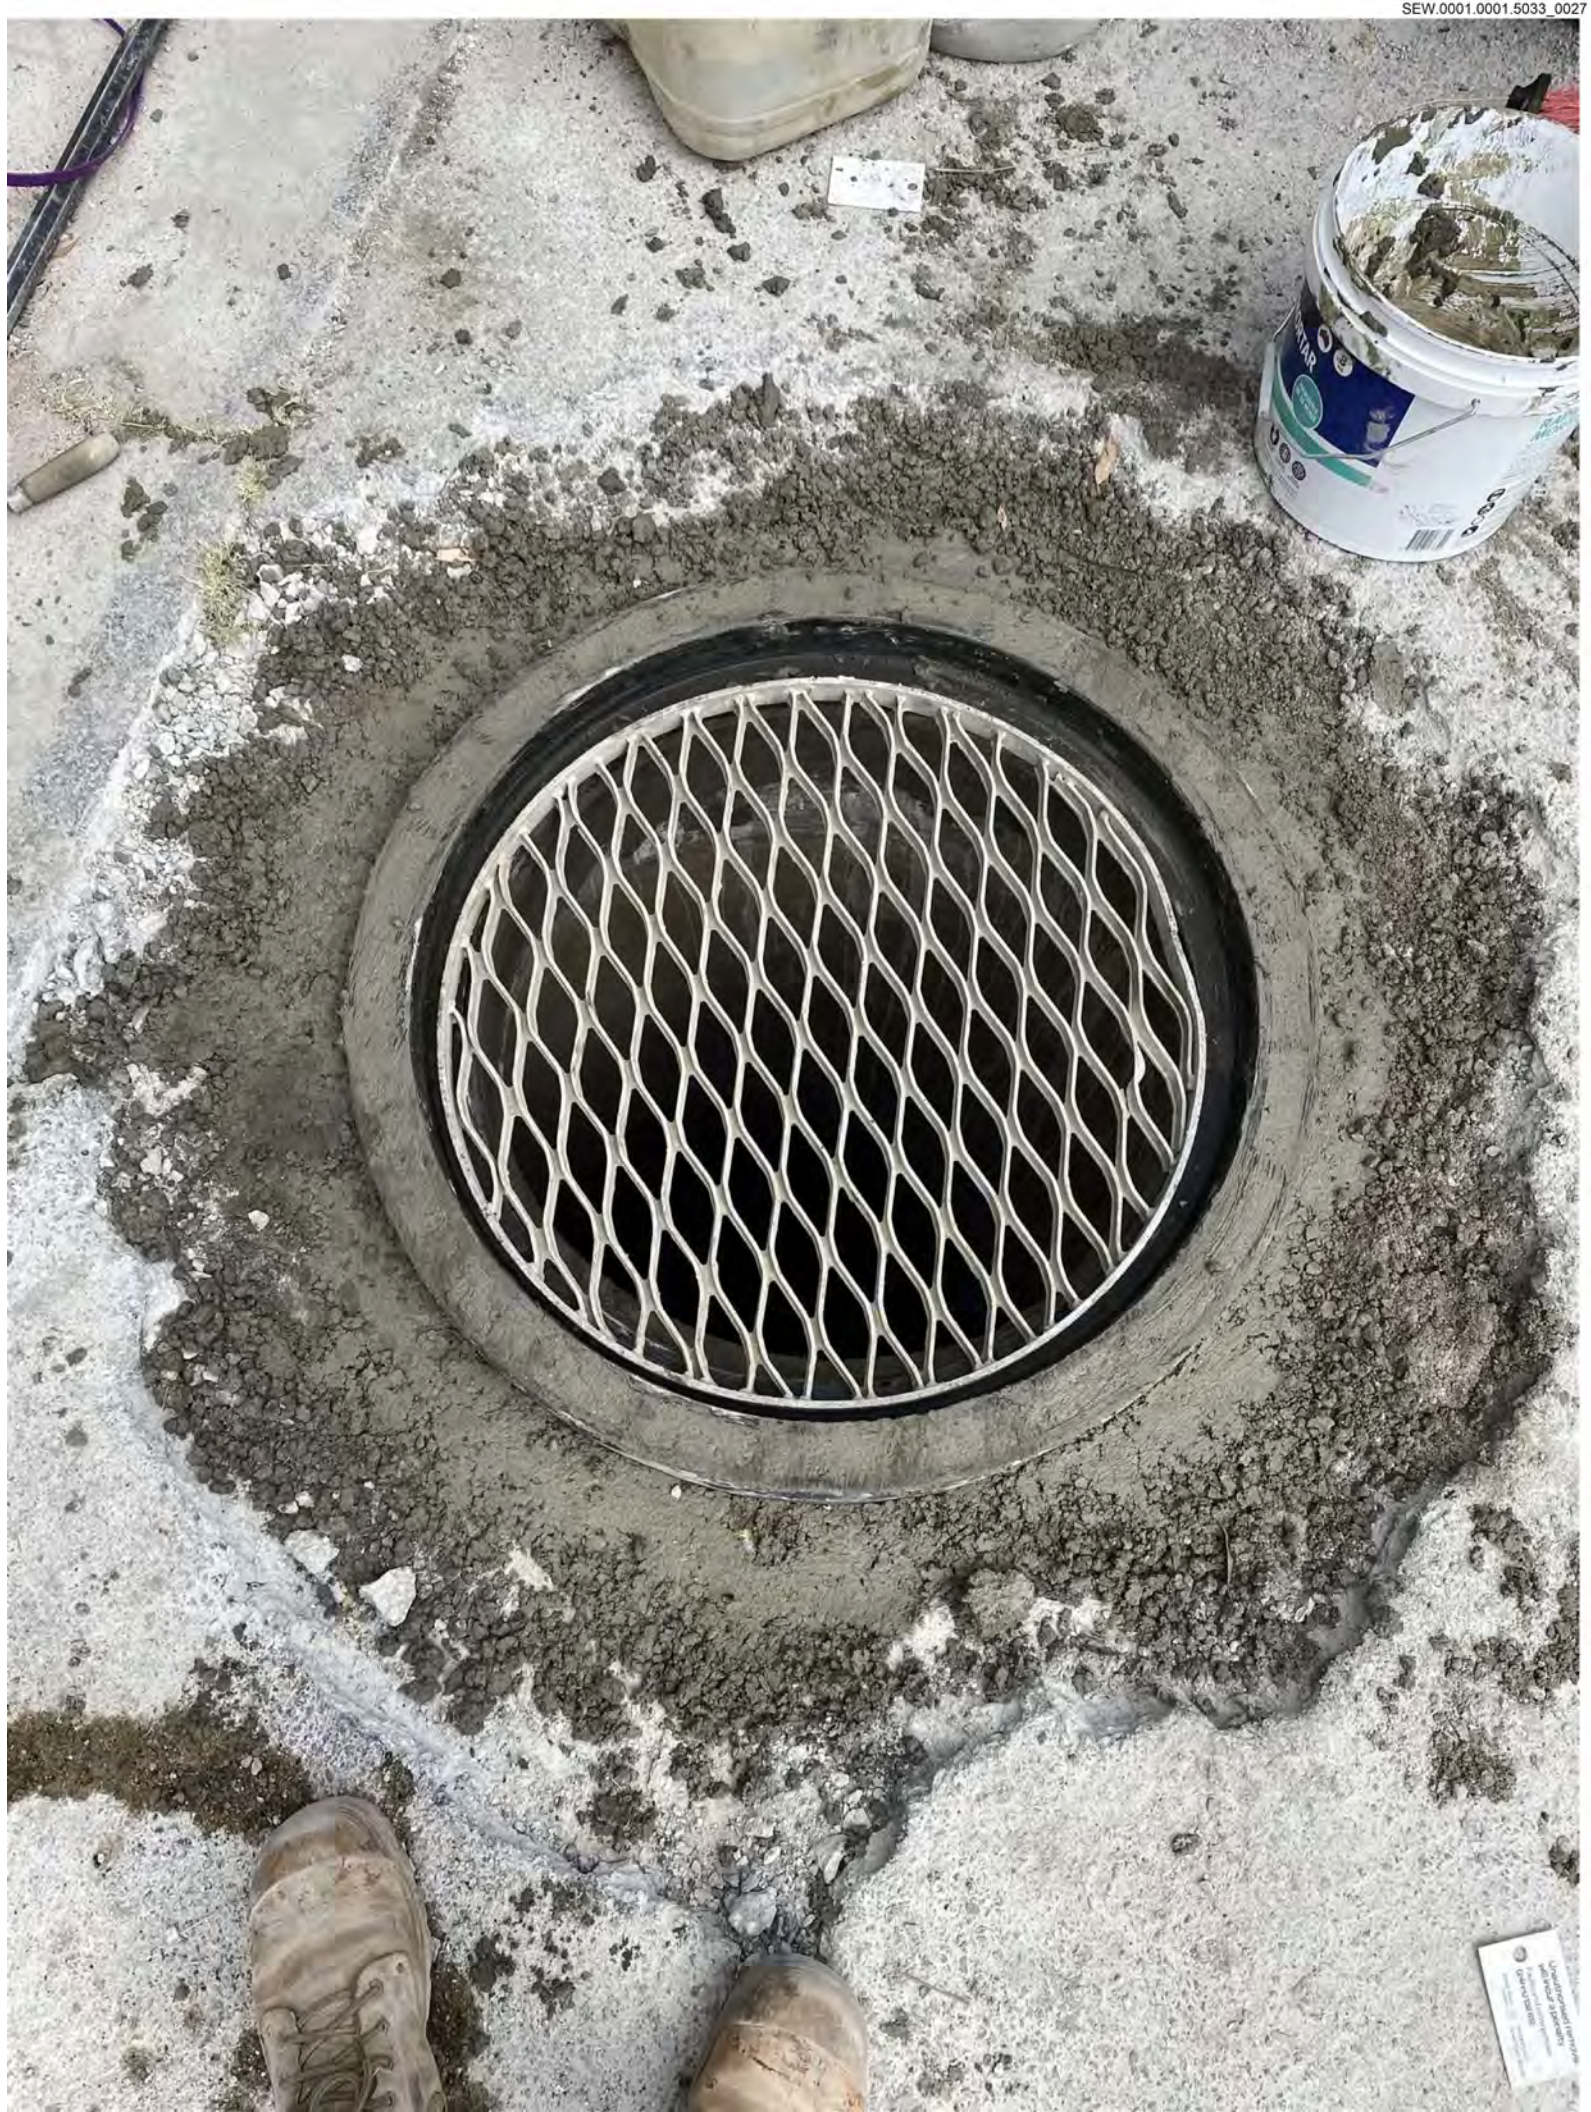
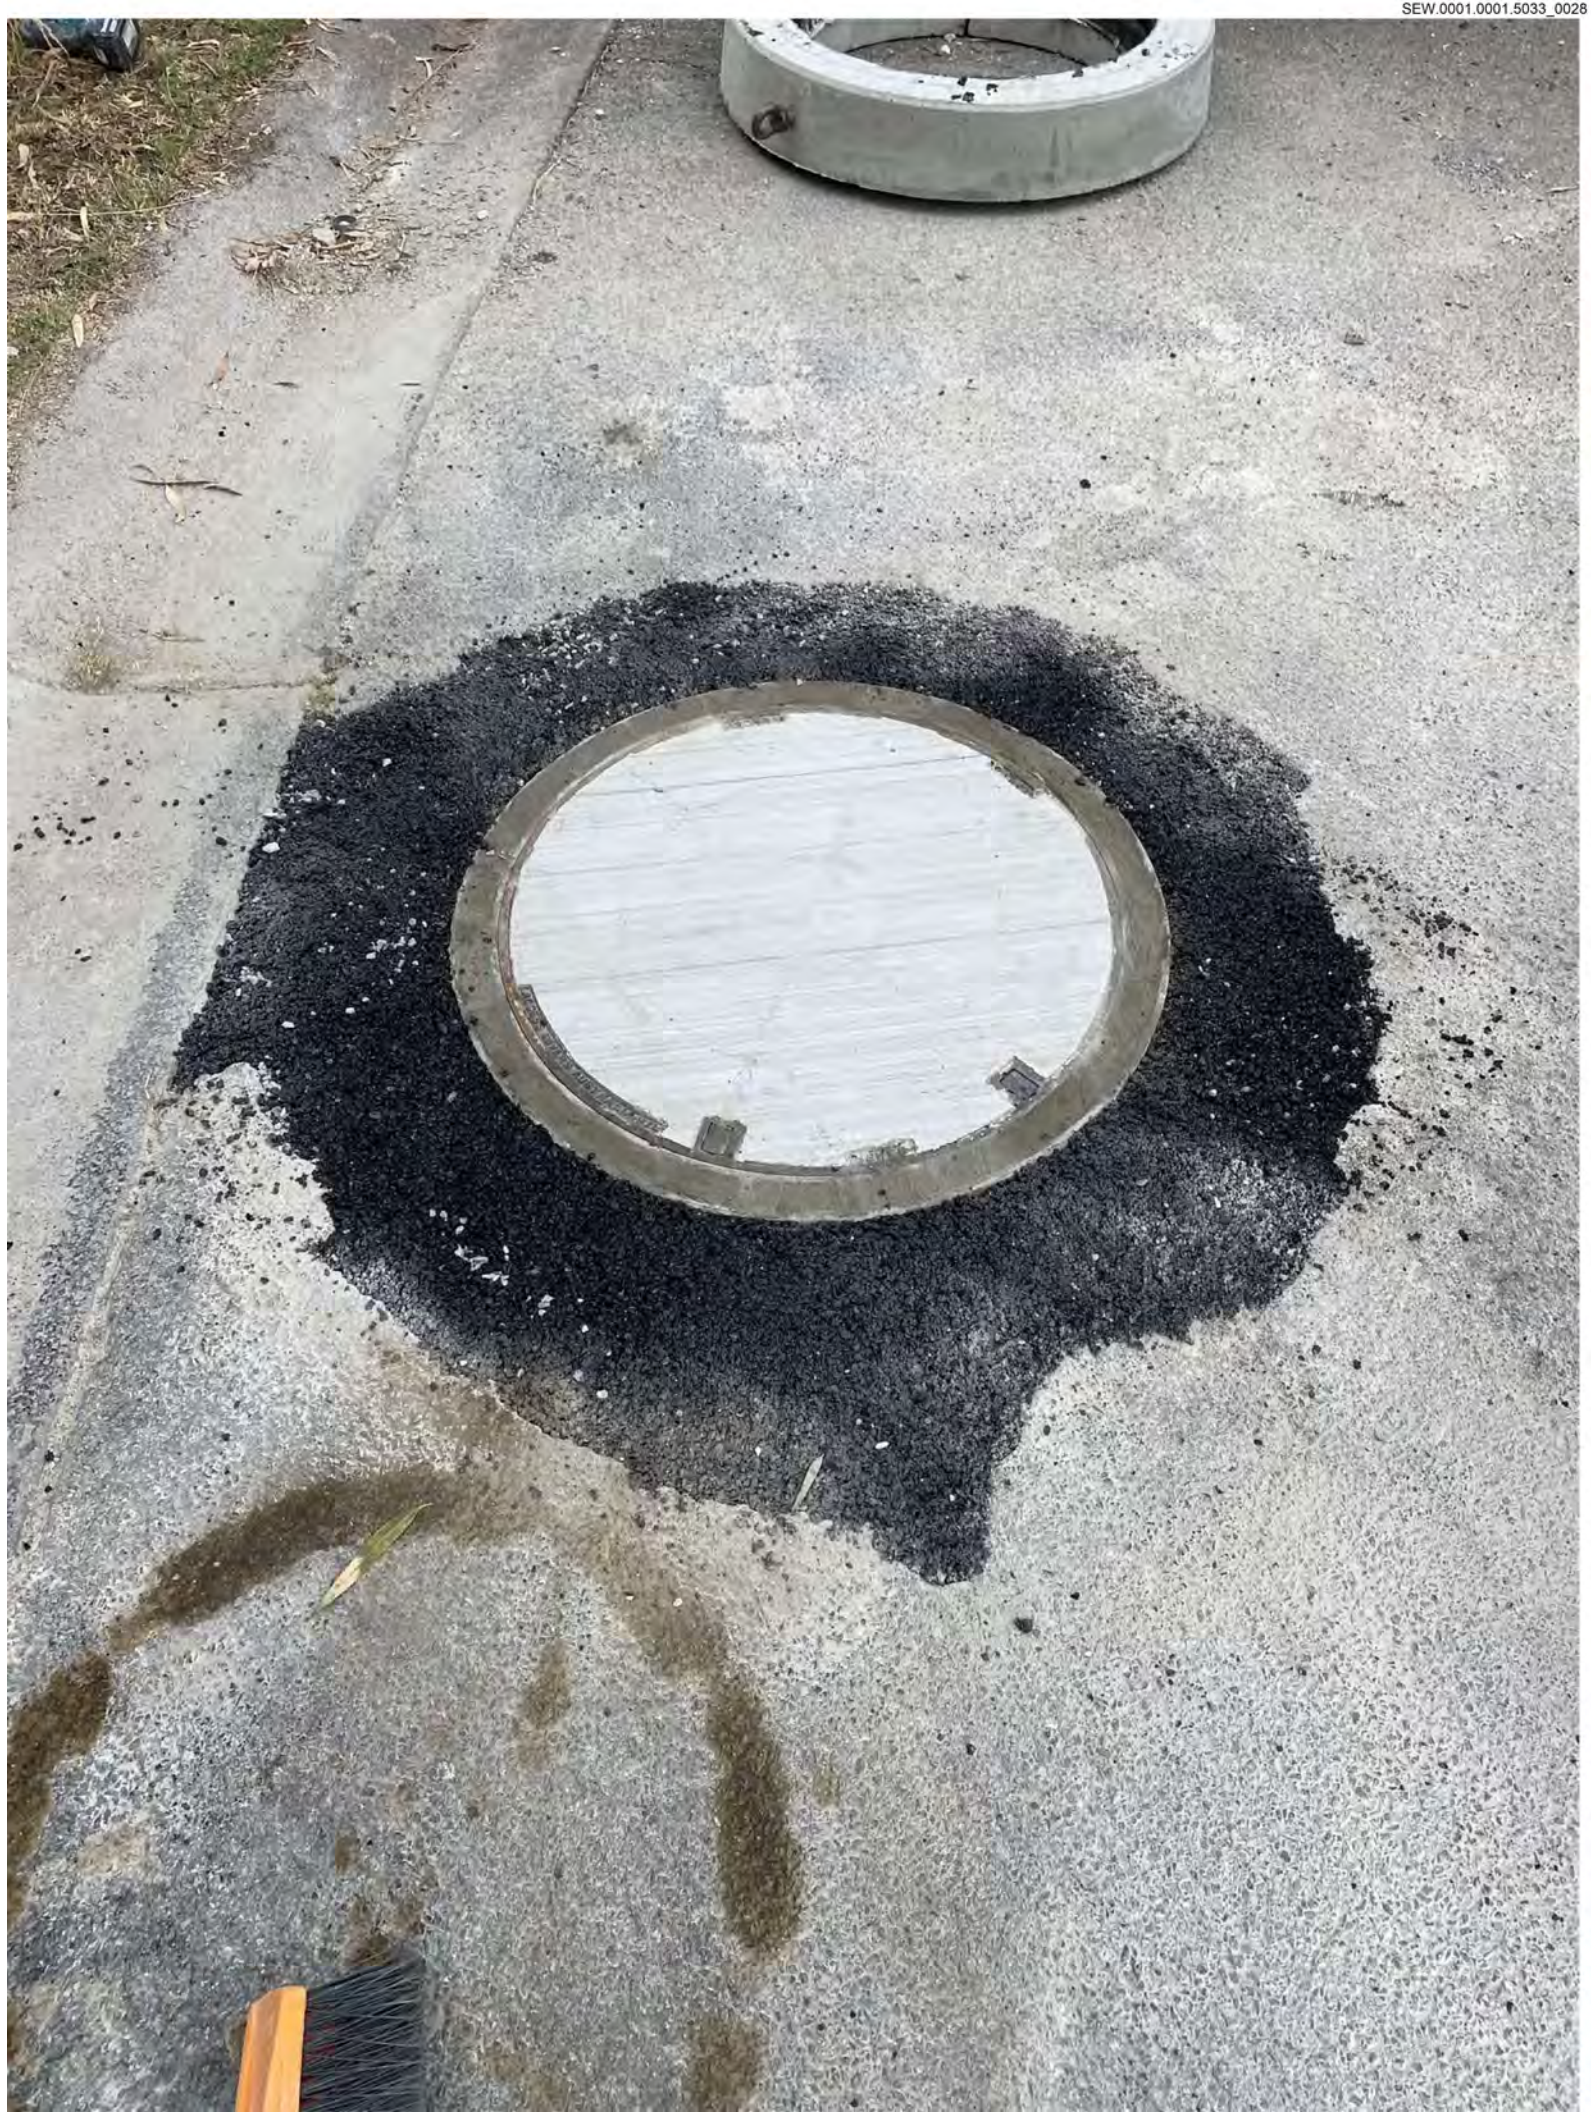
**Task Story:**[FT] [SSf0277] [7/1/2025 16:54] [ON SITE SERVICE OK] onsite, tried to open many ways with no luck will need to replace [FT] [SSf0277] [21/1/2025 16:00] [ON SITE SERVICE OK] onsite,met traffic jack hammered all day couldnt get cover to pop found starter bars going into sides of MH need to return tomorrow to finish [FT] [SSf0277] [22/1/2025 16:29] [OFF SITE] returned to site (computer issues in the morning) jack hammered down on starter bars (very hard concrete) and had to cut out removed cover put in new heavy gatic concreted in cover, finished with screenings and TSM packed up cleaned up all okay

**Failure Details:**2 Sewer Manhole - Cover damaged - Siezed

CommentsVer2 : concrete in chase

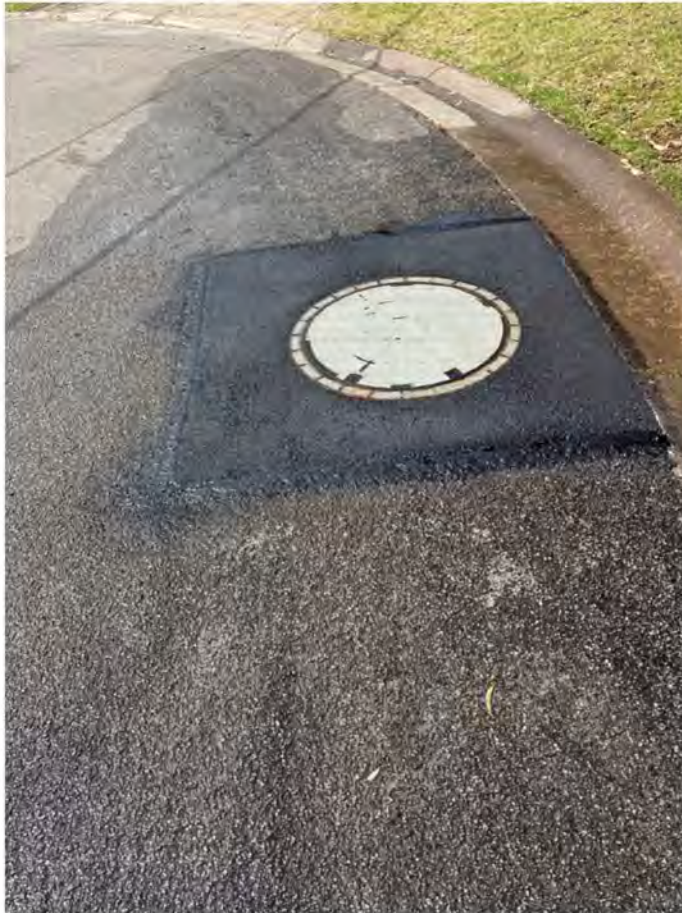
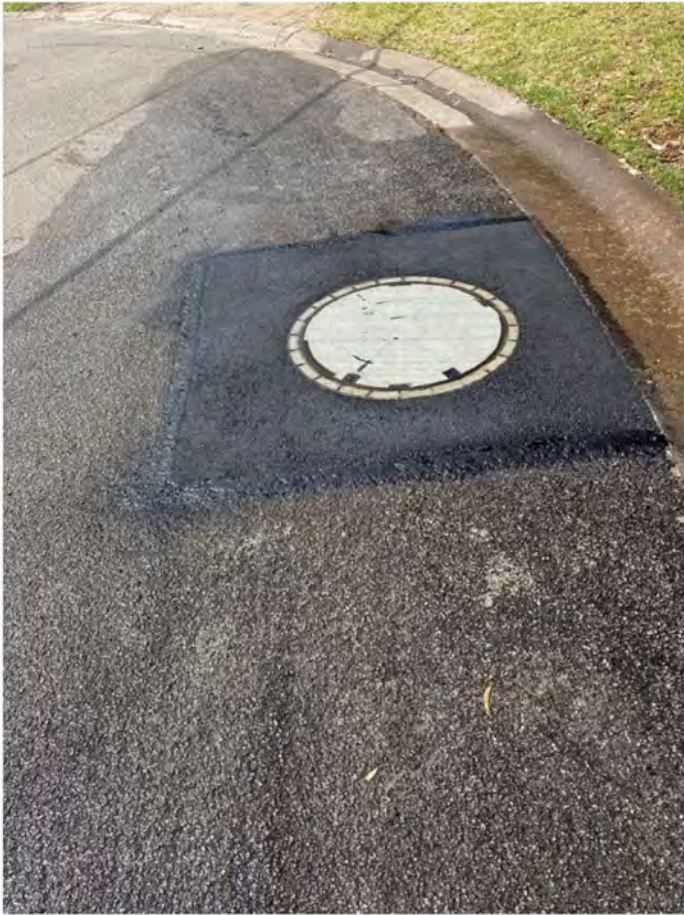
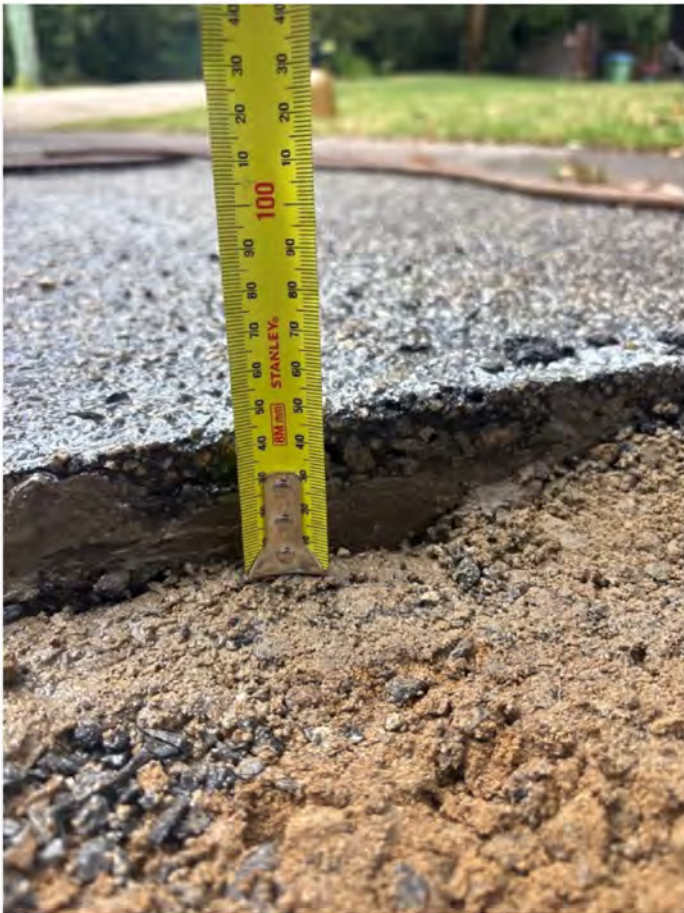
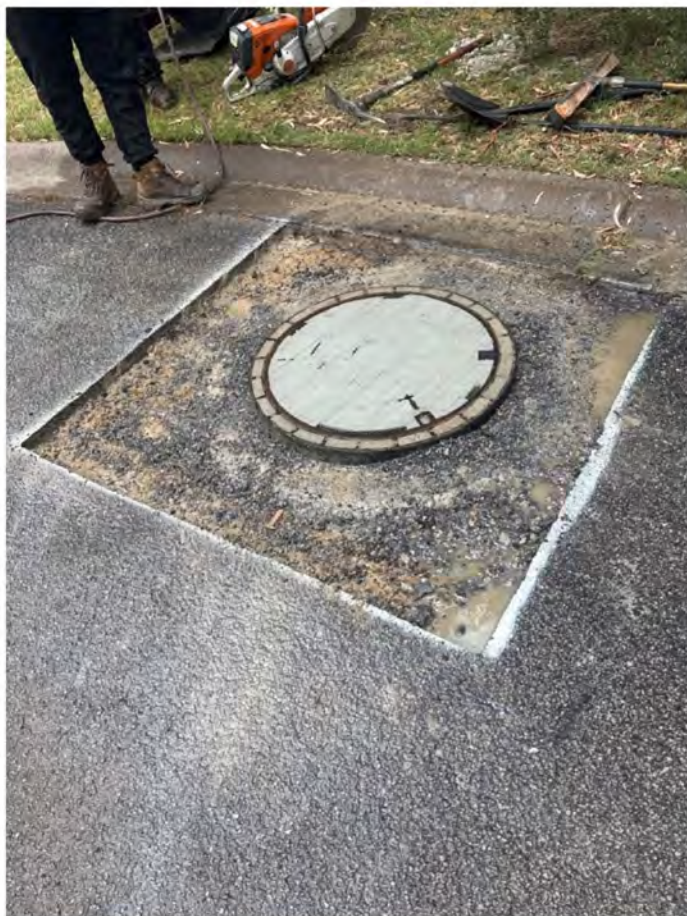
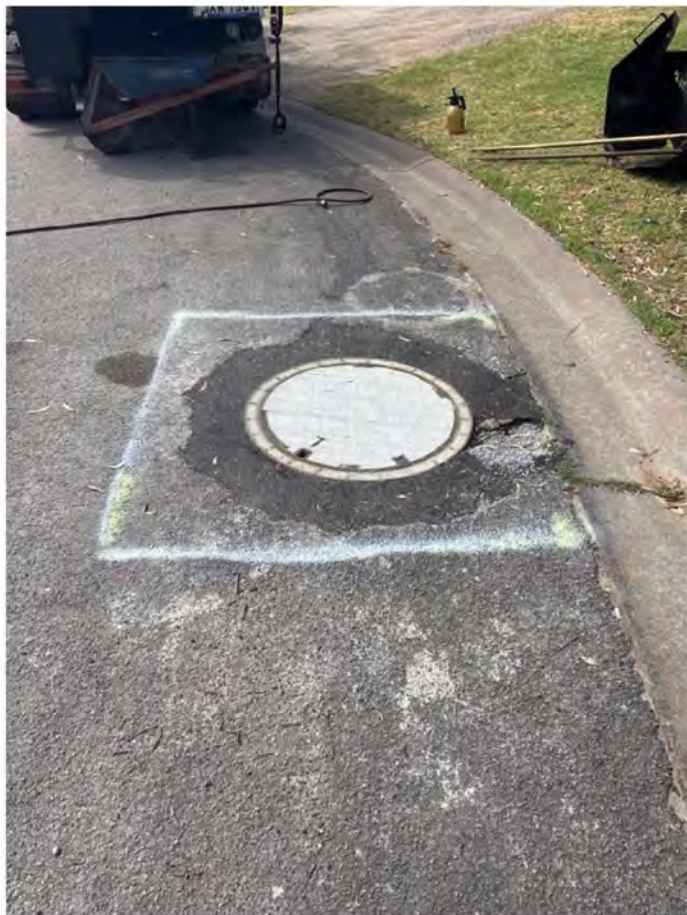
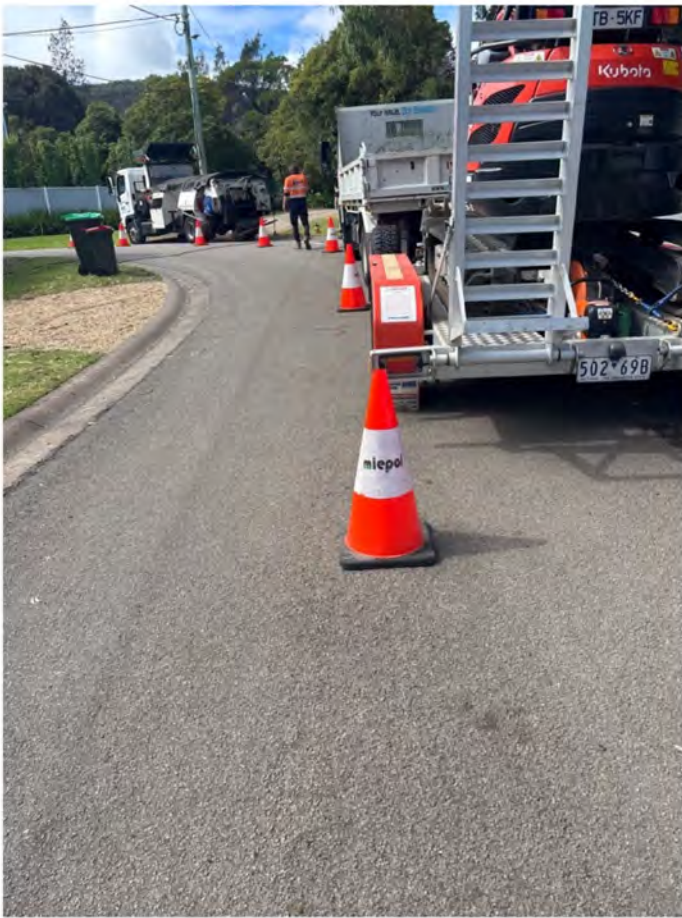
| Completion Comments: | 45mm depth |
