**Task Number:**1337352/001**Task Address:**27 COBURN AVENUE, MCCRAE VIC 3938**Program Name:**ServiceStream - FY2425 - CCTV Retic 3 (Apr25)**Task Work Type:**Scheduled Maintenance - CCTV Inspection**Source Of Work:****Facility:****Permit Not Required:**No**Permit Pre Approved:**No**Permit Reason:**Other**Permit Other Reason:**

**Request Details:**Clean + CCTV Inspection Program McCrae Package: 1. All lines to be cleaned PRIOR to CCTV Inspection 2. CCTV Inspection using WSA 05 2020 Codes 3. Any manhole alterations required to complete works, action request to be raised and Sewer Maintenance Technician to be contacted SI's to be completed: 1. Sewer Clean 2. Sewer CCTV 3. Sewer Manhole Fault and Inspection

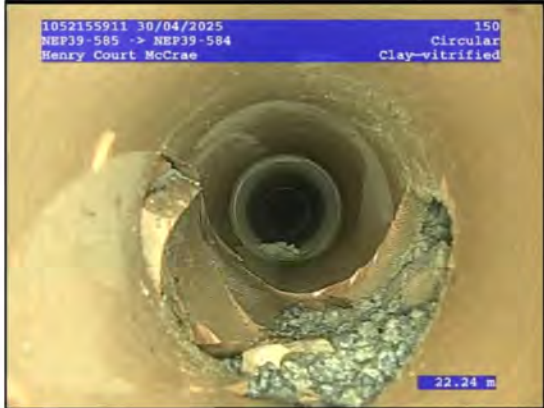
<table><tr> <th>1:349</th> <th>m+</th> <th>Code</th> <th>Observation Text</th> <th>MPEG</th> <th>Photo</th> <th>Grade</th> </tr><tr> <td></td> <td>22.24</td> <td>BE</td> <td>Conduit broken as a result of an exceptional event, e.g. external trauma, length of break: 500mm from 2 o'clock to 11 o'clock</td> <td>00:10:21</td> <td>5, 6</td> <td>1</td> </tr></table>

5, 00:10:21, 22.24  
Conduit broken as a result of an exceptional event, e.g. external trauma, length of break: 500mm from 2 o'clock to 11 o'clock

**Request Details:**Please dig out retic pipe id 1052155911 Approx 22.5m D/S of MH NEP39-585 pic of defect attached Please contact Pranay on PI when planning job as SEW will need to attend during dig.

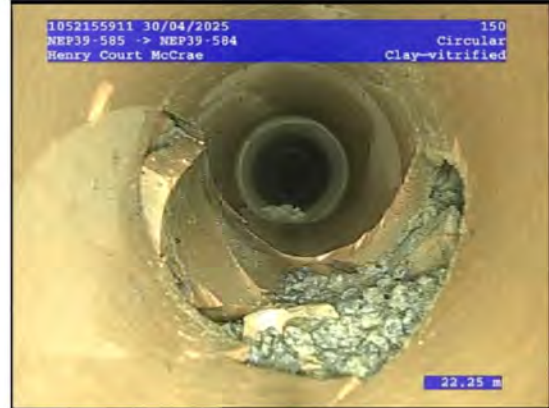
6, 00:10:21, 22.24  
Conduit broken as a result of an exceptional event, e.g. external trauma, length of break: 500mm from 2 o'clock to 11 o'clock

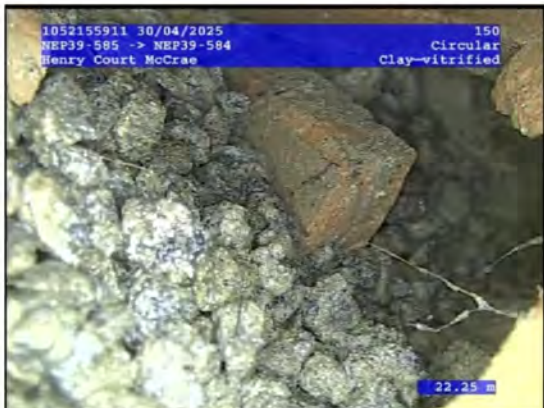
<table><tr> <th>1:349</th> <th>m+</th> <th>Code</th> <th>Observation Text</th> <th>MPEG</th> <th>Photo</th> <th>Grade</th> </tr><tr> <td></td> <td>22.25</td> <td>VV</td> <td>Void visible through defect, at joint</td> <td>00:10:42</td> <td>7, 8</td> <td></td> </tr></table>

7, 00:10:42, 22.25  
Void visible through defect, at joint

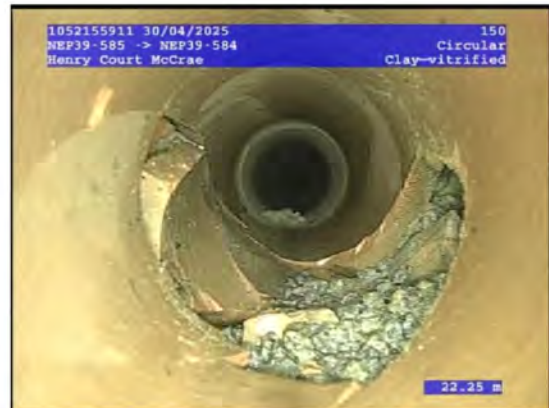
8, 00:10:42, 22.25  
Void visible through defect, at joint

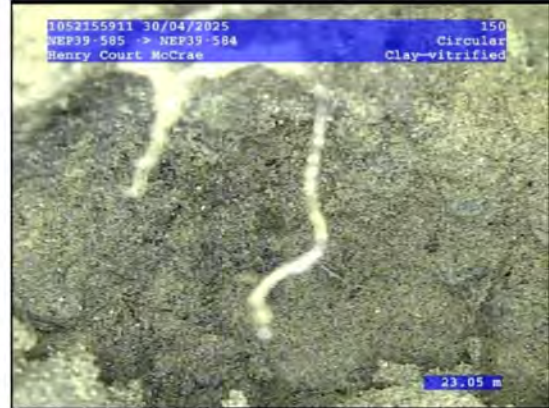
10, 00:12:29, 23.05

<table><tr> <th>1:349</th> <th>m+</th> <th>Code</th> <th>Observation Text</th> <th>MPEG</th> <th>Photo</th> <th>Grade</th> </tr><tr> <td></td> <td>23.05</td> <td>BM</td> <td>Breaking, one or more pieces of conduit are missing, length of break: 100mm from 11 o'clock to 12 o'clock</td> <td>00:12:29</td> <td>10, 11</td> <td>3</td> </tr></table>

Breaking, one or more pieces of conduit are missing, length of break: 100mm from 11 o'clock to 12 o'clock

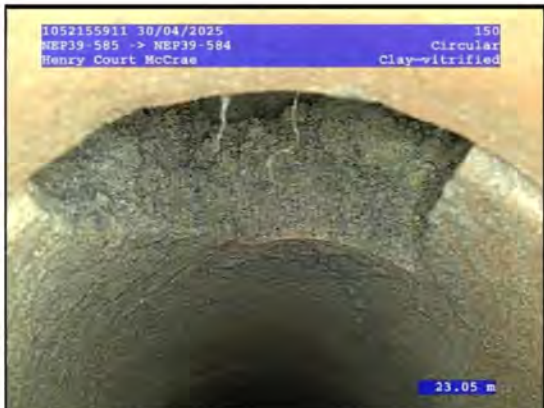
11, 00:12:29, 23.05

Breaking, one or more pieces of conduit are missing, length of break: 100mm from 11 o'clock to 12 o'clock

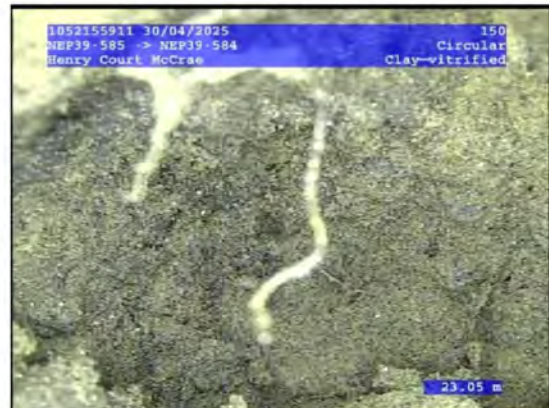
12, 00:12:37, 23.05

<table><tr> <th>1:349</th> <th>m+</th> <th>Code</th> <th>Observation Text</th> <th>MPEG</th> <th>Photo</th> <th>Grade</th> </tr><tr> <td></td> <td>23.05</td> <td>VV</td> <td>Void visible through defect, at joint</td> <td>00:12:37</td> <td>12, 13</td> <td></td> </tr></table>

Void visible through defect, at joint

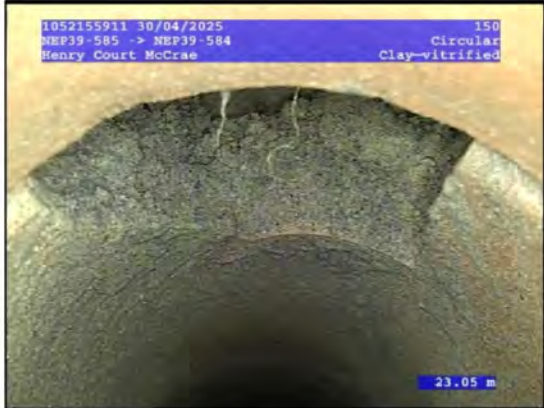
13, 00:12:37, 23.05  
Void visible through defect, at joint

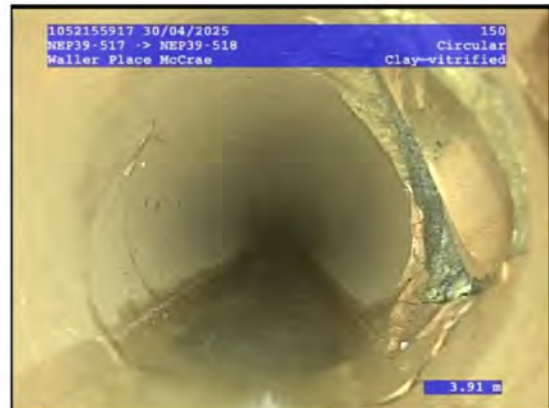
<table><tr> <th>1:464</th> <th>m+</th> <th>Code</th> <th>Observation Text</th> <th>MPEG</th> <th>Photo</th> <th>Grade</th> </tr><tr> <td></td> <td>3.91</td> <td>CM</td> <td>Cracking multiple or complex (s), at joint, width: 1.5mm from 4 o'clock to 10 o'clock / from connection</td> <td>00:03:18</td> <td>8, 9</td> <td>3</td> </tr></table>

8, 00:03:18, 3.91  
Cracking multiple or complex (s), at joint, width: 1.5mm from 4 o'clock to 10 o'clock / from connection

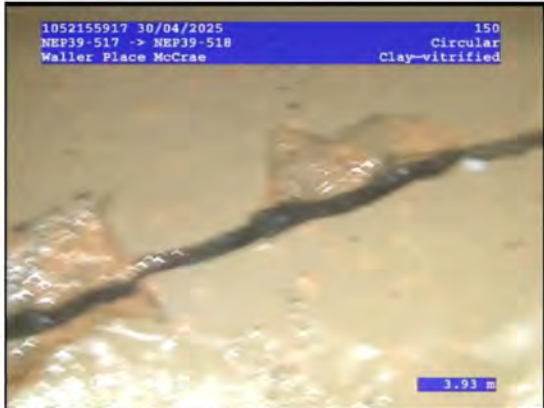
9, 00:03:18, 3.91  
Cracking multiple or complex (s), at joint, width: 1.5mm from 4 o'clock to 10 o'clock / from connection

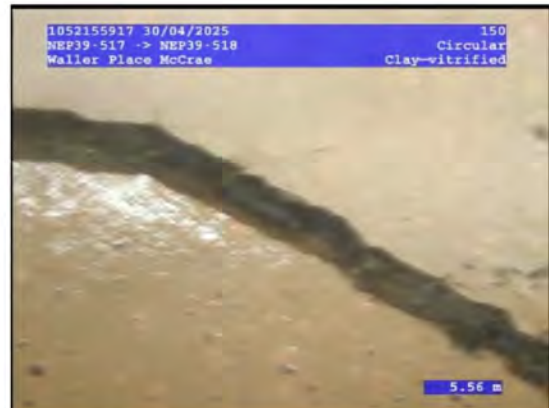
<table><tr> <th>1:464</th> <th>m+</th> <th>Code</th> <th>Observation Text</th> <th>MPEG</th> <th>Photo</th> <th>Grade</th> </tr><tr> <td></td> <td>5.56</td> <td>CC</td> <td>Circumferential cracking, width: 3mm from 12 o'clock to 12 o'clock / at connection</td> <td>00:05:03</td> <td>12</td> <td>2</td> </tr></table>

12, 00:05:03, 5.56  
Circumferential cracking, width: 3mm from 12 o'clock to 12 o'clock / at connection

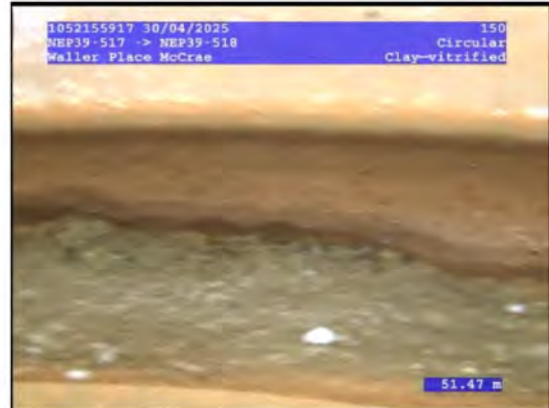
<table><tr> <th>1:464</th> <th>m+</th> <th>Code</th> <th>Observation Text</th> <th>MPEG</th> <th>Photo</th> <th>Grade</th> </tr><tr> <td></td> <td>51.47</td> <td>SOS</td> <td>Surface damage, spalling of a masonry or VC conduit including localised chipping, at joint, Obstruction: 20% from 12 o'clock to 12 o'clock</td> <td>00:19:55</td> <td>14</td> <td>3</td> </tr></table>

14, 00:19:55, 51.47  
Surface damage, spalling of a masonry or VC conduit including localised chipping, at joint, Obstruction: 20% from 12 o'clock to 12 o'clock

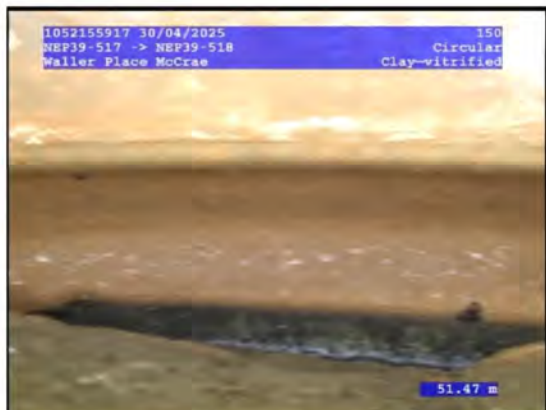
<table><tr> <th>1:464</th> <th>m+</th> <th>Code</th> <th>Observation Text</th> <th>MPEG</th> <th>Photo</th> <th>Grade</th> </tr><tr> <td></td> <td>51.47</td> <td>DJSRN</td> <td>Seal is visibly displaced and/or damaged but not intruding into the conduit from 9 o'clock to 11 o'clock</td> <td>00:20:09</td> <td>15</td> <td>1</td> </tr></table>

15, 00:20:09, 51.47  
Seal is visibly displaced and/or damaged but not intruding into the conduit from 9 o'clock to 11 o'clock

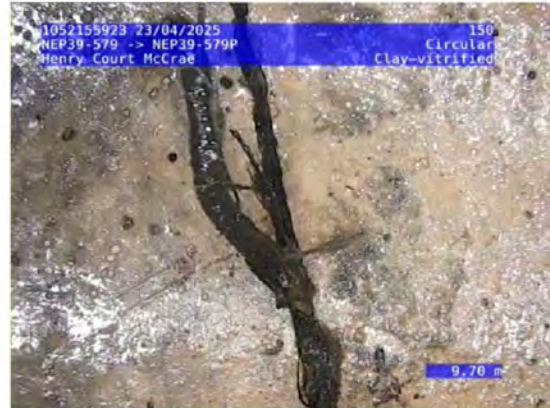
<table><tr> <th>1:199</th> <th>m+</th> <th>Code</th> <th>Observation Text</th> <th>MPEG</th> <th>Photo</th> <th>Grade</th> </tr><tr> <td></td> <td>9.70</td> <td>CL</td> <td>Longitudinal cracking, at joint, width: 2mm at 8 o'clock</td> <td>00:05:05</td> <td>2</td> <td>2</td> </tr></table>

2, 00:05:05, 9.70  
Longitudinal cracking, at joint, width: 2mm at 8 o'clock

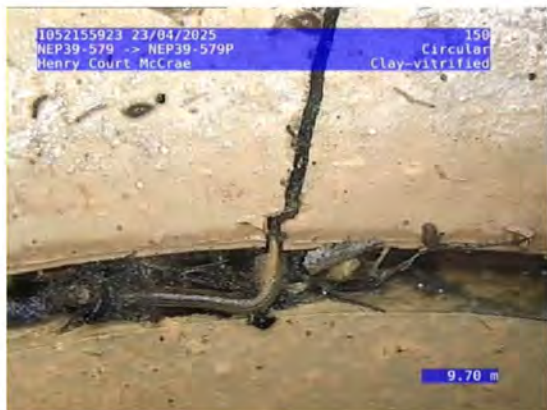
<table><tr> <th>1:199</th> <th>m+</th> <th>Code</th> <th>Observation Text</th> <th>MPEG</th> <th>Photo</th> <th>Grade</th> </tr><tr> <td></td> <td>9.70</td> <td>CL</td> <td>Longitudinal cracking, at joint, width: 2mm at 4 o'clock</td> <td>00:05:22</td> <td>3</td> <td>2</td> </tr></table>

3, 00:05:22, 9.70  
Longitudinal cracking, at joint, width: 2mm at 4 o'clock

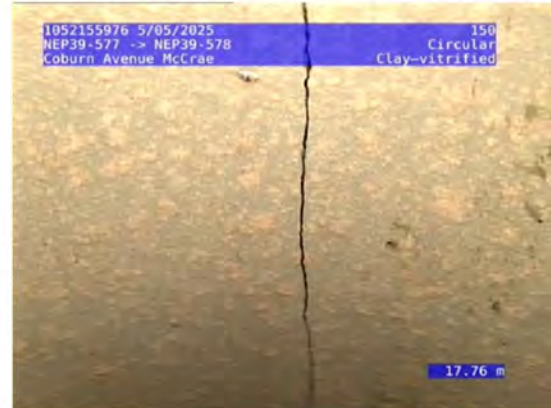
<table><tr> <th>1:223</th> <th>m+</th> <th>Code</th> <th>Observation Text</th> <th>MPEG</th> <th>Photo</th> <th>Grade</th> </tr><tr> <td></td> <td>17.76</td> <td>CL</td> <td>Longitudinal cracking, at joint, width: 0.5mm at 2 o'clock</td> <td>00:06:13</td> <td>2</td> <td>1</td> </tr></table>

2, 00:06:13, 17.76  
Longitudinal cracking, at joint, width: 0.5mm at 2 o'clock

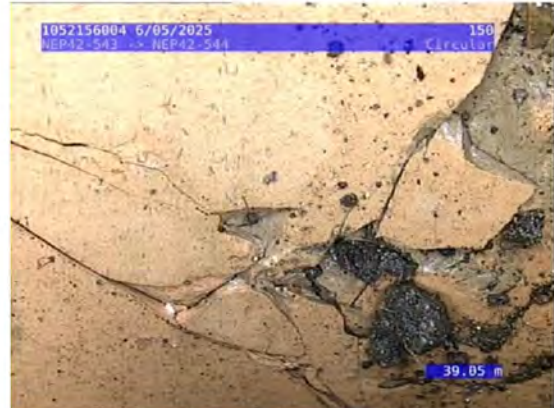
<table><tr> <th>1:344</th> <th>m+</th> <th>Code</th> <th>Observation Text</th> <th>MPEG</th> <th>Photo</th> <th>Grade</th> </tr><tr> <td></td> <td>39.05</td> <td>CM</td> <td>Cracking multiple or complex (s), at joint, width: 1mm from 4 o'clock to 7 o'clock</td> <td>00:17:19</td> <td>6</td> <td>1</td> </tr></table>

6, 00:17:19, 39.05  
Cracking multiple or complex (s), at joint, width: 1mm from 4 o'clock to 7 o'clock

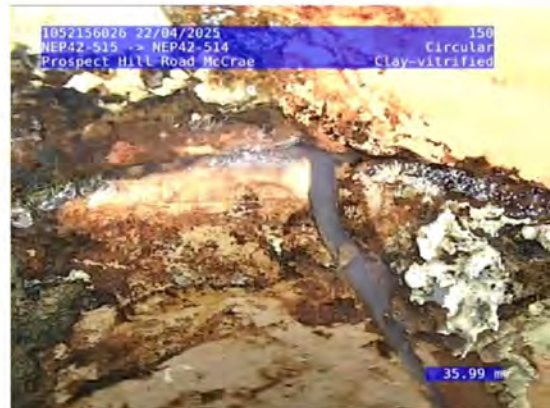
<table><tr> <th>1:318</th> <th>m+</th> <th>Code</th> <th>Observation Text</th> <th>MPEG</th> <th>Photo</th> <th>Grade</th> </tr><tr> <td></td> <td>35.99</td> <td>IG</td> <td>Infiltration, gushing, at joint from 11 o'clock to 1 o'clock</td> <td>00:11:00</td> <td>4, 5</td> <td>4</td> </tr></table>

4, 00:11:00, 35.99  
Infiltration, gushing, at joint from 11 o'clock to 1 o'clock

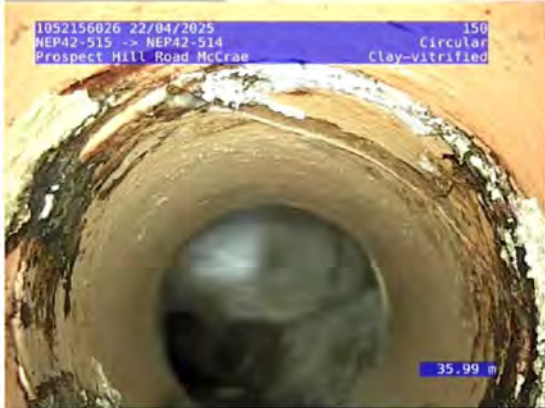
5, 00:11:00, 35.99  
Infiltration, gushing, at joint from 11 o'clock to 1 o'clock

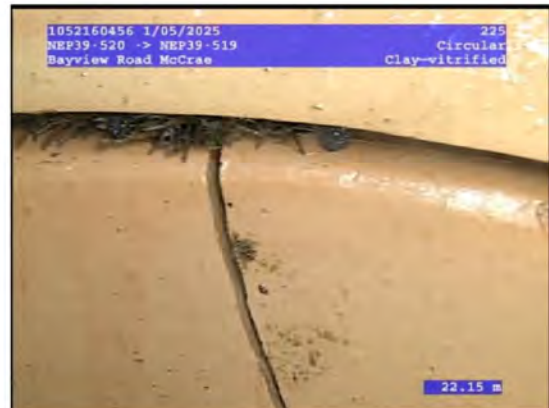
| 22.15 | CS | Simple cracking, at joint, width: 1mm from 3 o'clock to 8 o'clock | | | 00:07:01 | 4 | 1 | | |

4, 00:07:01, 22.15  
Simple cracking, at joint, width: 1mm from 3 o'clock to 8 o'clock

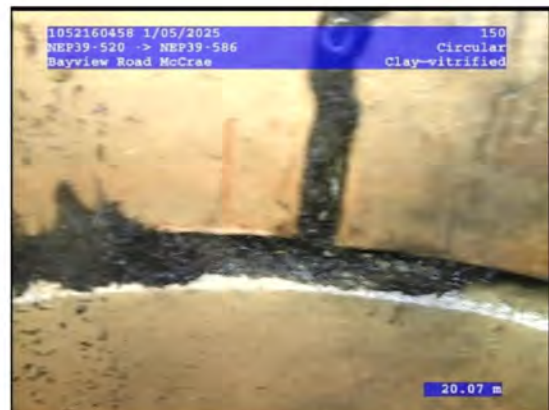
<table><tr> <th>1:228</th> <th>m+</th> <th>Code</th> <th>Observation Text</th> <th>MPEG</th> <th>Photo</th> <th>Grade</th> </tr><tr> <td></td> <td>20.07</td> <td>CM</td> <td>Cracking multiple or complex (s), at joint, width: 3mm from 12 o'clock to 12 o'clock</td> <td>00:06:46</td> <td>4, 5</td> <td>3</td> </tr></table>

4, 00:06:46, 20.07  
Cracking multiple or complex (s), at joint, width: 3mm from 12 o'clock to 12 o'clock

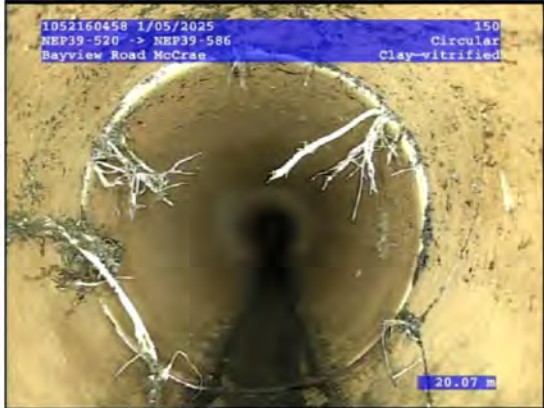
5, 00:06:46, 20.07  
Cracking multiple or complex (s), at joint, width: 3mm from 12 o'clock to 12 o'clock

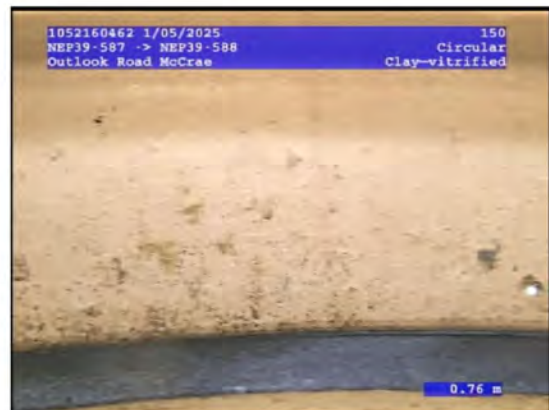
<table><tr> <th>1:146</th> <th>m+</th> <th>Code</th> <th>Observation Text</th> <th>MPEG</th> <th>Photo</th> <th>Grade</th> </tr><tr> <td></td> <td>0.76</td> <td>DJSRN</td> <td>Seal is visibly displaced and/or damaged but not intruding into the conduit from 12 o'clock to 12 o'clock</td> <td>00:01:04</td> <td>4</td> <td>1</td> </tr></table>

4, 00:01:04, 0.76  
Seal is visibly displaced and/or damaged but not intruding into the conduit from 12 o'clock to 12 o'clock

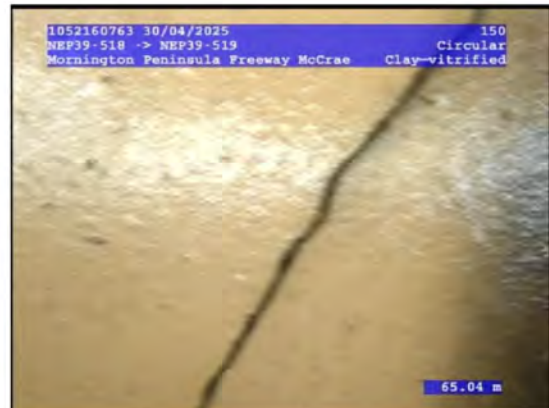
<table><tr> <th>1:783</th> <th>m+</th> <th>Code</th> <th>Observation Text</th> <th>MPEG</th> <th>Photo</th> <th>Grade</th> </tr><tr> <td></td> <td>65.04</td> <td>CS</td> <td>Simple cracking, width: 1mm from 4 o'clock to 8 o'clock</td> <td>00:24:20</td> <td>4</td> <td>1</td> </tr></table>

4, 00:24:20, 65.04  
Simple cracking, width: 1mm from 4 o'clock to 8 o'clock

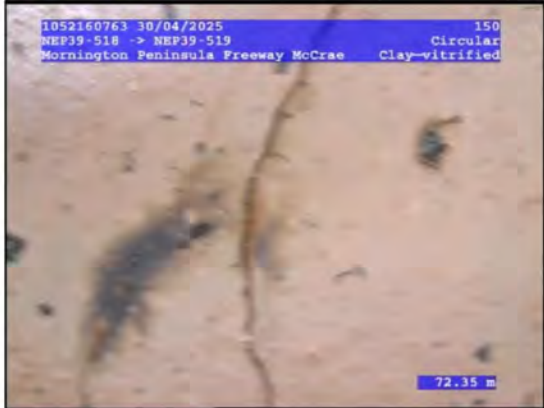
<table><tr> <th>1:783</th> <th>m+</th> <th>Code</th> <th>Observation Text</th> <th>MPEG</th> <th>Photo</th> <th>Grade</th> </tr><tr> <td></td> <td>72.34</td> <td>CL</td> <td>Longitudinal cracking, at joint, width: 1mm at 1 o'clock</td> <td>00:32:33</td> <td>5</td> <td>1</td> </tr></table>

5, 00:32:33, 72.34  
Longitudinal cracking, at joint, width: 1mm at 1 o'clock

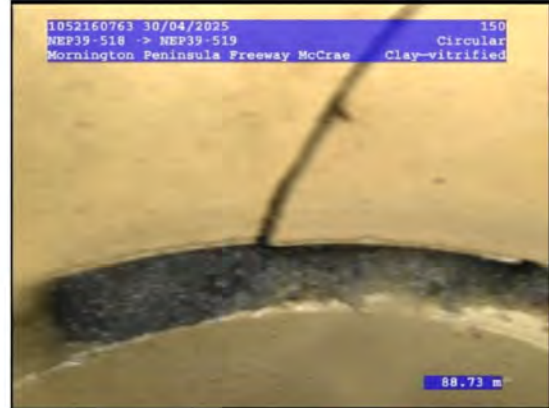
<table><tr> <th>1:783</th> <th>m+</th> <th>Code</th> <th>Observation Text</th> <th>MPEG</th> <th>Photo</th> <th>Grade</th> </tr><tr> <td></td> <td>88.73</td> <td>CS</td> <td>Simple cracking, at joint, width: 1mm from 9 o'clock to 10 o'clock</td> <td>00:43:40</td> <td>6</td> <td>1</td> </tr></table>

6, 00:43:40, 88.73  
Simple cracking, at joint, width: 1mm from 9 o'clock to 10 o'clock

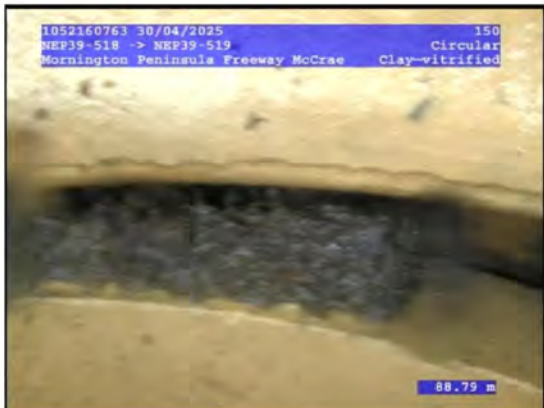
7, 00:44:03, 88.79  
Joint displaced angular at 3 o'clock

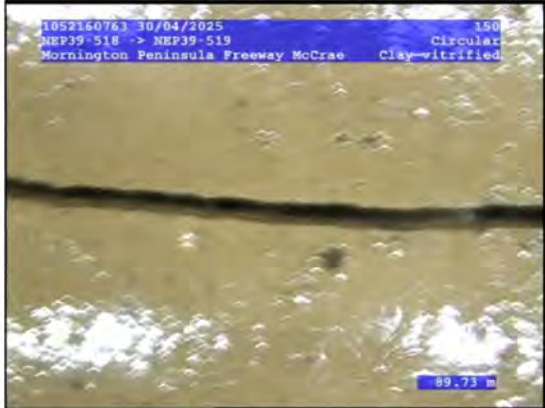
<table><tr> <th>1:783</th> <th>m+</th> <th>Code</th> <th>Observation Text</th> <th>MPEG</th> <th>Photo</th> <th>Grade</th> </tr><tr> <td></td> <td>89.73</td> <td>CC</td> <td>Circumferential cracking, width: 1.5mm from 12 o'clock to 12 o'clock</td> <td>00:45:52</td> <td>9</td> <td>2</td> </tr></table>

9, 00:45:52, 89.73  
Circumferential cracking, width: 1.5mm from 12 o'clock to 12 o'clock
