**AND IN THE MATTER OF A BOARD OF INQUIRY  
INTO THE MCCRAE LANDSLIDE**

**ENTITY: SOUTH EAST WATER  
CORPORATION**

**WITNESS STATEMENT OF JULIAN TULLY**

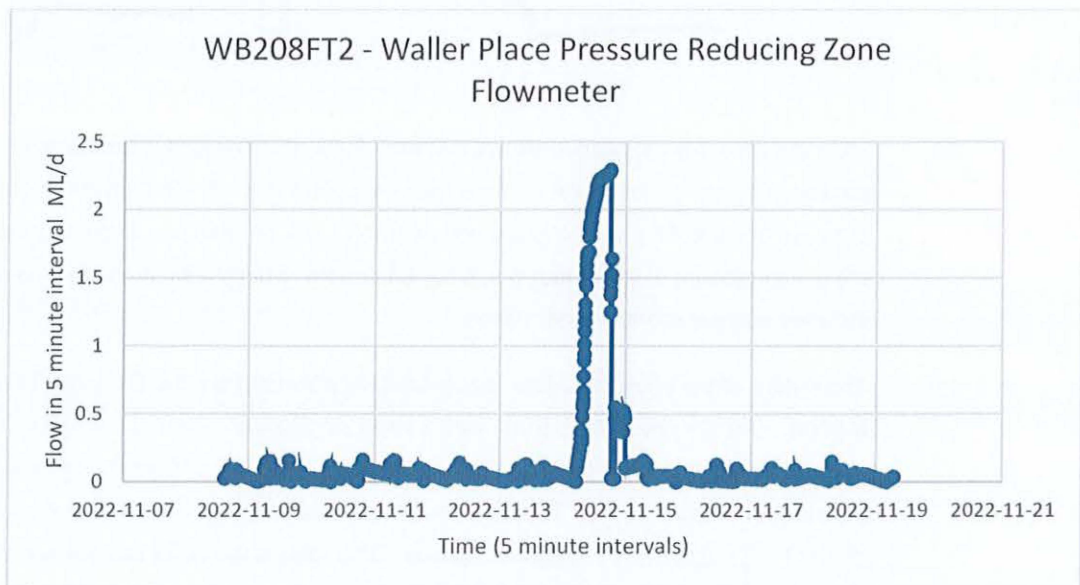
17. The graph shows that in a typical day, the flow through the flowmeter is quite small, with a maximum instantaneous flow of approximately 0.15 megalitres a day. The flow throughout the flowmeter fluctuates throughout the day as the customers vary their use of water. In the middle of the graph, there is a sudden increase in water flow, which indicates when the burst occurred. The maximum instantaneous flow of the burst was approximately 2.3 megalitres per day. Again, this is instantaneous flow rate and not volume.

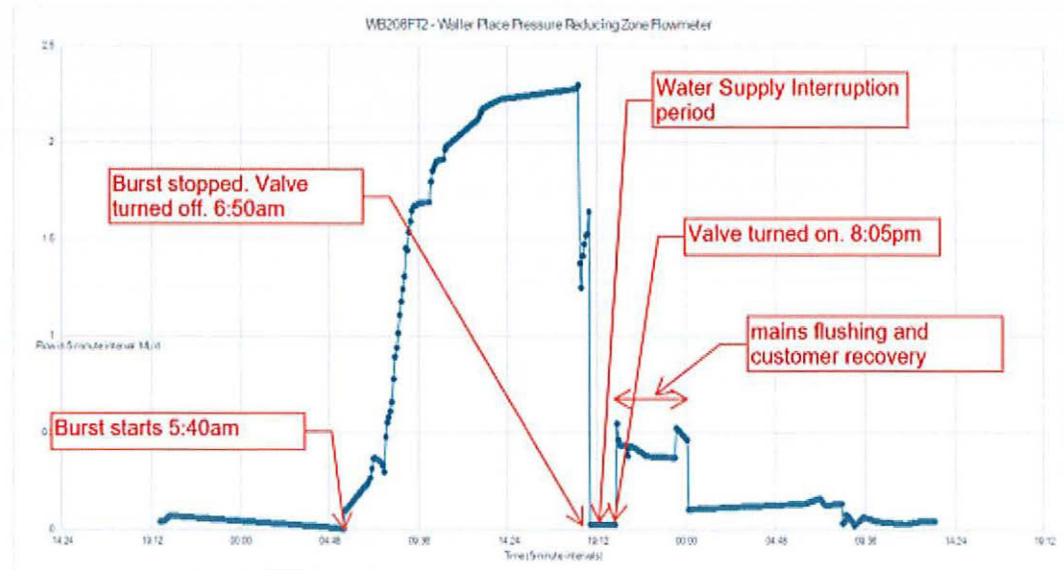
18. The timing of the sudden increase of flow is consistent with SEW maintenance records. The spreadsheet shows a significant increase in water flow starting 5:40am on 14/11/2022 and finishing at 6:45pm on 14/11/2022. The Montage record referred to as Exhibit 1 of this Statement shows that a burst was reported at 13:46 on 14/11/2022 and Water Supply Interruption (being when the valves are turned off, i.e. the approximate time the burst flow ceased) actual start was at 6:50pm on 14/11/2022. I set out below a portion of the above graph, with key events labelled as recorded in Montage.

19. From the data, my calculation shows that from 5:40am to 6:45pm, 0.9 megalitres of water passed through the flowmeter. This is the time period that correlates with the large increase of water flow shown in the above graph. This amount is a slight overestimation of the actual amount of water that would have been lost from the burst as the amount also includes some customer water usage.
