## Technical Memorandum

<b>Memo No.</b>	1	<b>Date of Issue</b>	25 July 2025
<b>Subject</b>	Geochemical Analysis of Groundwater Provenance	<b>Discipline</b>	Geochemistry / Hydrogeology
<b>Project Title</b>	SEW McCrae	<b>Project No.</b>	30043649
<b>Document No.</b>	30043649	<b>Revision</b>	0
<b>Lead Author</b>	Hugo Bolton, Technical Principal - Hydrogeologist		
<b>Reviewed by</b>	Paran Moyes	<b>Approved by</b>	David Hartley
<b>Prepared for</b>	Thomson Geer	<b>Attention to</b>	Cameron Roberts

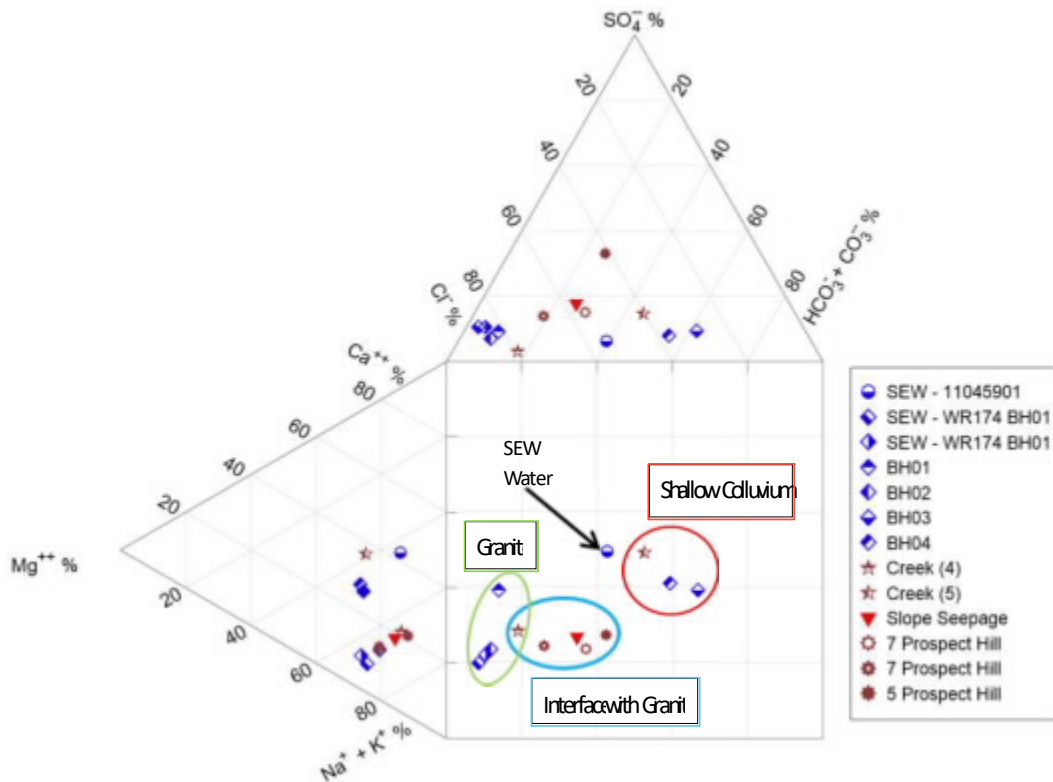
Figure 1: Durov Diagram for Selected Water Samples

Figure 1 provides a summary of the overall assessment for water types in the form of a Durov Diagram which allows for a visual inspection of the data at a single point while considering various chemical parameters. A Durov Diagram is a graphical method used to display the chemical composition of selected components of a water sample (i.e., four predominant cations as  $\text{Na}^+$ ,  $\text{K}^+$ ,  $\text{Mg}^{2+}$  and  $\text{Ca}^{2+}$ ; and four predominant anions as  $\text{Cl}^-$ ,  $\text{HCO}_3^- + \text{CHO}_3^{2-}$  and  $\text{SO}_4^{2-}$ ) and provides a visual summary of the water types. The Durov Diagram shows a grouping of three water types:

These three water types are labelled on Figure 1.

The shallow perched aquifer colluvium water type sits aside from the other two water types. The landslide water (“Slope Seepage”) has a comparatively higher sodium and chloride signature when compared to the colluvium. This is a result of the groundwater associated from the landslide seepage being at the interface with the granite. It is assessed that this is because it has partially taken on its characteristic sodium chloride signature.

Groundwater adjacent to the building foundation drainage system at 5 and 7 Prospect Hill has a similar signature to the landslide water sample. This indicates that the colluvium granite interface water is being captured by their building foundation drainage systems.

Also shown on the Durov Diagram are two different samples from Coburn Creek. Coburn Creek is a discharge point for groundwater. Sample labelled “Creek (4)” is located further up catchment at Browne Street whereas Creek (5) is located at Burrell Street. Creek (4) had evident exposed weather granite upstream whereas Creek (5) did not. Photos of the exposed weathered granite are shown in Photo 33A and 33B as per PSM report (MSC.5087.0001.0414).

This above analysis indicates that the landslide water seeping for the face of the slope shortly after the January 2025 landslides was natural background water. This fits with the conceptual model being presented of water flowing from the interface with the granite. This seepage flow still continues to this day and would have occurred prior to the landslide.
