Multidisciplinary Expert Supplementary Report

Board of Inquiry into McCrae Landslide

Prepared for: Thomson Geer

30 July 2025

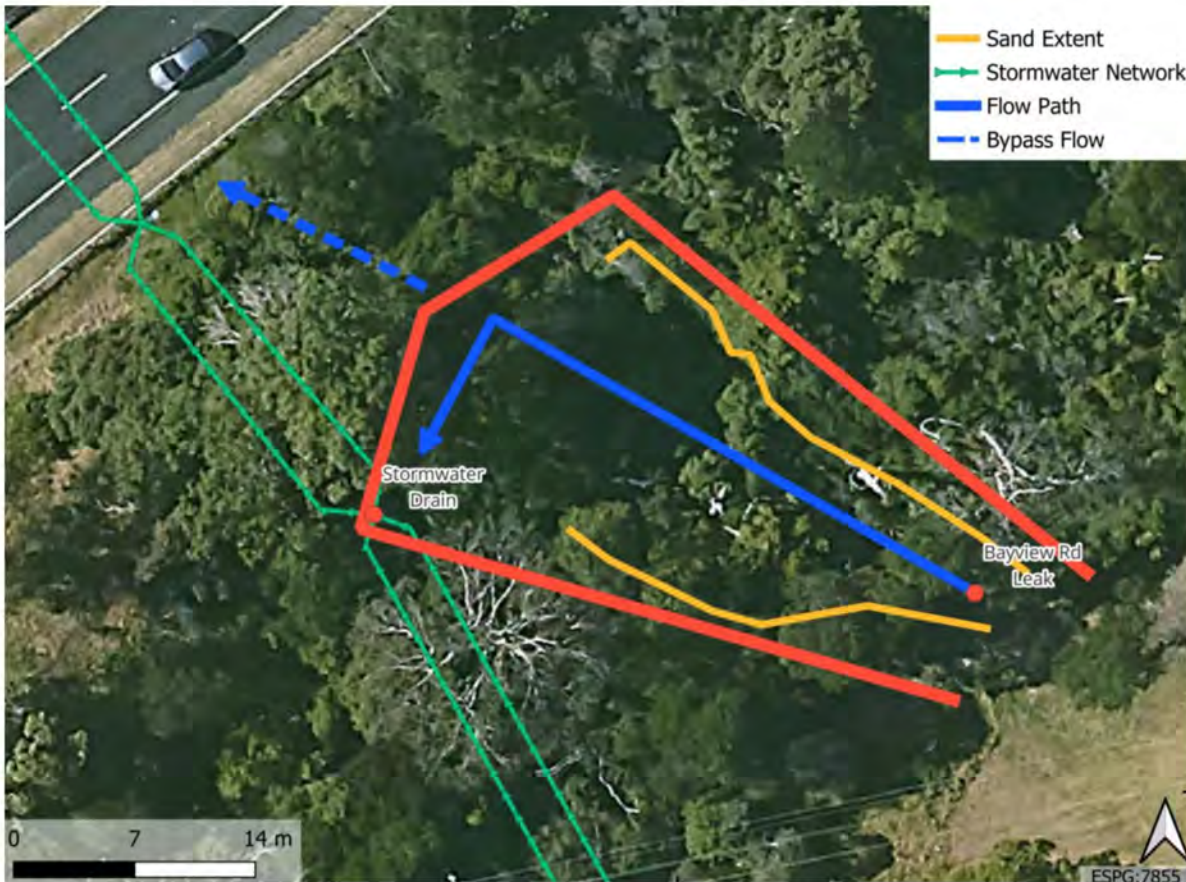
The figure notes a 'bypass flow' continuing north of the stormwater grate and down the cut slope of the M11. It should be noted that the model developed does not represent the channel running parallel to the direction of traffic along the M11, outfalling into the stormwater grate well. Therefore, the lack of visual confirmation that the Bypass flow happened is allowed for by the slight discrepancies of the model. The model outputs note that the Bypass flow accounts for only a small percentage (3% for the 10 L/s model, and 5% of the 20 L/s model) of the overall flow and it is very shallow.

Figure 34: Schematic model of the Bayview Road leak showing surface extents and possible flow paths

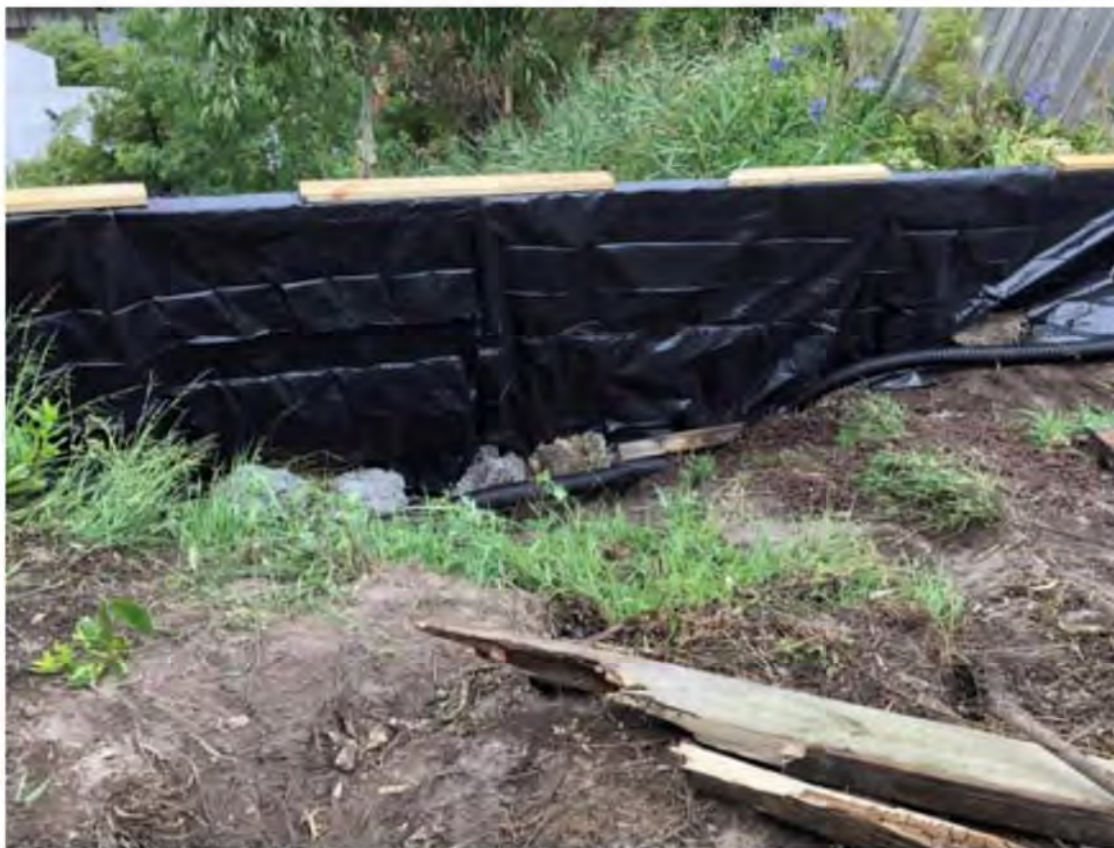
Figure 1: GB-12, taken from Annexure of Witness Statement of G Borghesi, showing construction of original retaining wall,

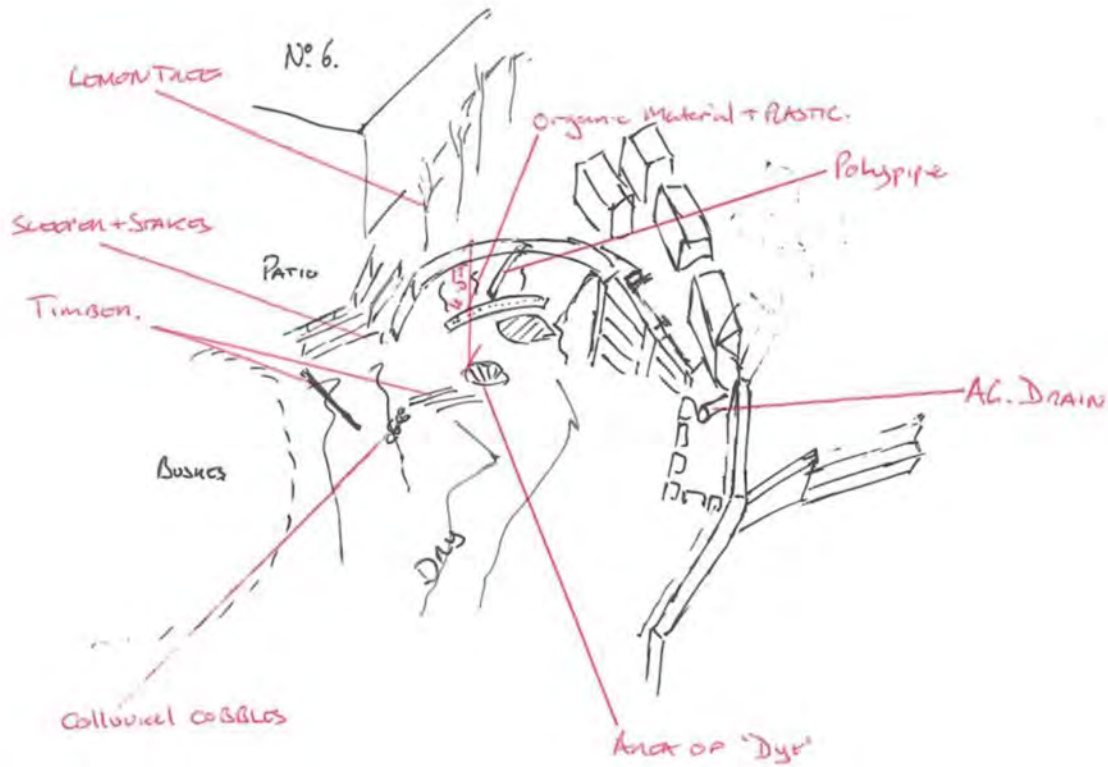
Figure 2: Sketch showing features noted by SMEC of the McCrae Landslip, from vantage points within 10-12 View Point Road property extents.

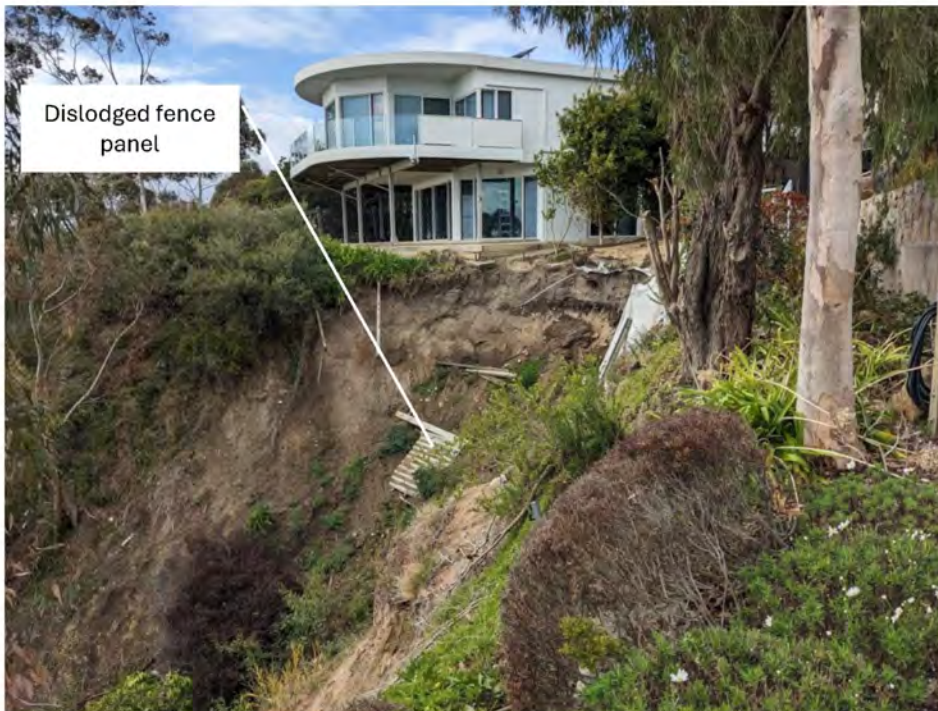
Figure 6: 17/6/25 Photo 03 Looking east showing the upper slope of the escarpment, and assumed extent of slip, showing debris downslope of the backscarp

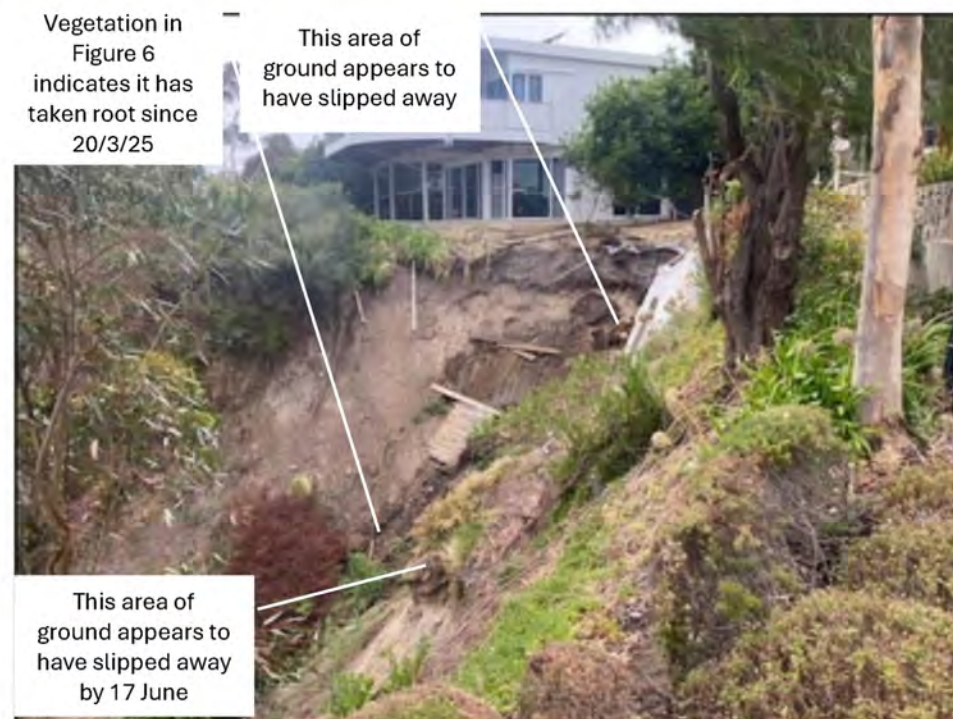
Photograph 7: Site conditions on 20 March 2025

Figure 7 is included to enable the reader to compare a photo taken by CivilTest on 20 March 2025, and included in the CivilTest letter to Mr. Borghesi on 4 April 2025 (Appendix B Ref 4), to Figure 6. Some deterioration appears to have occurred in the time between the two photographs.

Figure 7: 20/3/25 taken from CivilTest Letter dated 4 April 2025 Reference 1222044-15.

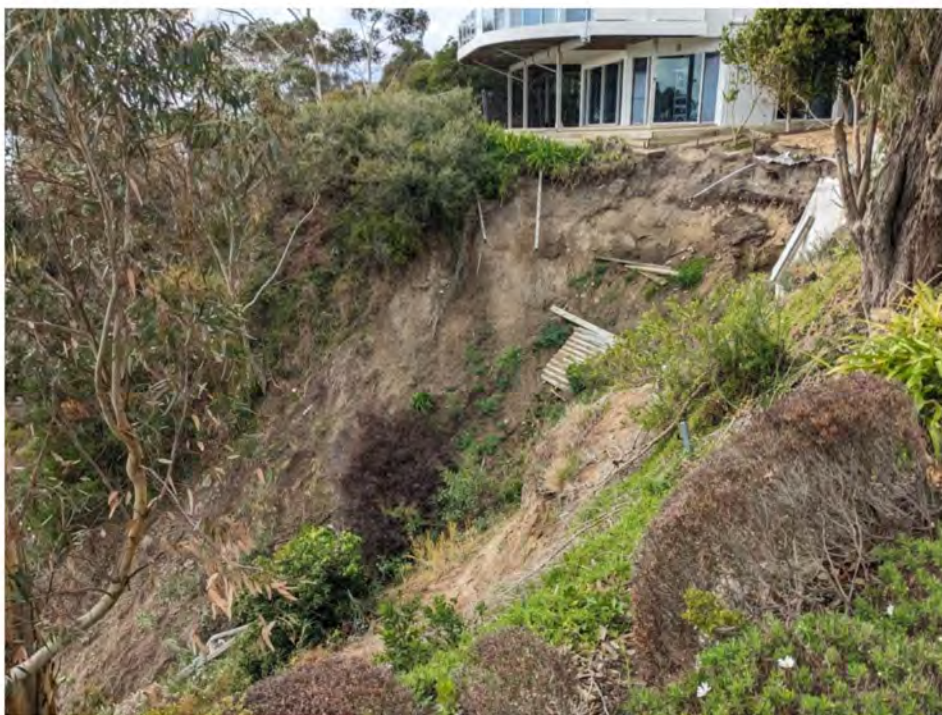
Figure 8: 17/6/25 Photo 04 Looking east showing the detail of the backscarp. Note the vertical nature of the backscarp, approximately 4.5m high

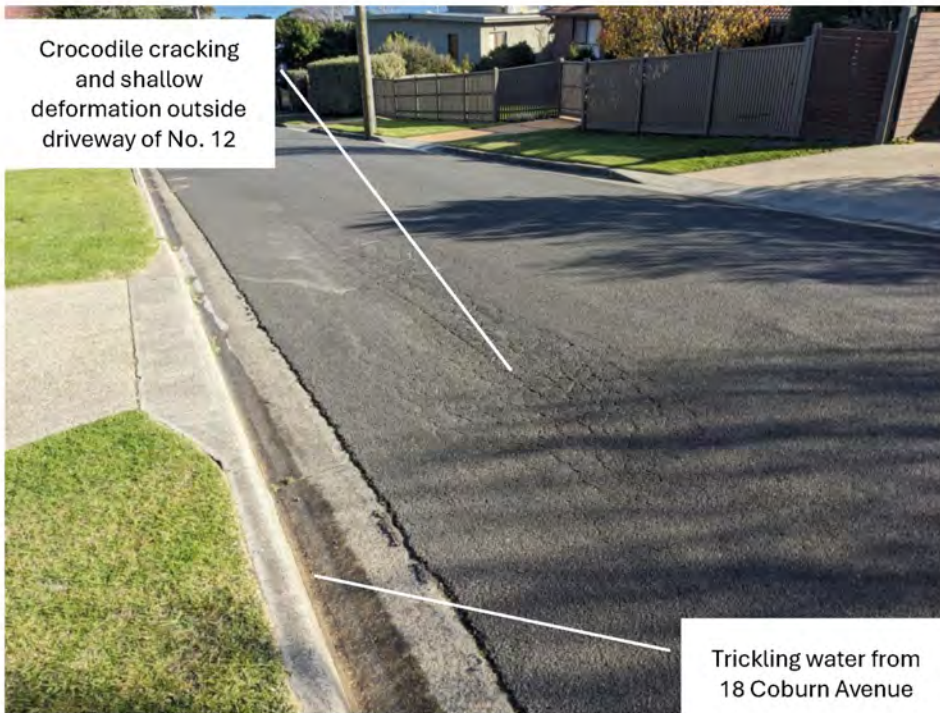
Figure 14: 20/6/25 12 Coburn Avenue, looking west showing condition of pavement

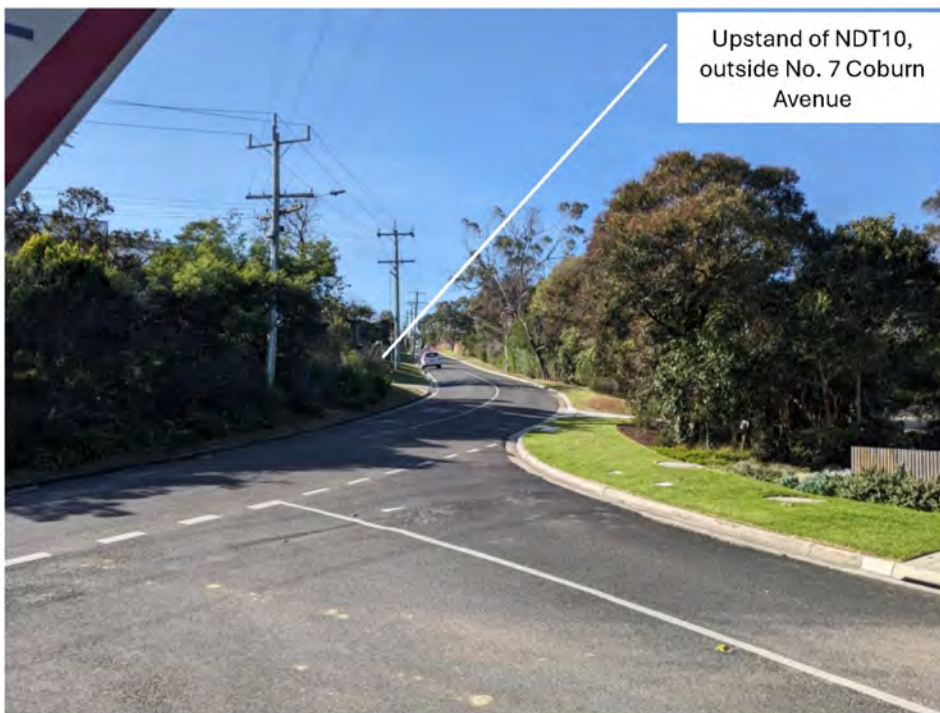
Figure 15: 20/6/25 Coburn Avenue looking east up hill towards NDT10, and location of locally saturated verge.

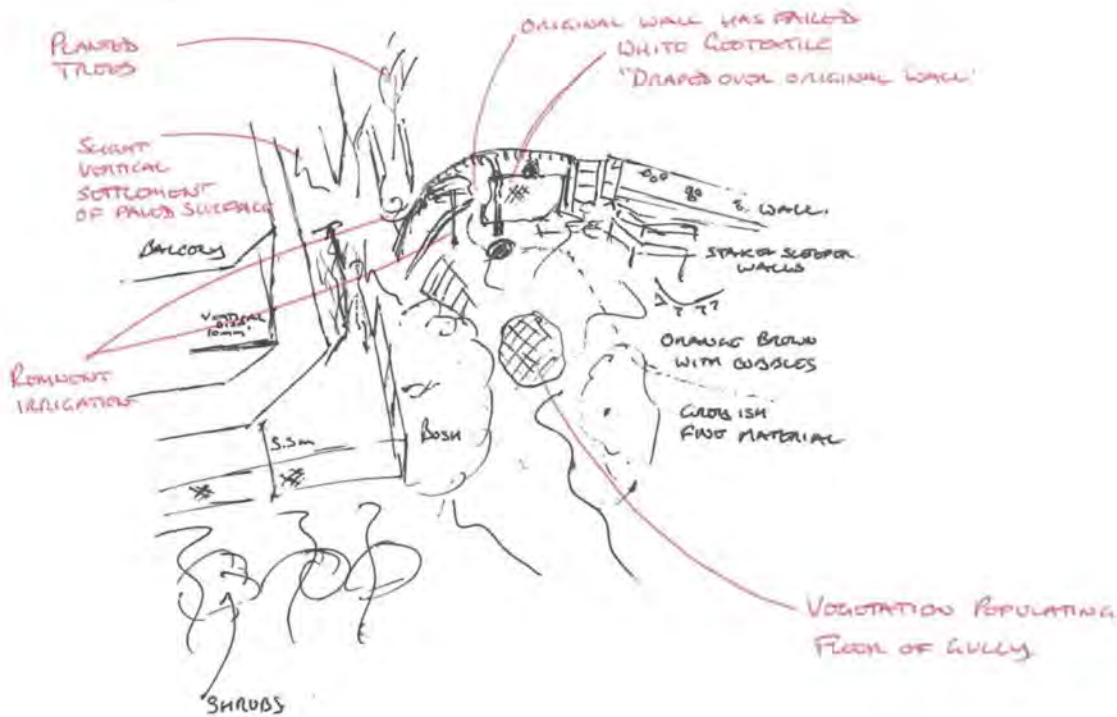
Figure 16: Sketch showing features noted by SMEC of the McCrae Landslip, from vantage points within 6 View Point Road property extents.

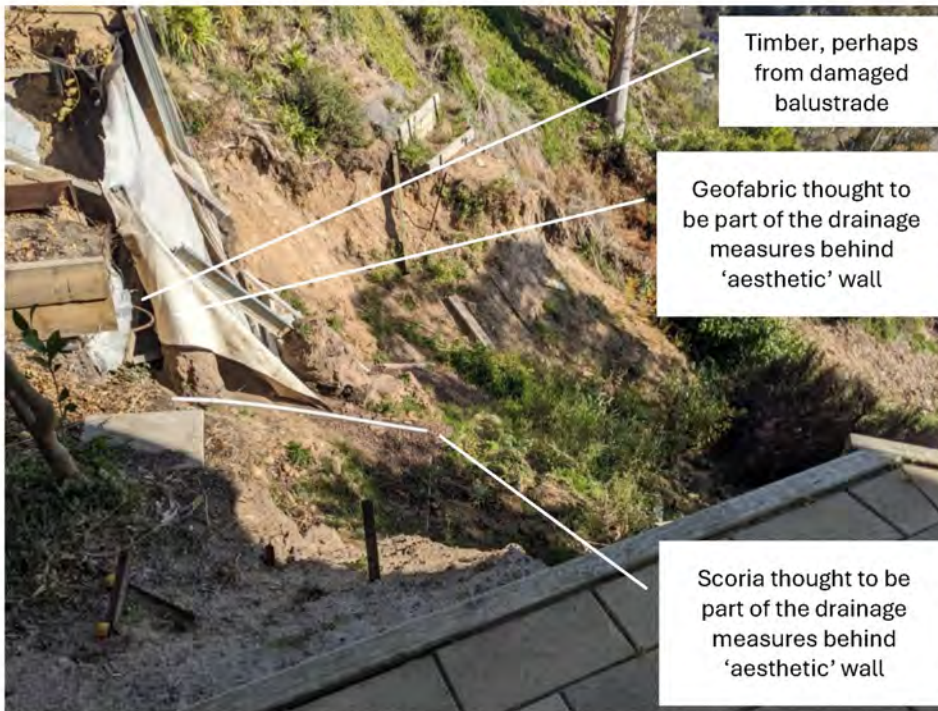
Figure 19: 20/6/25 Looking west showing failed slope material below retaining wall, note the vegetation at the floor of the failed material

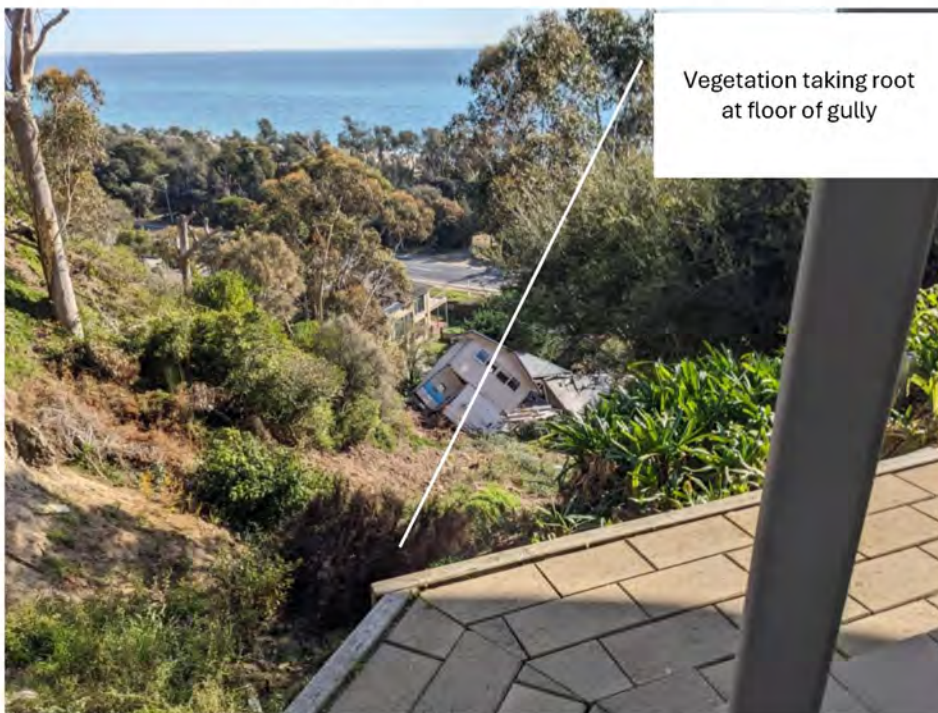
Figure 20: 20/6/25 looking north west showing debris flow towards Penny Lane

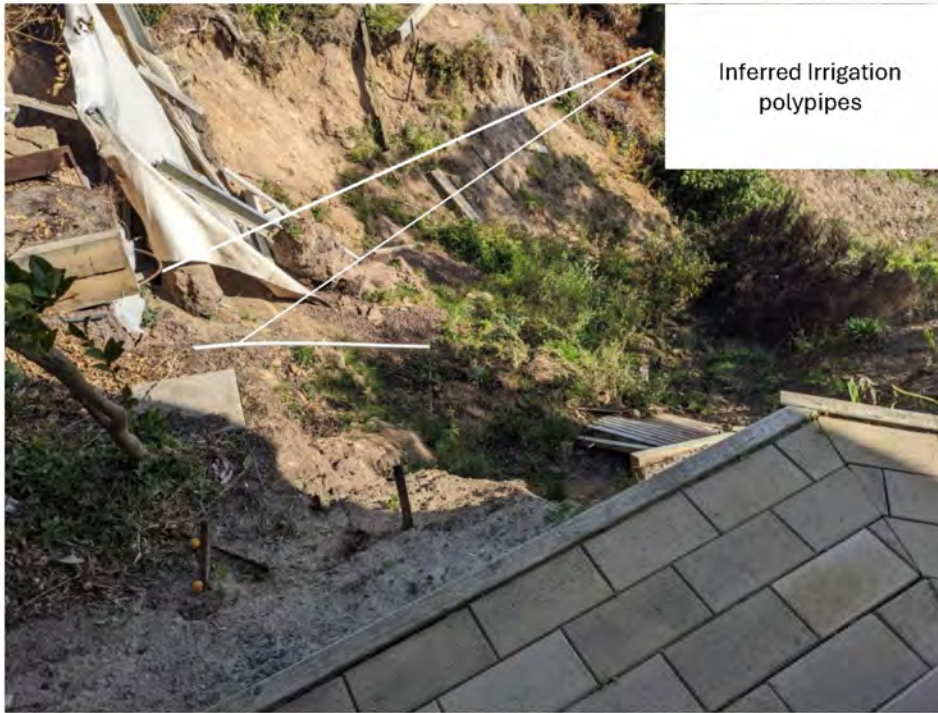
Figure 23: 20/6/25 Looking north west down the failure, showing depth of slope movement.

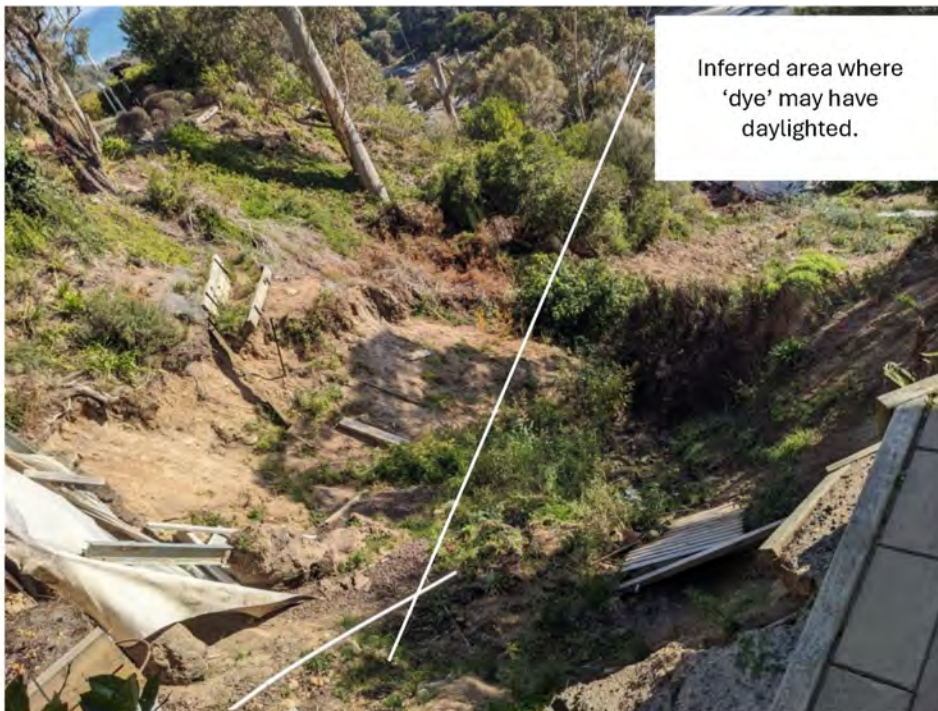
Figure 24: 20/6/25 6 View Point Road, looking north west showing path of landslide

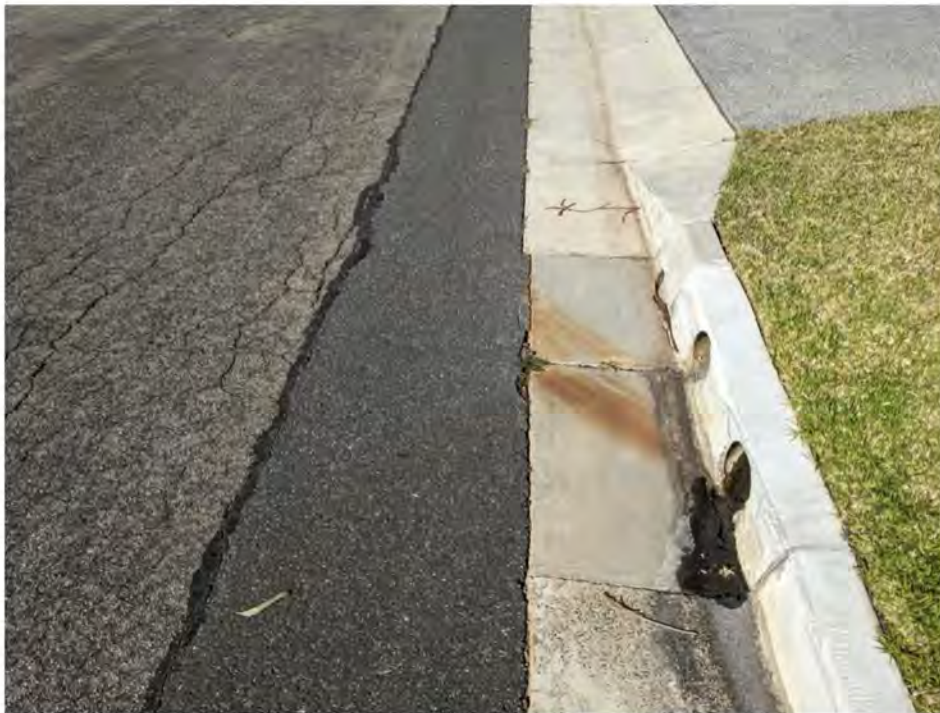
Figure 31: 20/6/25 5 Prospect Hill Road, looking south showing detail of staining flowing from the joint between asphalt and kerb

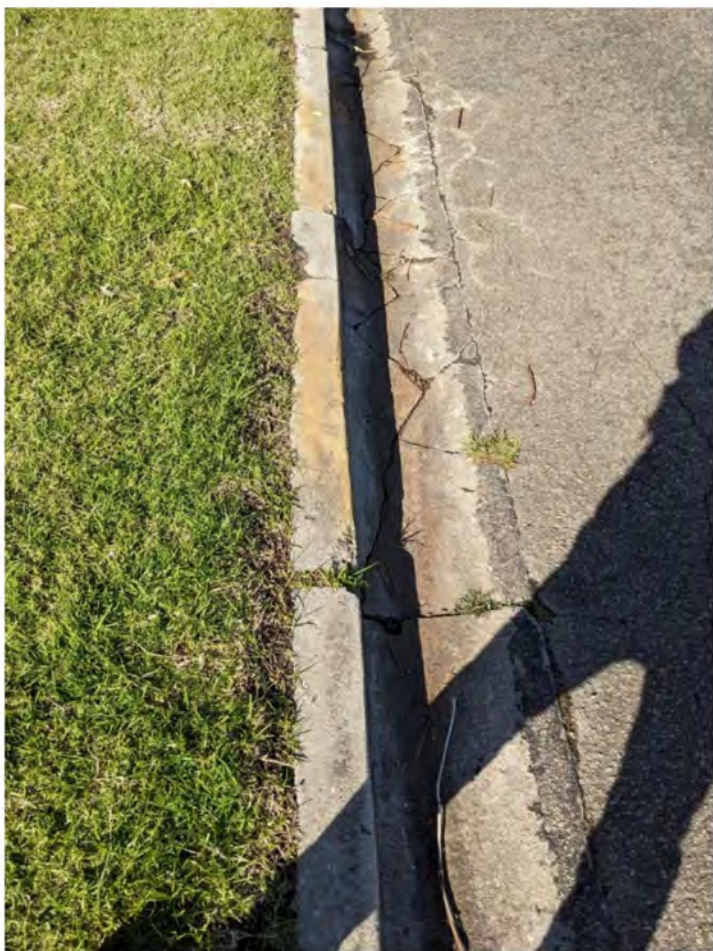
Figure 32: 20/6/25 Looking north from 6 Prospect Hill Road, showing cracking, and staining of kerb suggesting runoff has previously flowed over of kerb.

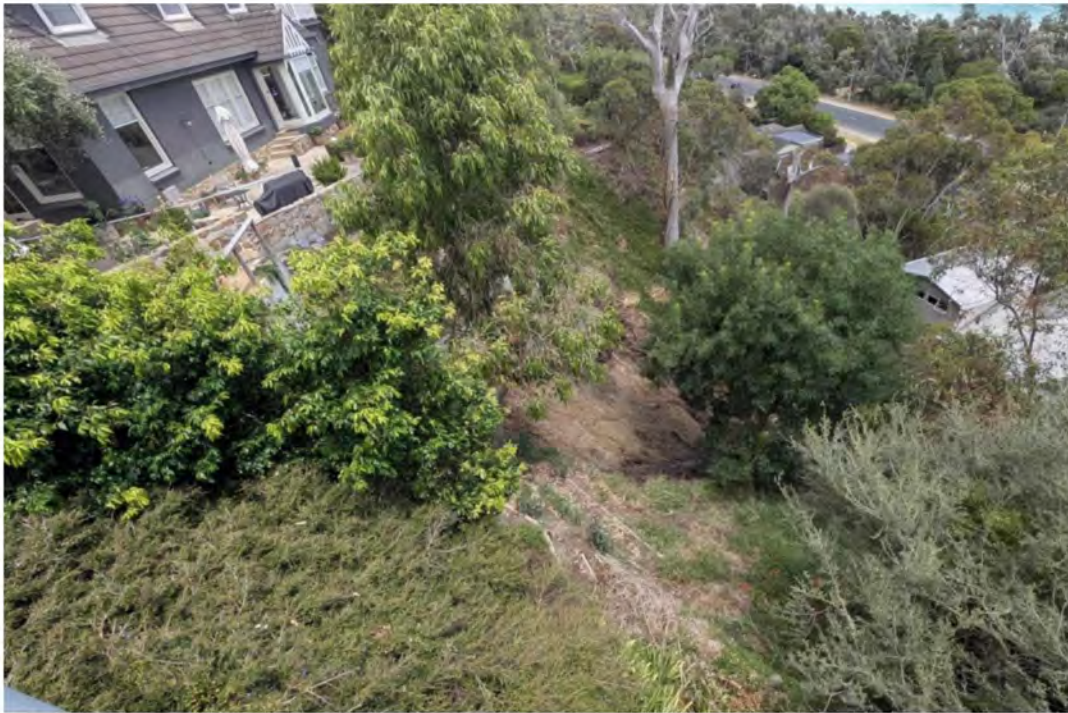
Figure 2: Looking at 5 January 2025 failure, taken on 7 January 2025 by Kevin Hutchings

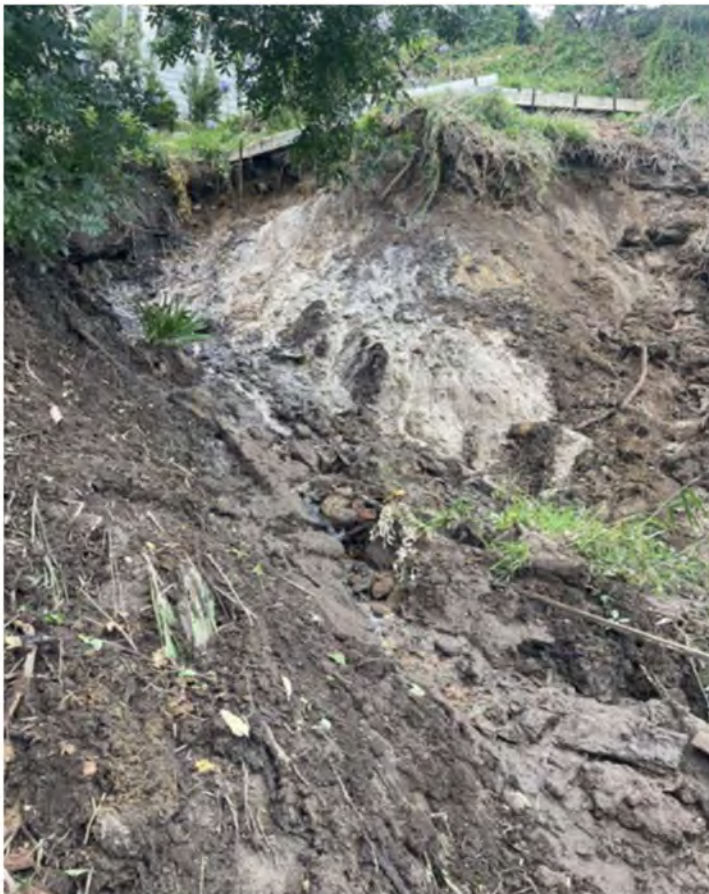
Figure 3: Photo taken by SEW personnel 6 January 2025 showing landslide from midslope of 10-12 View Point Road

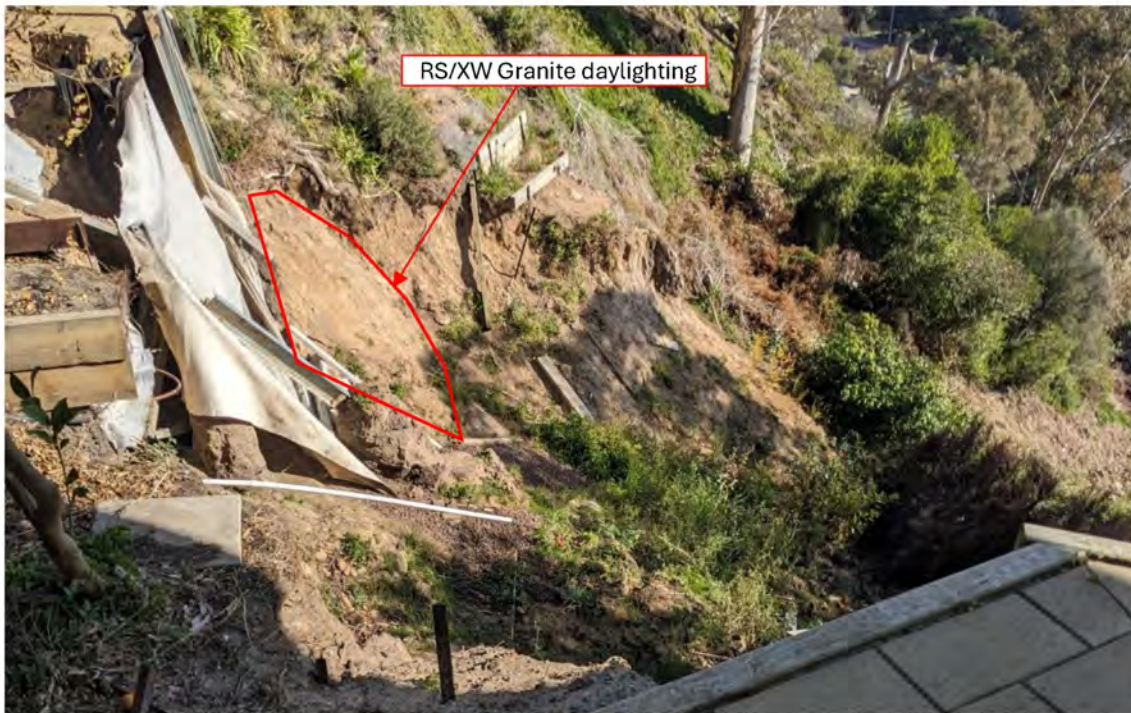
Figure 8: Site photograph looking at backscarp from 6 View Point Road

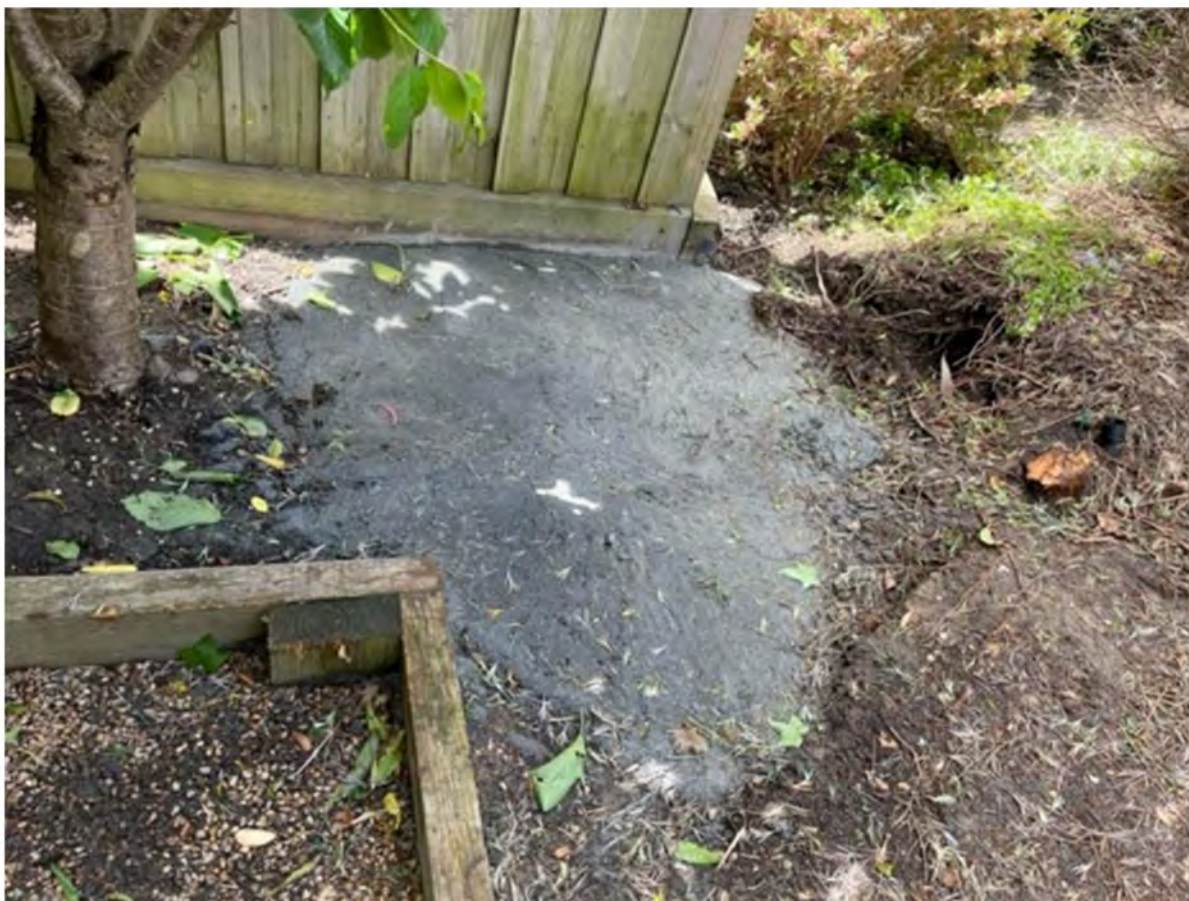
Figure 25: Photograph from email of 22 November 2022, showing detail of sinkhole repair within private land.

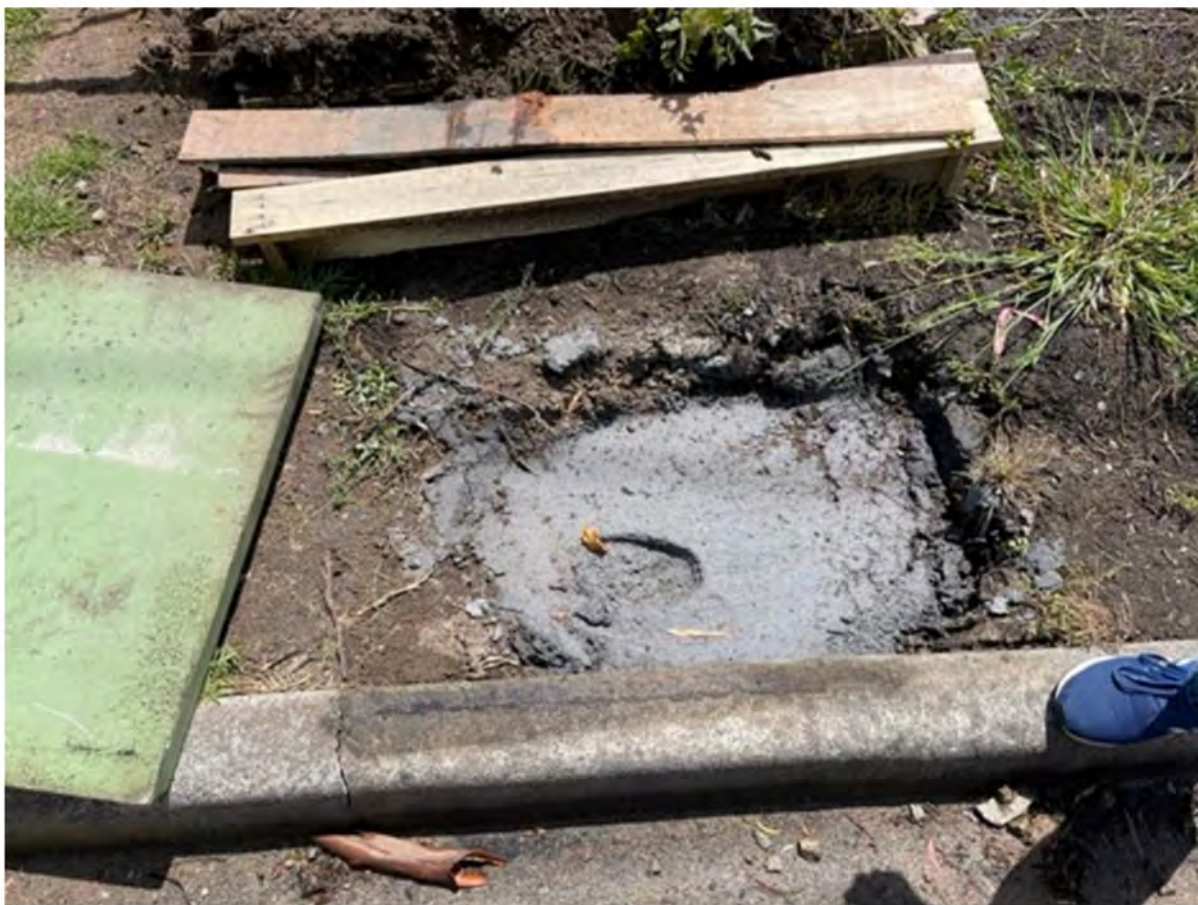
Figure 26: Photograph from email of 22 November 2022, showing detail of sinkhole repair adjacent to a kerb.

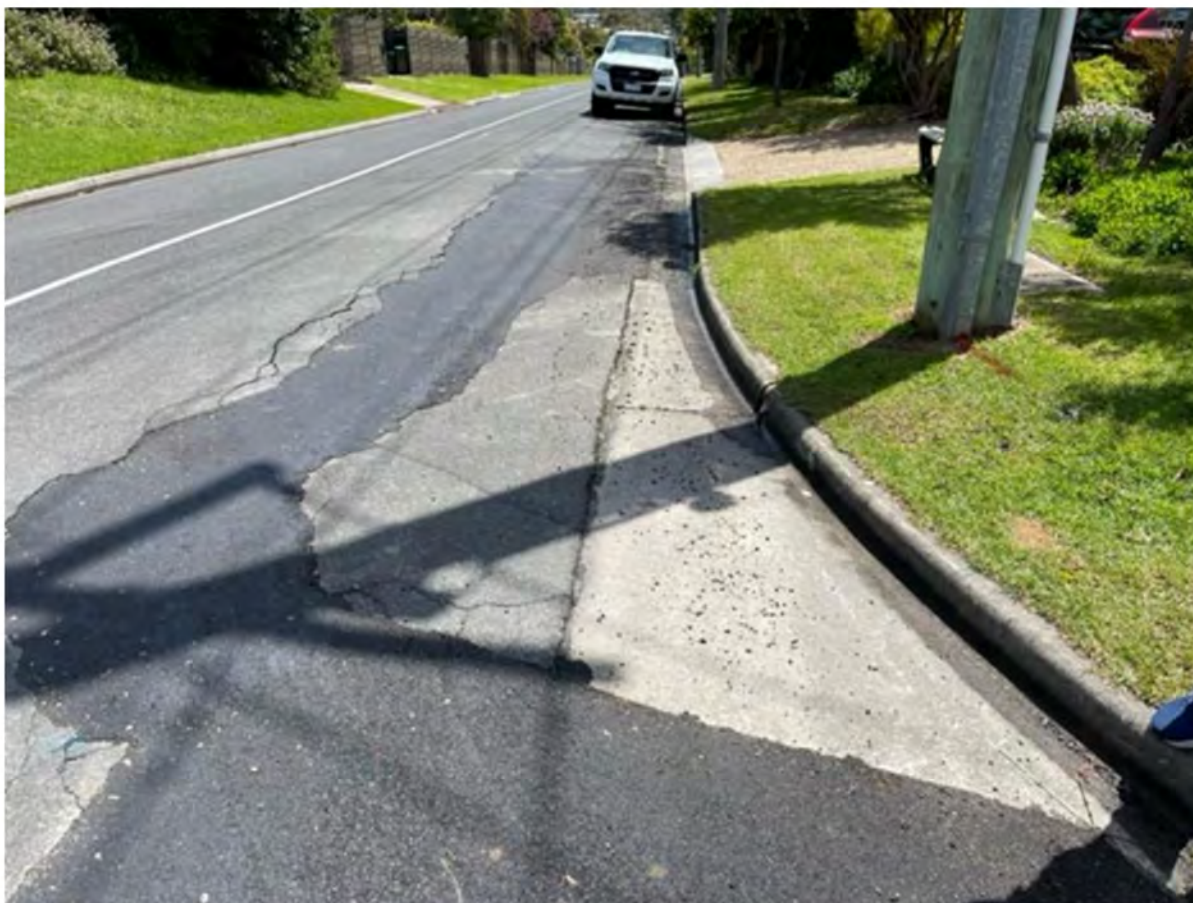
Figure 27: Photograph from SEW taken on 15 November 2022 (approximately), looking west along Coburn Avenue from junction with Prospect Hill Road showing completed mains repair works.
