29 April 2025

Our Ref: 1250546-1 Issue 2 WR: 22220

RE: McCrae Groundwater Investigation MCCRAE

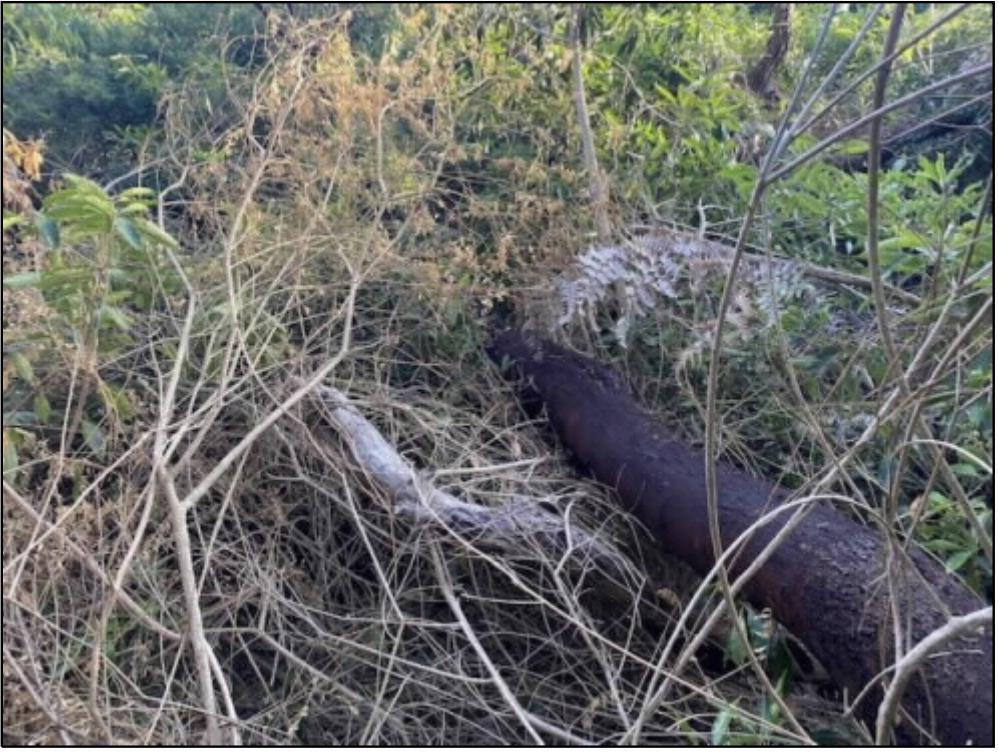
In the vegetated area, the ground surface was dry, but evidence of potential recent disturbance and inundation was noted in the form of collapsed trees that appeared to have fallen recently due to the condition of the attached foliage, and also areas of migrated sediment were present.

Site photograph 1: Disturbed vegetation North of the burst pipe location

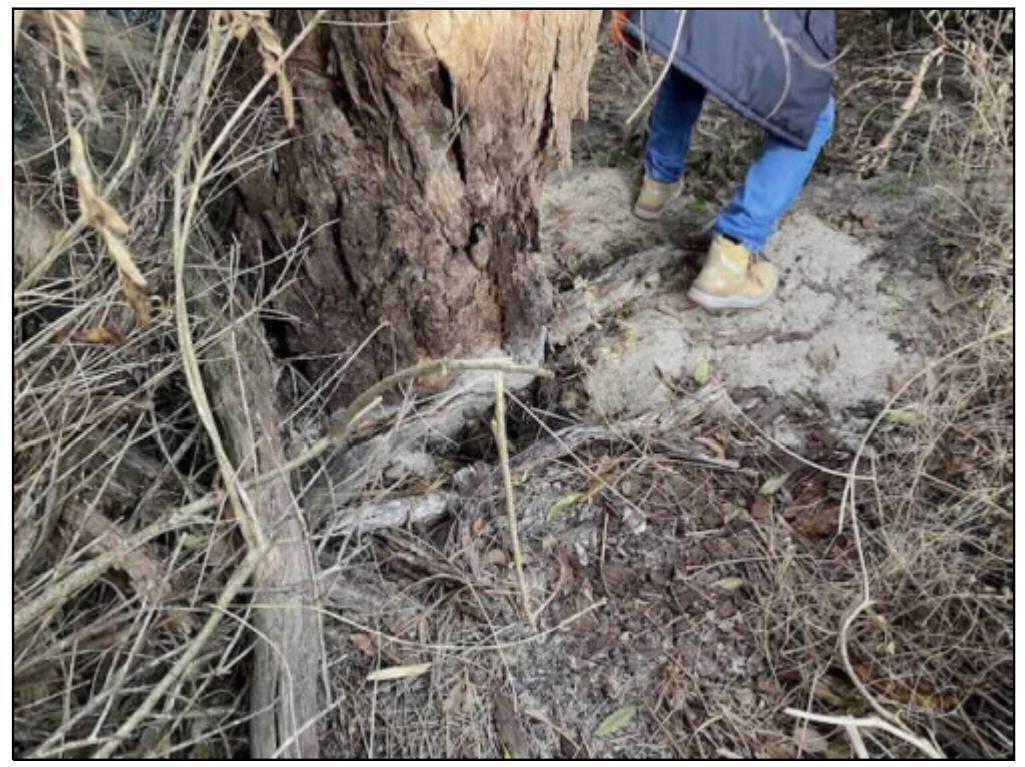
Site photograph 2: Example of recently deposited sediment, North of the burst location

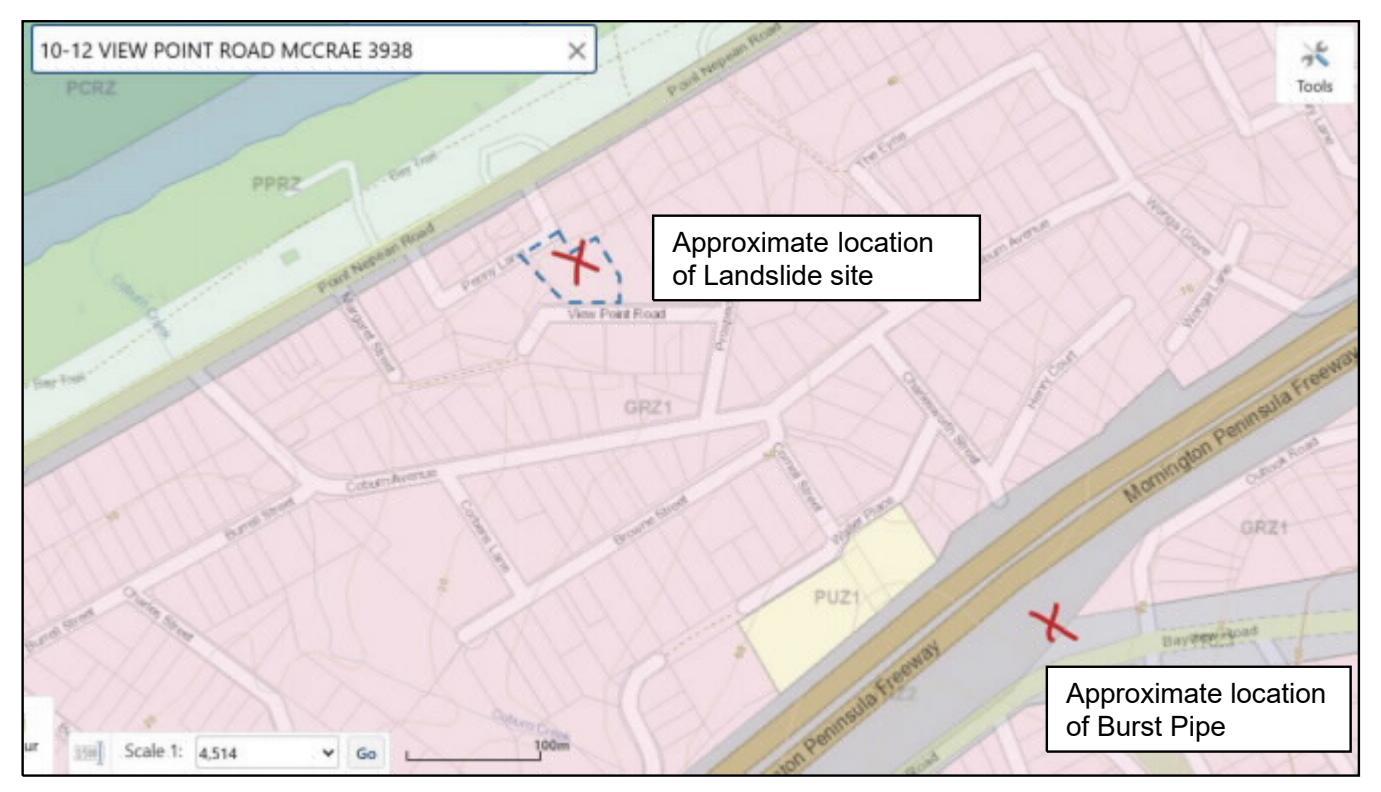
Image 1: VicPlan screenshot

While VicPlan contours should not be used as a precise guide for determining site levels, they can help to provide an understanding of the general topography of the local area. It can be observed that the burst pipe location is located between 70-80 AHD on the map, and the landslide location is located around 30 AHD. Furthermore, the contour generally moves downwards in a North-Westerly direction, or the general direction of the foreshore. Based on the media provided to Civiltest, it appears that the water allegedly originating from the burst water pipe was moving downslope with the natural contour.
