From:	Swain, Charles [Charles.Swain@sew.com.au]
Sent:	3/02/2025 4:08:19 PM
To:	McCreesh, Declan [Declan.McCreesh@sew.com.au]
Subject:	FW: Detail on how burst in Bayview rd, McCrae was identified
Attachments:	IMG_6690.jpg; IMG_6691.jpg; IMG_6693.jpg

From: Loudon, Gary <<u>Gary.Loudon@sew.com.au</u>> Sent: Thursday, 30 January 2025 2:43 PM To: Swain, Charles <<u>Charles.Swain@sew.com.au</u>> Cc: Pham, Dat <<u>Dat.Pham@sew.com.au</u>>; Meng, Jie <<u>Jie.Meng@sew.com.au</u>> Subject: Detail on how burst in Bayview rd, McCrae was identified

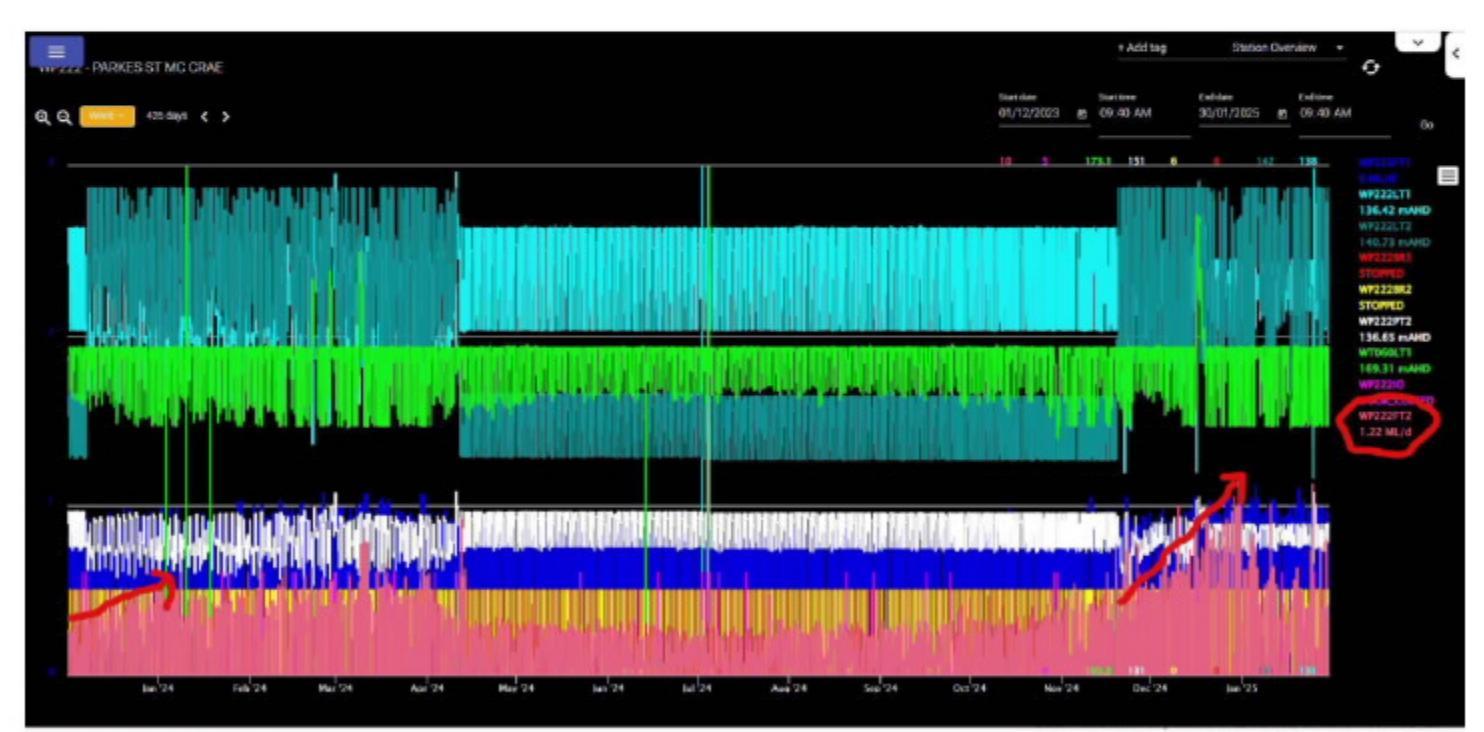
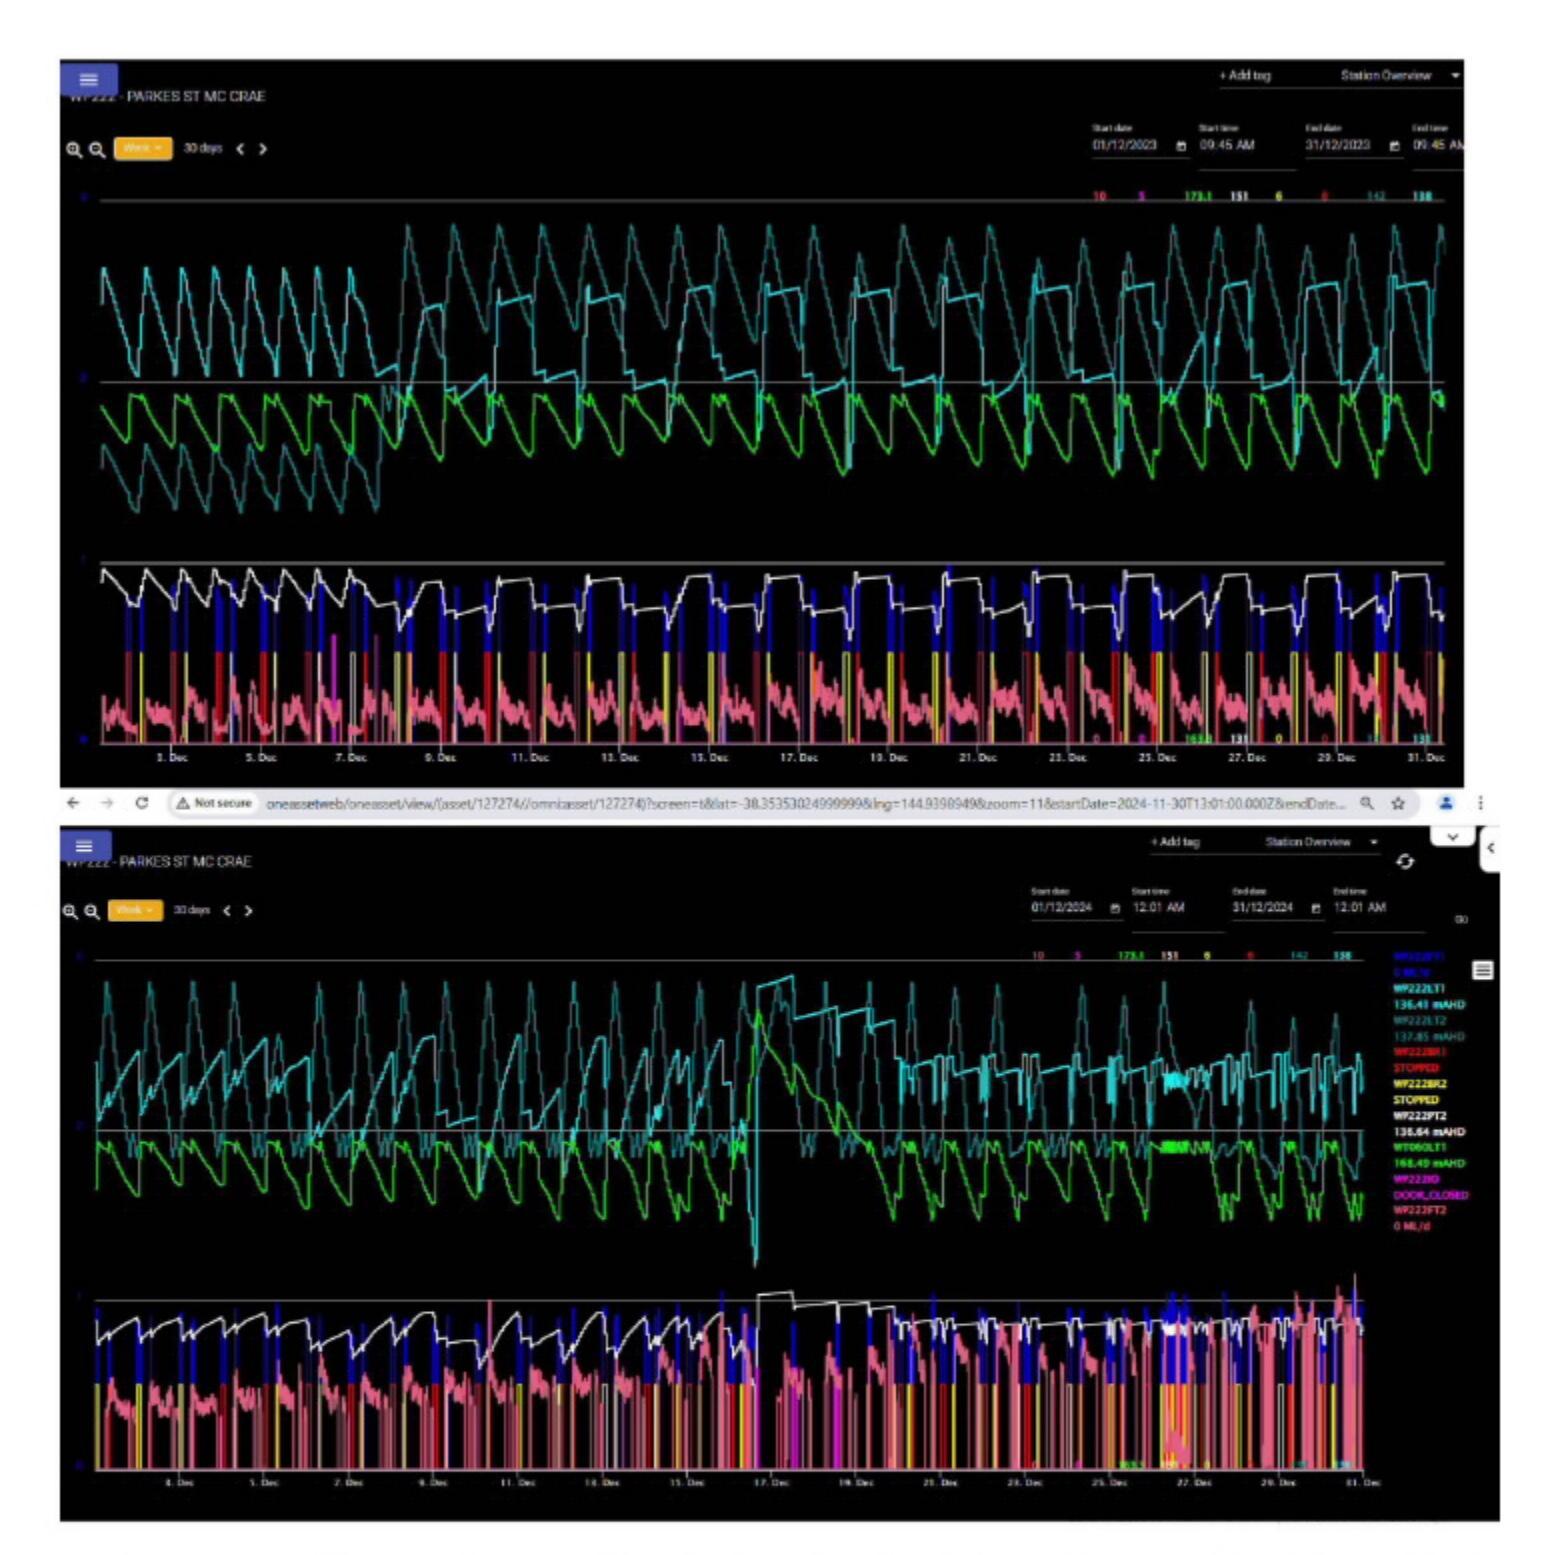
DEC 2023 vs DEC 2024

As Parkes Street tanks supply the area, I looked at the tank outflow (Tag WP222FT2) difference from DEC 2023 to that of DEC 2024.

Its difficult to get a baseline flow for the tanks as they fill during the night, but I could see an increase in flow rate (see red trendline arrow in snip below).

DEC 23 ( ave peak time flow leading to New Years 1-1.5meg ) to DEC 24 (ave peak time flow leading to New Years 2.5 - 3meg )

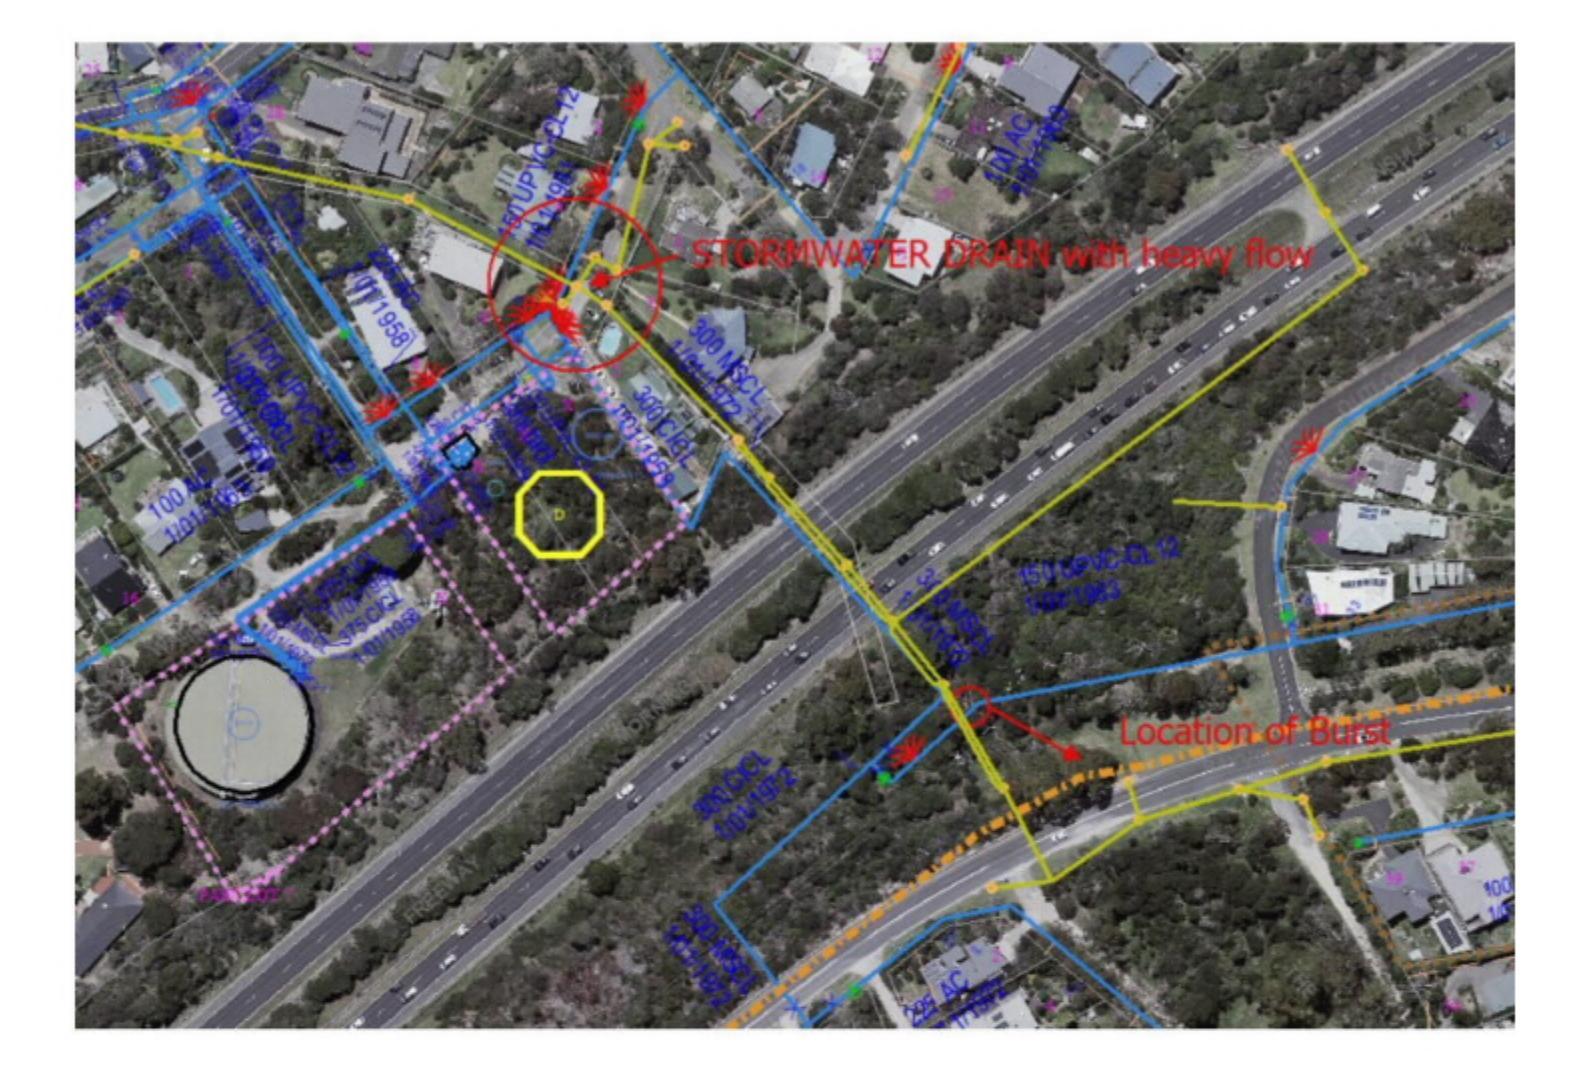
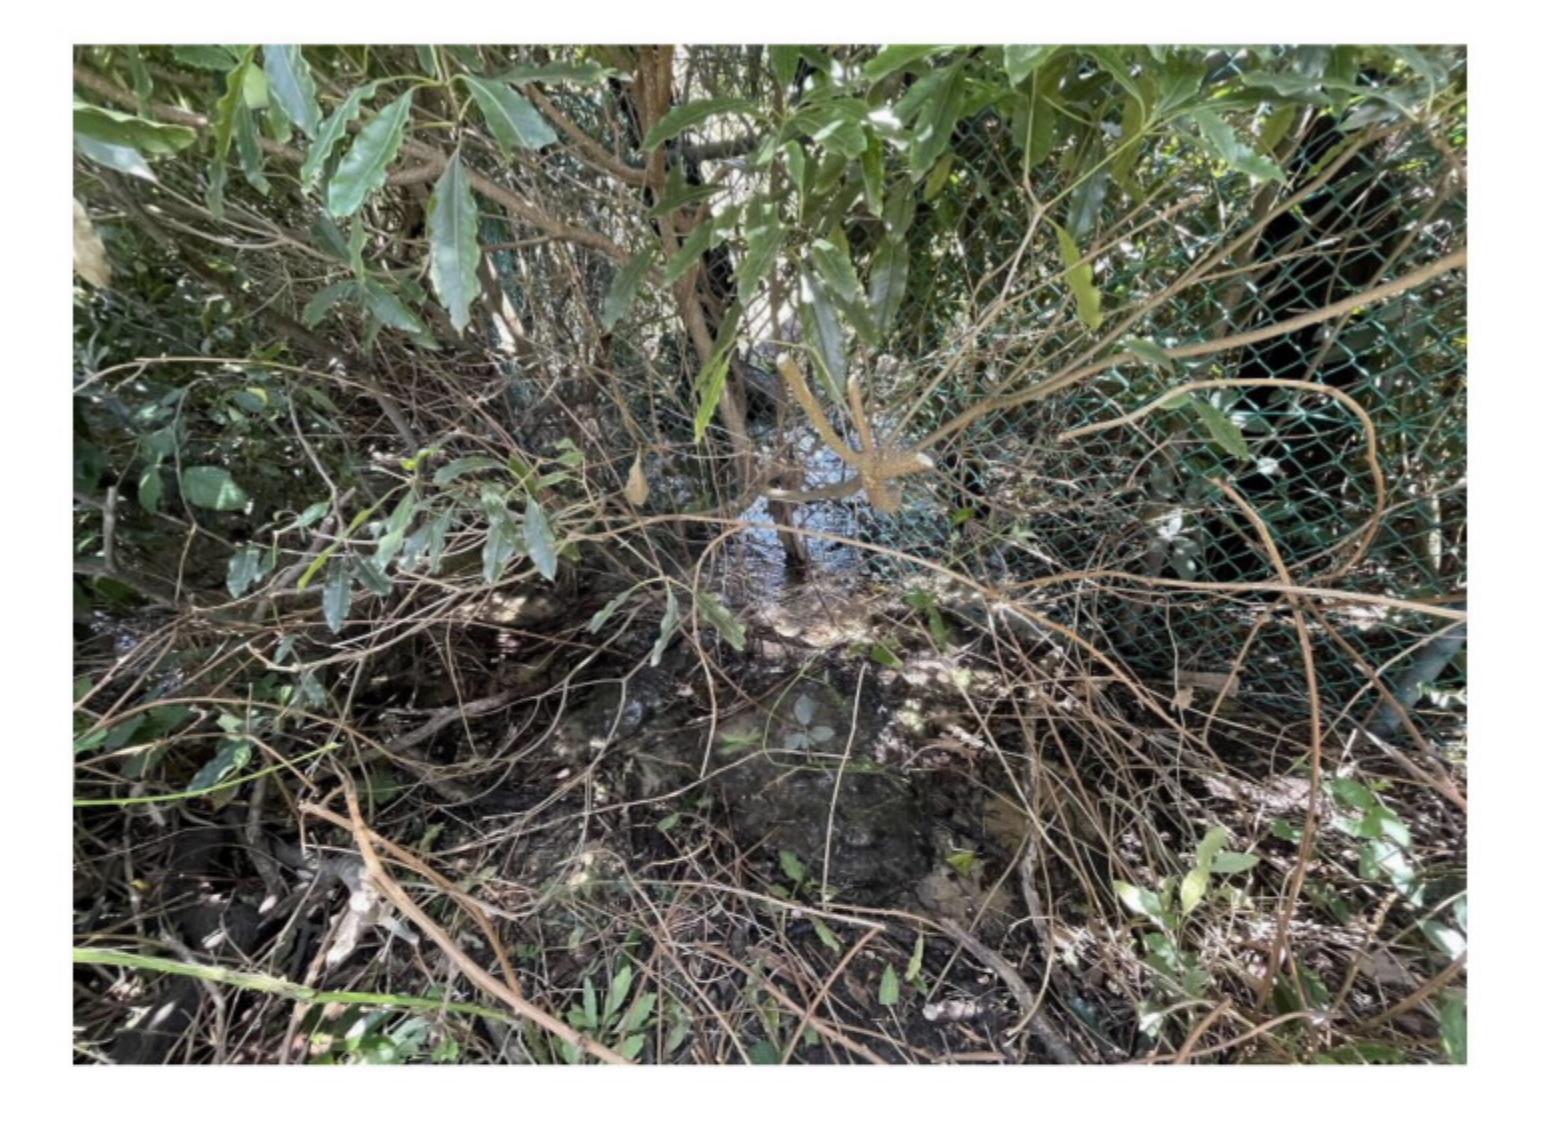
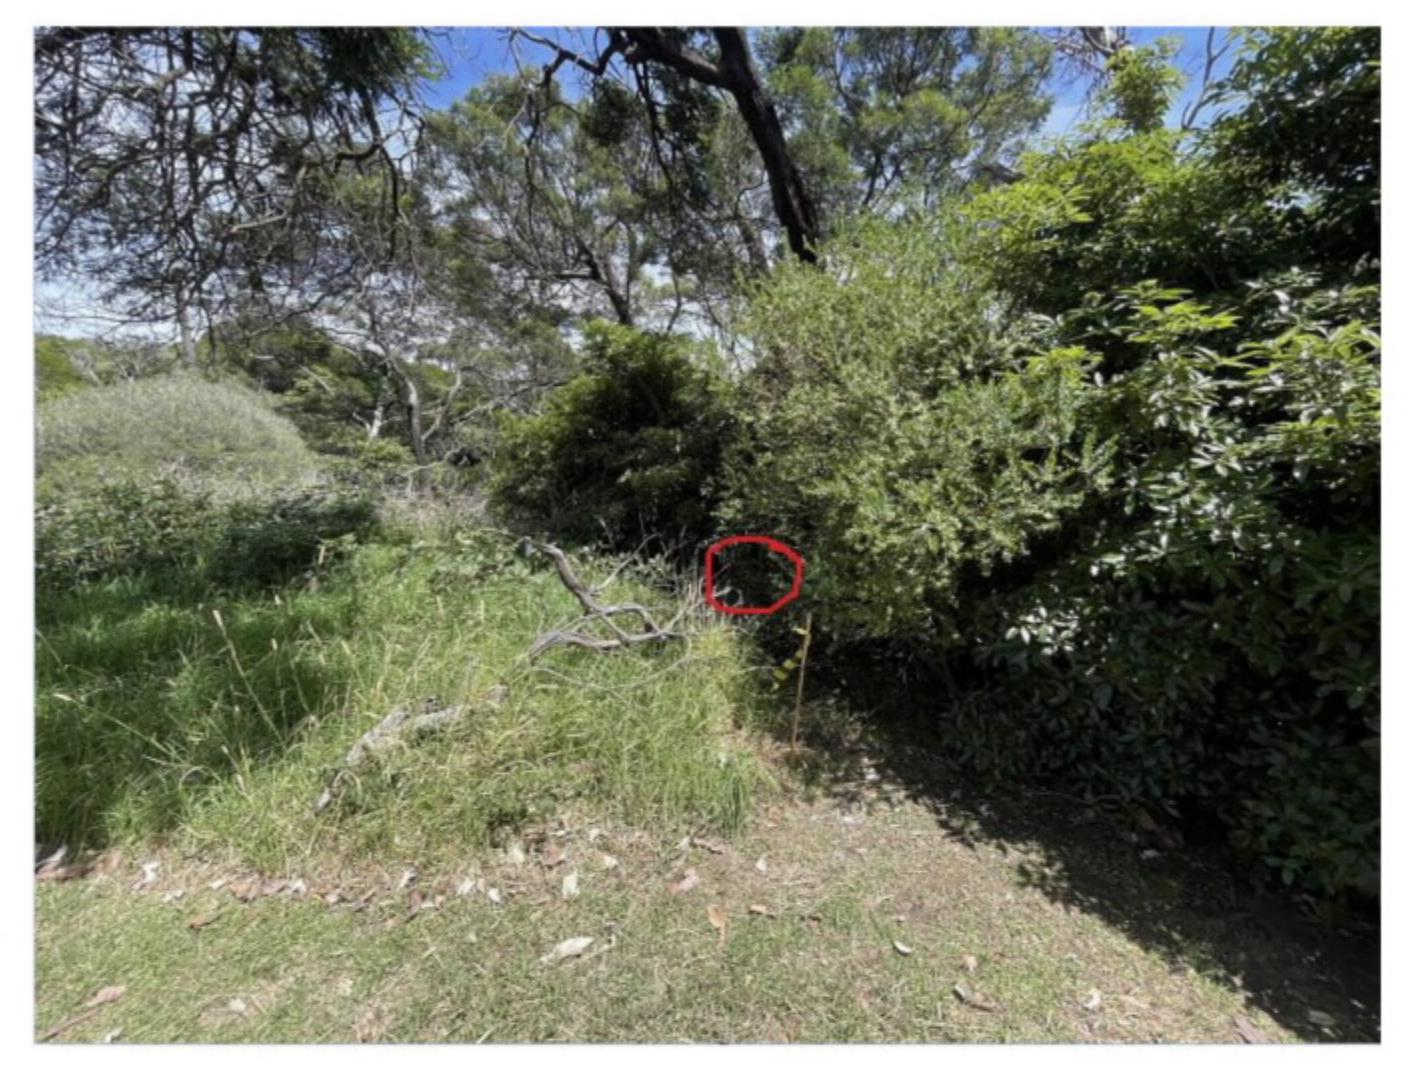
When I said I heard the burst first, what I was hearing was the water from the burst falling through the grate 3-4m into a large storm water pit.

From the grate I followed the flow of water to the actual burst 15m away uphill from the grate

The grate is roughly 5m in length, 1m in width and 3-4m depth (see photos) The open grate, I assume, is there the catch rainfall from this adjacent creek (currently dry) as it's the lowest point before it crosses the Peninsula Link.

Whilst doing so I sounded the valves on the water mains adjacent to the drain uphill towards the tanks. It was whilst locating and sounding the valves in heavy bushland on the other side of the Mornington Freeway opp Bayview Road that I firstly heard water flow and later discovered water flowing into the large storm water pit through a grate that crosses the Peninsula link over to Waller Place. Following that surface water from the pit....i located the burst and tested the water's EC confirming it was potable water.

Note that the burst is not something someone would have called in as it was away from any walking paths and in heavy unmaintained bushland.

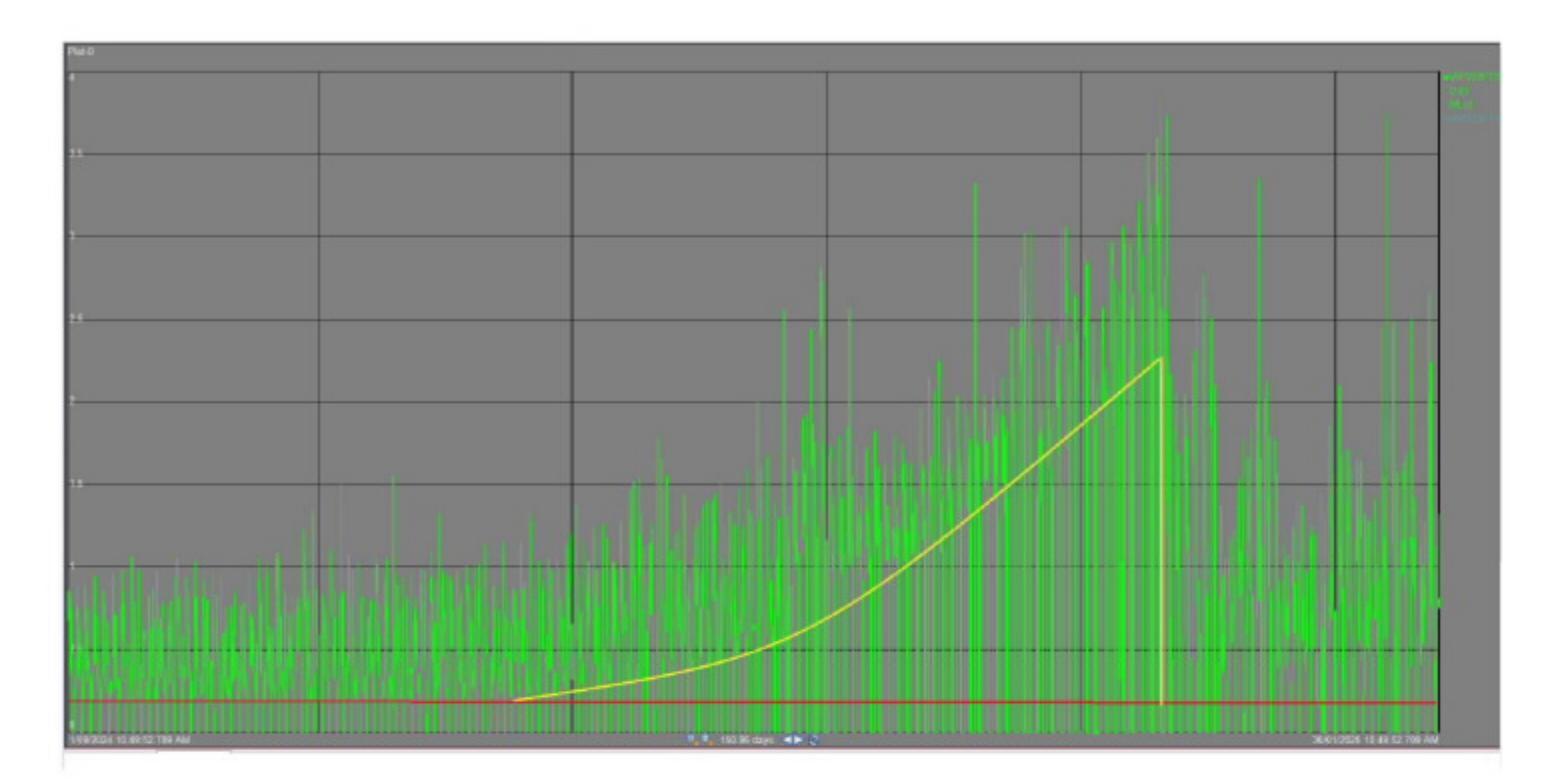
Once the repair was done by Service Stream, Dat and I were able to determine the approx. time and volume with a trend of the step change from the outlet of the tank at McCrae.

Below. Red line is baseline, yellow is increase. I believe it started early November until end of December, so ~60days. At the end it was a 2ML/d burst. Volume wise it was about 60ML.
