Attendees –

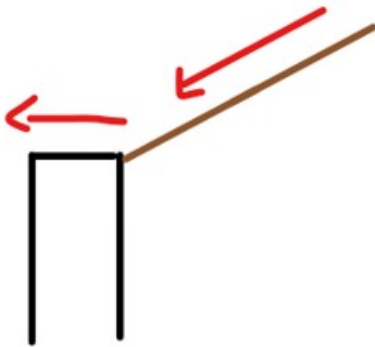
- Main concern is that if a landslide happens it will just go over the top of the retaining wall.
