McCrae Landslide Board of Inquiry

Opening Address
Senior Counsel Assisting

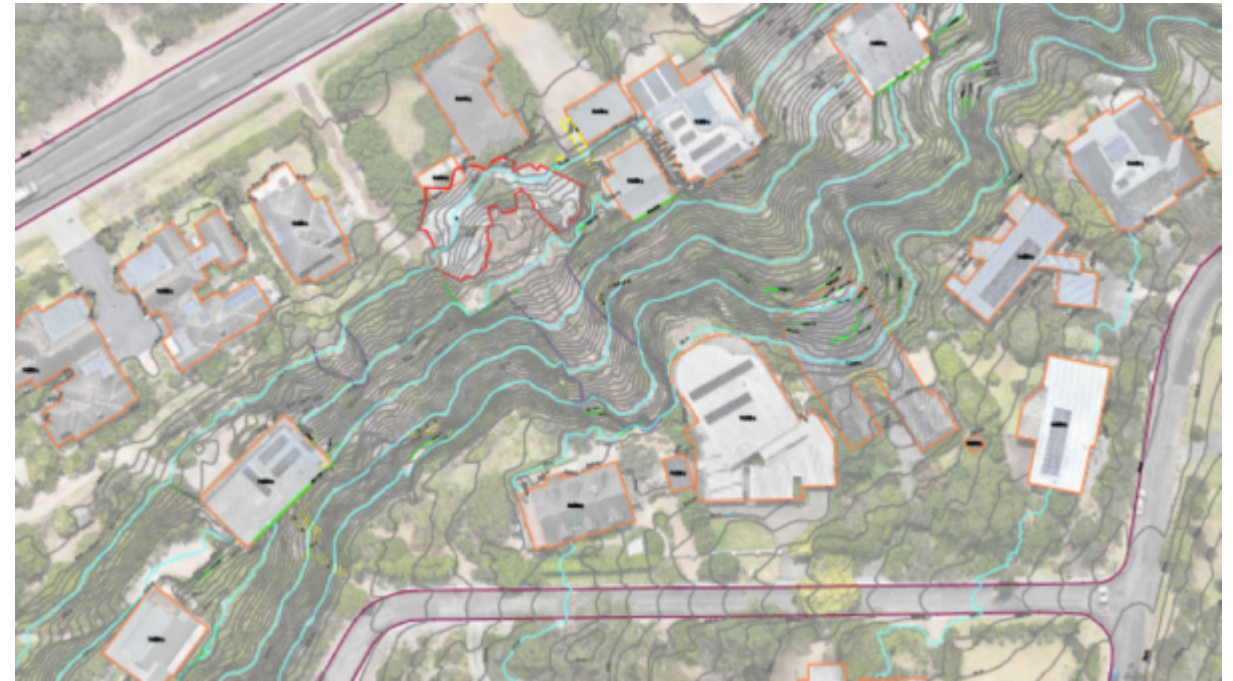
Location of the landslides overlaid by topographic map

The suburb can be defined by its near continuous coastal escarpment.

Along the toe of the escarpment is a low coastal plain, featuring small, low-lying dunes.

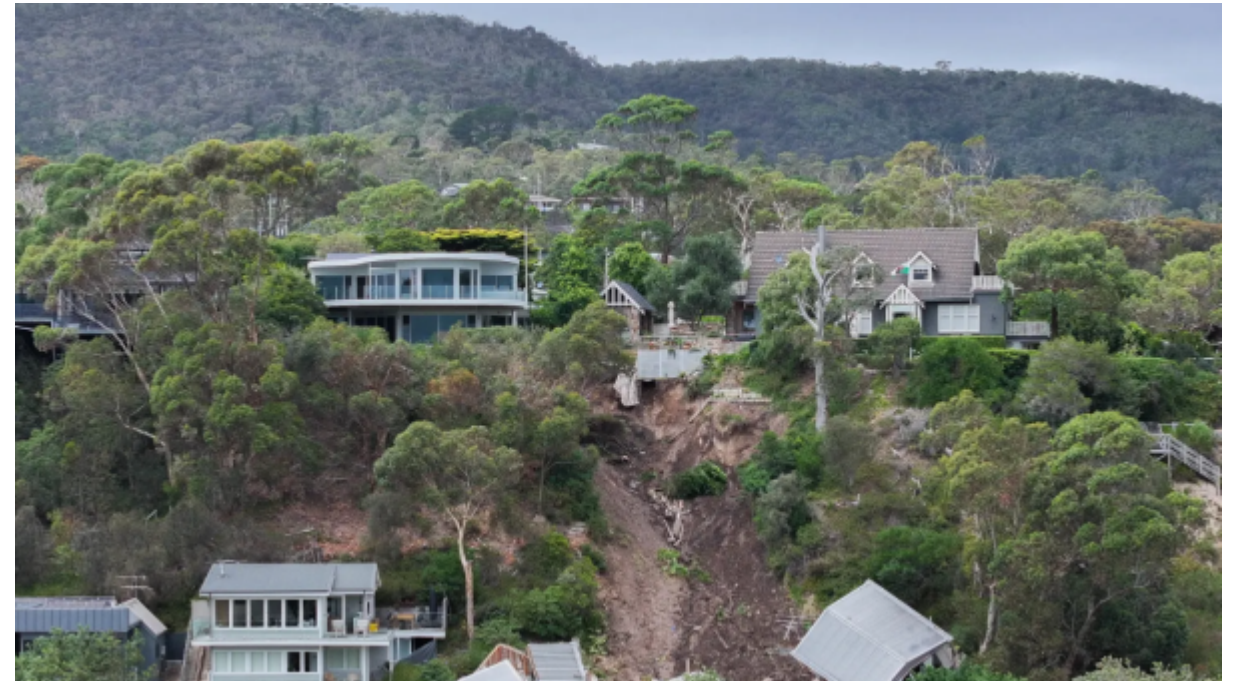
Landslide that occurred on 14 January 2025

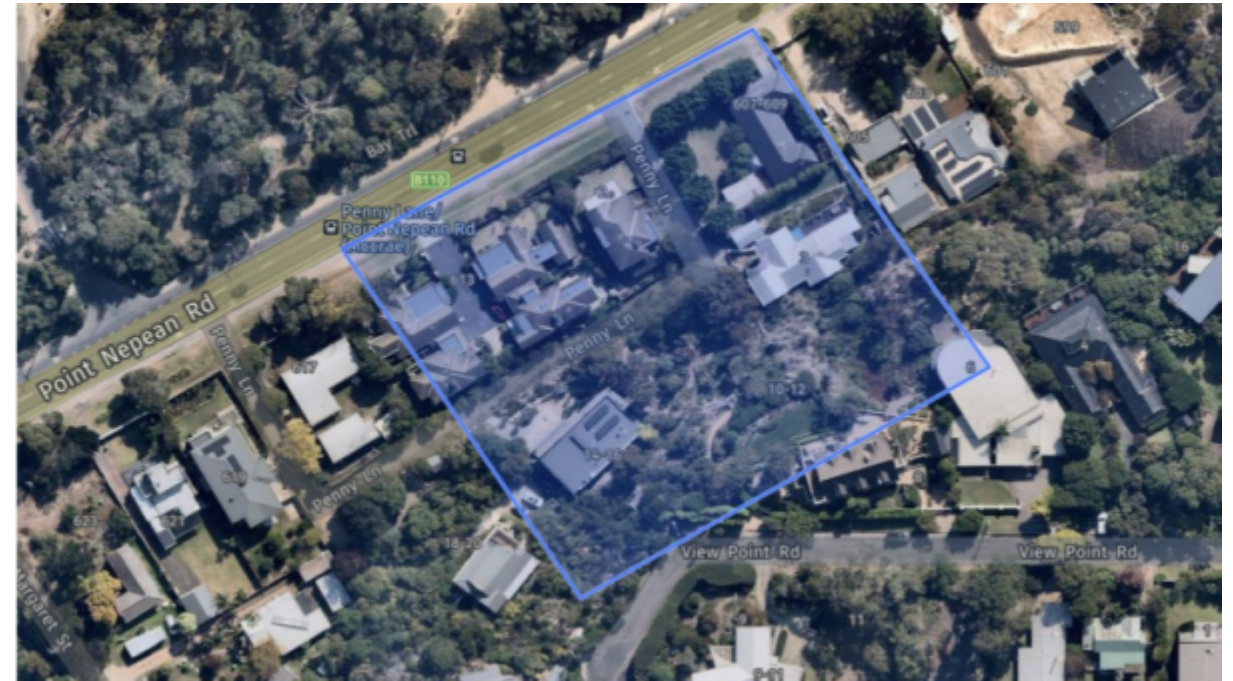
Evacuation area following the 15 November landslide

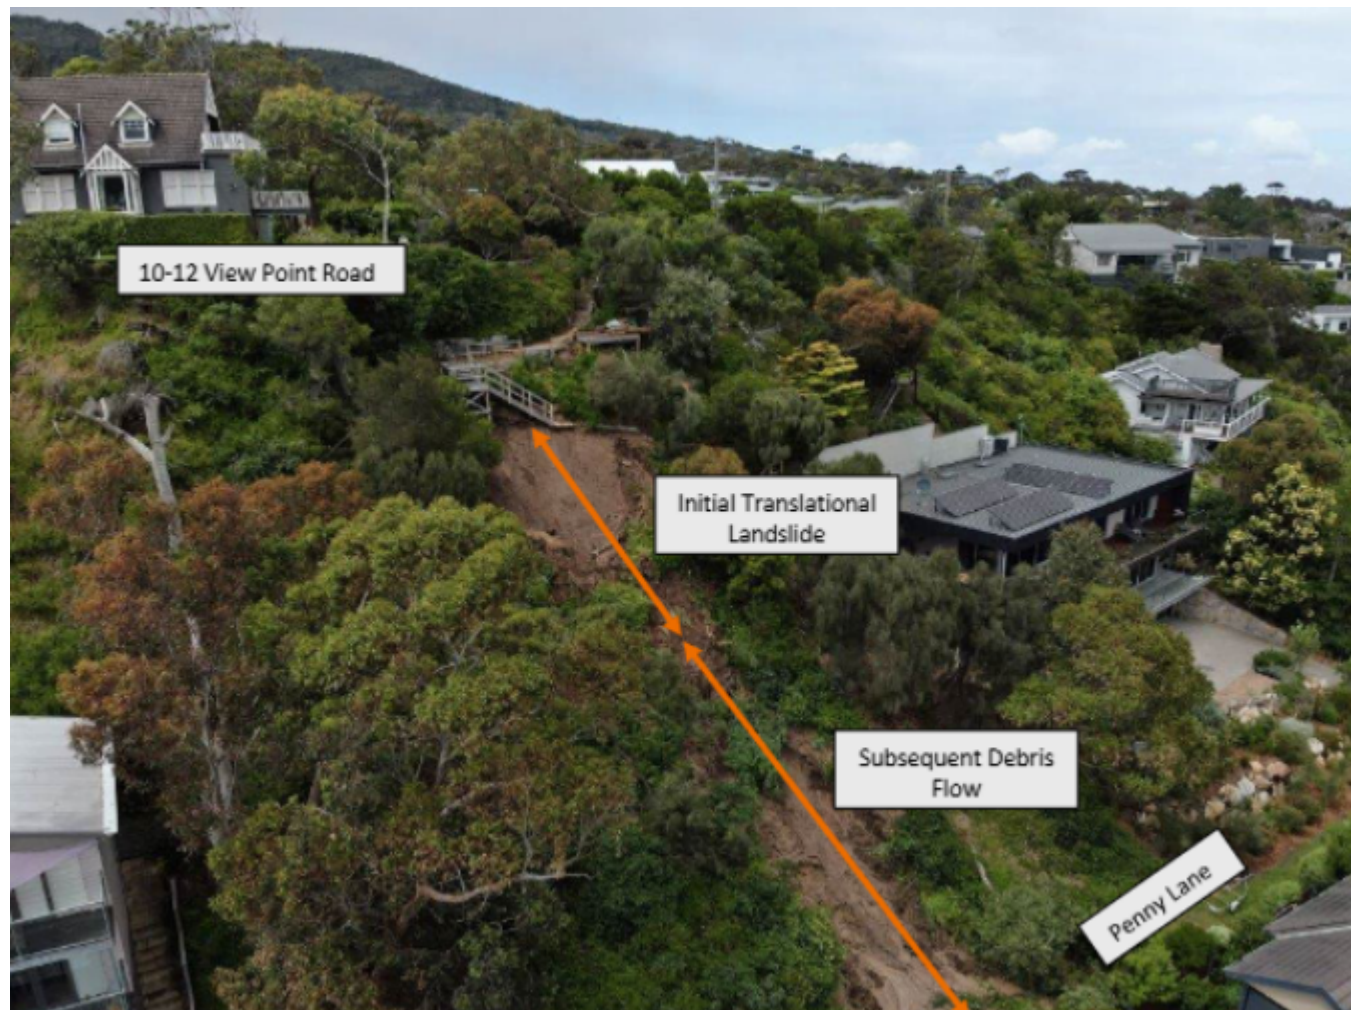
Scale of the landslides

This image depicts the location of the initial landslide on 14 November 2022 at 10-12 View Point Road and the subsequent debris flow down the hill on 15 November 2022.

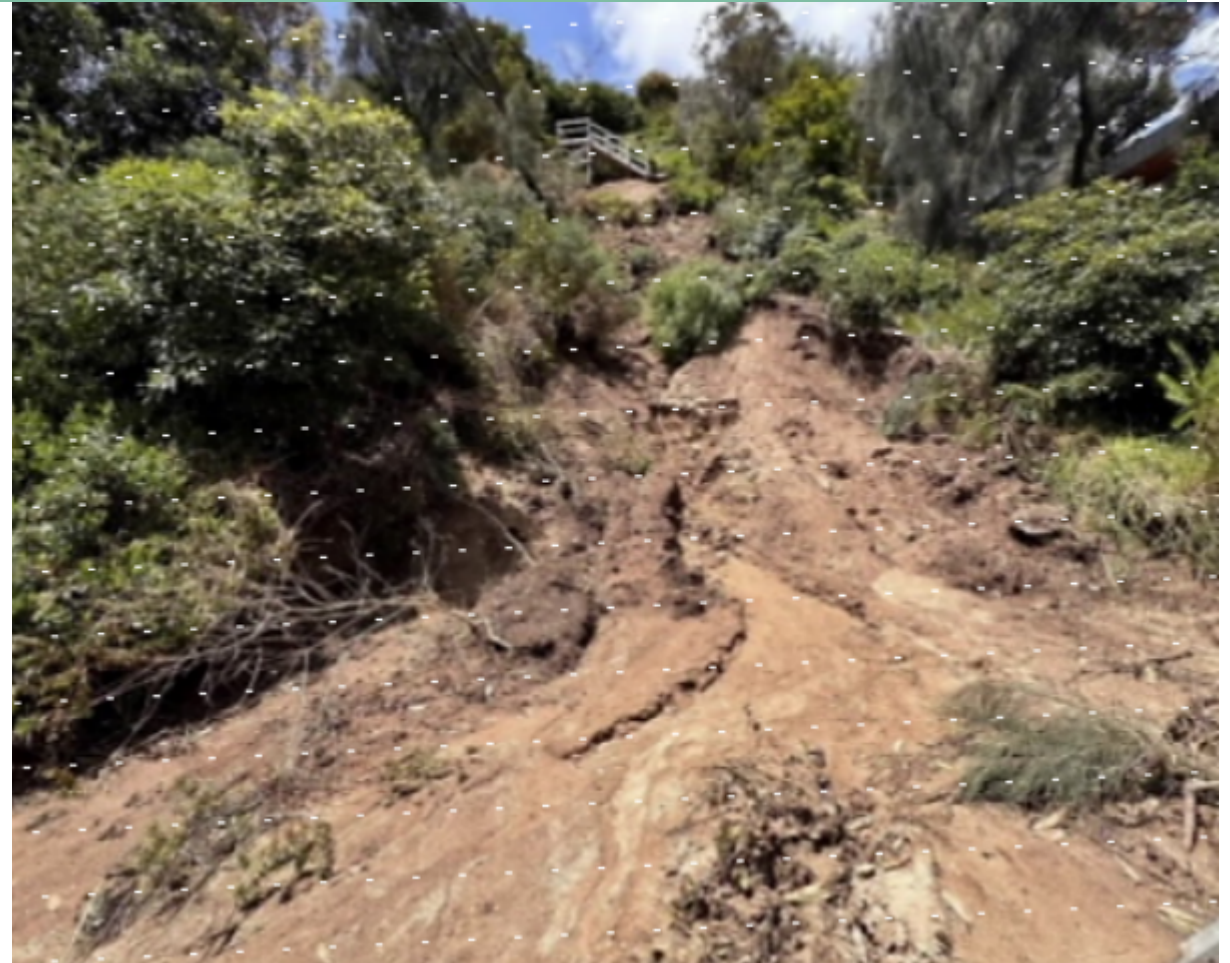
View looking up at the 2022 landslides

This image depicts the **subsequent debris flow** that impacted the slope leading down to Penny Lane from View Point Road, McCrae.

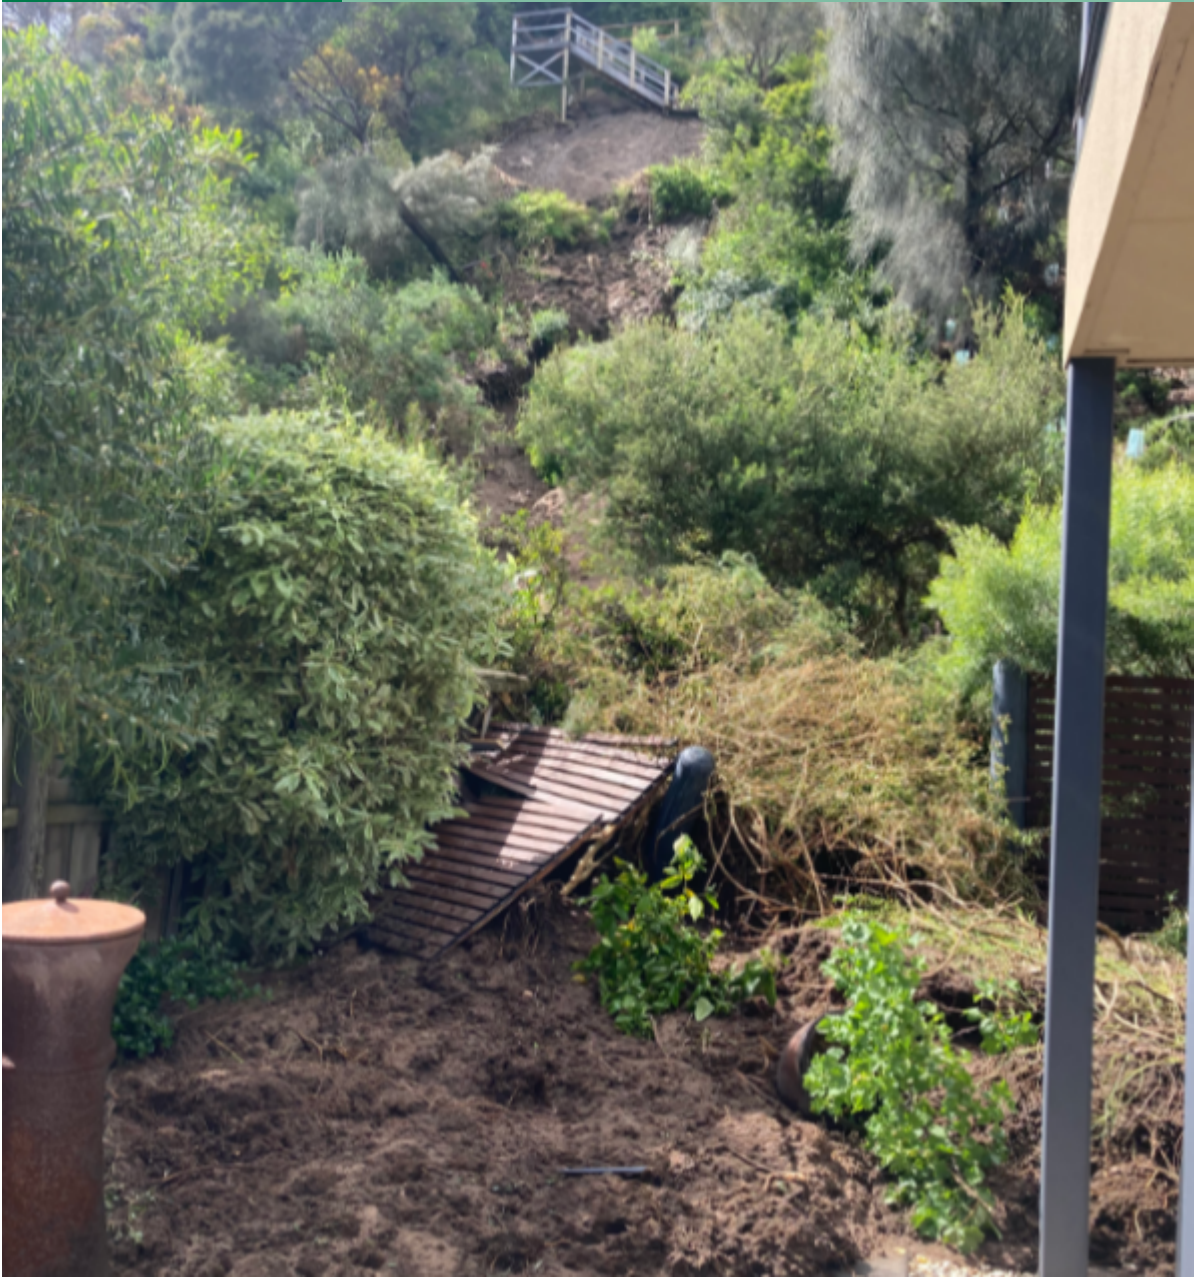
Image of the **debris flow** from the **15 November 2022** landslide - taken by a resident of 3/613 Point Nepean Road from their garden.

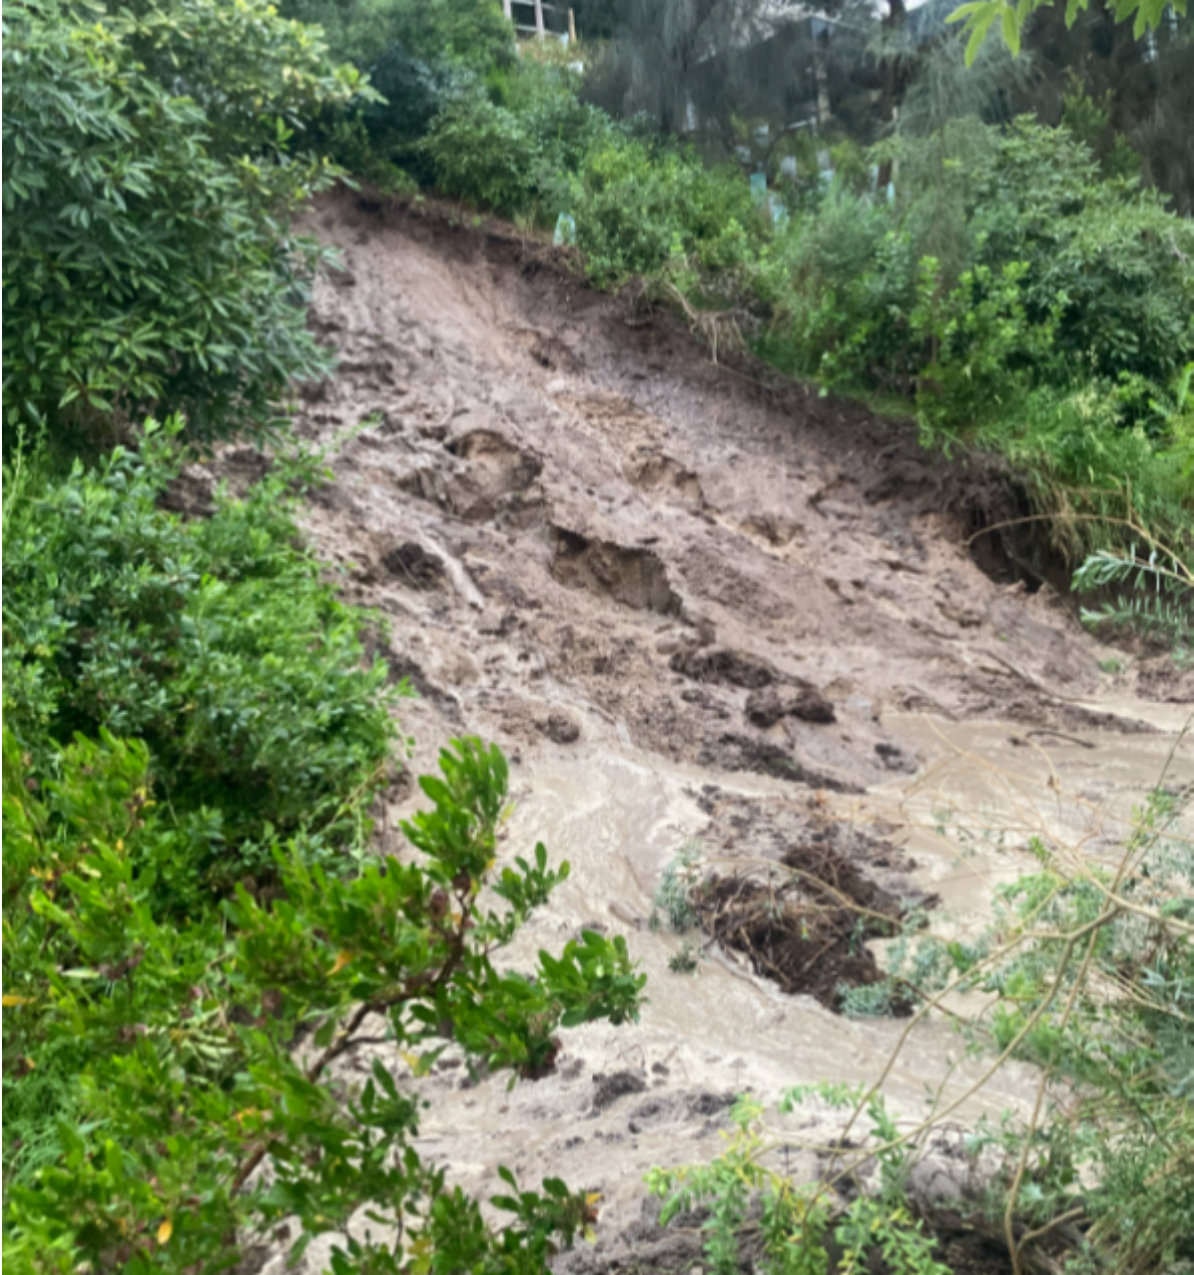
A resident of 3/613 Point Nepean Road took this image of the escarpment in the morning of 15 November 2022, following the landslide.

The image indicates the presence of significant water flow down the escarpment at that time.

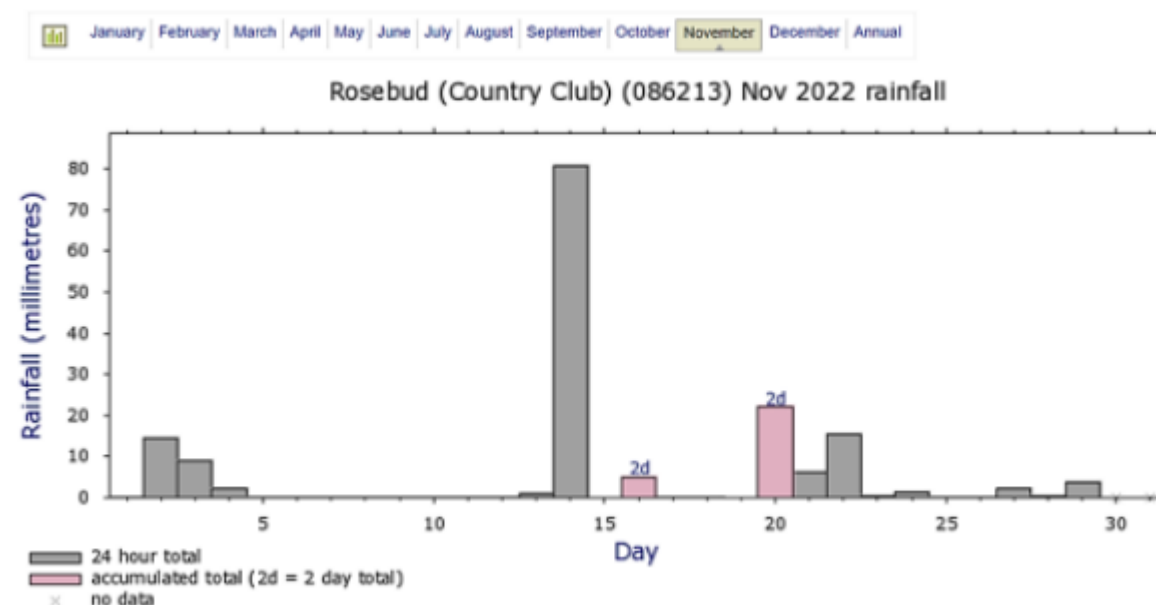
Daily precipitation November 2022 – Rosebud Station

On 14 November 2022, the date of the first landslide for 2022, **80mm of rain** was recorded at the Bureau of Meteorology rain gauge located at Rosebud Country Club, approximately 3 – 4km away.

According to data, this was the **highest single day of rainfall** at that rain gauge since February 2005.

More generally, the monthly precipitation for **October and November 2022 was much higher** than previous years, dating back to 1927.

The precipitation for **November 2022 was triple the historical average**.

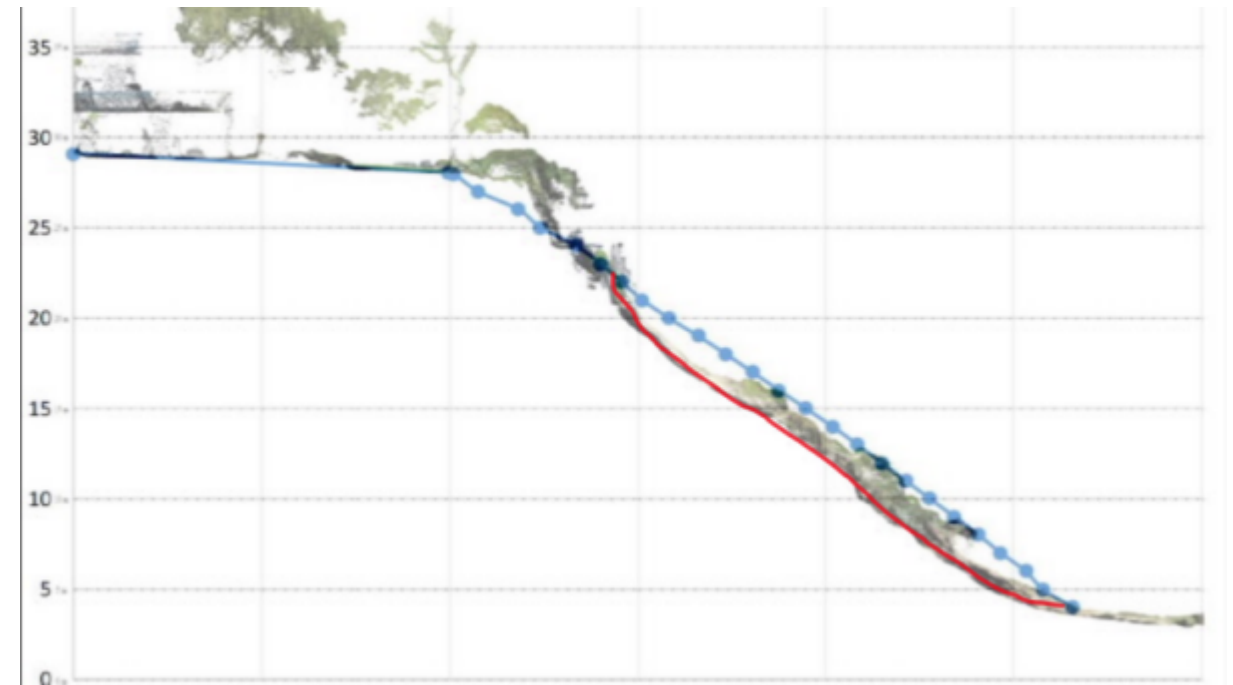
Land survey of slope beneath 10-12 View Point Road

A land survey was conducted by G.J Martin Consulting Land Surveyors on 11 November 2022.

A drone topographical survey was conducted by Civiltest Pty Ltd on 2 December 2022.

The two surveys have been overlaid to estimate the **extent of the earth flow** on 15 November 2022.

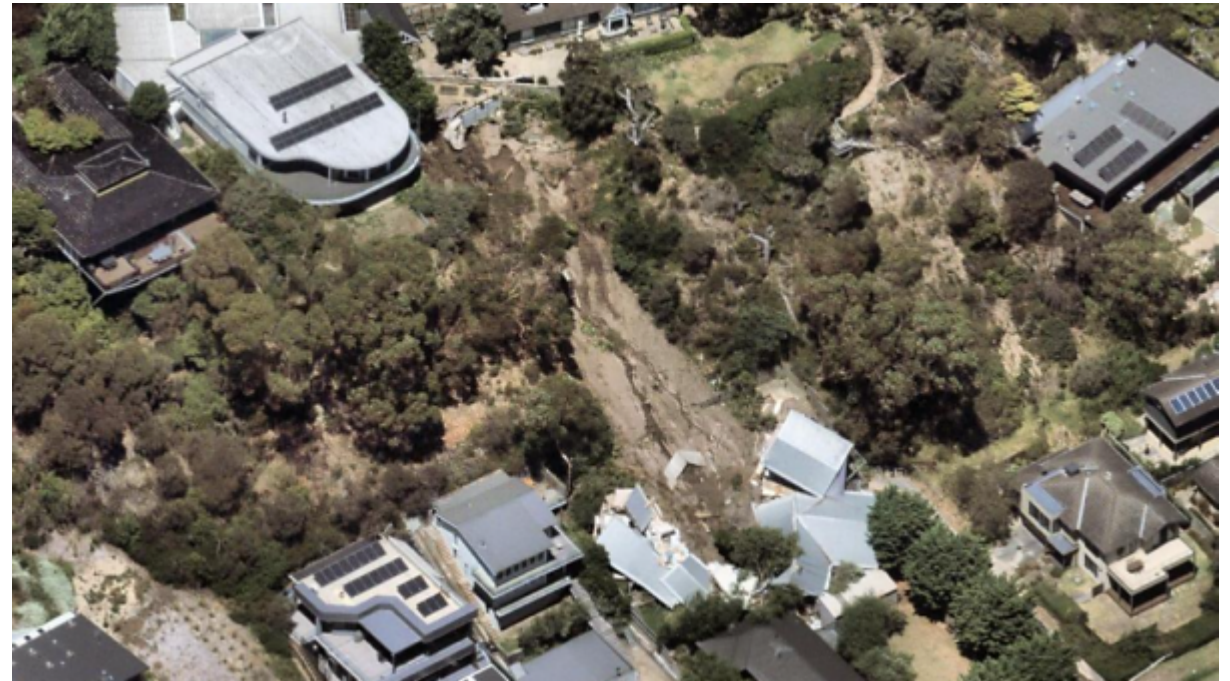
3 Penny Lane after the 14 January 2025 landslide

On 14 January 2025 at approximately 8:30am, a subsequent landslide destroyed the dwelling at **3 Penny Lane**.

The source of the landslide was **10-12 View Point Road**, which is situated directly upslope.

The collapse shunted the house on 3 Penny Lane towards **607-609 Point Nepean Road**. It did not impact the building on this property, except for some distortion to a rear retaining wall.

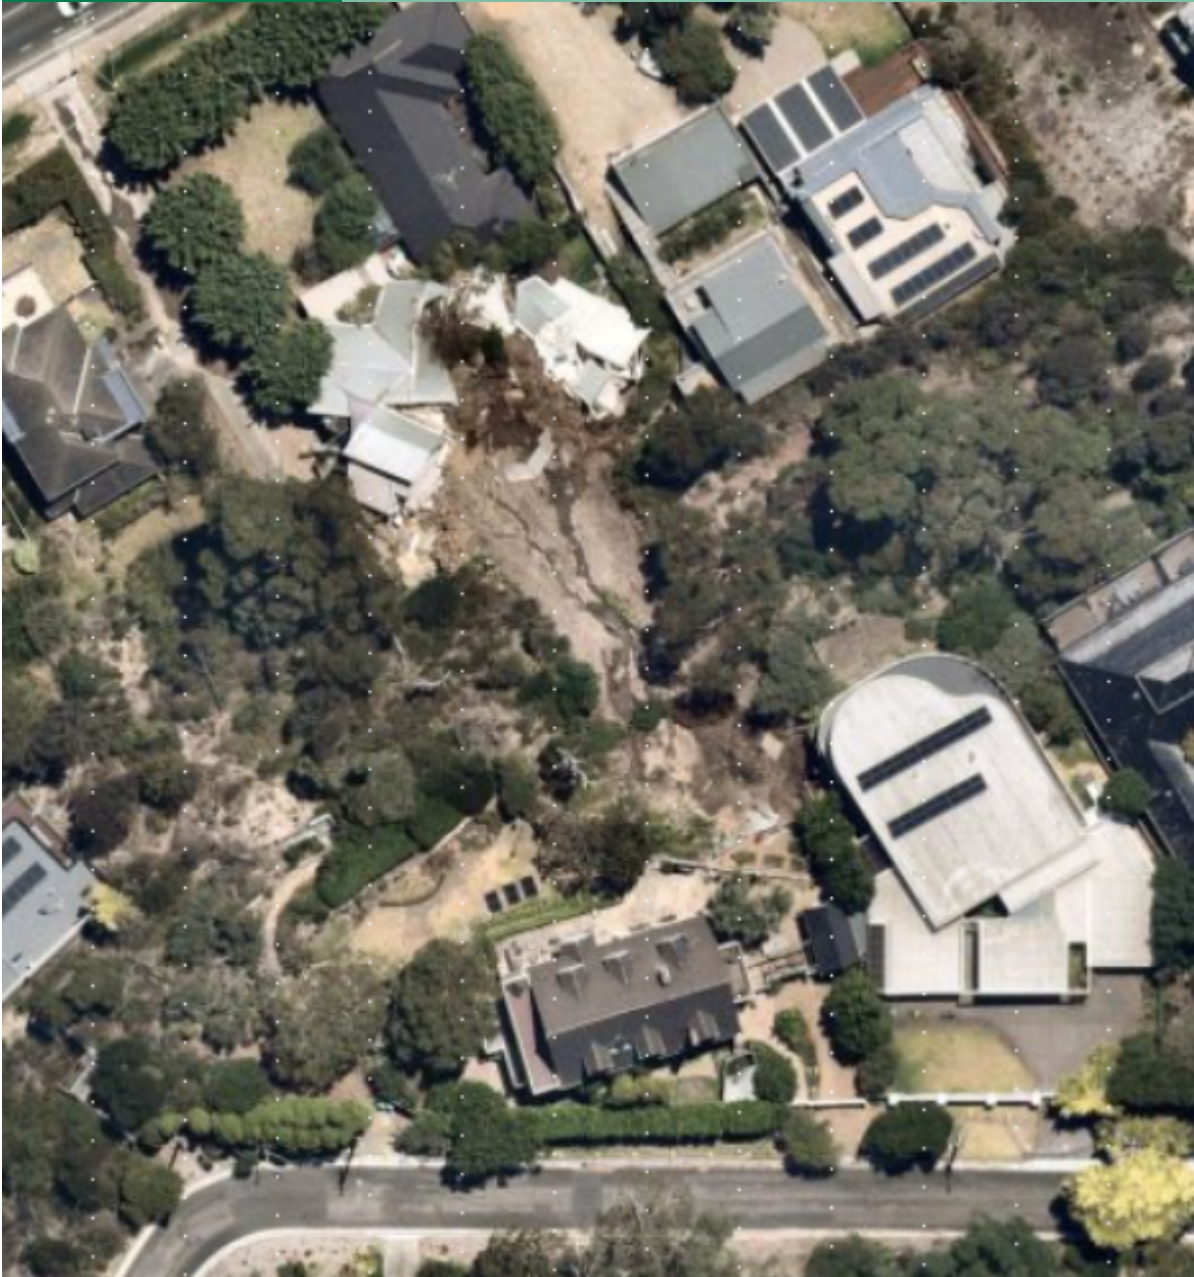
After 2025

This an aerial image of the landslide site after the 14 January 2025 landslide

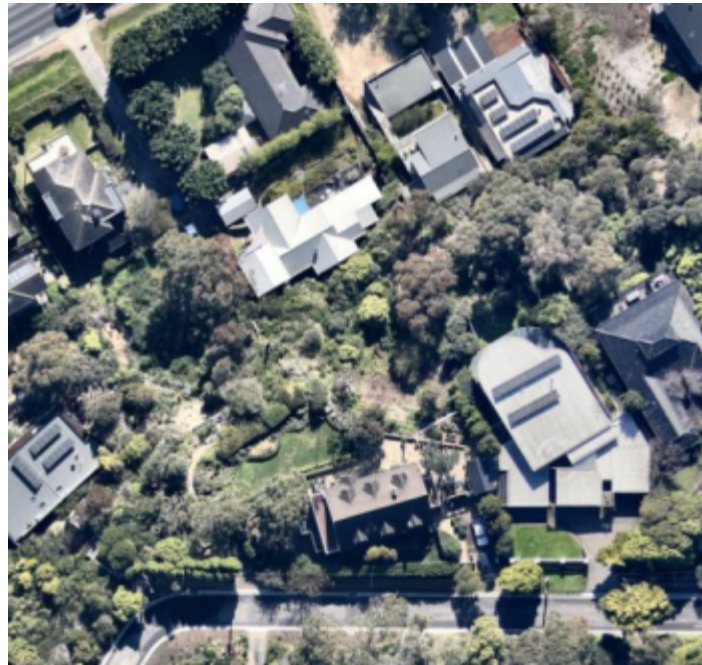
Before

These are aerial images of the same landslide site, before and after the 14 January 2025 landslide.

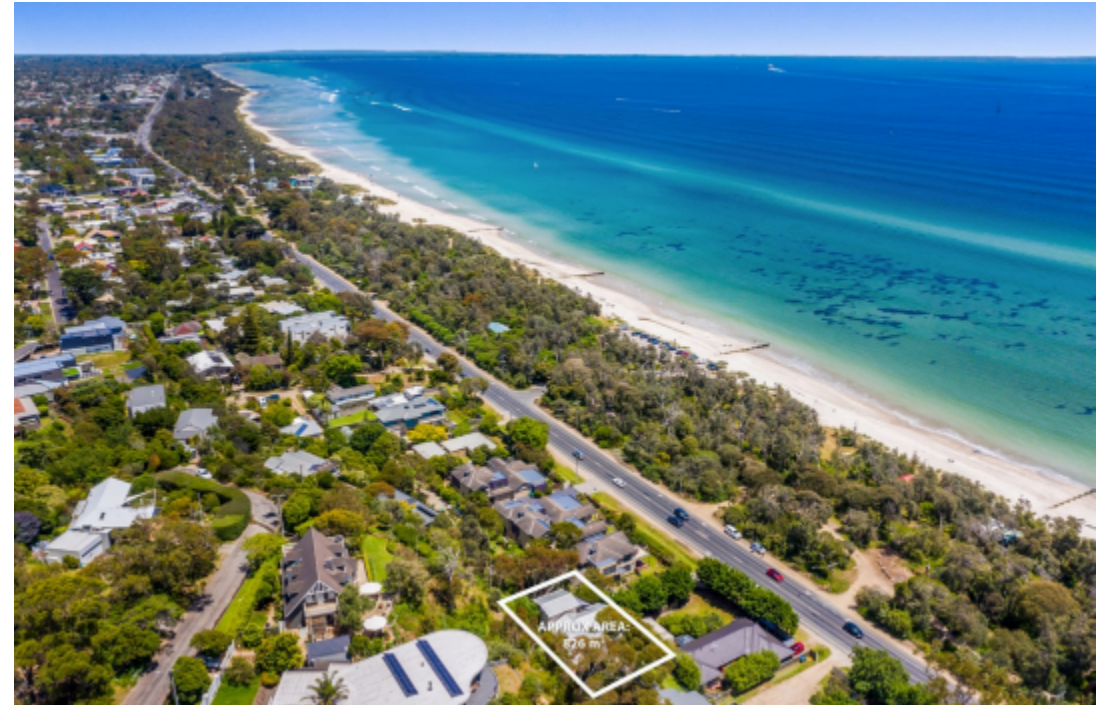
The Property was built on a slope that runs from roughly beach level at Point Nepean Road and Penny Lane, to the top of the McCrae Hill on View Point Road.

3 Penny Lane relative to the beach

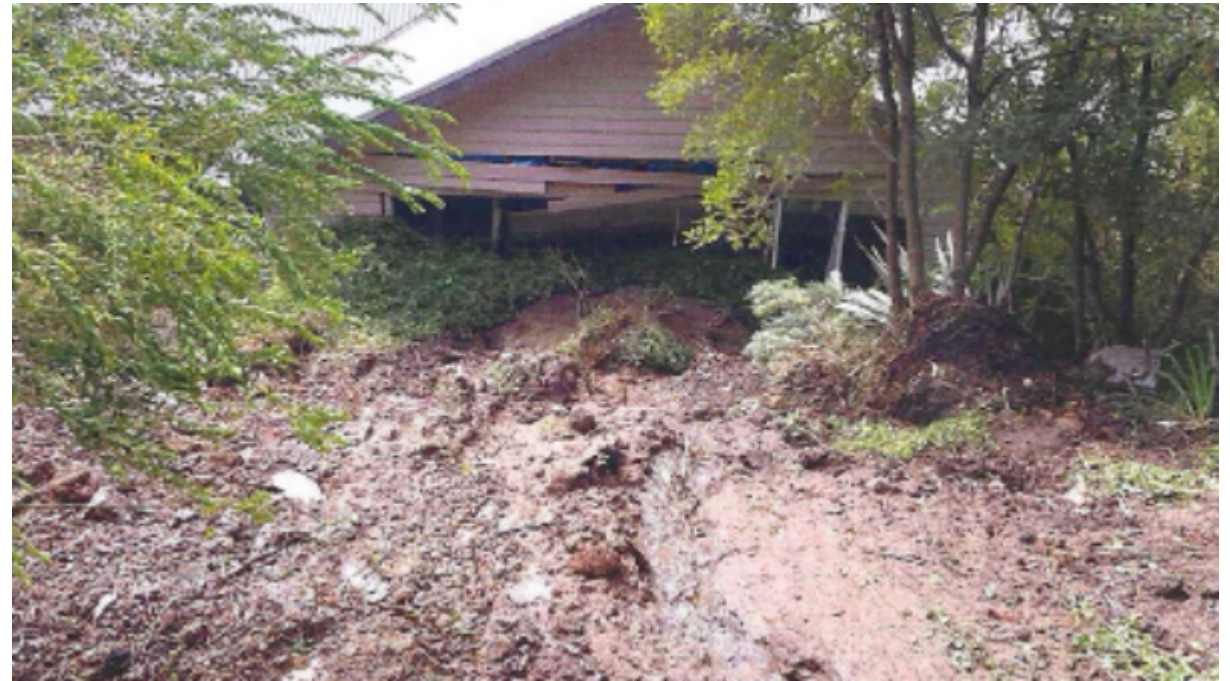
Rear of 3 Penny Lane after the 5 January 2025 landslide

The property sustained structural damage to the rear of the 3-storey dwelling.

Approximately **20 - 25 tonnes** of material struck the dwelling, causing moderate damage to the external walls and structural piers.

The rear external wall of the centre of the dwelling was deemed unsafe and unstable.

The source of the landslide was directly upslope towards 10 – 12 View Point Road.

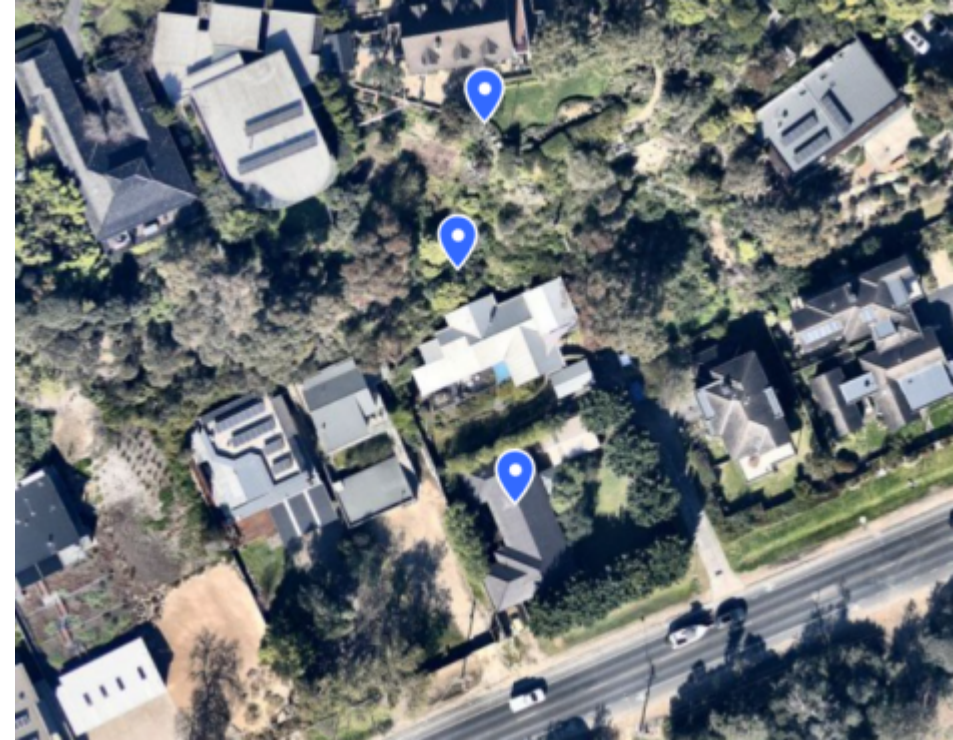
- **10-12 View Point Road** (source of the landslide)
- **3 Penny Lane** (impacted by debris)
- **607-609 Point Nepean Road** (located downhill of potential landslide activity)

Properties affected by the 5 January 2025 landslide

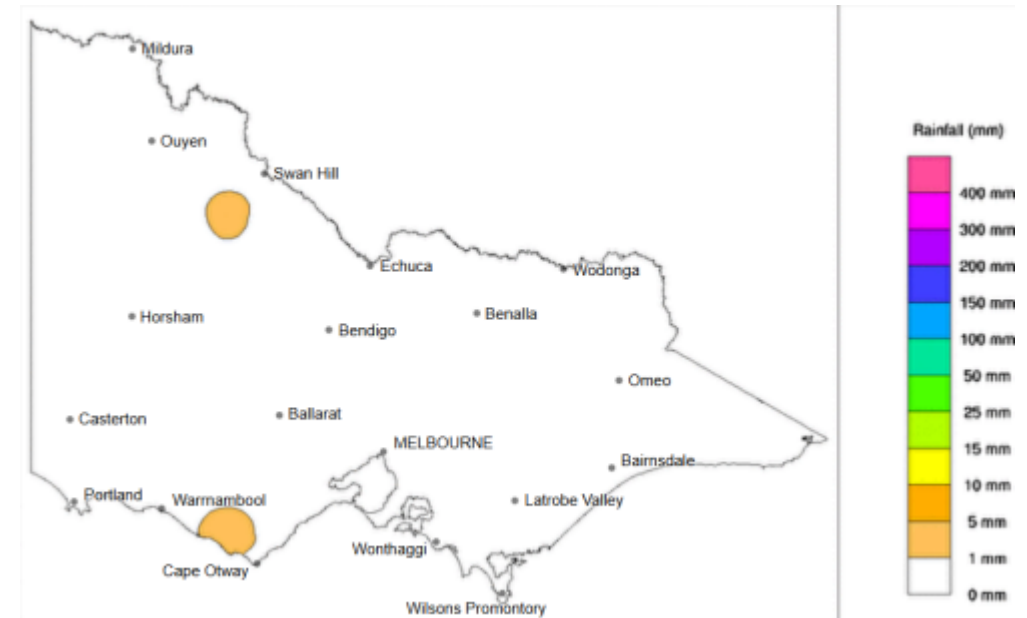
Rainfall data indicated there was **no** rainfall in the month of January leading up to the 5 January 2025 landslide.

Rainfall data from 5 January 2025 shows 0mm of rain in McCrae

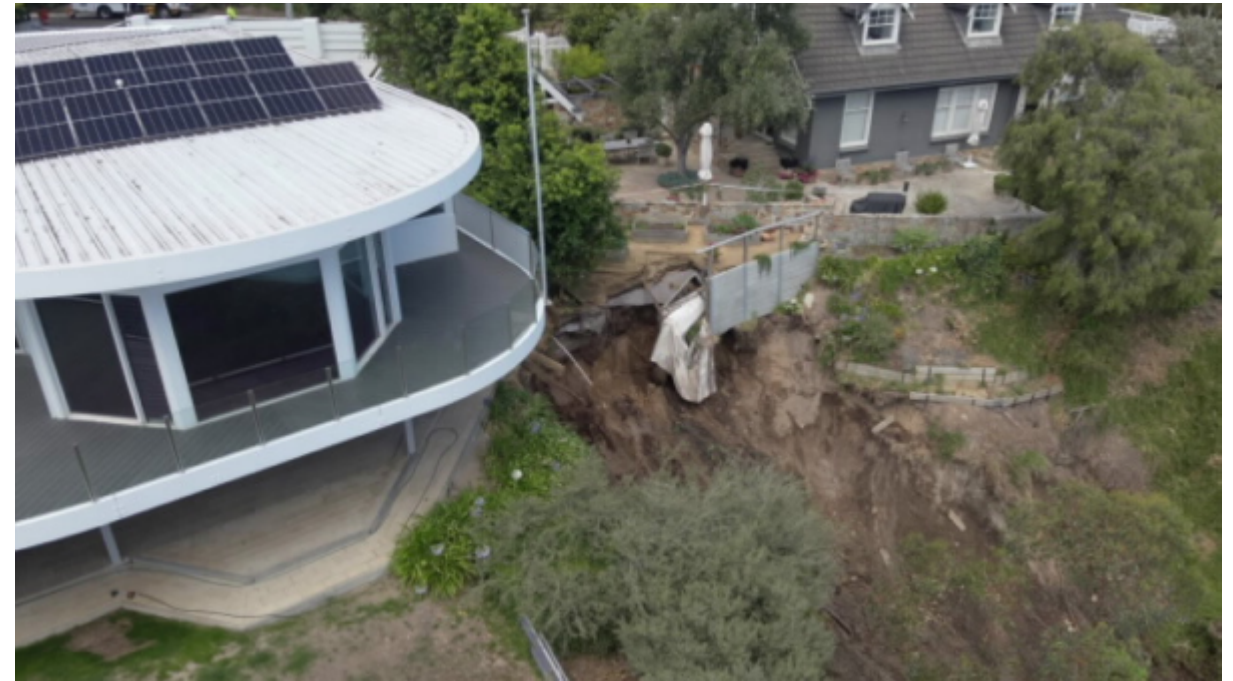
Upper portion of debris located at the rear of 10-12 View Point Road

A significant portion of the head scarp was saturated in the wake of the 5 January 2025 landslide.

A measurable flow of water (0.15-0.2L/s) was observed to be flowing down the hill.

The seepage was observed at the point between the surface soils and underlying natural soils.

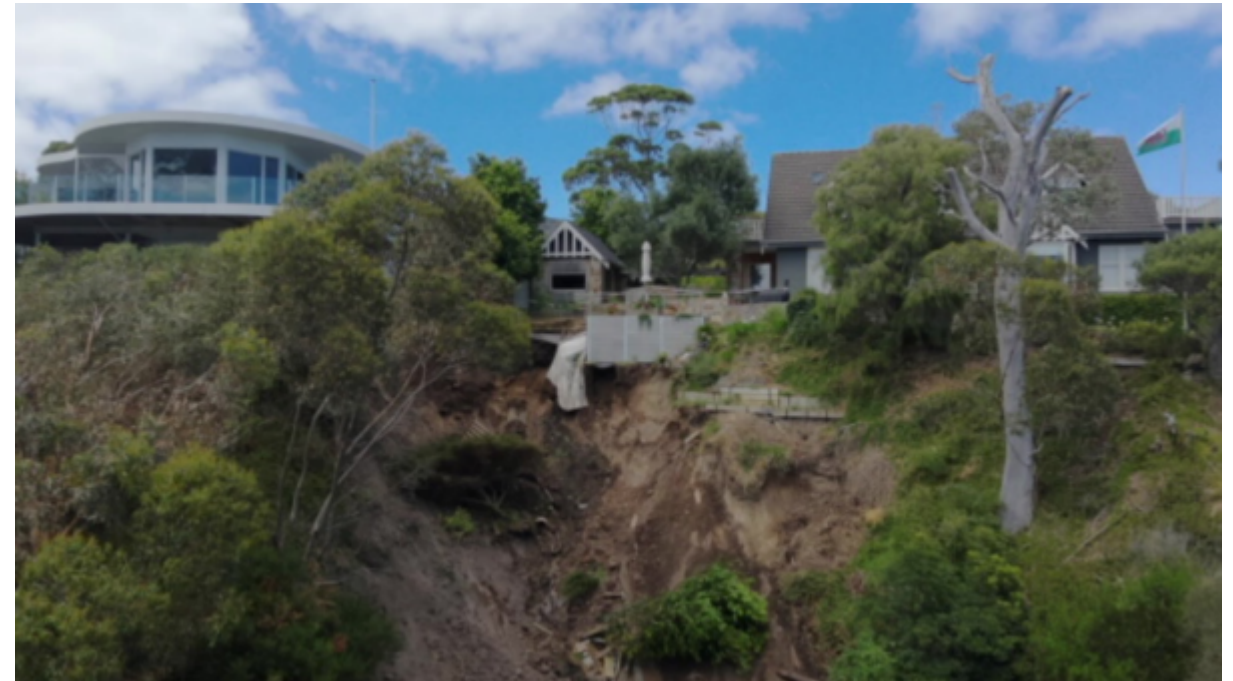
Source area located below retaining wall of 10-12 View Point Road

Subsurface water was observed during a geotechnical engineer's visit discharging from points near the initial landslide area (5 January 2025 landslide) at the rear of 10-12 View Point Road.

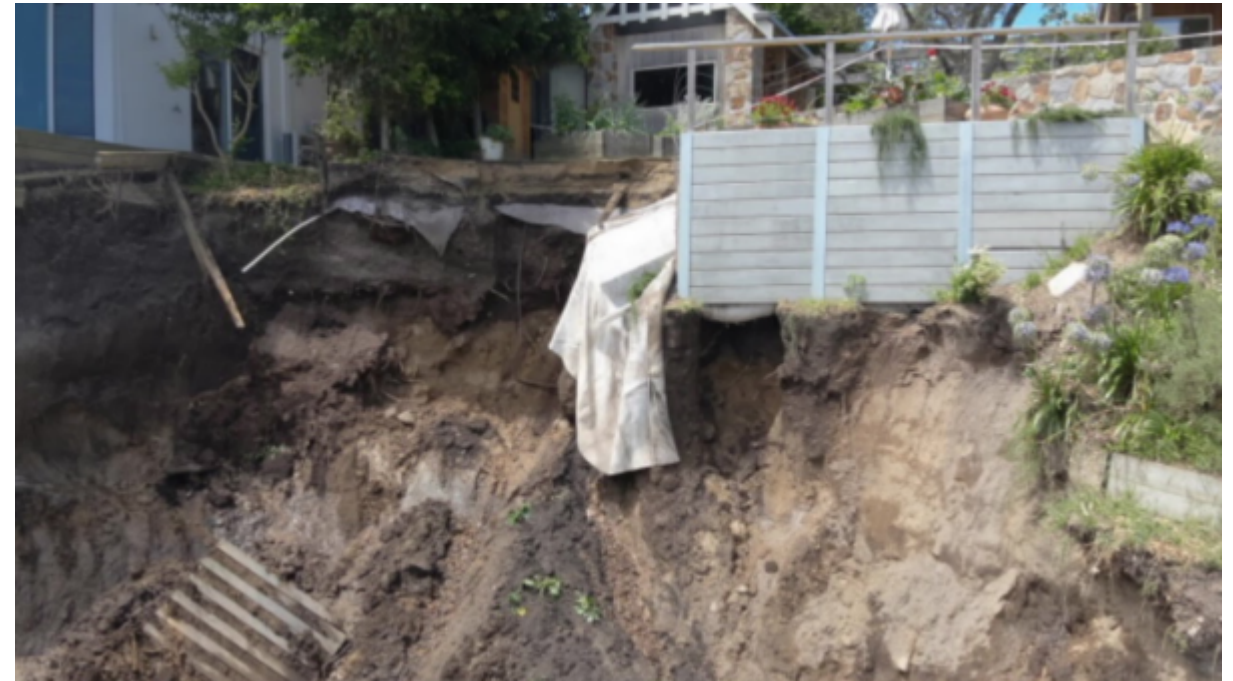
Upper portion of debris located at the rear of 10-12 View Point Road

Some of the exposed material in the gully is observed to be dark in colour. Whereas material exposed in an adjacent slope appeared to be pale brown and sandy.

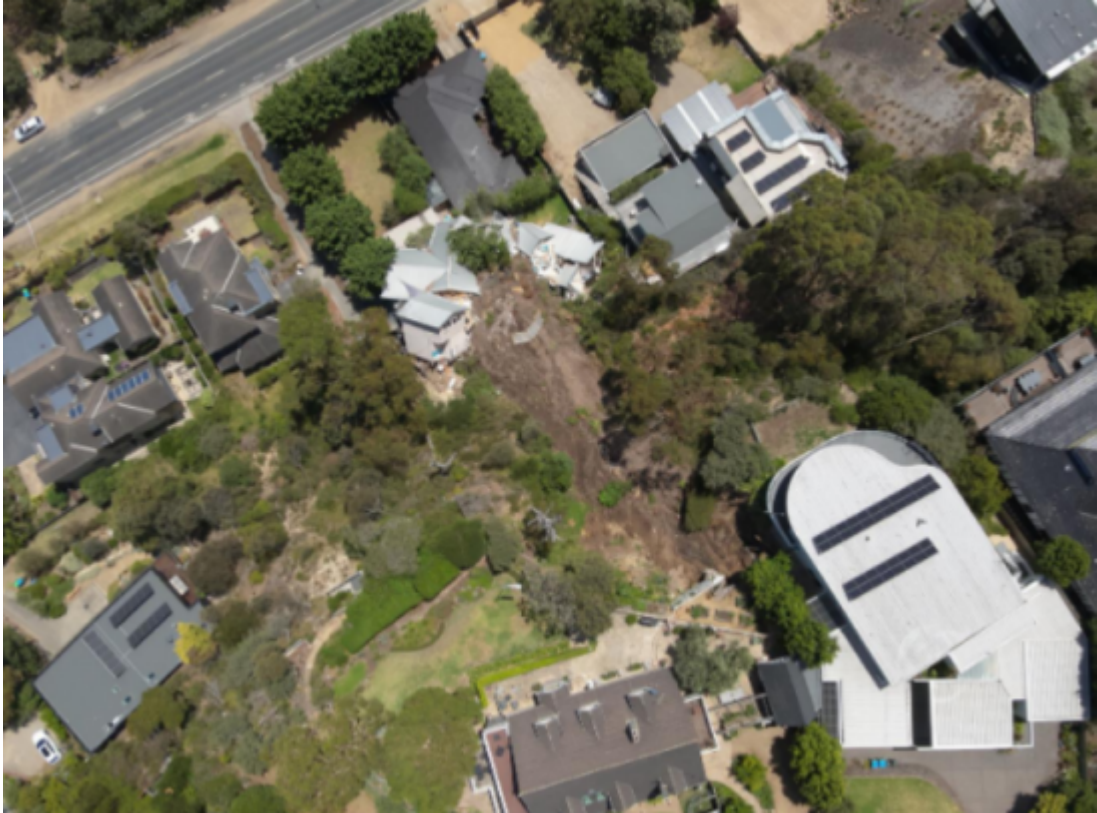
Whilst failure mechanisms were not able to be identified immediately, it was concluded that the landslide transitioned into rapid debris flow, with runout extending its reach to below properties.

It was acknowledged that 2 Penny Lane acted as a barrier to slow and stop debris.

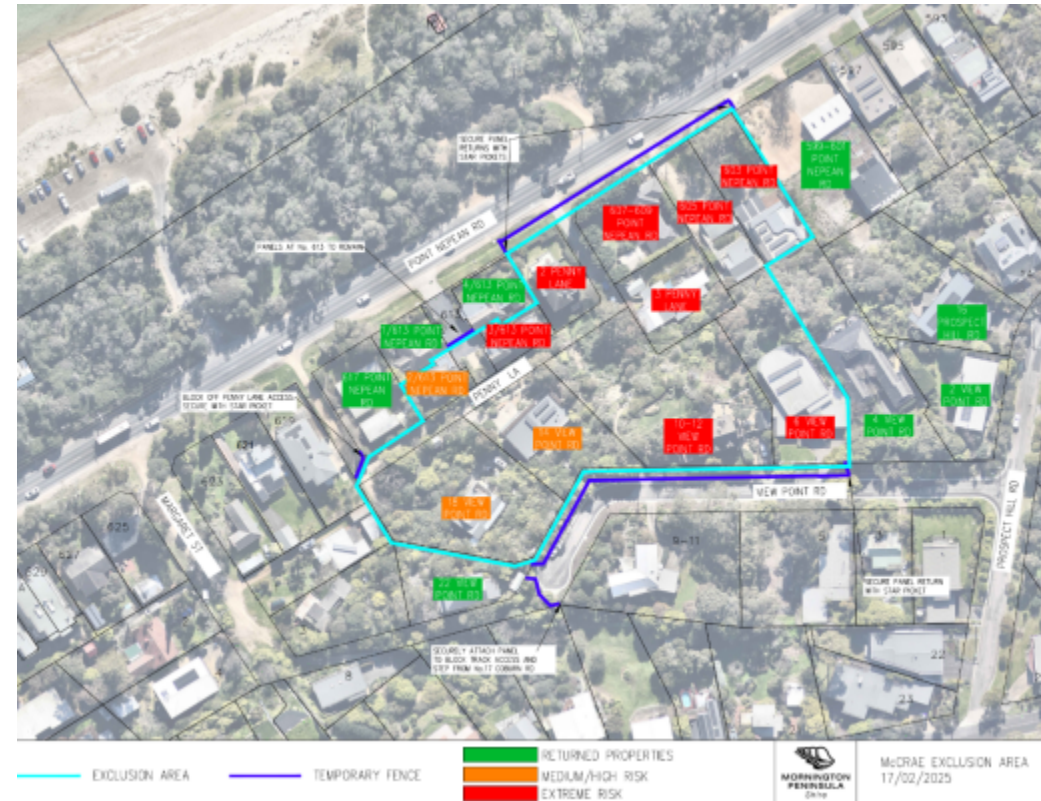
8 properties still remain in the exclusion zone with residents unable to return home.

McCrae Exclusion Area (as at 17 February 2025)
