McCrae Landslide - Evacuation Order Area

Geotechnical Factual Report

PSM5665-GFR REV0 9 April 2025

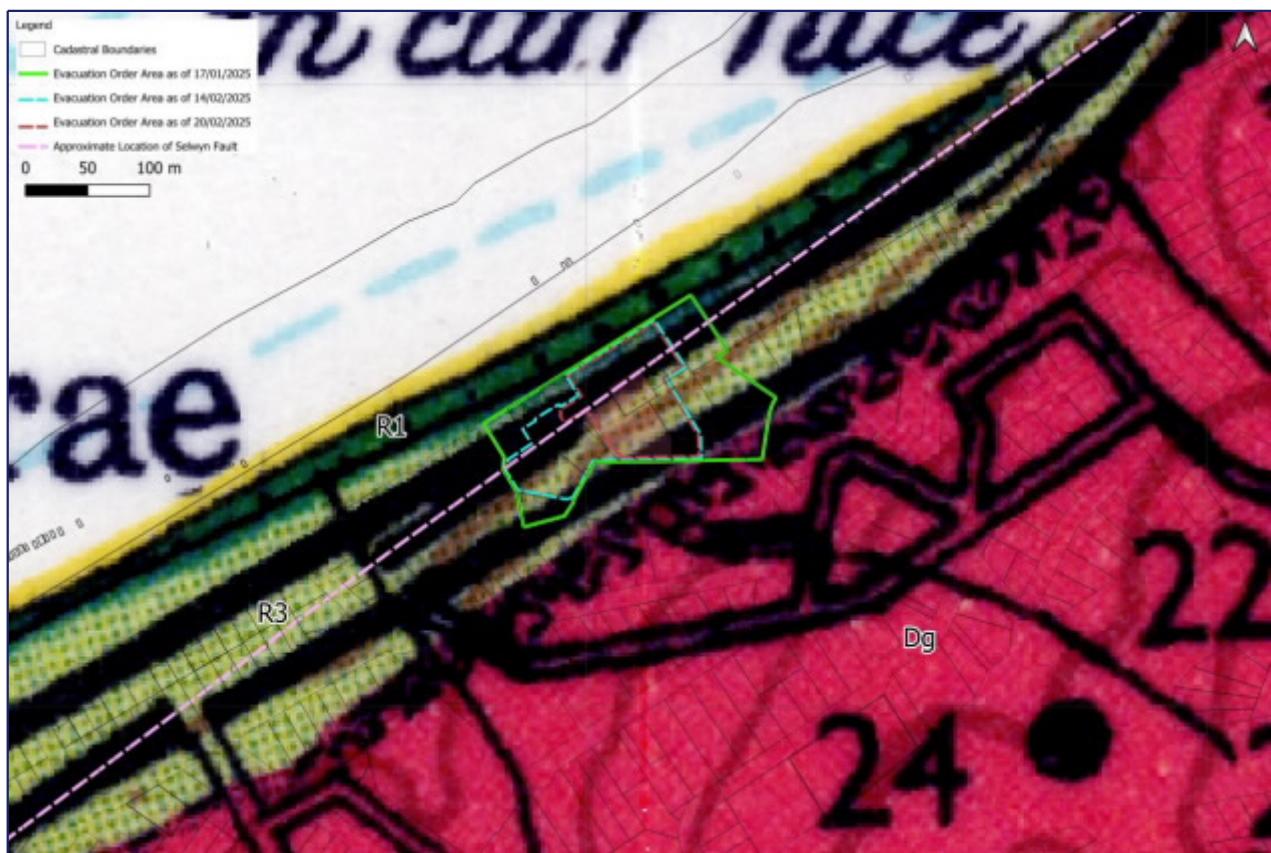
Inset 2: Mapped geology from the published Sorrento 1:63,360 geological map.

- Quaternary raised coastal deposits comprising siliceous and calcareous sand, shell beds, guano (Mud Islands) at the base of the escarpment (shown as R3 in Inset 2)
- Palaeozoic granodiorite and granite comprising the elevated terrain of and behind the escarpment (shown as Dg in Inset 2).

A major regional thrust fault, the Selwyn Fault is mapped at a scale of 1:250,000 to strike WSW-ENE and crossing immediately north of the Site (ref Inset 2).

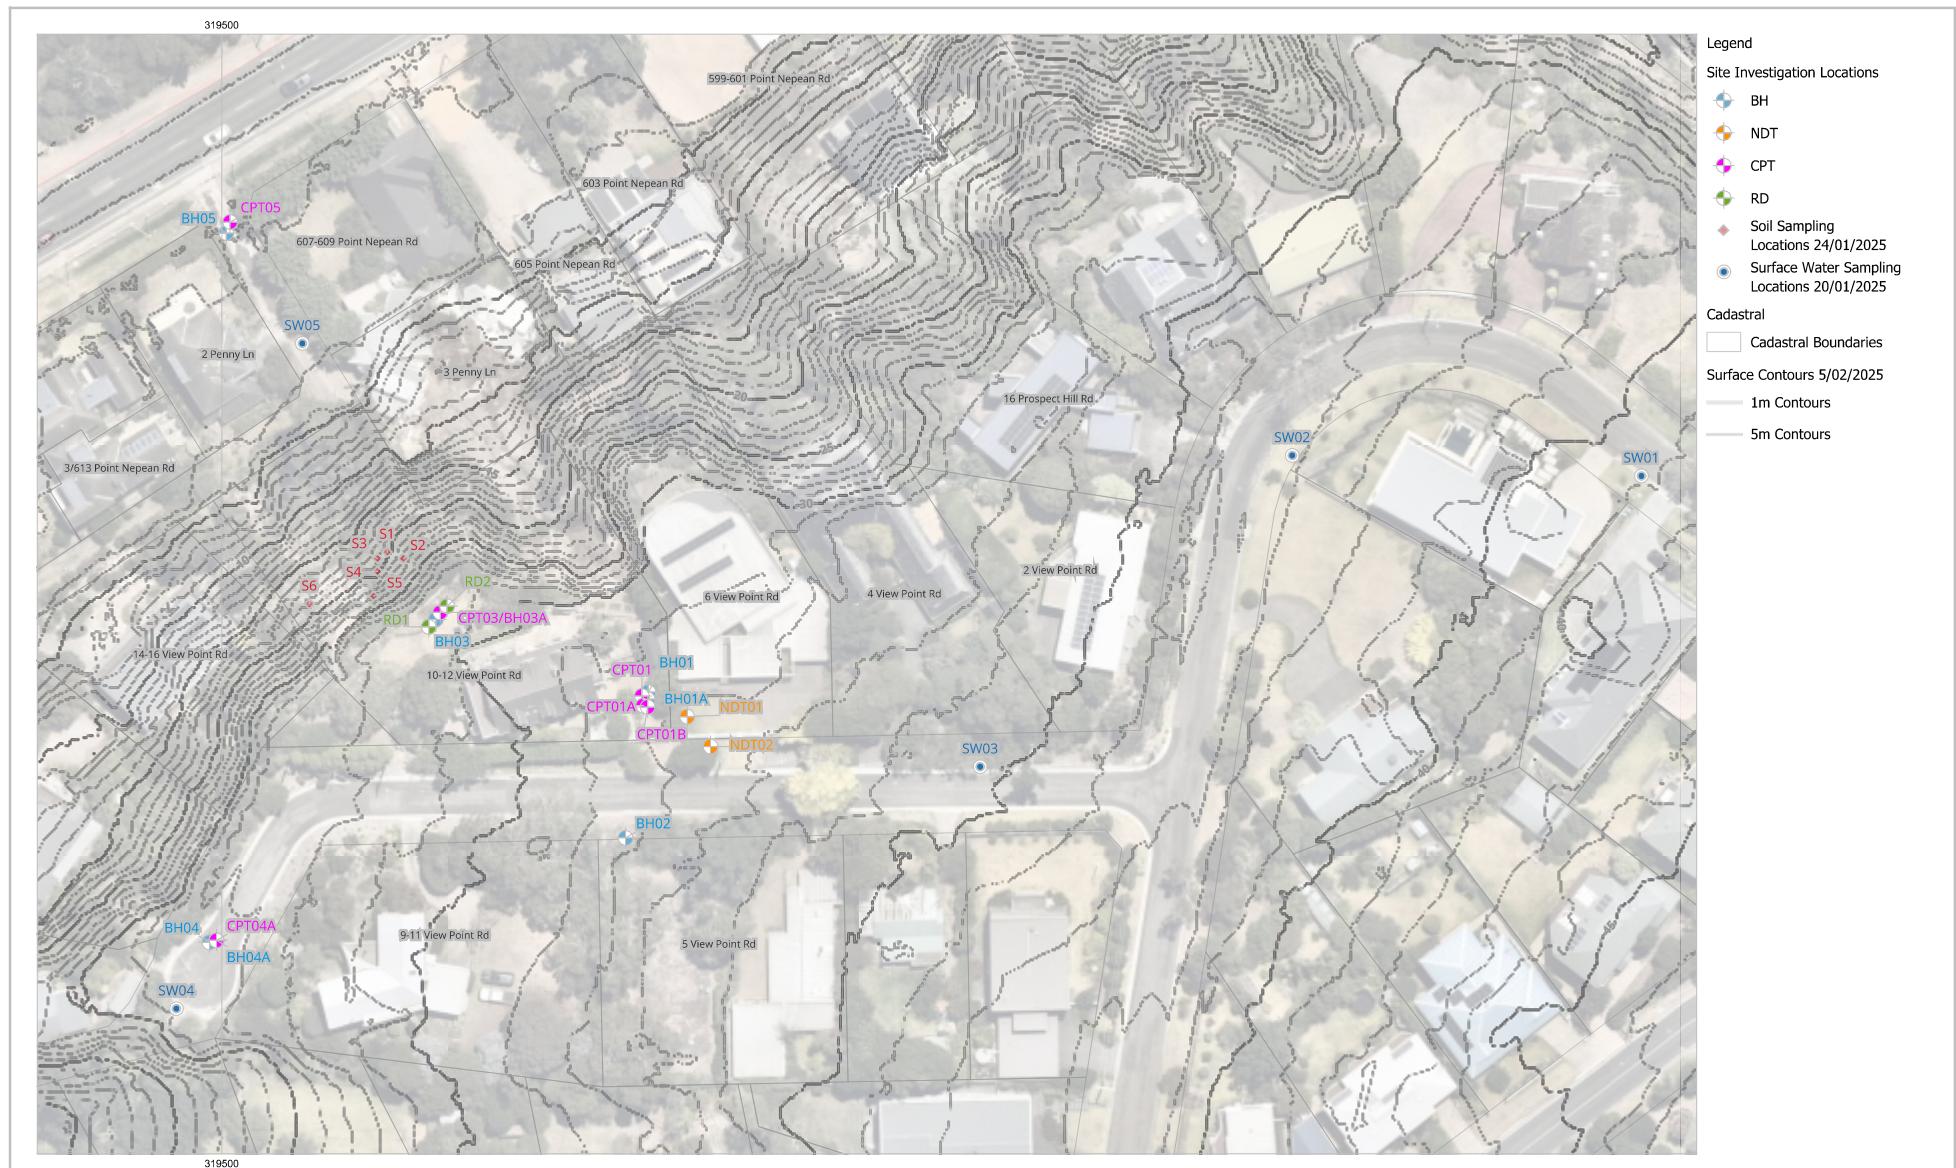
MORNINGTON PENINSULA
SHIRE COUNCIL
MCCRAE LANDSLIDE
GEOTECHNICAL
AND GROUNDWATER
INVESTIGATION PLAN

Soil samples were collected during the Site walkover on 24 January 2025 from the escarpment and flanks of the McCrae Landslide, Figure 1. Soil samples were also taken from boreholes BH01 to BH05 during the February 2025 site investigations. All were tested in a NATA accredited laboratory for moisture content, particle size distribution and Atterberg limits, Table 5. Laboratory testing certificates are presented in Appendix E.

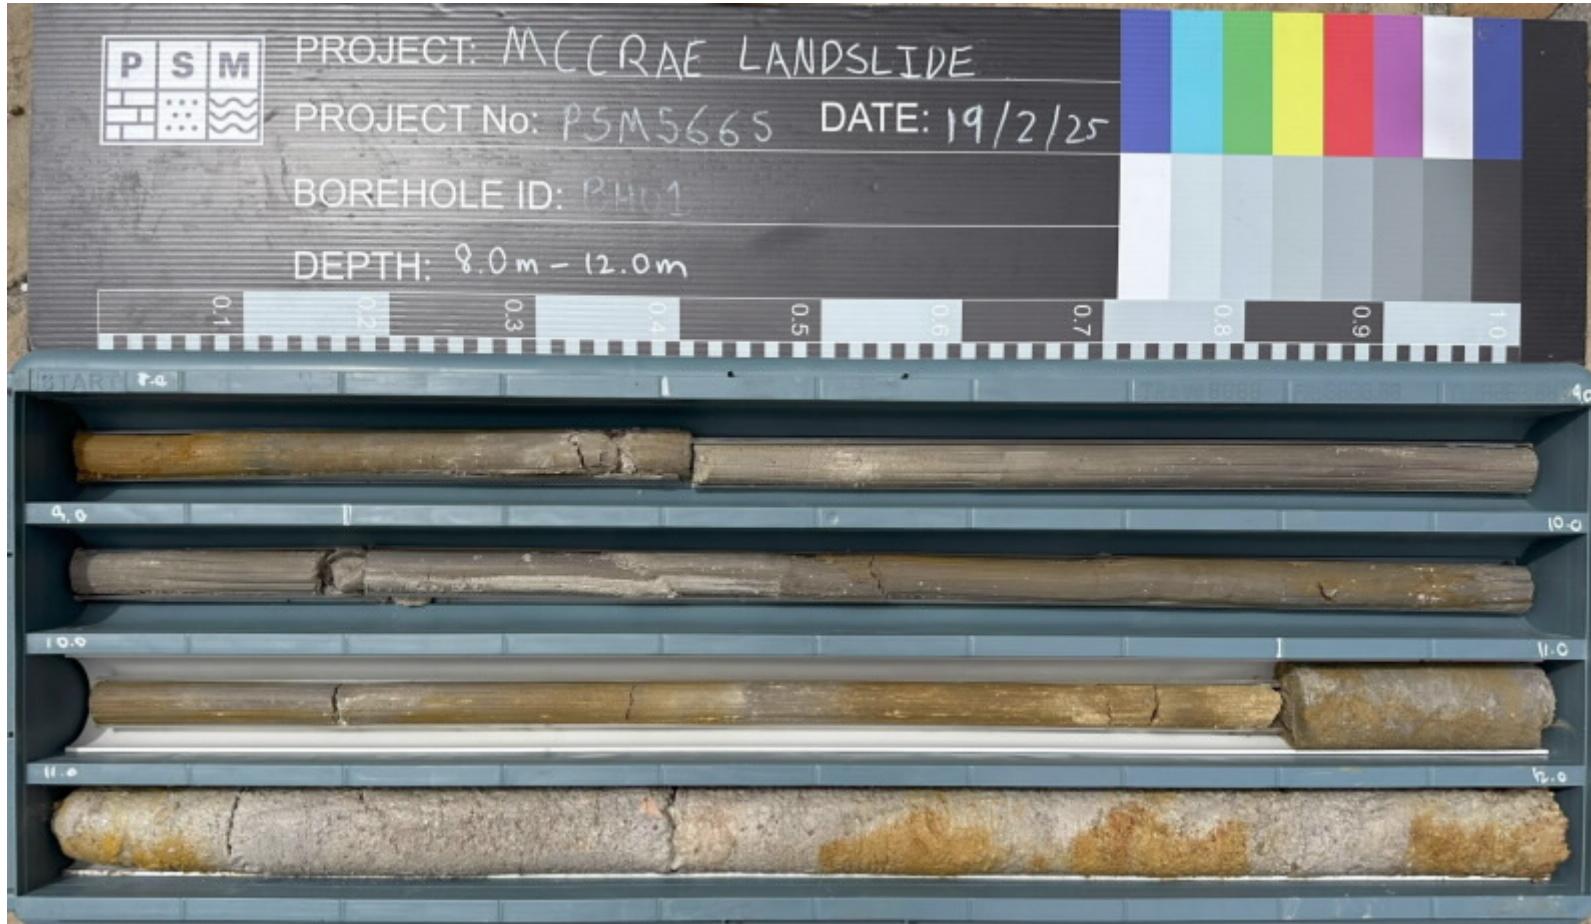
PointID : BH01 Depth Range: 8.00 - 12.00 m

TITLE Mornington Peninsula Shire Council McCrae Landslide Geotechnical Investigation Core Photo - BH01: 8.00 m - 12.00 m	DRAWN	BTA	DATE	6/03/2025
		CHECKED	TN	DATE	6/03/2025
		SCALE	Not To Scale		A4
		PROJECT NO	PSM5665	FIGURE NO	3/8

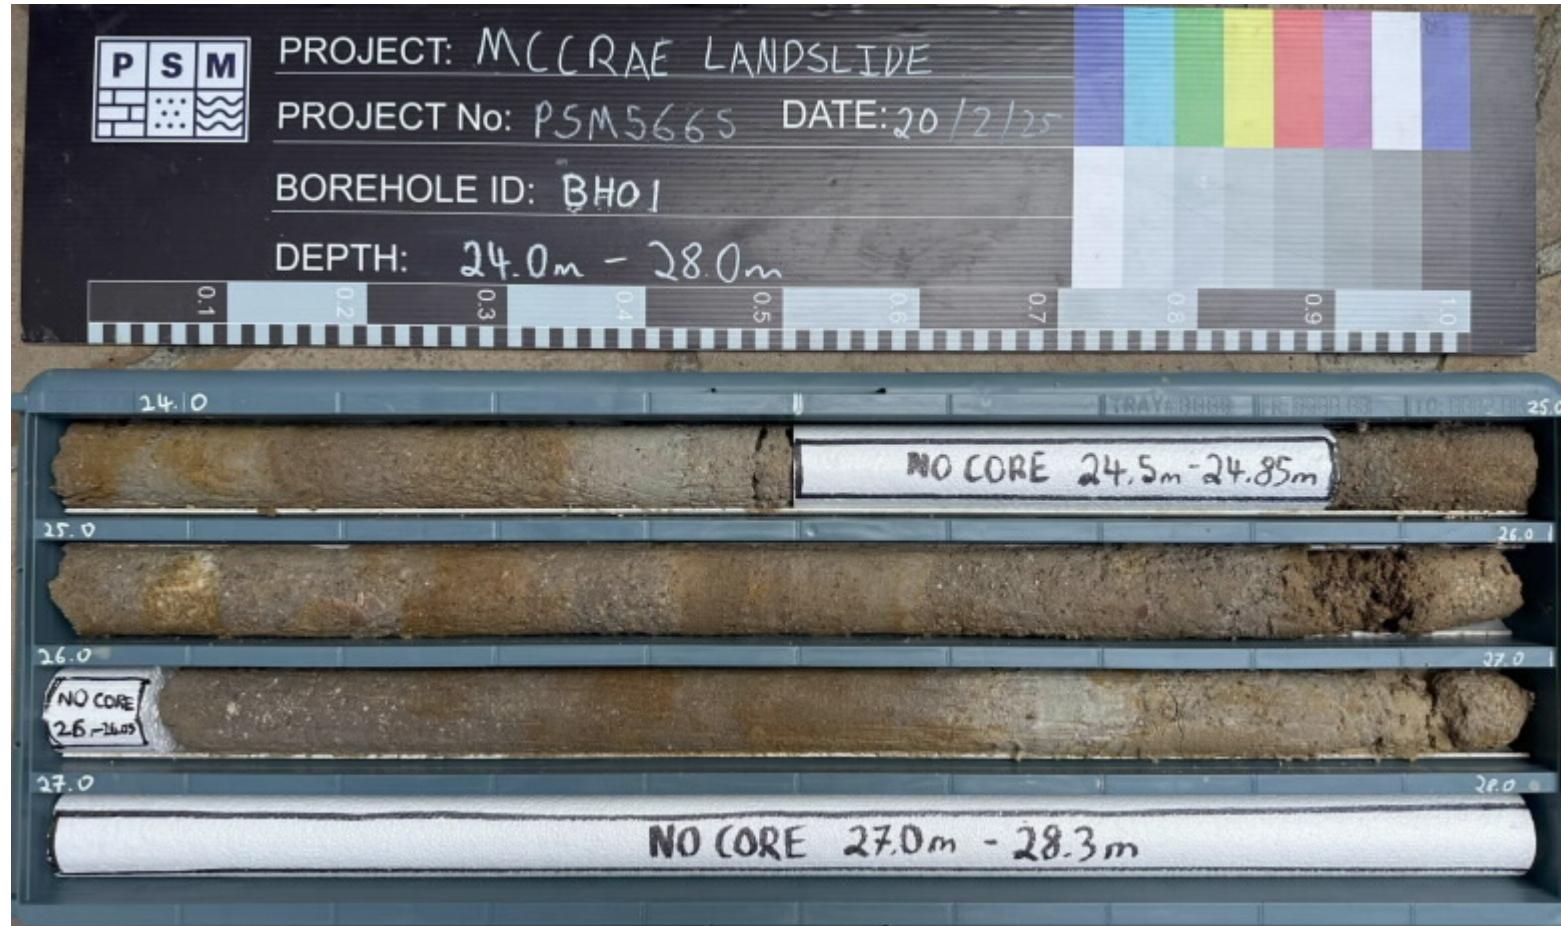
PointID : BH01 Depth Range: 24.00 - 28.00 m

TITLE Mornington Peninsula Shire Council McCrae Landslide Geotechnical Investigation Core Photo - BH01: 24.00 m - 28.00 m	DRAWN	BTA	DATE
		CHECKED	TN	DATE
		SCALE	Not To Scale	A4
		PROJECT No	PSM5665	FIGURE No
				7/8

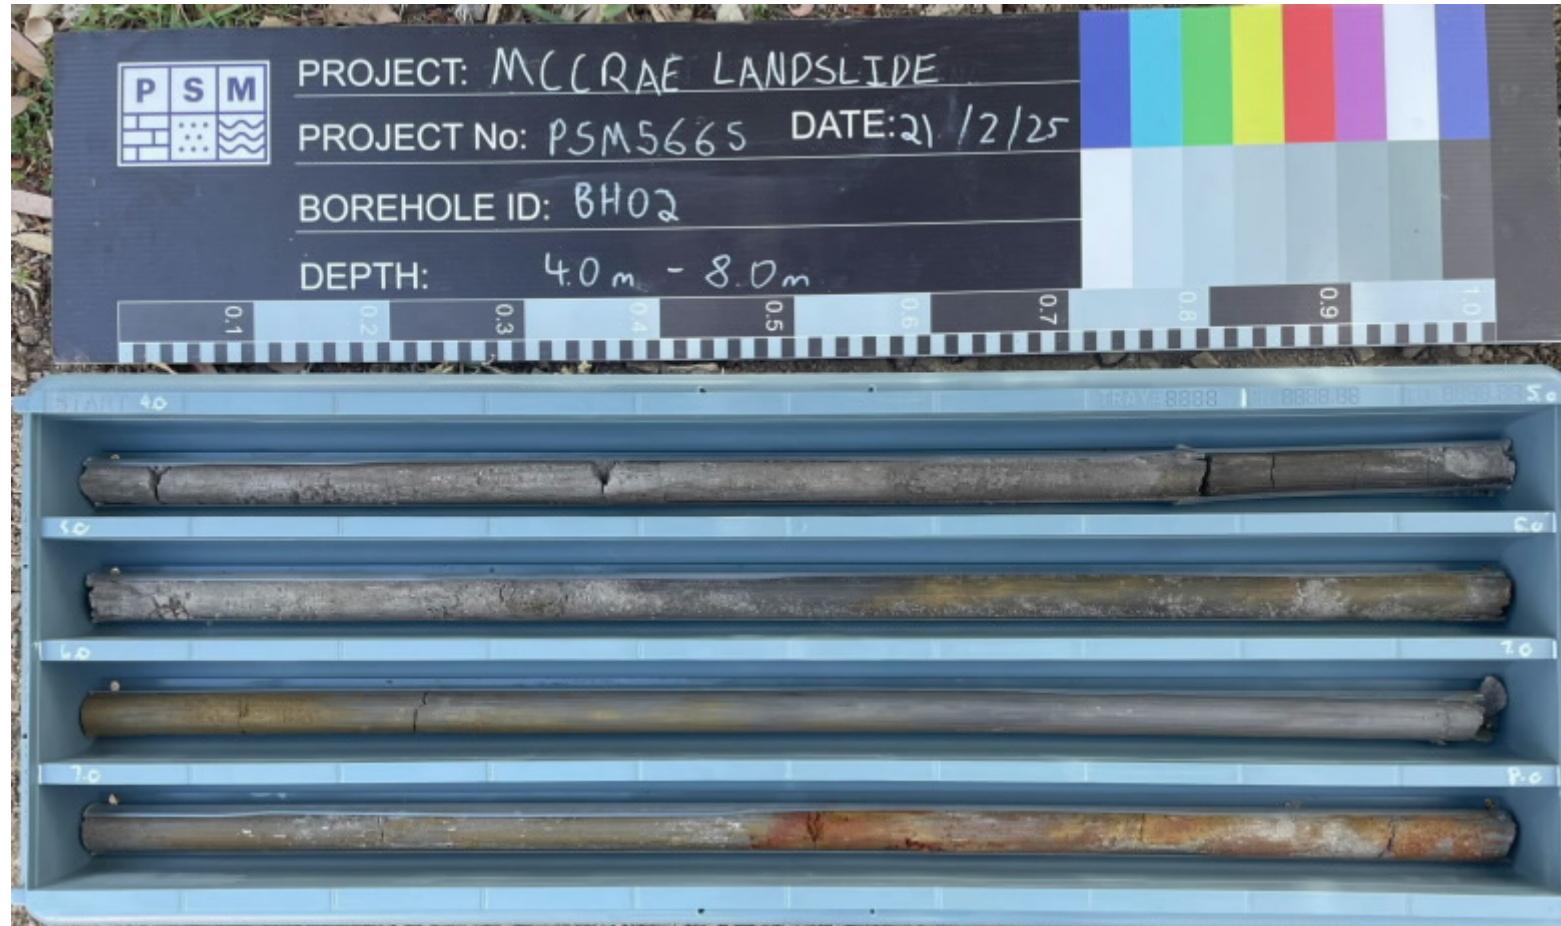
PointID : BH02 Depth Range: 4.00 - 8.00 m

TITLE Mornington Peninsula Shire Council McCrae Landslide Geotechnical Investigation Core Photo - BH02: 4.00 m - 8.00 m	DRAWN	BTA	DATE
		CHECKED	TN	DATE
		SCALE	Not To Scale	A4
		PROJECT NO	PSM5665	FIGURE NO
				2/8

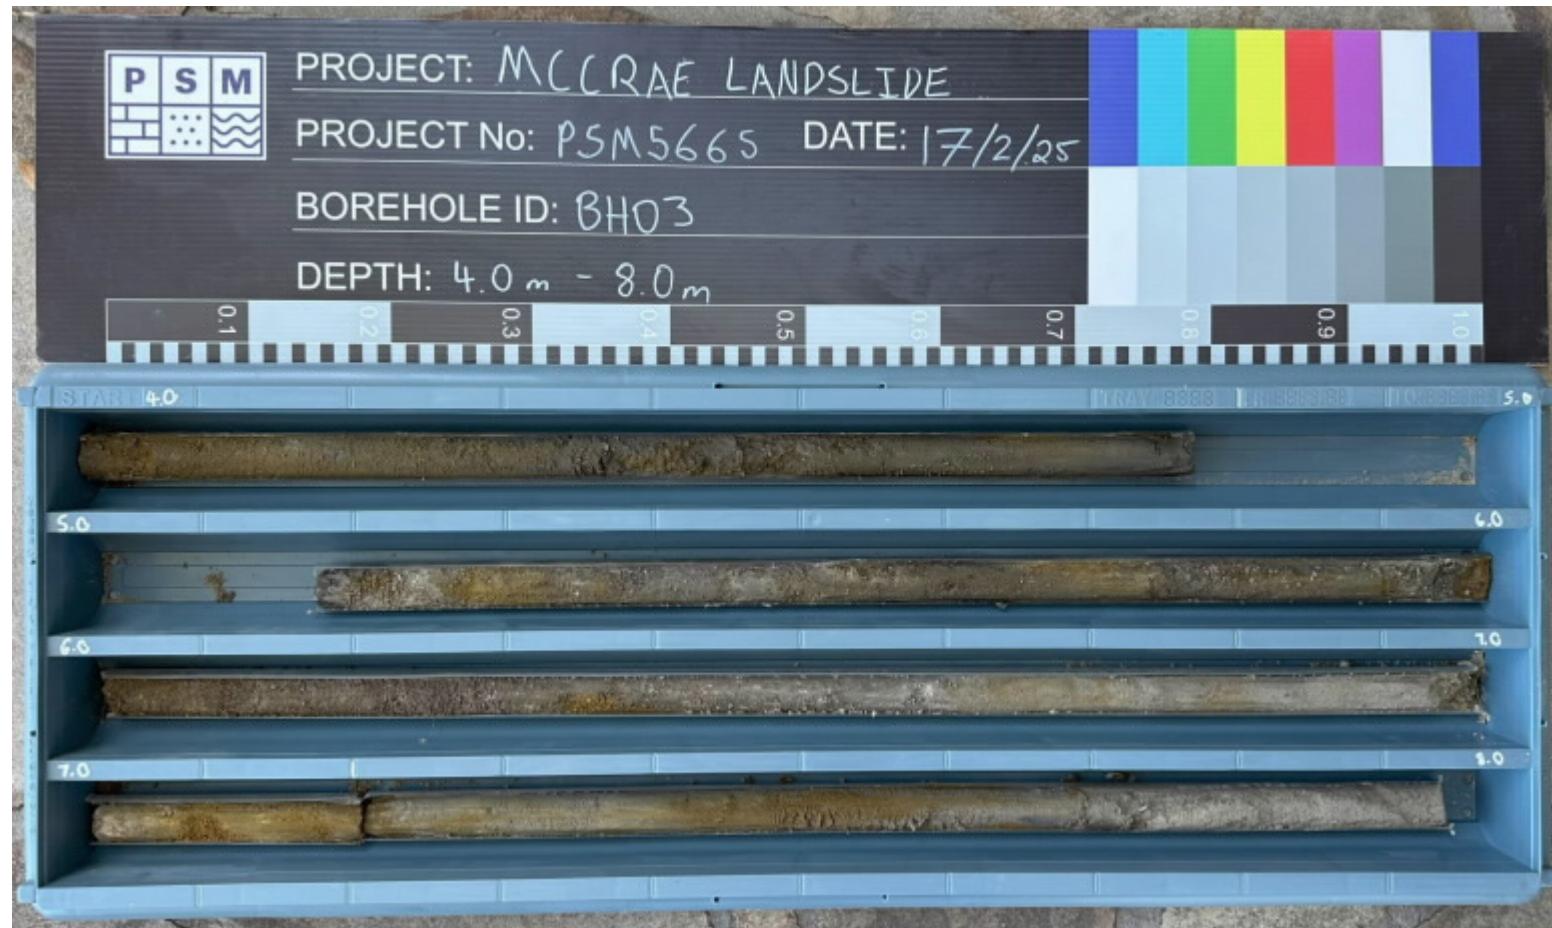
PointID : BH03 Depth Range: 4.00 - 8.00 m

TITLE Mornington Peninsula Shire Council McCrae Landslide Geotechnical Investigation Core Photo - BH03: 4.00 m - 8.00 m	DRAWN	BTA	DATE	6/03/2025
		CHECKED	TN	DATE	6/03/2025
		SCALE	Not To Scale		A4
		PROJECT NO	PSM5665	FIGURE NO	2/8

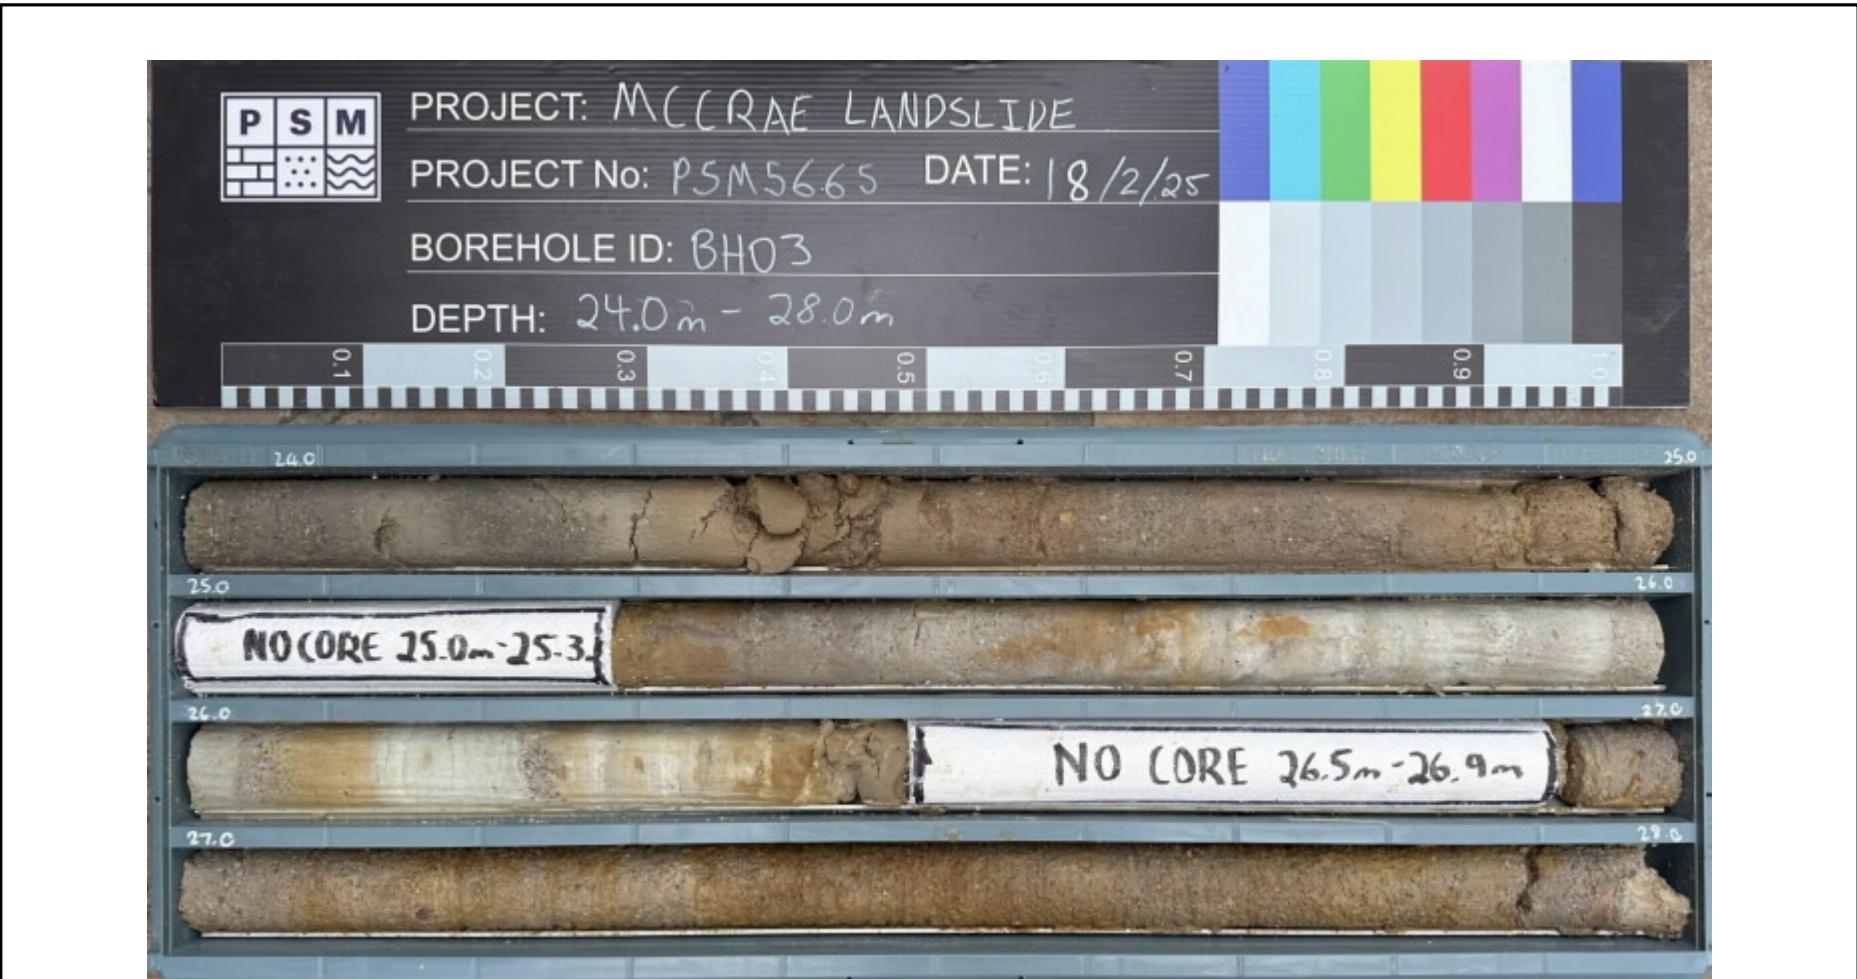
PointID : BH03 Depth Range: 24.00 - 28.00 m

TITLE Mornington Peninsula Shire Council McCrae Landslide Geotechnical Investigation Core Photo - BH03: 24.00 m - 28.00 m	DRAWN	BTA	DATE
		CHECKED	TN	DATE
		SCALE	Not To Scale	A4
		PROJECT No	PSM5665	FIGURE No
				7/8

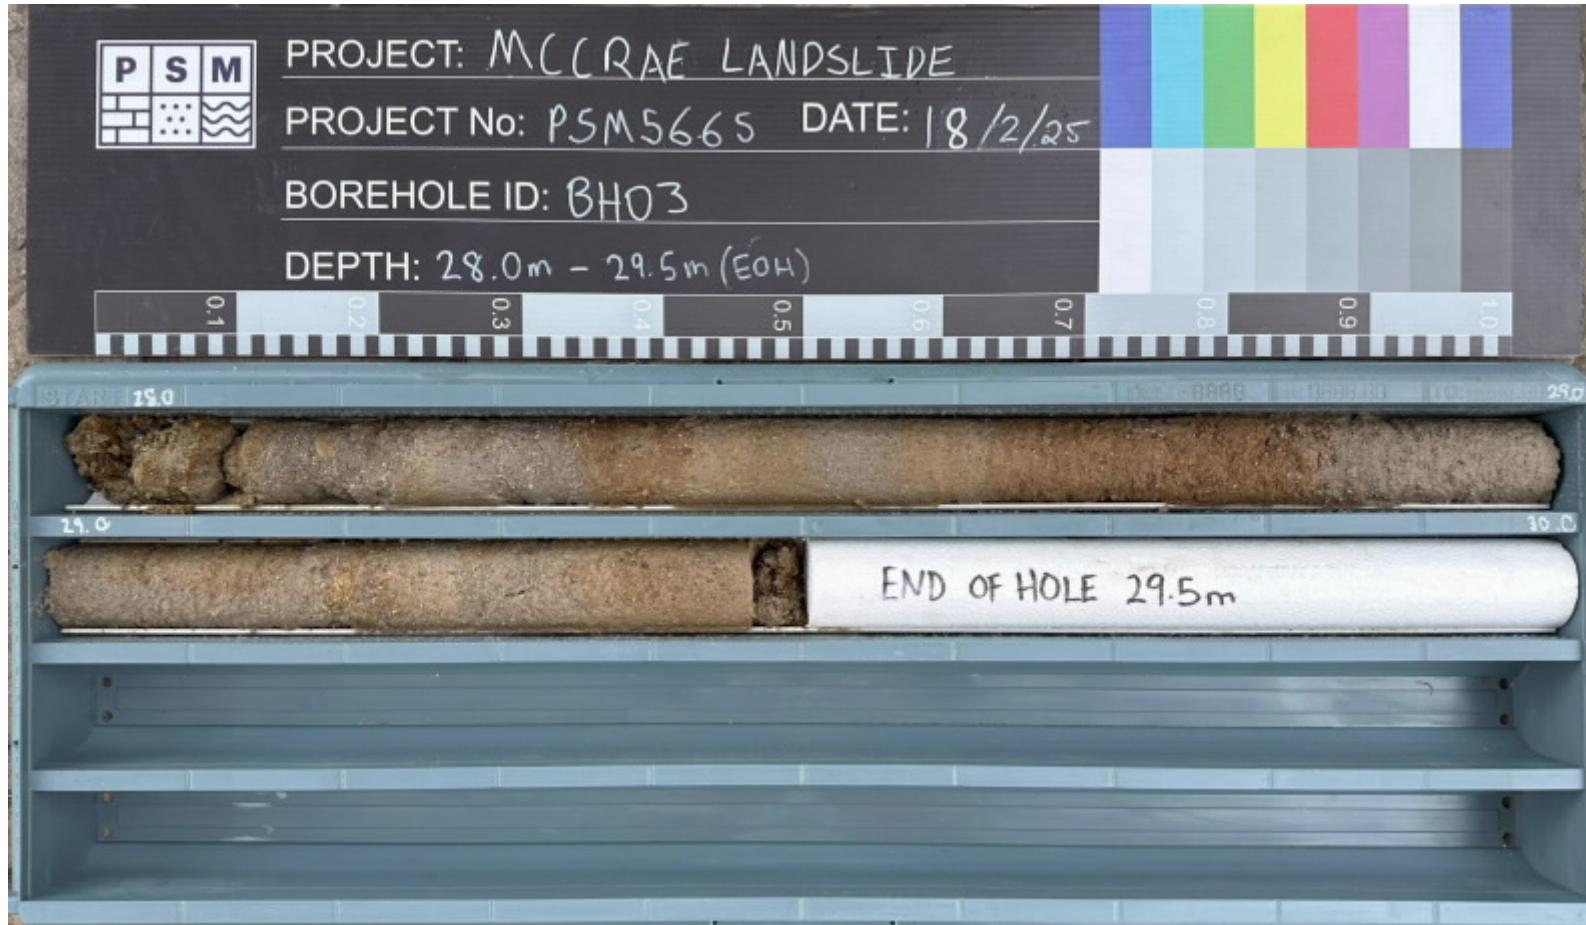
PointID : BH03 Depth Range: 28.00 - 29.50 m

TITLE Mornington Peninsula Shire Council McCrae Landslide Geotechnical Investigation Core Photo - BH03: 28.00 m - 29.50 m	DRAWN	BTA	DATE
		CHECKED	TN	DATE
		SCALE	Not To Scale	A4
		PROJECT NO	PSM5665	FIGURE NO
				8/8

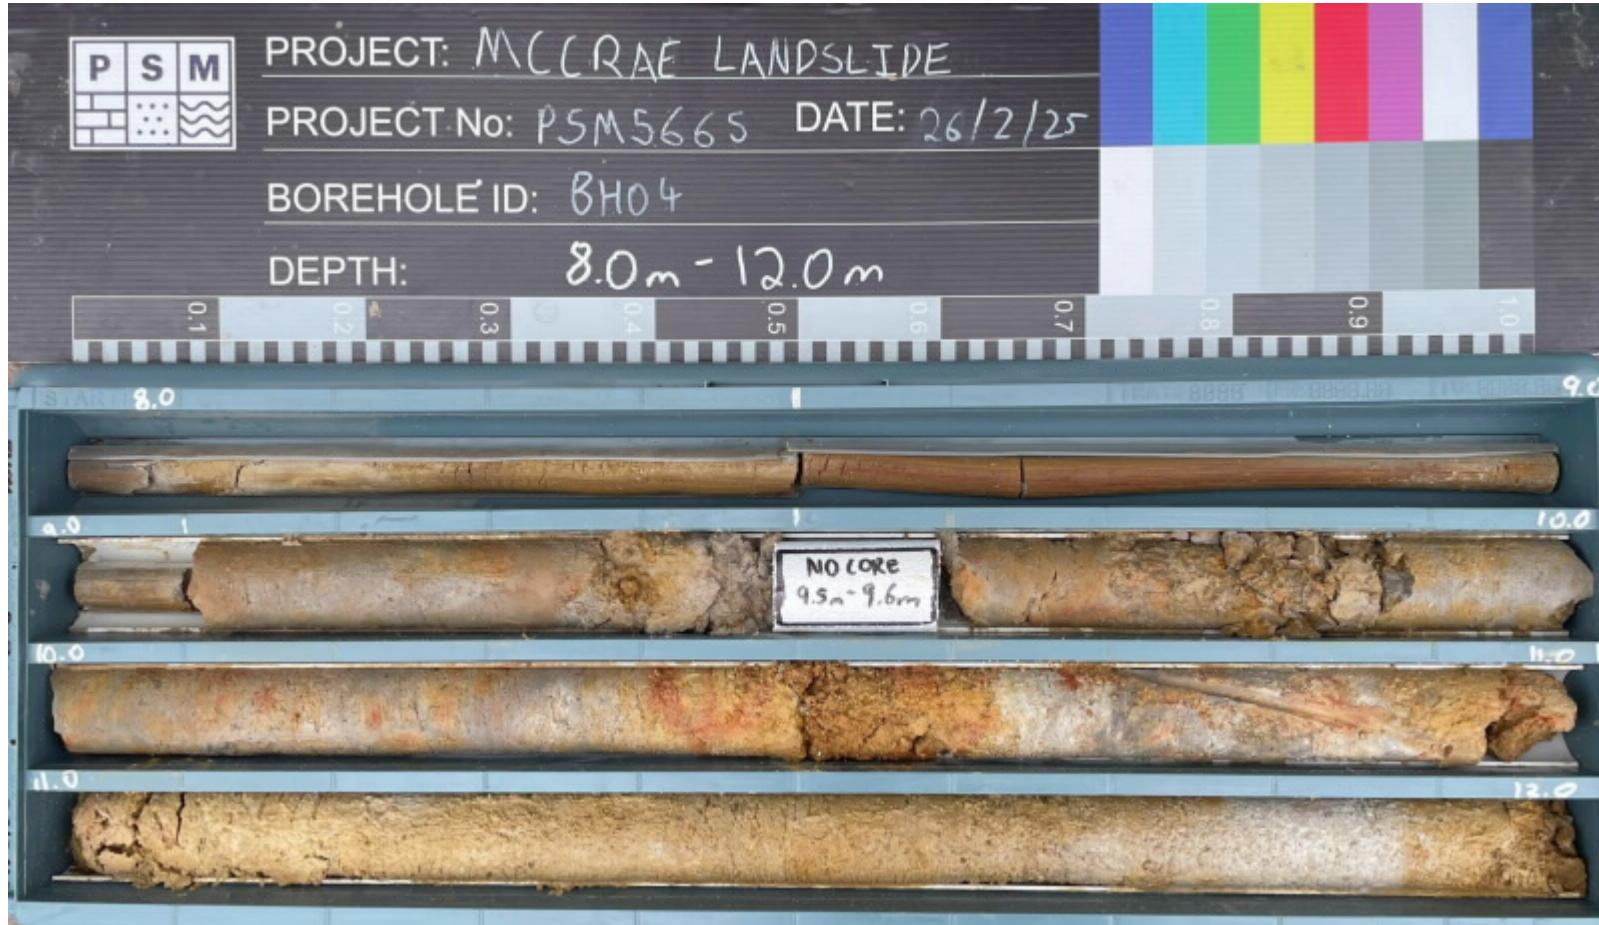
PointID : BH04 Depth Range: 8.00 - 12.00 m

TITLE Mornington Peninsula Shire Council McCrae Landslide Geotechnical Investigation Core Photo - BH04: 8.00 m - 12.00 m	DRAWN	BTA	DATE	6/03/2025
		CHECKED	TN	DATE	6/03/2025
		SCALE	Not To Scale		A4
		PROJECT NO	PSM5665	FIGURE NO	3/8

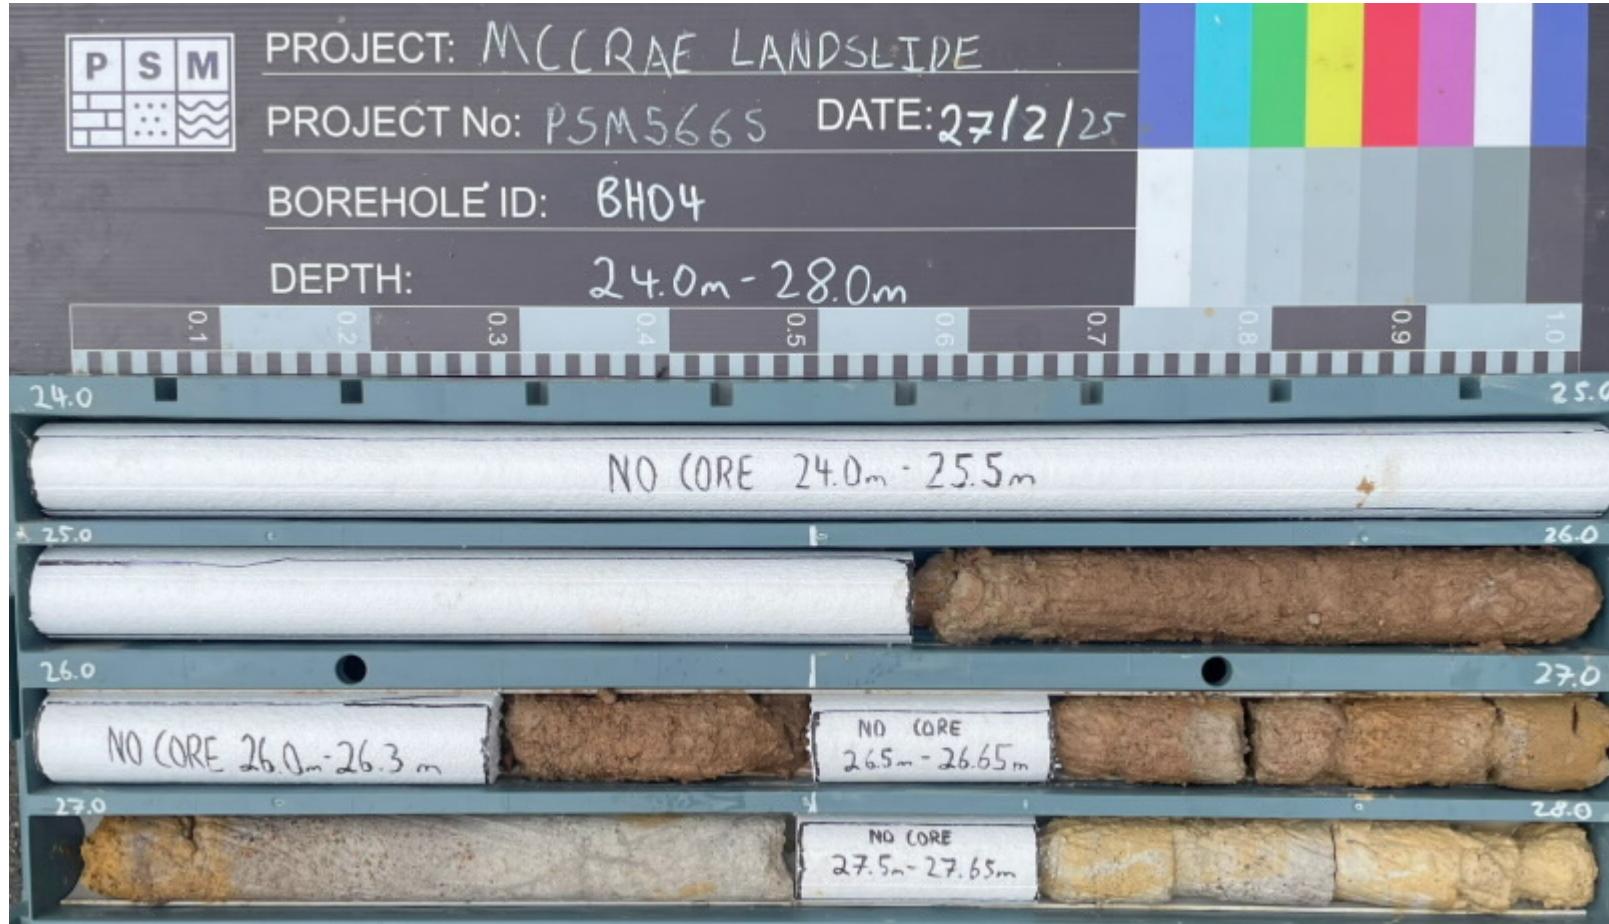
PointID : BH04 Depth Range: 24.00 - 28.00 m

TITLE Mornington Peninsula Shire Council McCrae Landslide Geotechnical Investigation Core Photo - BH04: 24.00 m - 28.00 m	DRAWN	BTA	DATE	6/03/2025
		CHECKED	TN	DATE	6/03/2025
		SCALE	Not To Scale		A4
		PROJECT NO	PSM5665	FIGURE NO	7/8

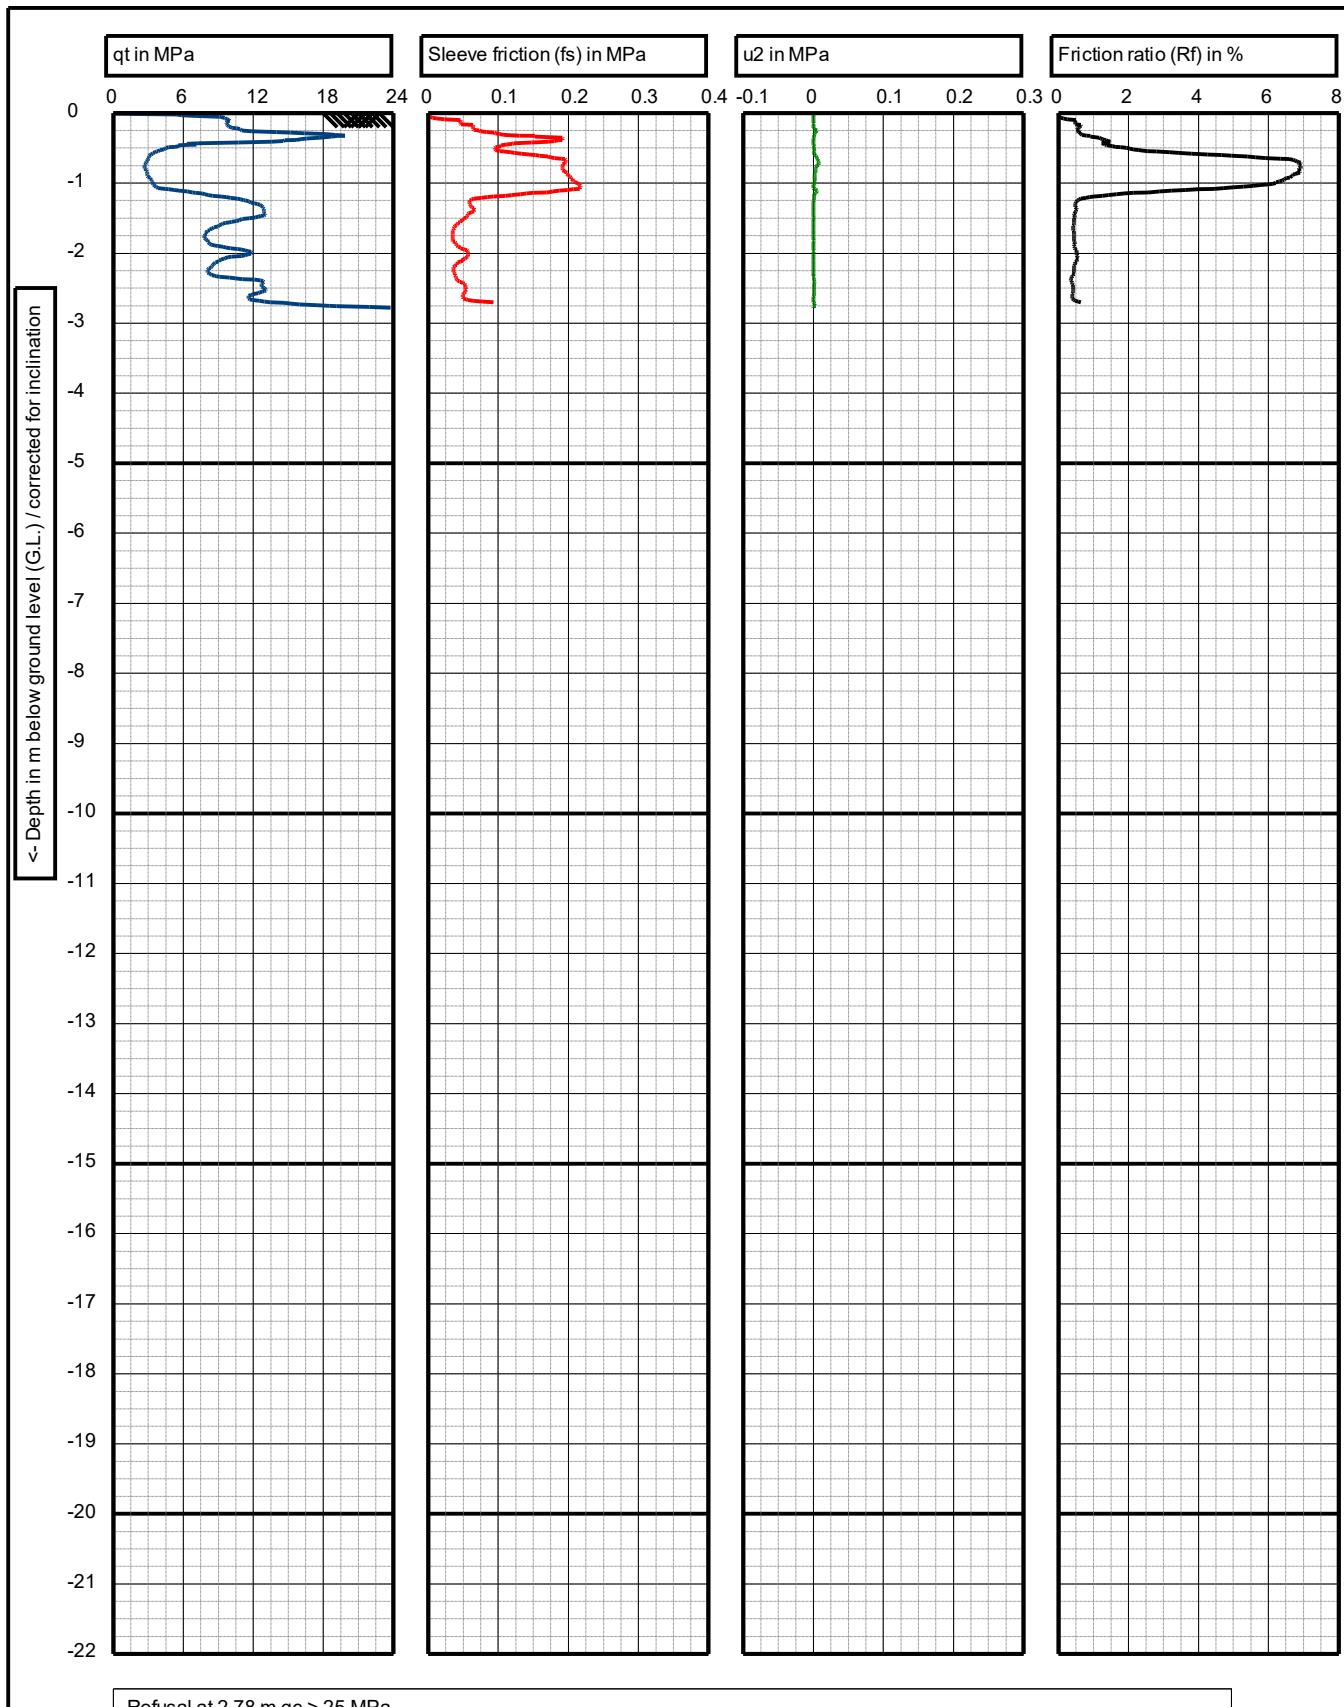
Refusal at 2.78 m $qc > 25$ MPa
