## Chronology of customer requests received from the Shire between November 2024 and late January 2025 that could be related to Water Main Burst.

### Stormwater Drainage Concern

# Q4.3(iii)-A

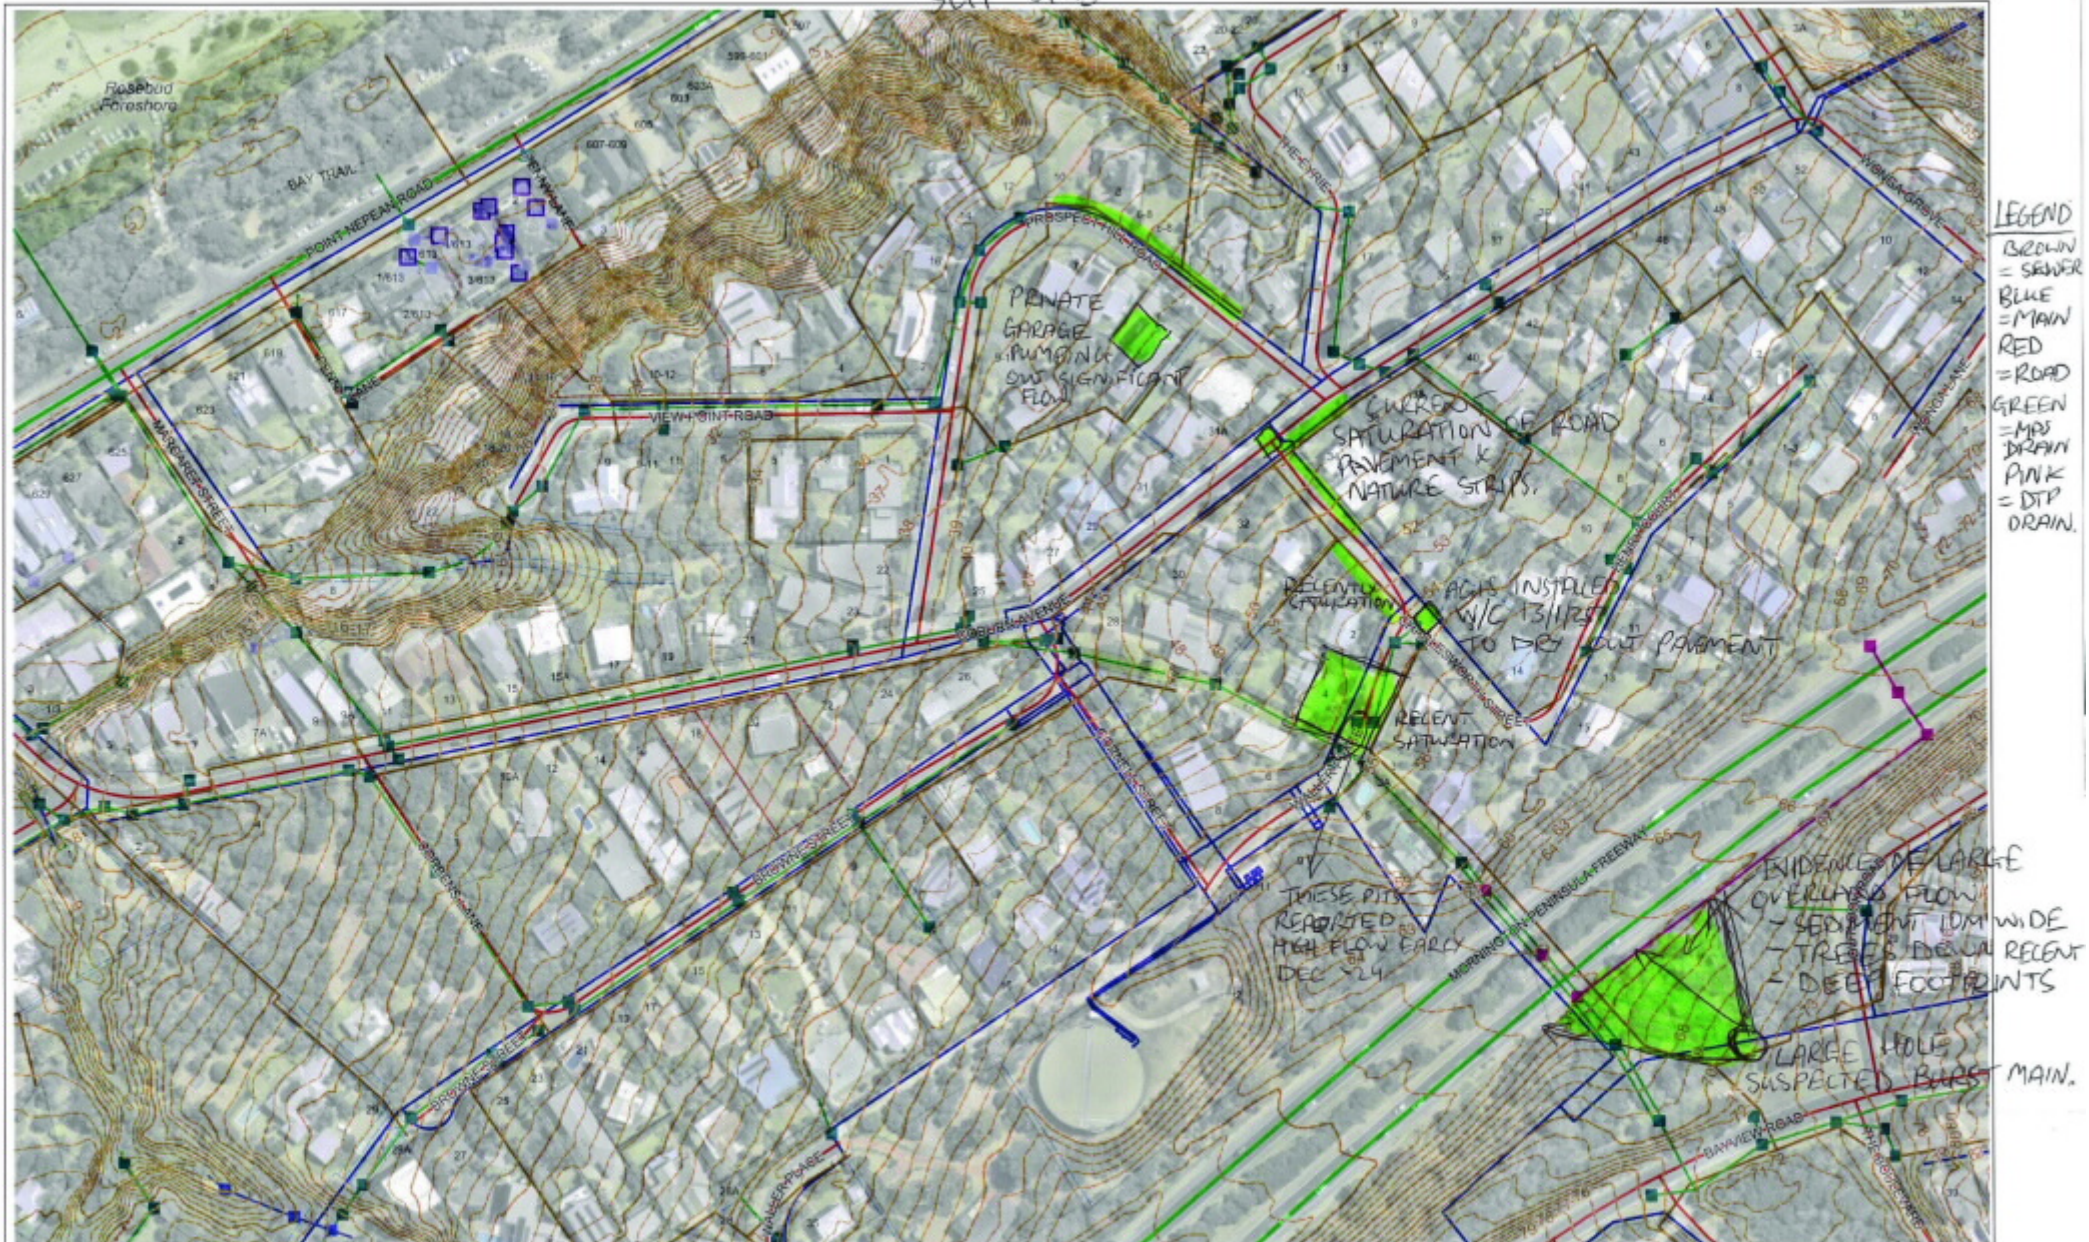
SLIP SITE

SKETCH FROM ONSITE OBSERVATIONS & RESIDENT DISCUSSIONS.

OBSERVATIONS SUGGEST WATER MAY BE FLOWING IN SEWER TRENCHES (NOT WITHIN PIPES).

GREEN HIGHLIGHT SHOWS RECENT OR CURRENT SATURATED ZONES.  
ZONES FURTHER UP HILL OCCURRED FIRST IN DECEMBER 2024

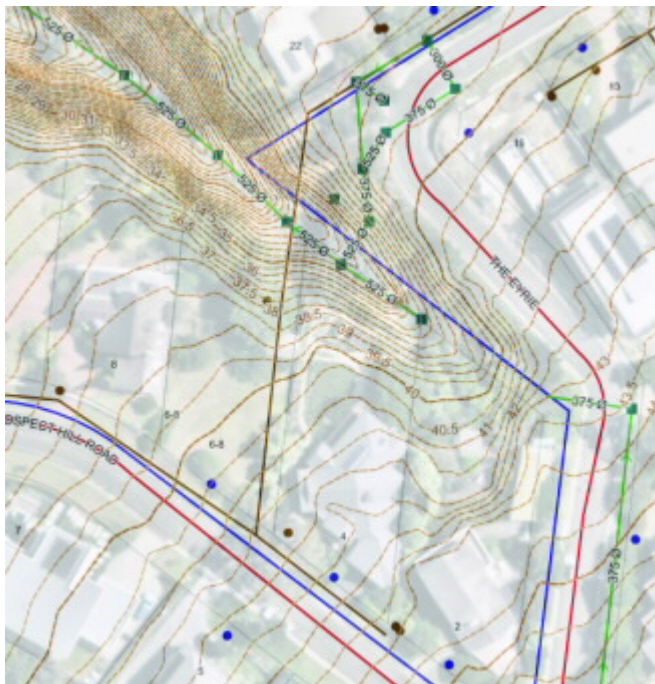
Could you please also advise whether the sewer running between Prospect Hill Rd and The Eyrie (map below) runs north through gravity or is pumped south?
