Leak Report

4 Waller Place McCrae Victoria 3938 Australia

Leak Address	4 Waller Place McCrae Victoria 3938 Australia
Zone	South East Water ► Reactive Leaks
Leak Asset Type	No Leaks Found
Has the leak been called in by DS Technician?	Yes
Job Ref	1295094/003
Leak Visible	No

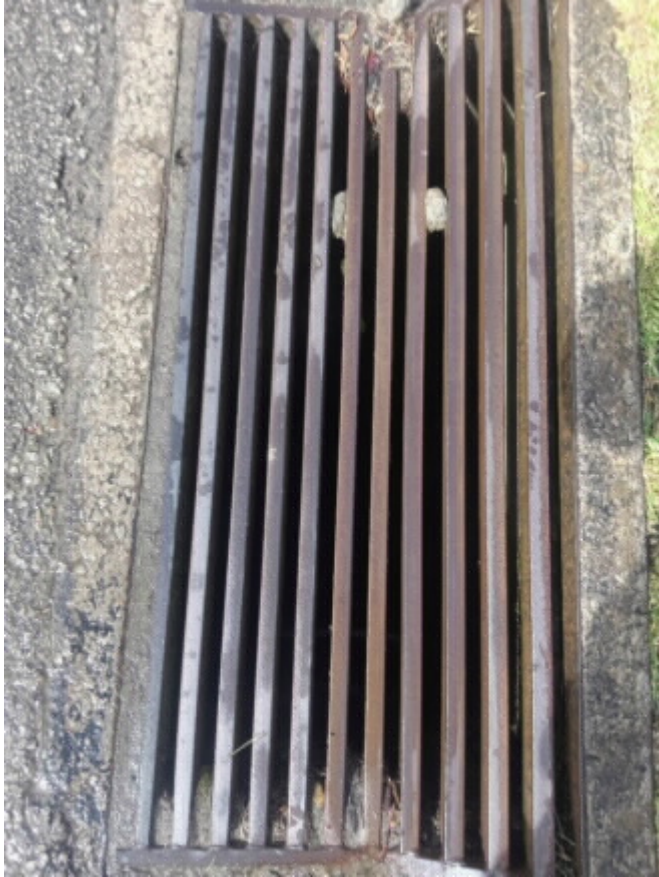
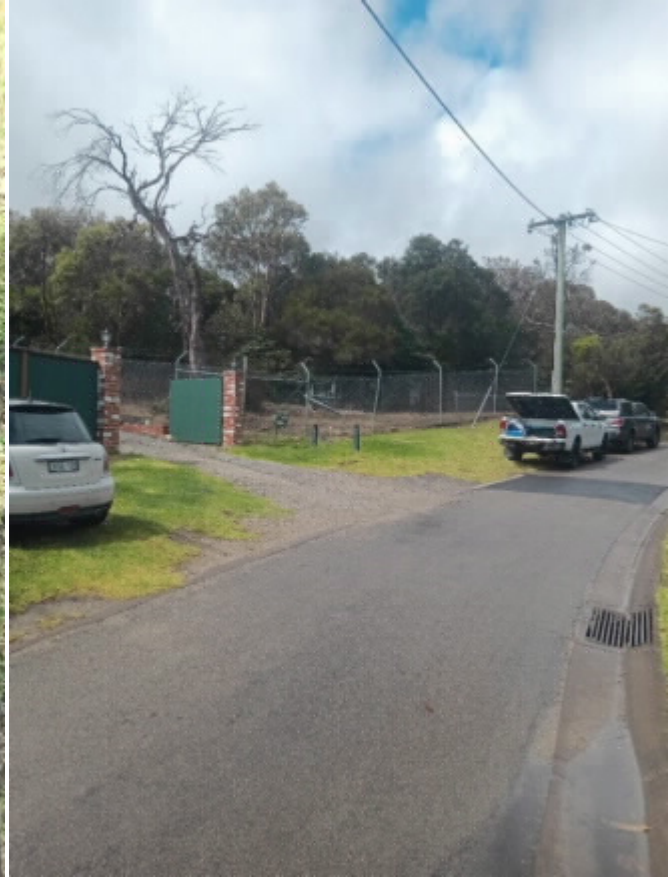
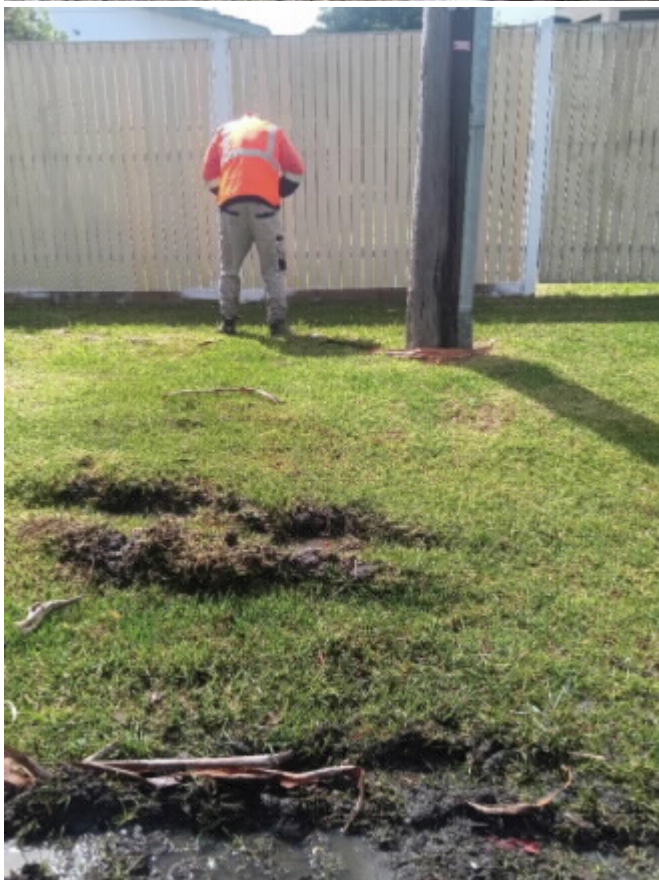
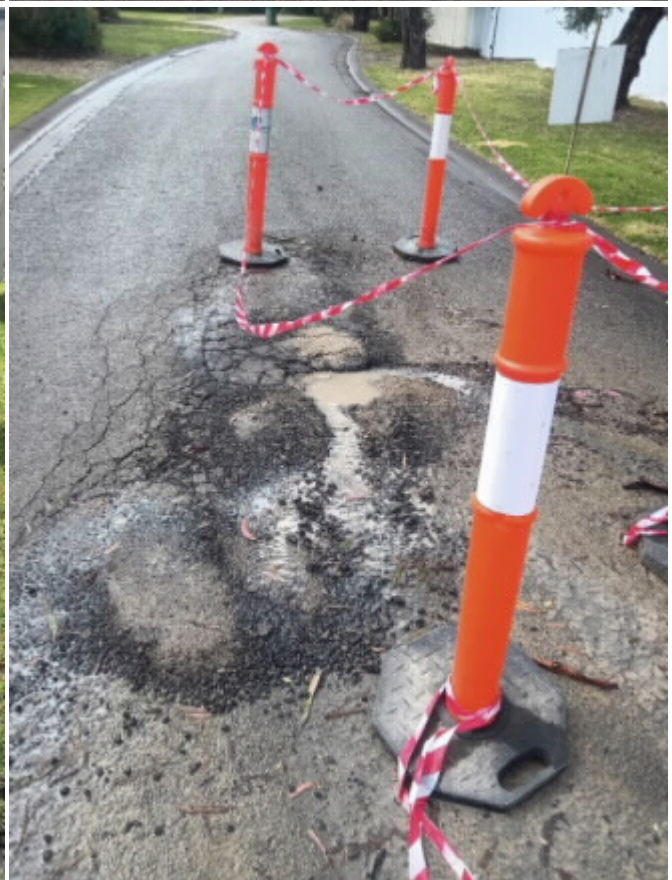
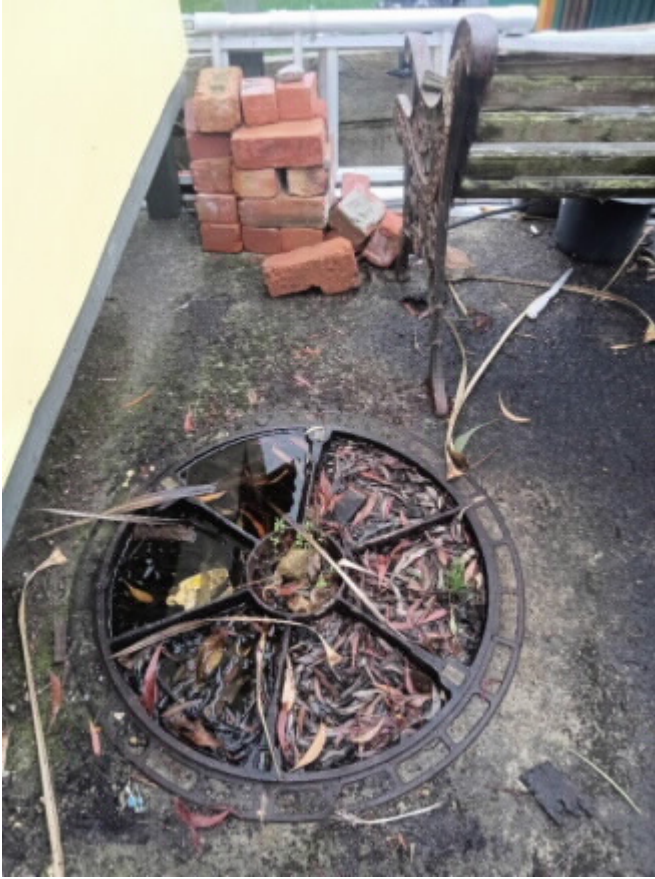
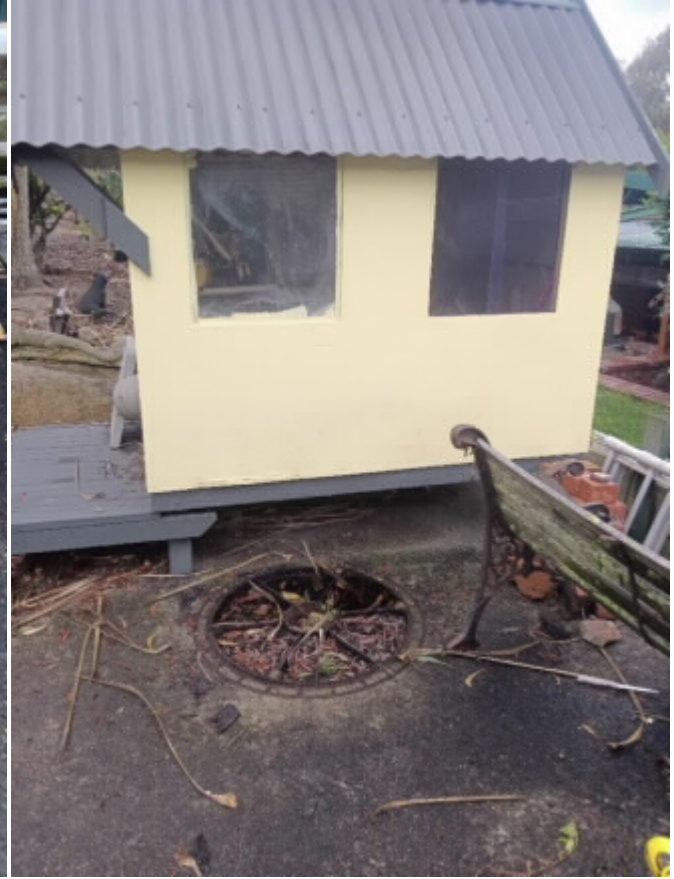
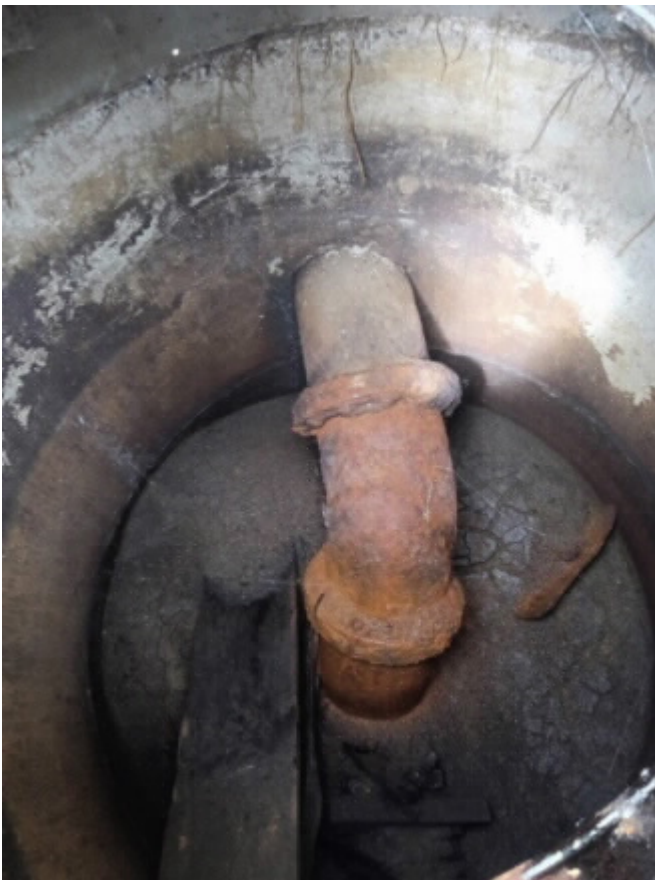
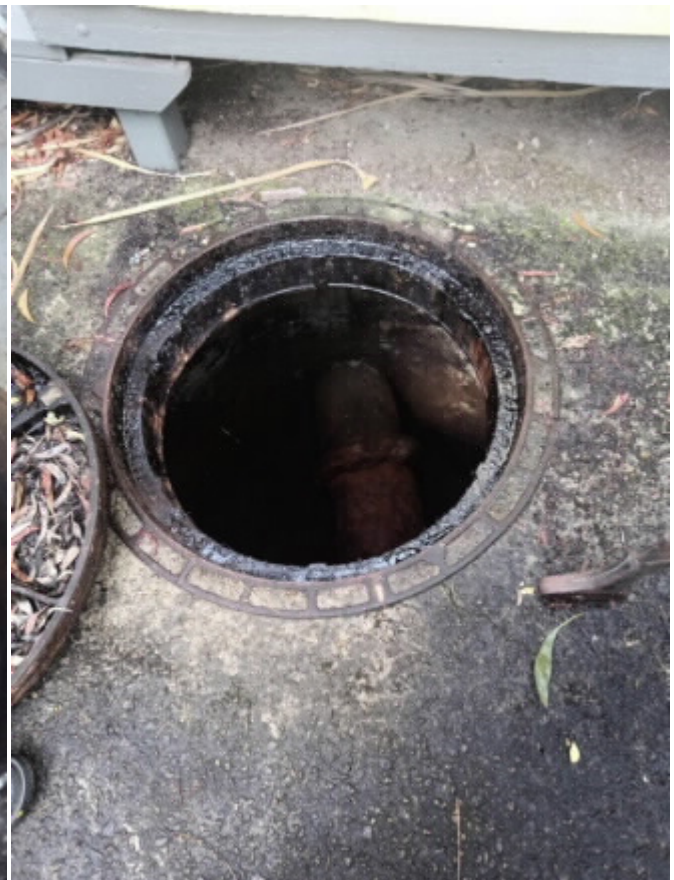
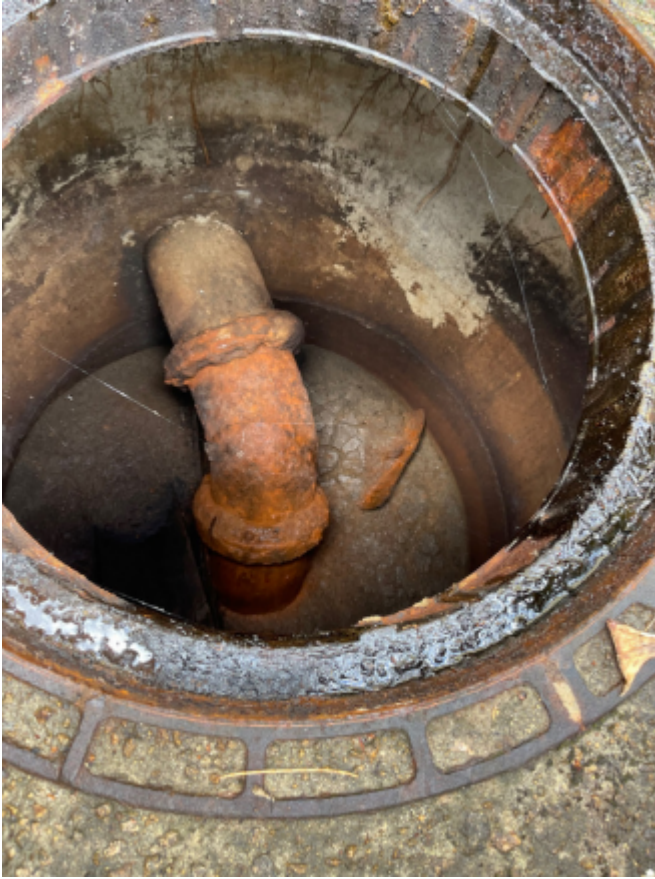
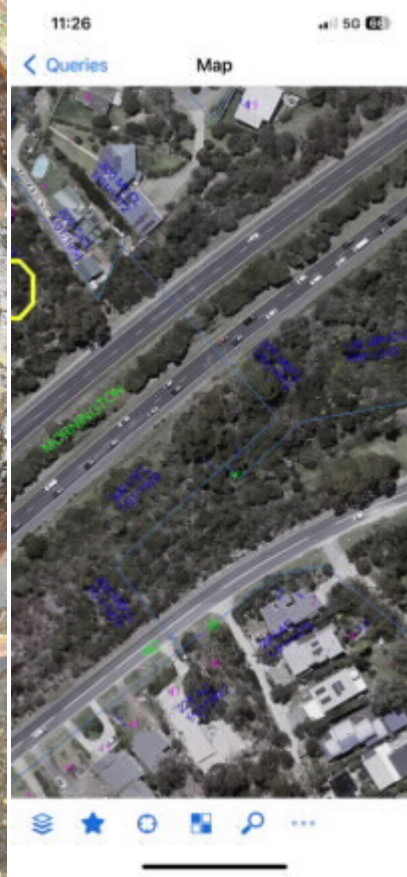
Photo

Sounded all assets in the area, followed suspect 300mm main and no leaks were detected. Chlorine sample needs to be taken when rain stops.

The new owners at 4 Waller and the owner Bret of number 5 (has lived here for the past 20 years) has let us at the back of his block where he has an old Water style lid cover (see attached photos) it houses the 14" main elbow it's very deep 4m is actually not on his property, although it's fencing inside his property, we just popped the and sounded it directly, no noise at all. Apparently the drains run all year round, but the water has got a lot worse and it's affected on the roadways and two locations bubbling up and damaging the road. It been partially barricaded of.

I don't believe there's any leaks on the mains but still some of the smaller pipes really haven't checked out. Jason Marsh will return take samples when it's not raining for a few days.
