Our Ref: PSM5226-002L

RE: RISK ASSESSMENT. 10-12 VIEW POINT ROAD, MCRAE

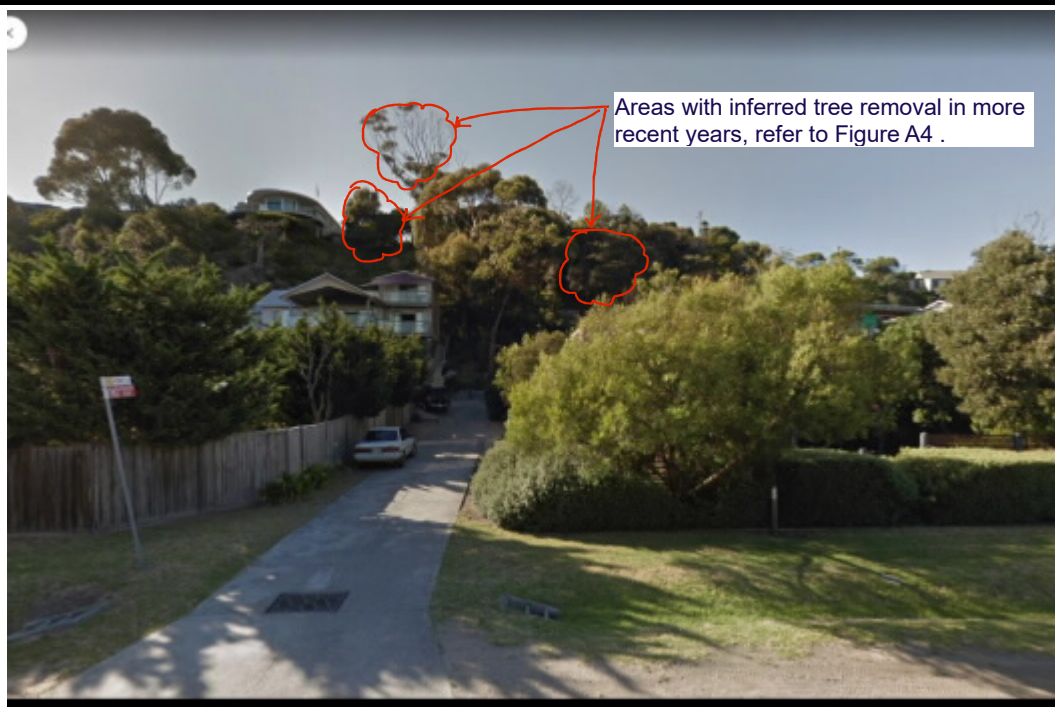
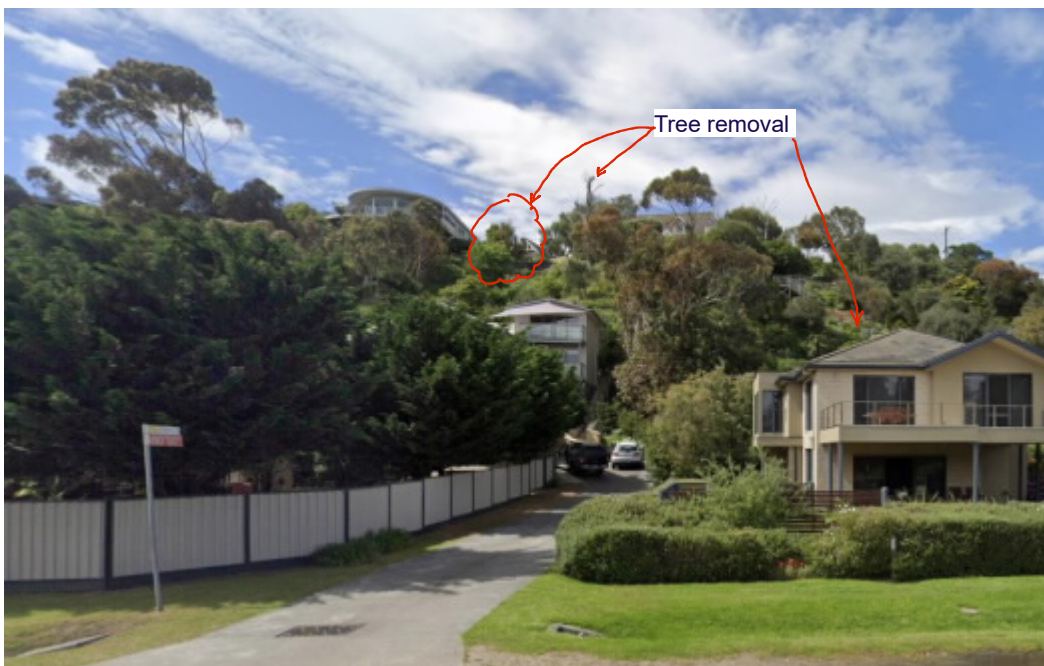
- A series of trees were removed on property P1 between April 2021 and September 2021, Appendix A1. This is supported by street view images between February 2018 and October 2022, Appendix A2.
- The translational slide scarp has approximate dimensions of 8 m x 5 m, Appendix A3.
- The debris flow:
 - Initiated from an area approximately 12m southeast of the property P1 northwestern boundary and was approximately 4 m wide.
 - Run out was approximately 5 m into properties P2 and P3, Appendix A3.

Figure A3: Google Street View February 2018

Figure A4: Google Street View October 2022
