INITIAL INSPECTION REPORT

Application No: EO-151/22

Property Address: 2 Penny Lane MCCRAE VIC 3938

Date: 21/11/2022

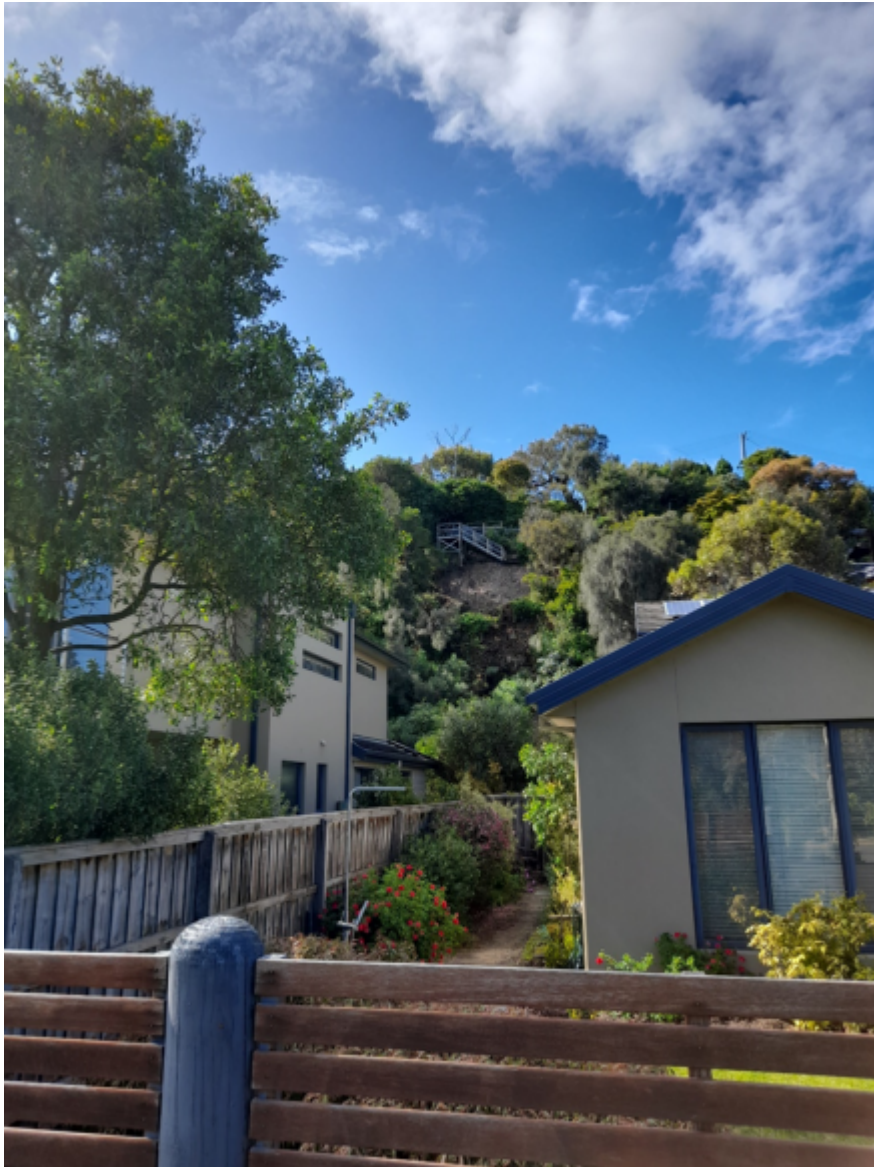
Photograph 1: The photo below is taken from the street Point Nepean Road, McCrae

I observed from Point Nepean road perspective the land slip up at the top of the crest to a number of properties that face another road at the top of the embankment. Soil has collapsed from the top crest embankment and has slid approx. halfway down the embankment bring vegetation down with the displaced soil/rock. Some of the soil that has been further displaced and descended to the natural ground level at the bottom of the hill has become liquified due to a burst water hose saturating the soil whereby the soil has fallen into the backyards of 2 Penny Lane and 3/613 Point Nepean rd McCrae.

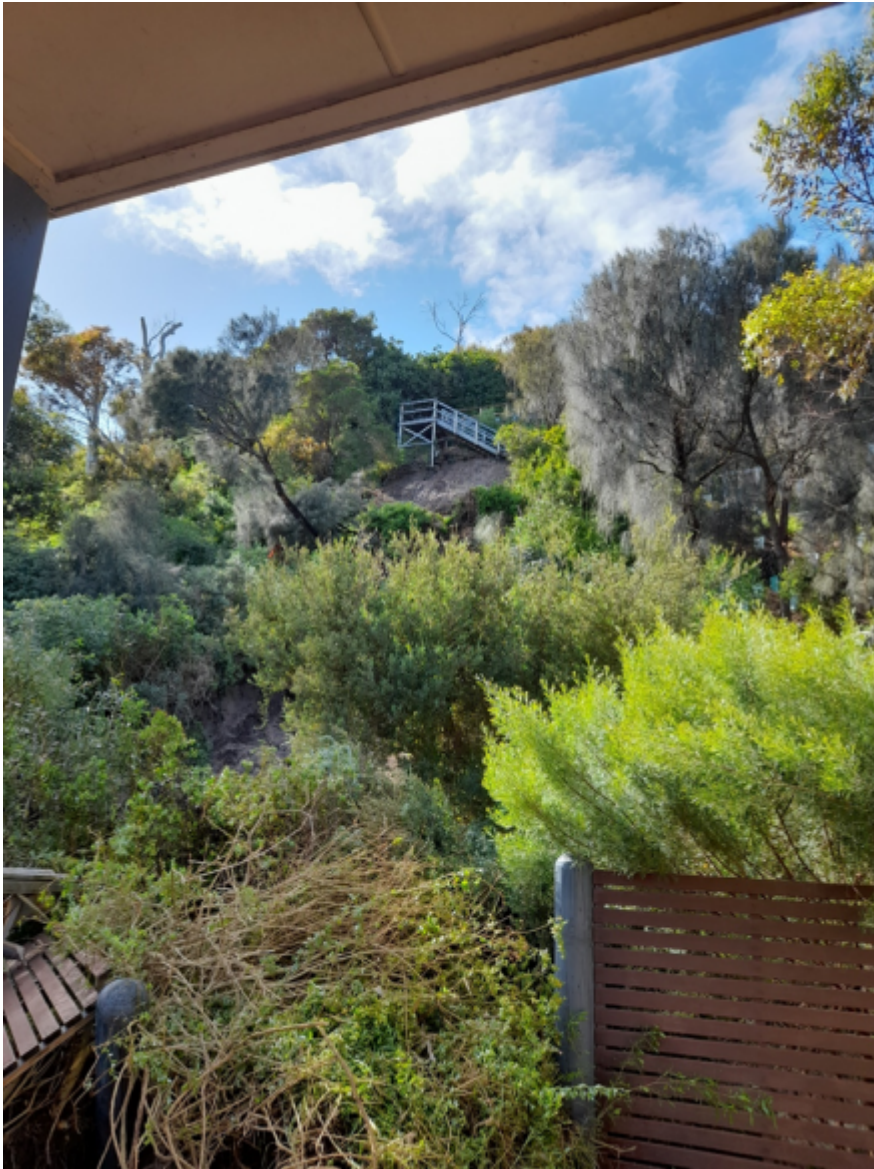
Photograph 2: The photo below is taken from the rear of 3/613 Point Nepean and 2 Penny Lane

There did not appear to be any visual signs of damage/impact the subject dwelling however a rear fence appeared to have been damaged by soil displaced from the land slip and the soil was very close to the subject dwelling at the time of inspection however as the dwelling is considered in line with the path of land slip it could be impacted if further land slip were to occur, A Geologist is expected to attend the land slip at 1:30pm today to survey land affected and to provide a report of the land slip impact.

As there was no one home during my inspection I left an Emergency Order at the front door of the dwelling which was later hand delivered to the owner Mr Wells by Ashley Hansen the Municipal Building Surveyor.
