# INITIAL INSPECTION REPORT

Application No: EO-147/22

Property Address: 3/613 Point Nepean Road MCCRAE VIC 3938

Date: 21/11/2022

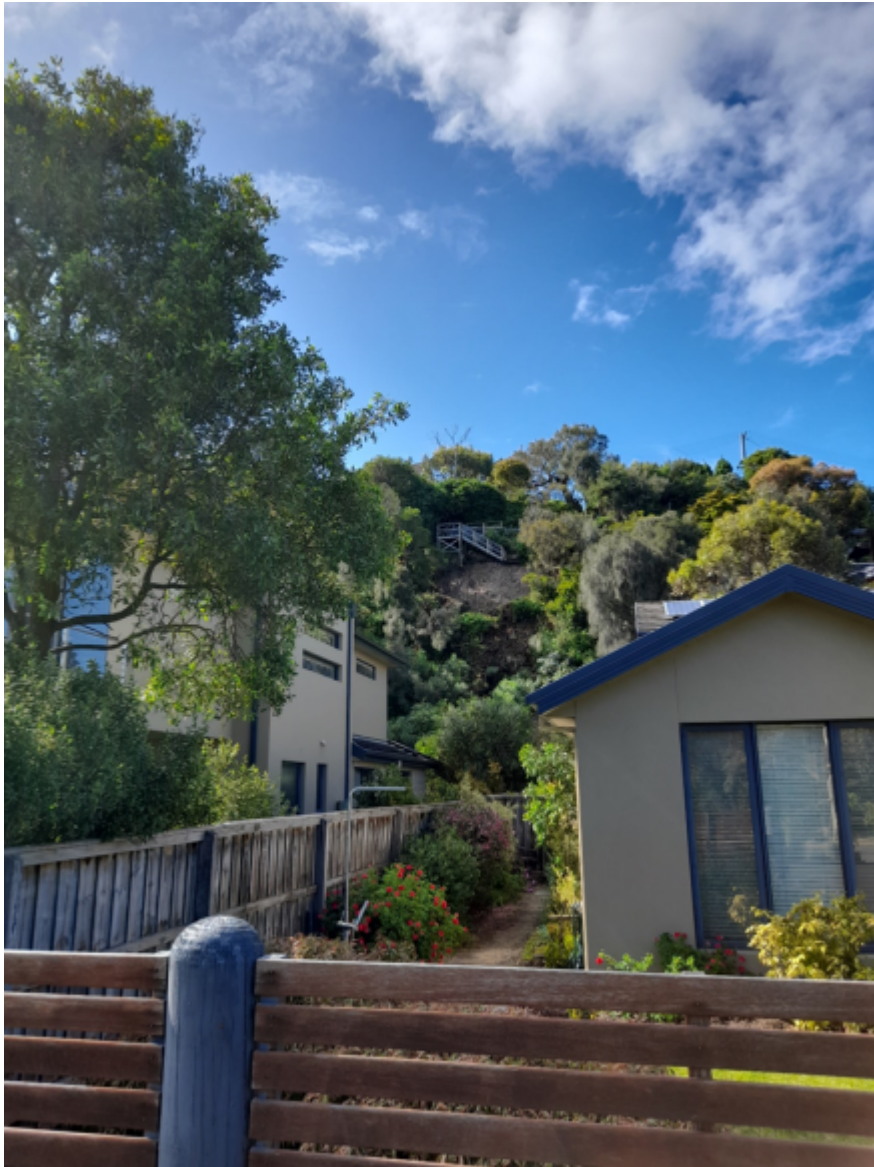
Photograph 1: The photo below is taken from the street Point Nepean Road, McCrae

I observed from Point Nepean road perspective the land slip up at the top of the crest to a number of properties that face another road at the top of the embankment. Soil has collapsed from the top crest embankment and has slid approx. halfway down the embankment bring vegetation down with the displaced soil/rock. Some of the soil that has been further displaced and descended to the natural ground level at the bottom of the hill has become liquified due to a burst water hose saturating the soil whereby the soil has fallen into the backyards of 2 Penny Lane and 3/613 Point Nepean rd McCrae.

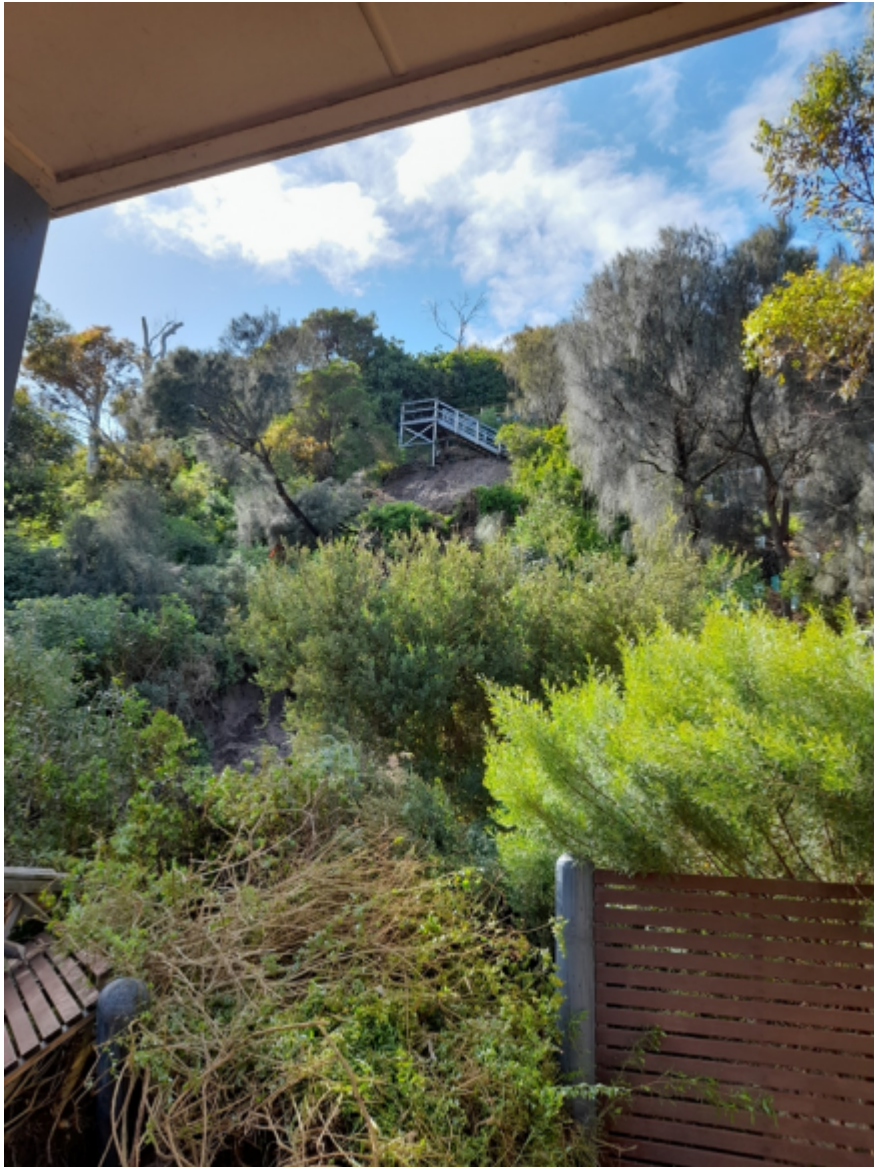
Photograph 2: The photo below is taken from the rear of 3/613 Point Nepean and 2 Penny Lane

There was built up soil against the rear external wall of the dwelling approx. 2 to 3 feet of soil in height at the time of inspection however as the unit is considered in the in line with the path of land slip it could be impacted if further land slip were to occur, A Geologist is expected to attend the land slip at 1:30pm today to survey land affected and to provide a report of the land slip impact.

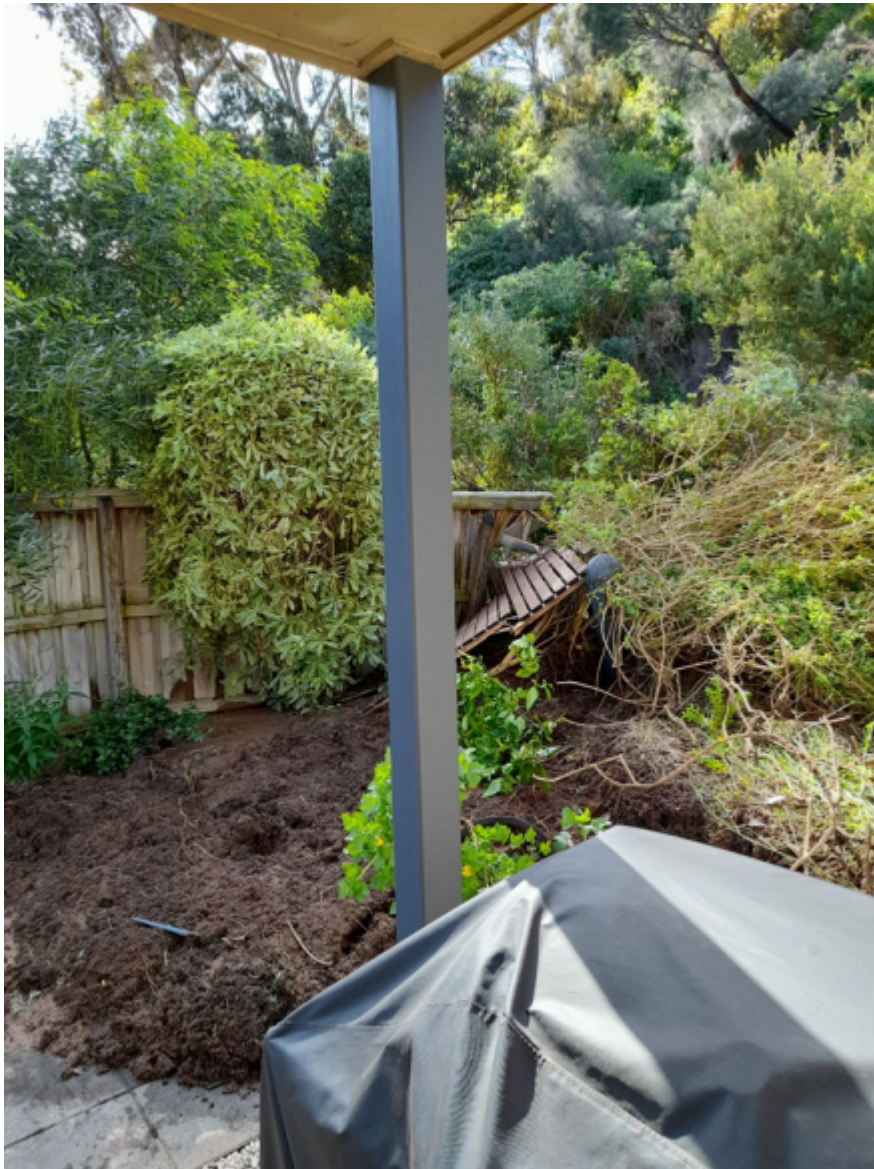
Photo taken of soil disbursement onto 2 Penny Lane rear yard with partial fence collapse.
