# McCrae Landslide - Evacuation Order Area

Geotechnical Factual Report

PSM5665-GFR REV0 9 April 2025

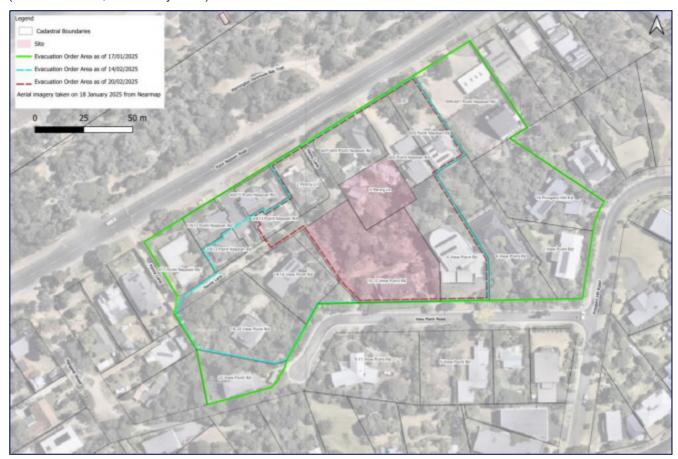
Inset 1: EO area established in response to the McCrae Landslide.

This report presents the results of the geotechnical site investigation ('Investigation') carried out by PSM in response to two landslides that occurred on 5 January 2025 and 14 January 2025 between properties located at 10-12 View Point Road and 3 Penny Lane, McCrae, Victoria. Collectively, these are referred to as the 'McCrae Landslide' and the "Site" and highlighted with red shading in Inset 1. The Investigation was carried out within and outside of an Evacuation Order (EO) area impacting 19 properties around the McCrae Landslide. This was part of an EO issued on 14 January 2025 by the State Emergency Service (SES) and Mornington Peninsula Shire Council (MPSC) on 17 January 2025 and updated on the 14 and 20 February 2025, Inset 1.

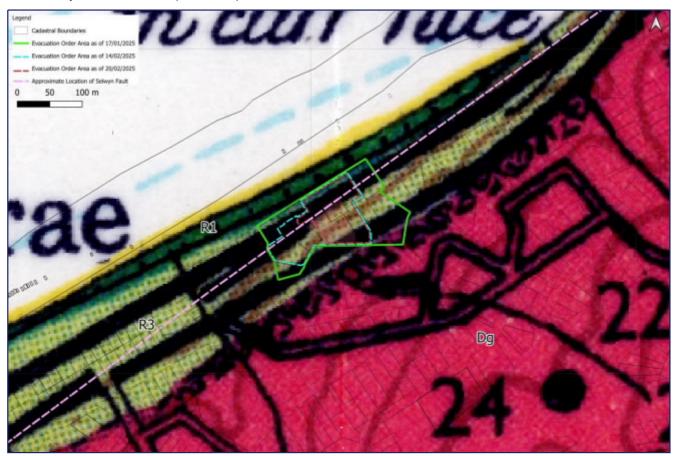
Inset 2: Mapped geology from the published Sorrento 1:63,360 geological map.

- Quaternary raised coastal deposits comprising siliceous and calcareous sand, shell beds, guano (Mud Islands) at the base of the escarpment (shown as R3 in Inset 2)
- Palaeozoic granodiorite and granite comprising the elevated terrain of and behind the escarpment (shown as Dg in Inset 2).

A major regional thrust fault, the Selwyn Faut is mapped at a scale of 1:250,000 to strike WSW-ENE and crossing immediately north of the Site (ref Inset 2).

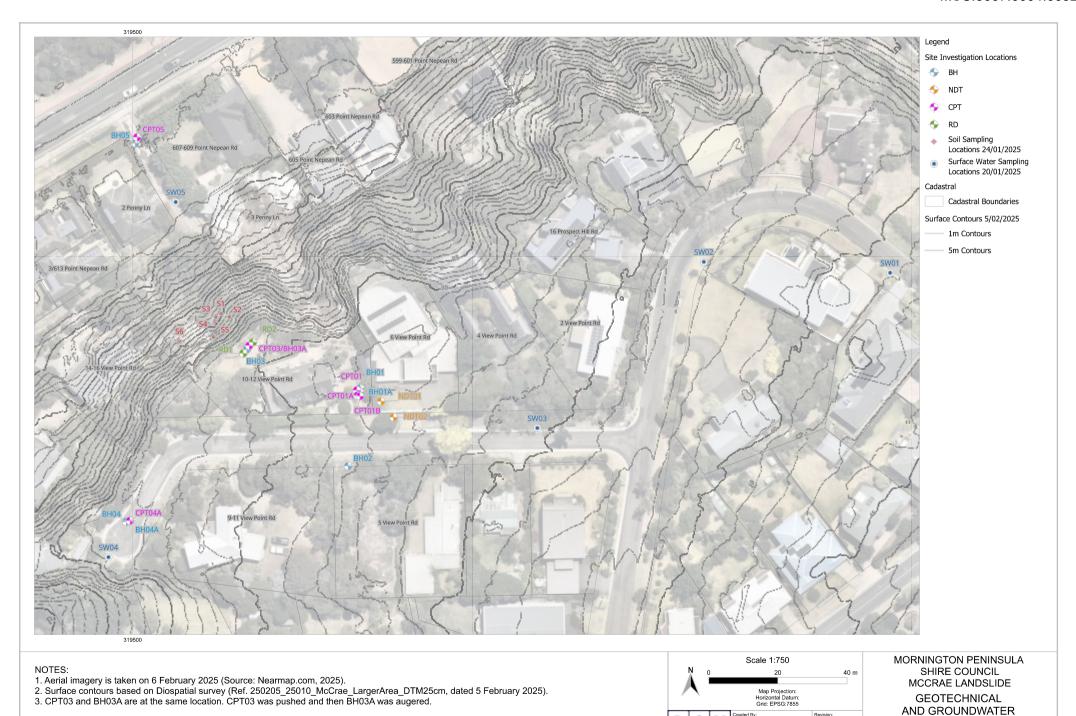
FIGURE 1

Figure 1 Geotechnical and Groundwater Investigation Plan

Soil samples were collected during the Site walkover on 24 January 2025 from the escarpment and flanks of the McCrae Landslide, Figure 1. Soil samples were also taken from boreholes BH01 to BH05 during the February 2025 site investigations. All were tested in a NATA accredited laboratory for moisture content, particle size distribution and Atterberg limits, Table 5. Laboratory testing certificates are presented in Appendix E.

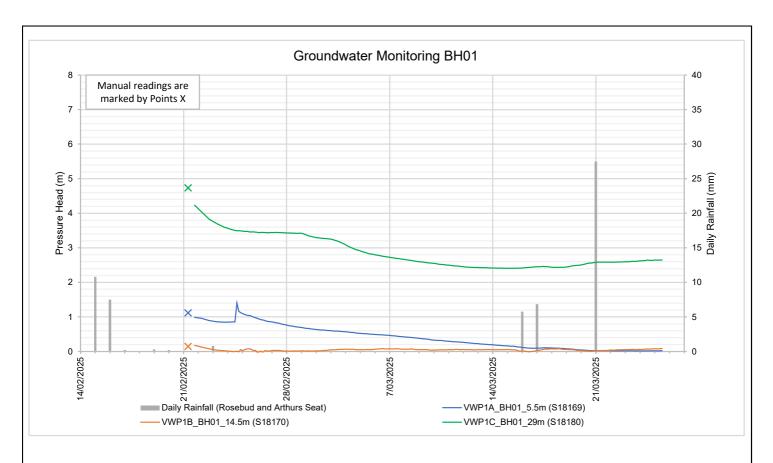
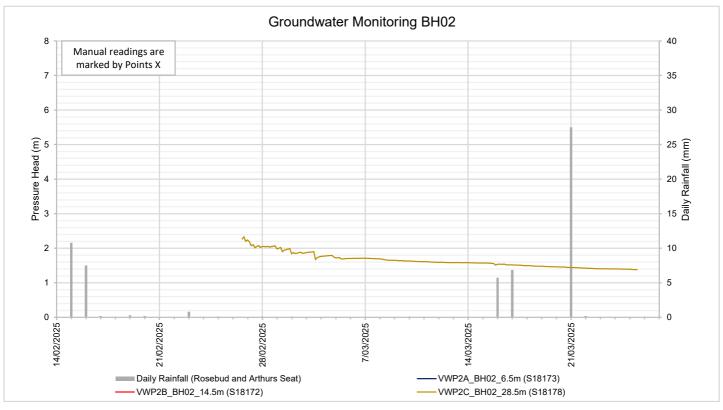
FIGURE G1

Notes: 1. Daily rainfall data has been averaged from the daily rainfall available at Rosebud (Country Club) Station ID 86213 and Arthurs Seat Rain Gauge at Seawinds National Park Station ID 586202. This data is provided up to 24/03/2025.

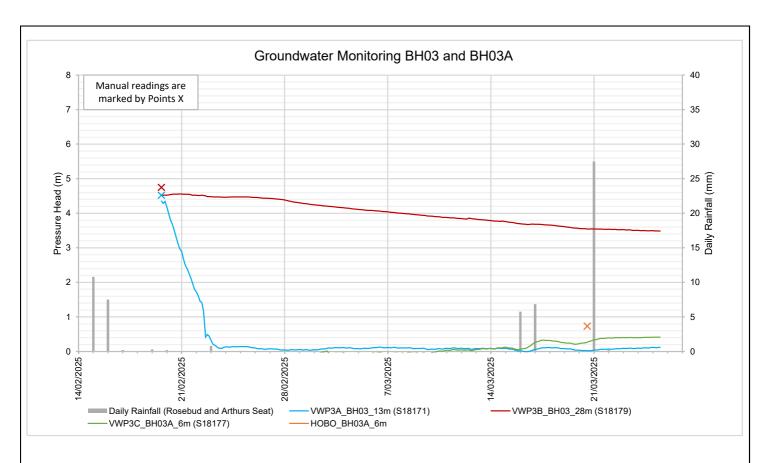
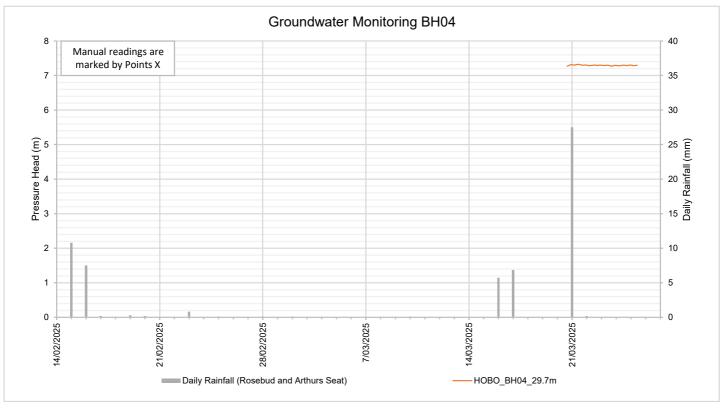
FIGURE G2

Notes: 1. Daily rainfall data has been averaged from the daily rainfall available at Rosebud (Country Club) Station ID 86213 and Arthurs Seat Rain Gauge at Seawinds National Park Station ID 586202. This data is provided up to 24/03/2025.
