**1.14 BN2025 - Erosion Management Overlays and Future Options**

The purpose of this briefing is to outline how landslide risk is currently managed and options for bringing forward the review of existing landslide susceptibility data to inform a planning scheme amendment.

**Draft for Comment** Landslide  
Susceptibility Assessment,  
Stage 2  
Mornington Peninsula Shire, Victoria

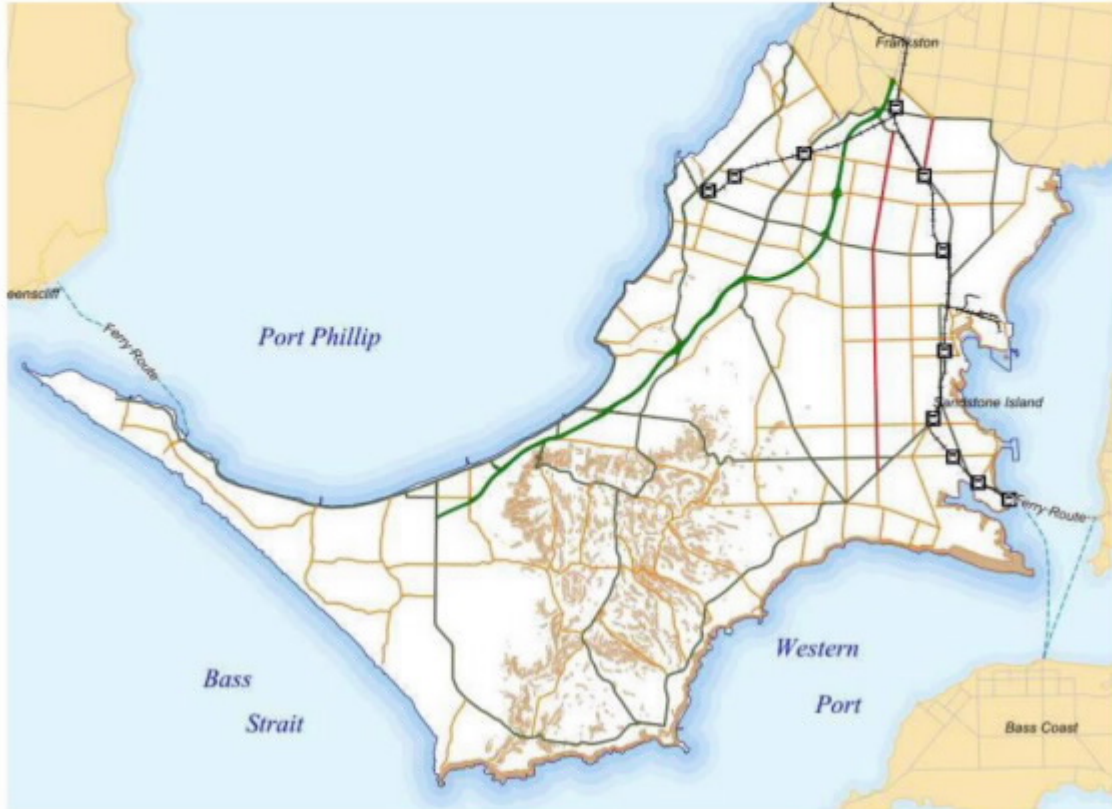
Existing coverage of Erosion Management Overlays on the Mornington Peninsula Shire

There are currently six Erosion Management Overlays (EMO) in the Mornington Peninsula Planning Scheme. The areas they cover are outlined in Attachment 1.

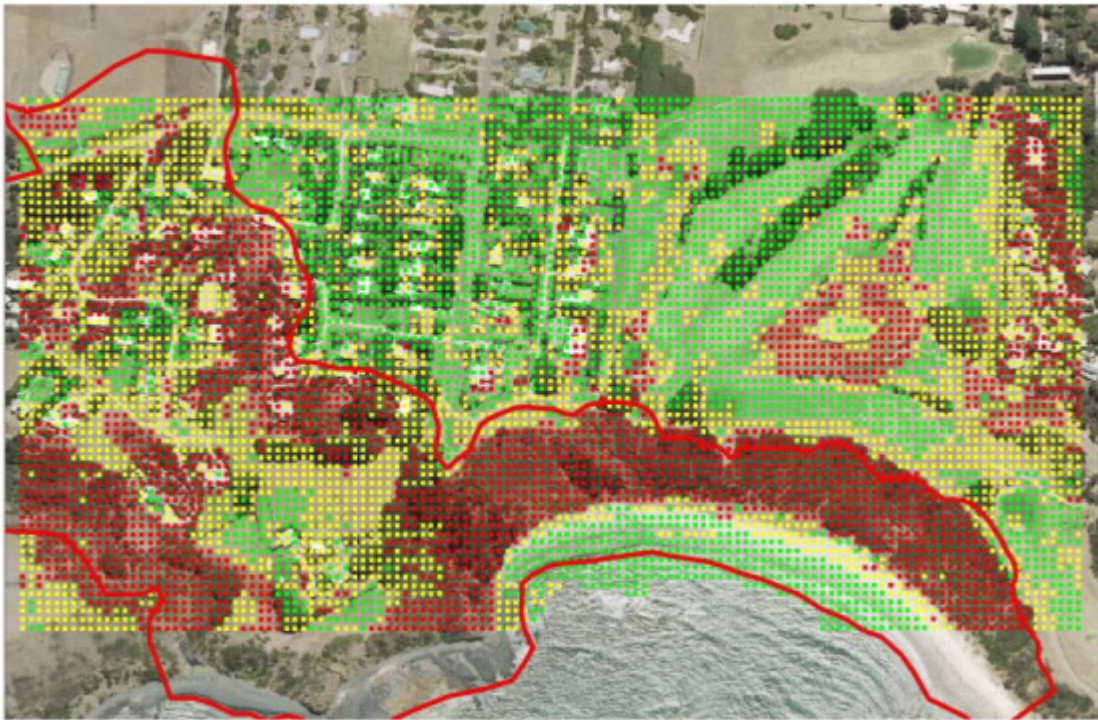
**Figure 10-4: Flinders South-West - LP(2008A-1)**

The model showed a good correlation with the boundaries identified in LP(2008A) for the south-west of the Flinders township as can be seen above. Differences between the field observations and the model within the red zone are as a result of accumulation zones of landslides which cannot be predicted by the GIS model. The model also highlights a large dam to the north of the cliffs in the east of the plan. This dam was outside the previous study area.

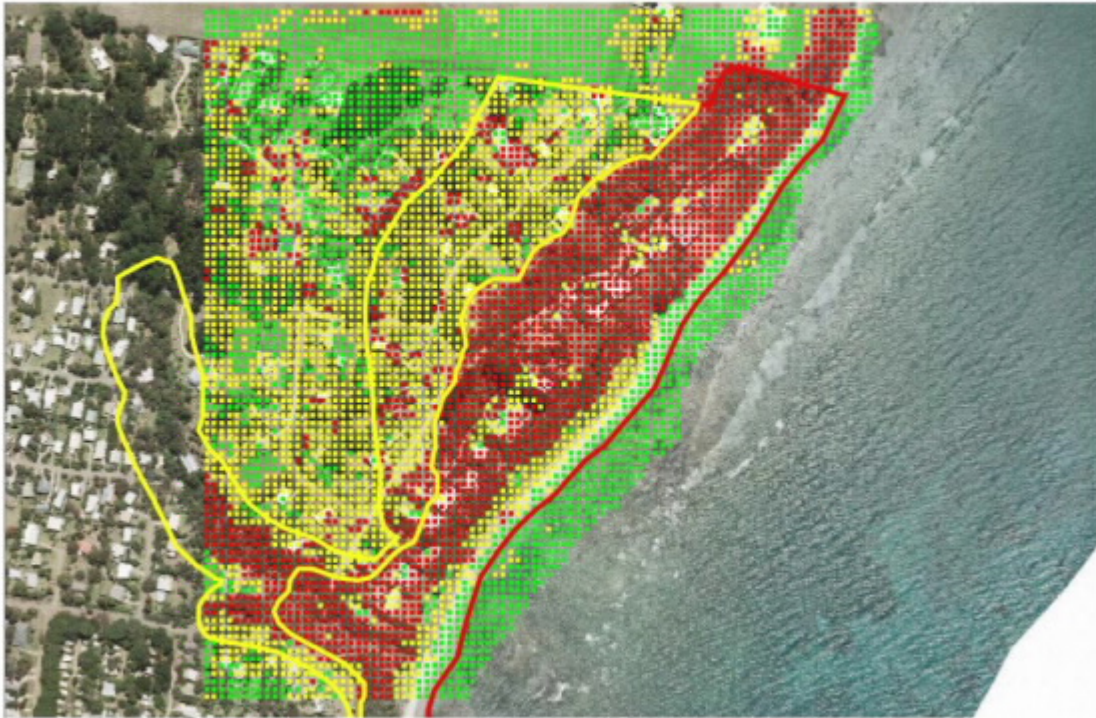
**Figure 10-5: Flinders East - LP(2008A-2)**

The model showed a good correlation with the boundaries of the red zone and a reasonable correlation with the yellow zone identified in LP(2008A) for the east of the Flinders township as can be seen above. One of the significant discrepancies is in the area of the creek. The GIS model predicts higher susceptibility than the field study, mostly as a result of the shallow bedrock which is not allowed for in the GIS model. Discrepancies outside of the yellow zone can be attributed to the LIDAR data including the slopes in the vicinity of features such as retaining walls and cuts.

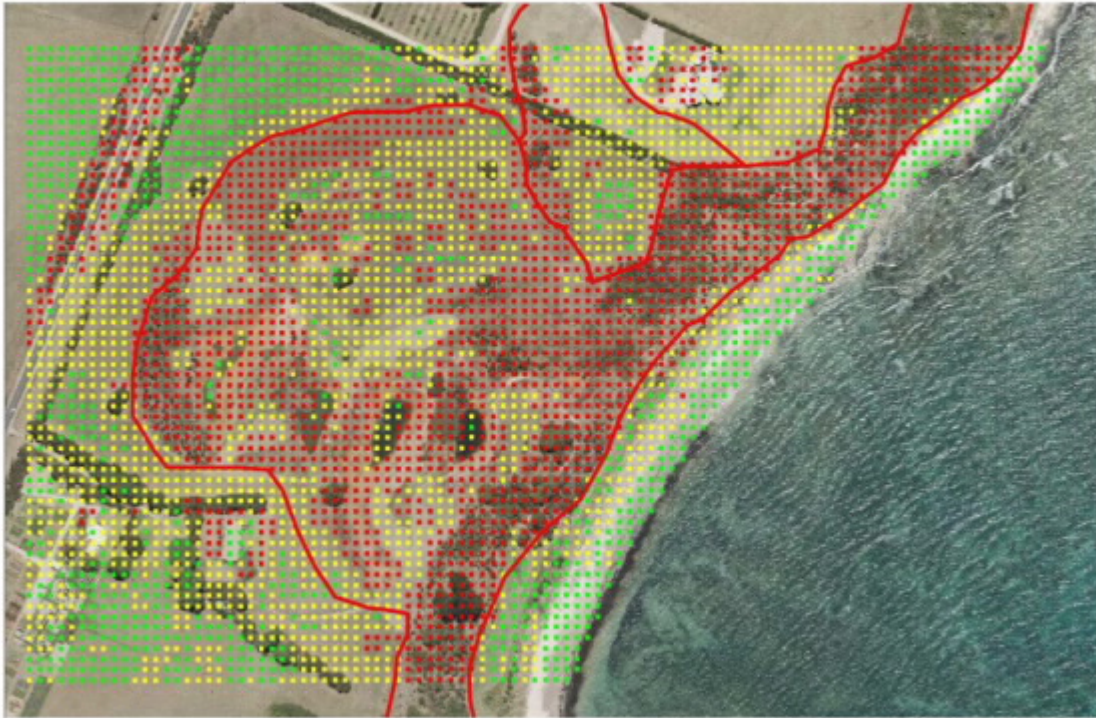
**Figure 10-7: Shoreham - DP(2000)**

The model shows a good correlation between the boundary of the observed landslide and the area of high landslide susceptibility from the GIS model. The model also predicted the impact of the cliff face and the presence of creep in the vicinity of the cliffs. However, the more level area within the landslip was not predicted and only areas of medium susceptibility were identified. For large landslides, the GIS model indicates areas of less susceptibility than should occur. However, this is largely overcome by adopting a 'high' susceptibility in areas of known landslip.

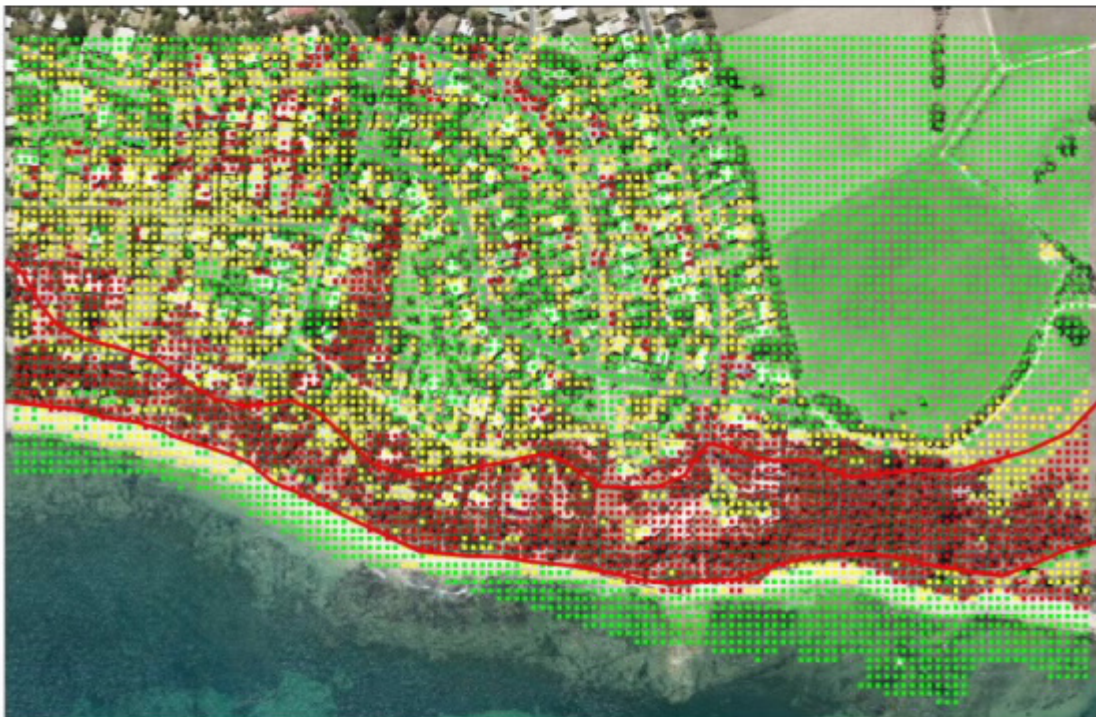
**Figure 10-8: Somers - LP(2010C)**

The results of the verification are shown in Figure 9-8 and are discussed below. The extent of the areas of 'high landslide susceptibility' as identified in aerial photography is shown with a red line. The results of the predictive model are shown as a grid of coloured squares with the red squares representing the predicted locations of high susceptibility.

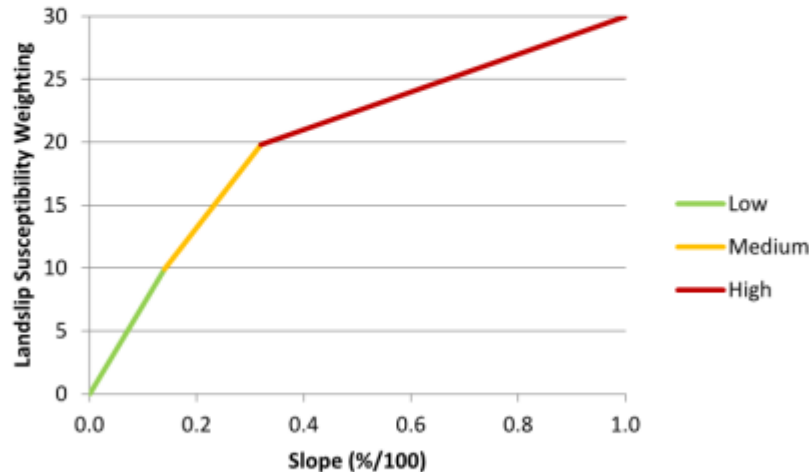
**Figure 10-9: Slope vs. Susceptibility Weighting for Older Volcanics**

Considering these values the susceptibility weighting for the Older Volcanics has been adopted as shown in Figure 9-9.

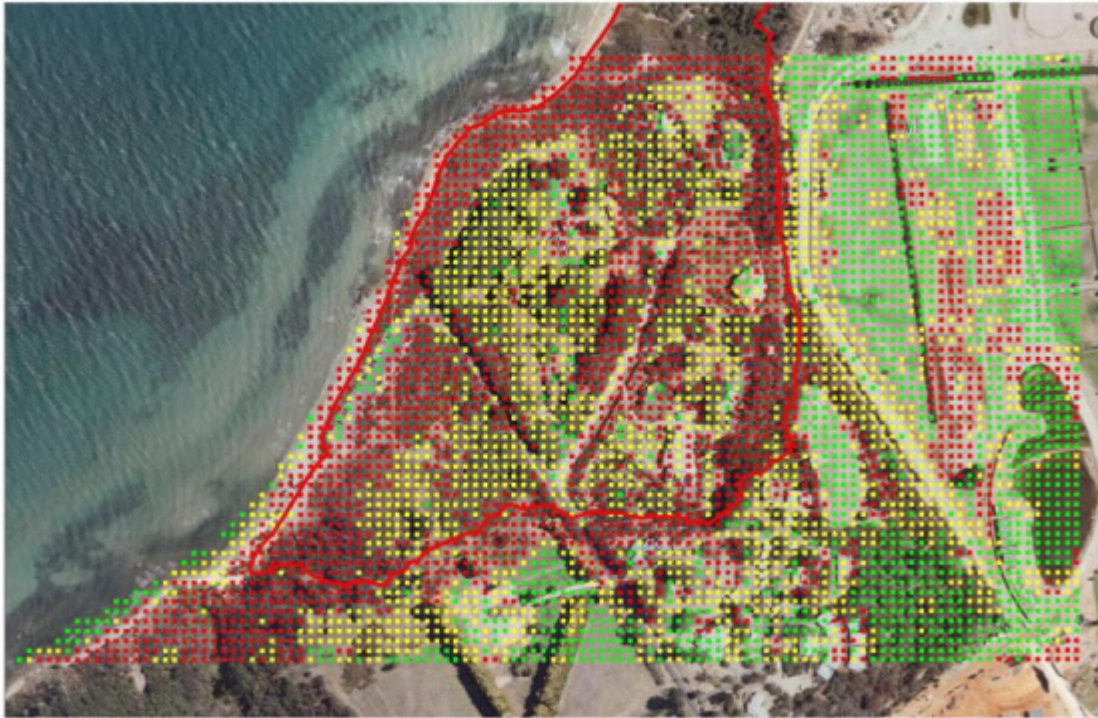
**Figure 10-13: Sunnyside Beach and Royston Court - LP(2009A) & PA(2000B)**

While the model shows a reasonable prediction with the landslip extremities, there are 'medium' landslip susceptible zones within the landslip itself. This was discussed in the previous section and is overcome within the model by measures indicated earlier.

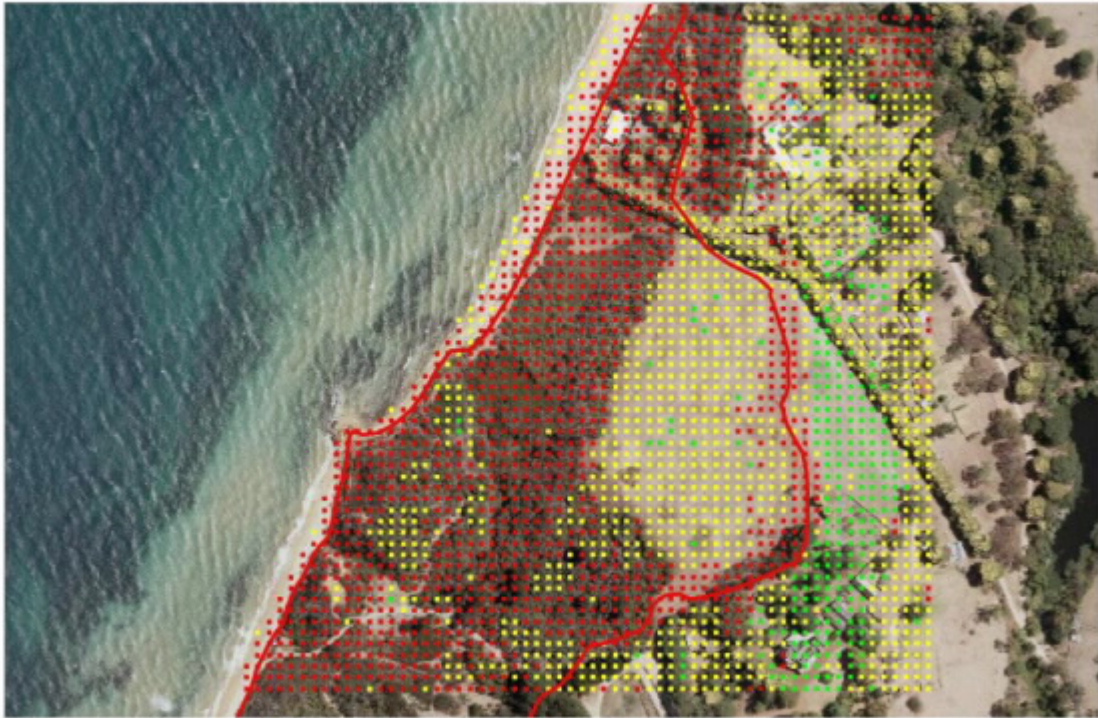
**Figure 10-14: Norman Myer Lodge LP(2007A)**

The predictive model showed a very good correlation with the landslide identified at the Norman Myer Lodge property. The figure above shows the location of the landslides determined from aerial photography compared to the model. The landslide scarp is well predicted in the computer model, while a creep zone within the landslide was predicted, rather than a high susceptibility zone as discussed earlier. This creep zone was identified on the ground during the 2007 investigation.

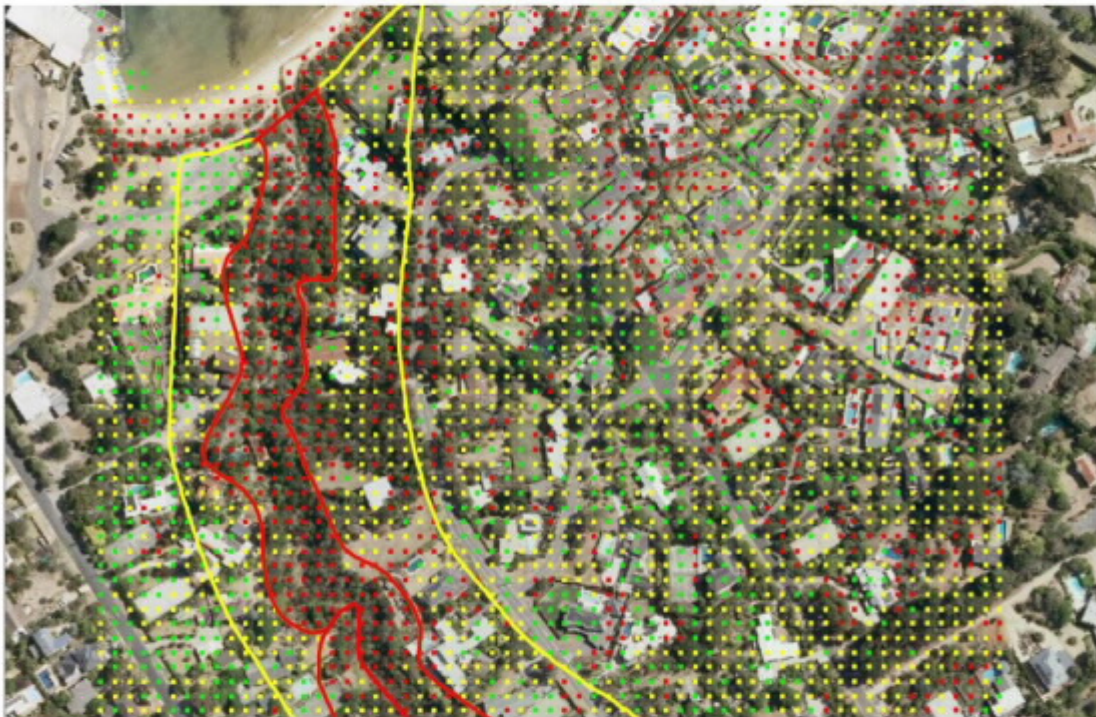
**Figure 10-15: Ballar Creek - CG(1999)**

The results of the verification are shown in Figure 9-15 and are discussed below. The boundaries of the high susceptibility zone and medium susceptibility zone determined from CG(1999) report are shown as a solid red and yellow lines while the results of the predictive model are shown as a grid of coloured squares.

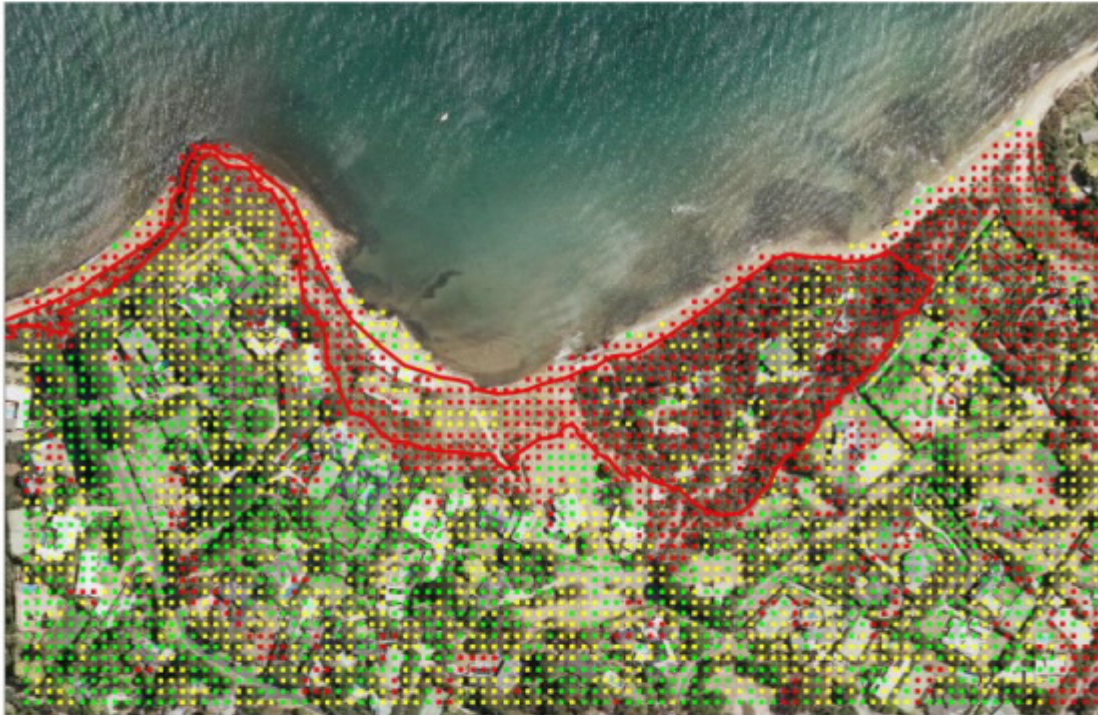
**Figure 10-16: Davey's Bay - PA(2006A) & CF(1993)**

The results of the verification are shown in Figure 9-16 and are discussed below. The boundary of the high susceptibility zone determined from aerial photographs and visual inspections is shown as a solid red line while the results of the predictive model are shown as a grid of coloured squares with the red squares representing the predicted locations of high susceptibility.

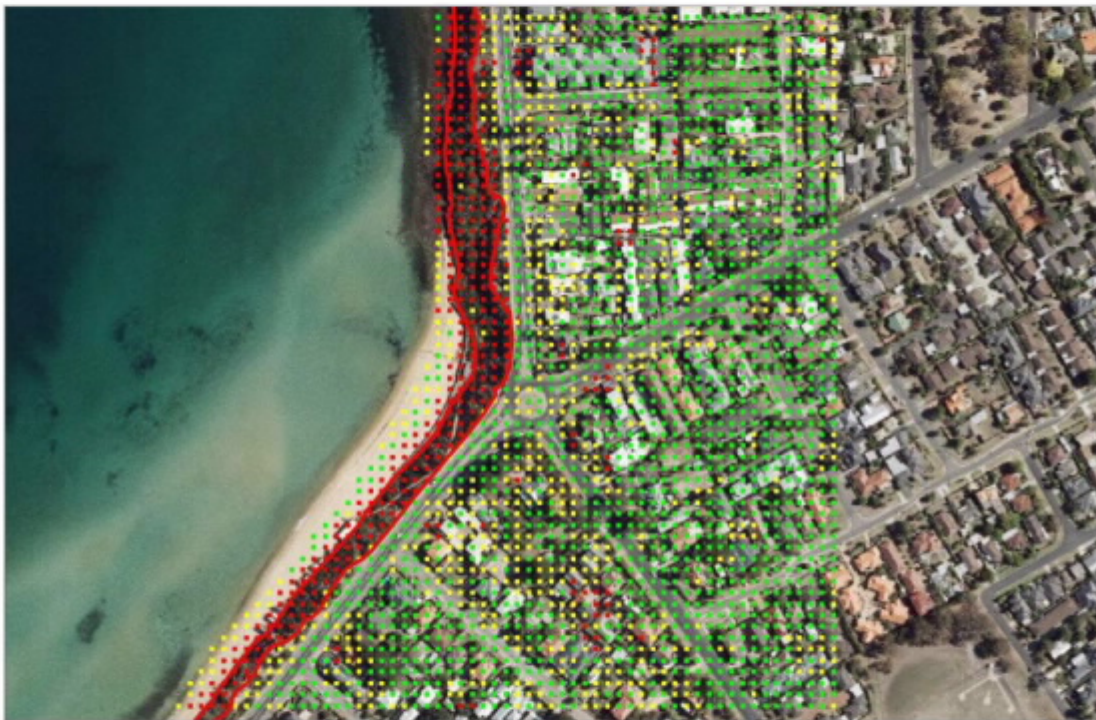
**Figure 10-17: Fishermans Beach - PA(2003)**

The results of the verification are shown in Figure 9-17 and are discussed below. The boundary of the high susceptibility zone determined from aerial photographs and visual inspections is shown as a solid red line while the results of the predictive model are shown as a grid of coloured squares with the red squares representing the predicted locations of high susceptibility.

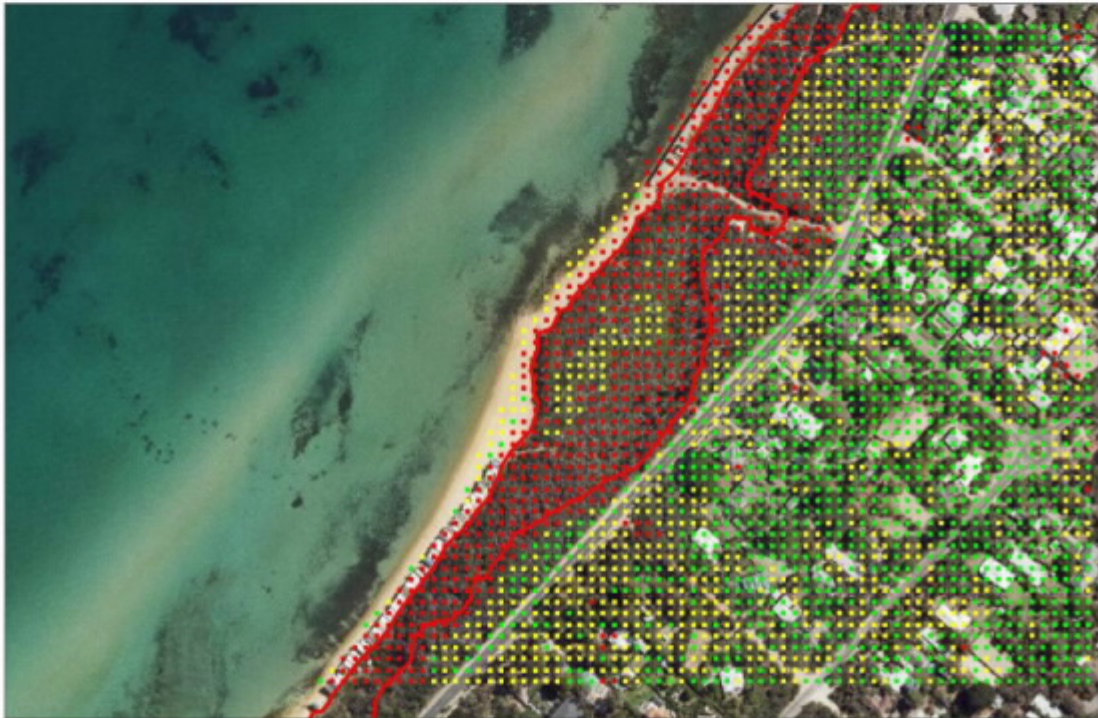
**Figure 10-18: Mount Martha North - LP(2009B)**

This landslide was also used to confirm the model for the Balcombe Clays. The results of the verification are shown in Figure 9-18 and are discussed below.

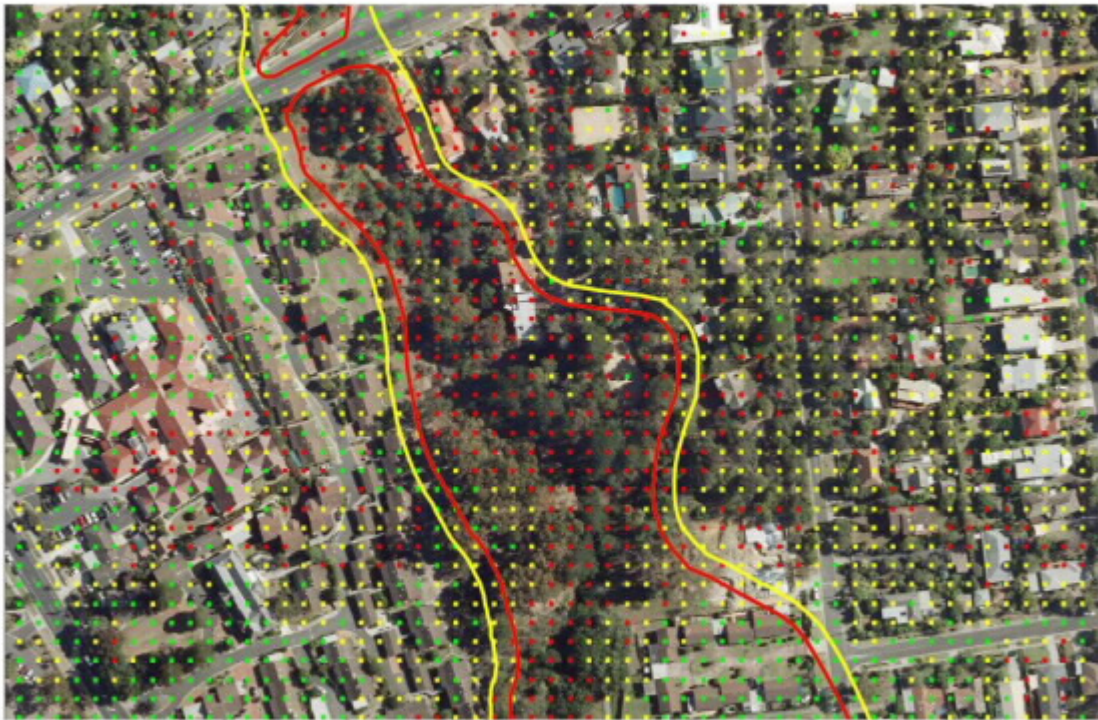
**Figure 10-23: Tanti Creek - LP(2010B)**

There was a good correlation between the model and the boundaries for the EMO identified in Lane Piper (2010B) in the vicinity of Barkly Street. The model predicted well the high susceptibility zones within the creek and the medium susceptibility zones where creep was observed up slope of the creek. The model also predicted that there were zones of high landslide susceptibility outside of the EMO, especially to the east of the creek to the south of Barkly Street.

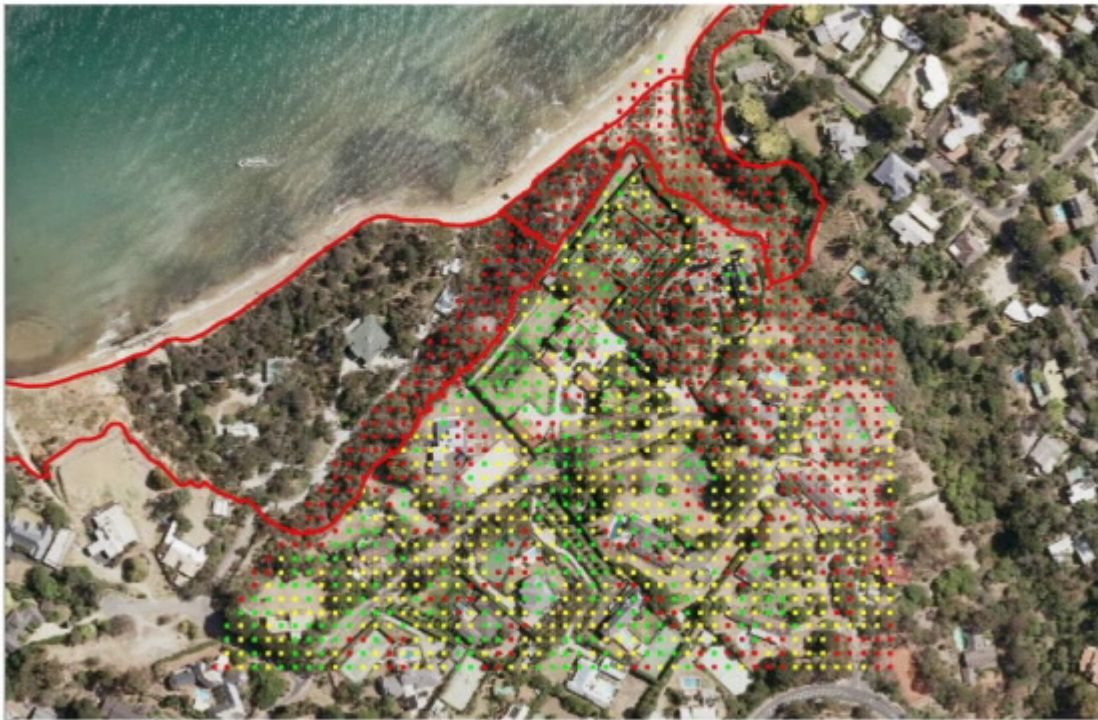
**Figure 10-29: Davey's Bay - CF(1993)**

The model correctly identified the granitic headscarp of the Davey's Bay landslide and also instability within the Kackeraboite Creek. The model indicates that up slope of the creek banks there are also areas of high landslide susceptibility.

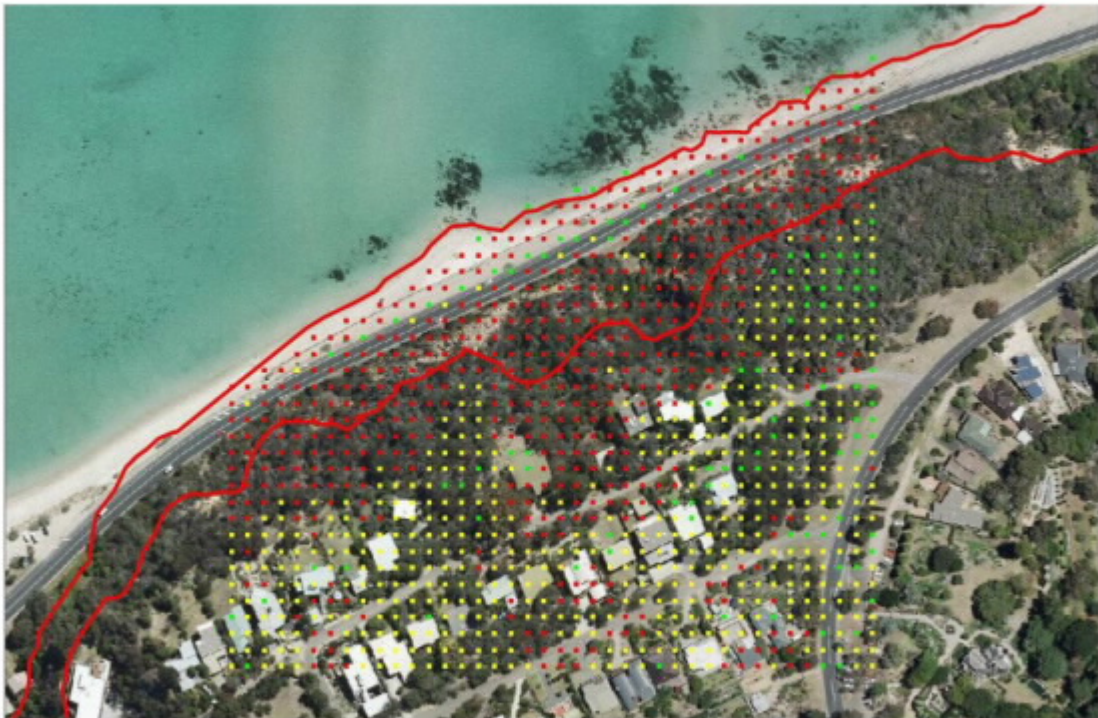
**Figure 10-30: Anthony's Nose PA(2000A)**

The model predicts the location of the cliff face as well as highlighting areas of high landslide susceptibility further upslope from the cliff face that were not readily identifiable in the aerial photographs possibly hidden by vegetation.

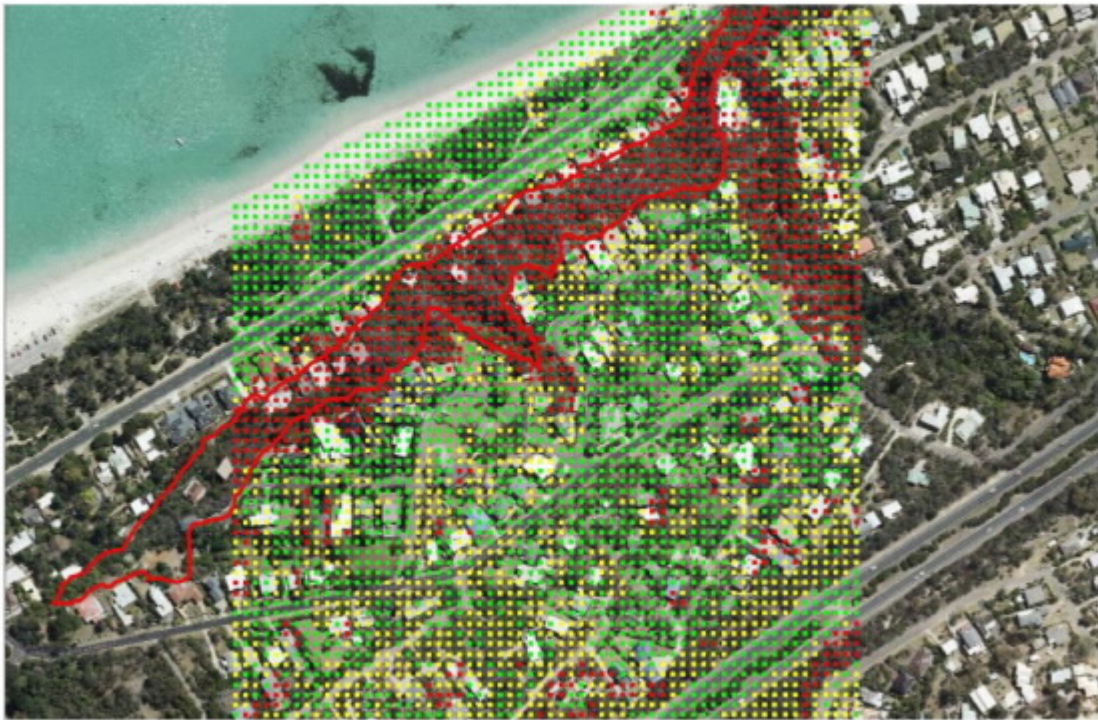
**Figure 10-32: McCrae - LP(2007B)**

The results of the predictive model very closely match the areas identified in the aerial photography. The main differences between the two being that the model has correctly identified gullies that have been identified to have stability issues in the field.

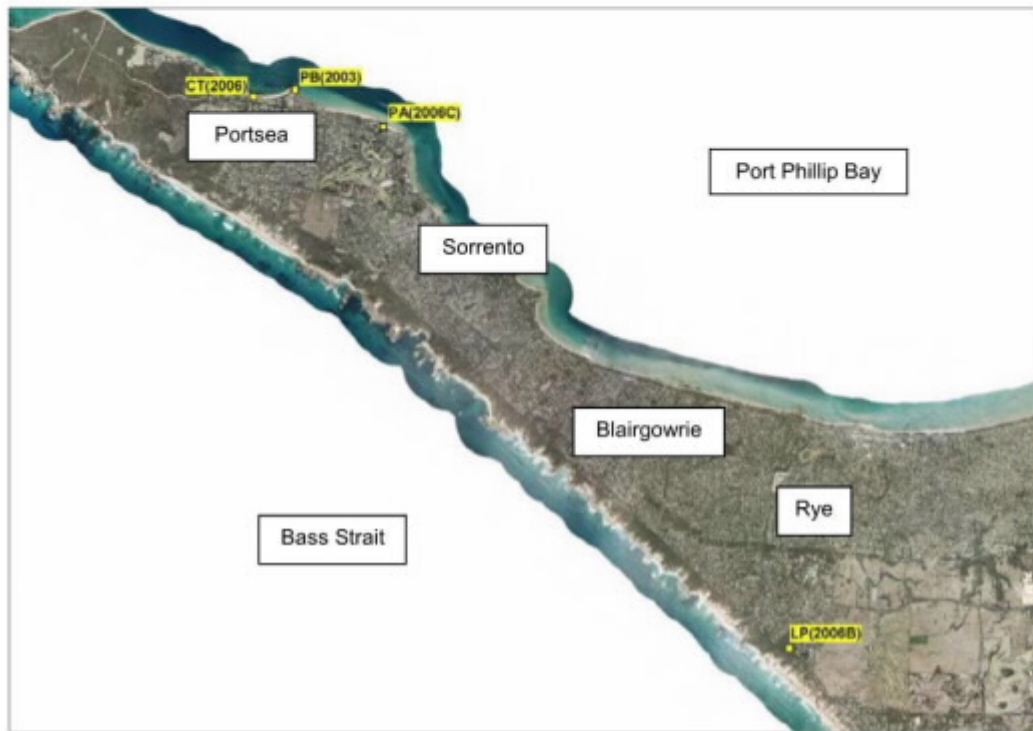
**Figure 10-35: Sites used for Quaternary Sand Verification**

The location of the areas used to develop the model are shown below.

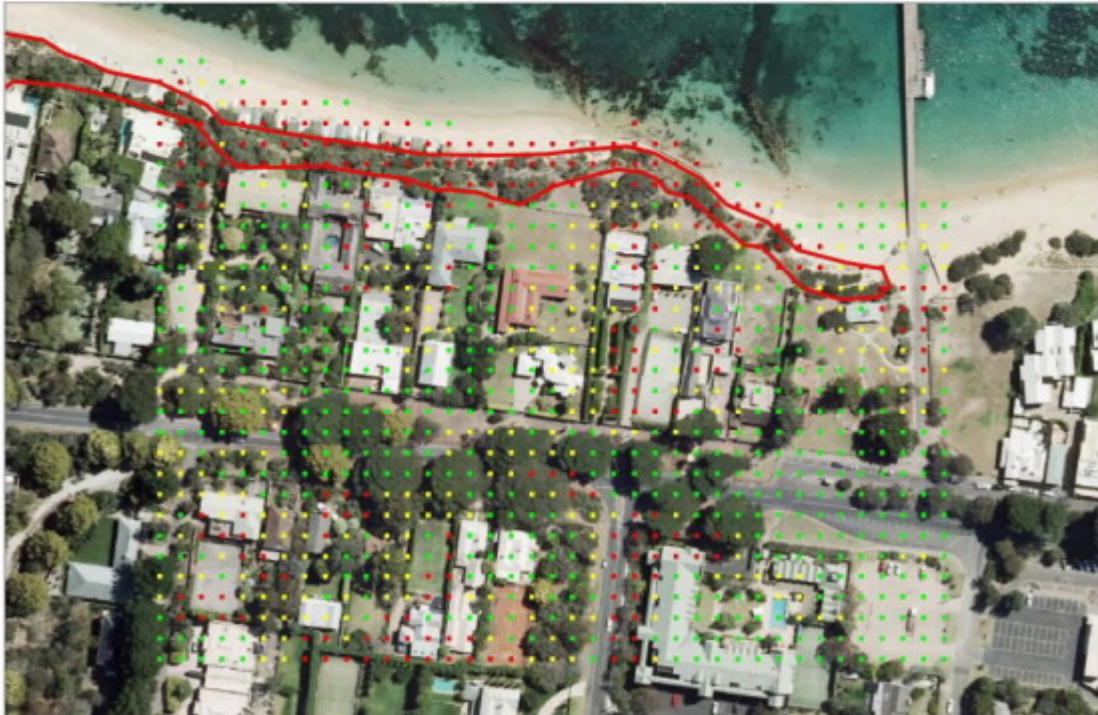
**Figure 10-37: 3804 Pt. Nepean Road - CT(2006)**

The results of the verification are shown in Figure 9-37 and are discussed below.

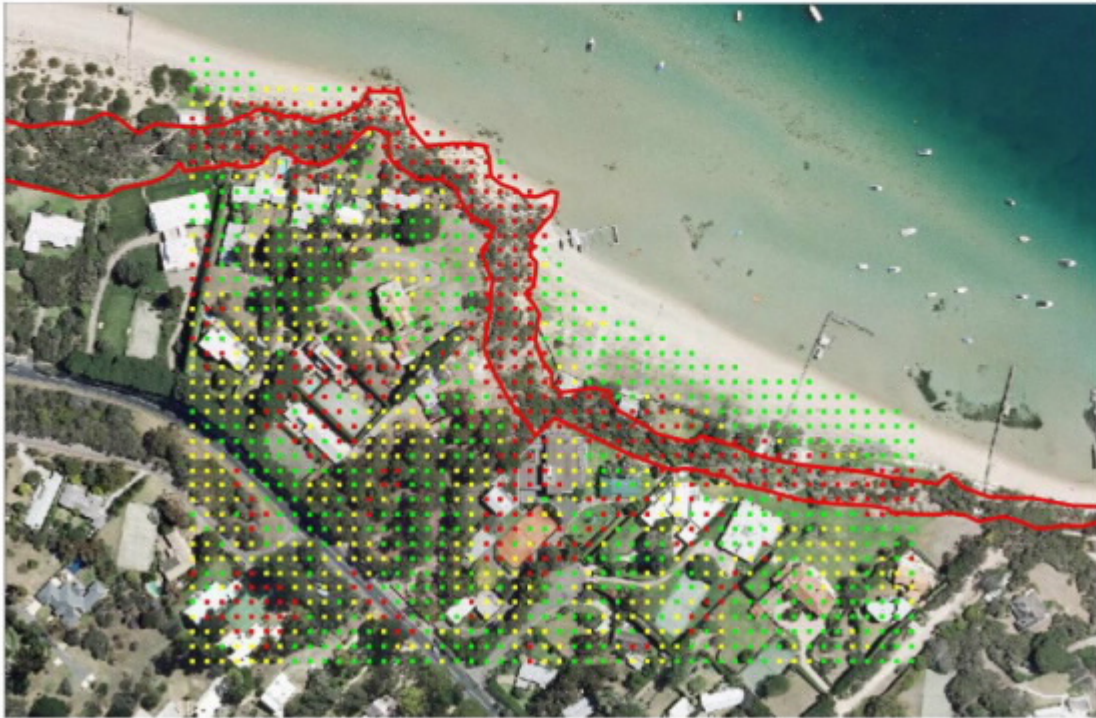
**Figure 10-39: 3550 Pt. Nepean Road - PA(2006C)**

This site is another typical example of the steep coastal cliffs in the area. The results of the verification are shown in Figure 9-38 and are discussed below.

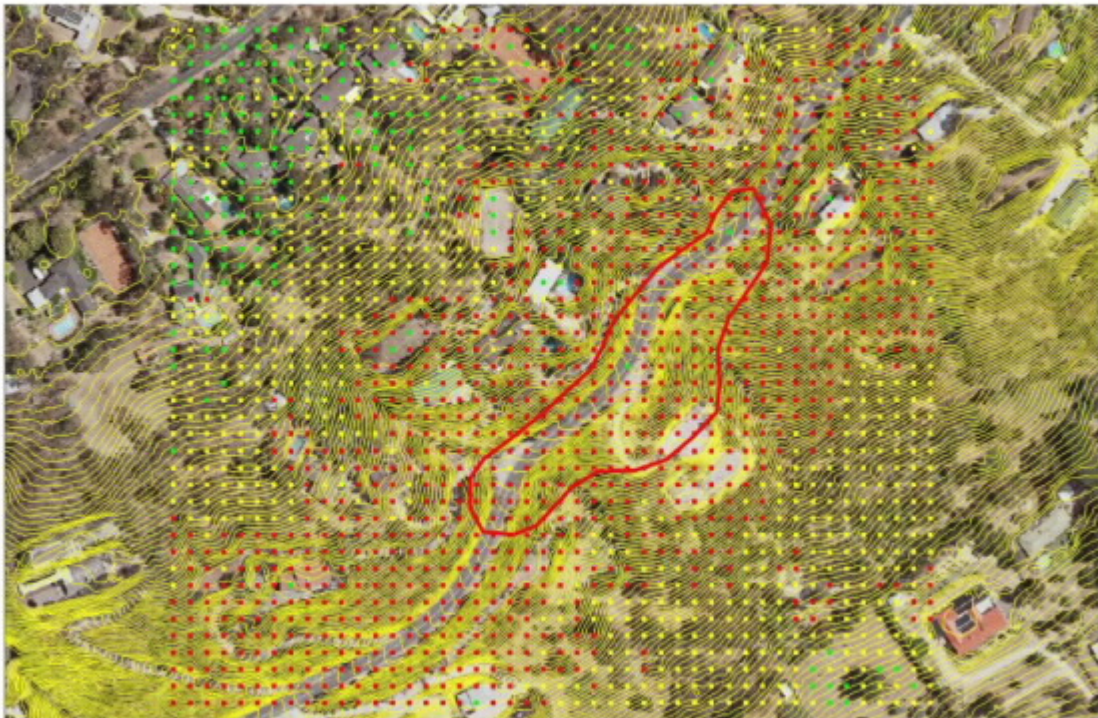
**Figure 10-45: Two Bays Road - PA(1996)**

At the break in slope, the model predicts a change to a moderate landslide susceptibility. Further up slope the slope flattens out and the model predicts a change to a low susceptibility. The model accurately reflects observed conditions.
