Monitoring – GPS Sensor System

Monitoring – Tilt Sensor System

General Arrangement Monitoring Systems

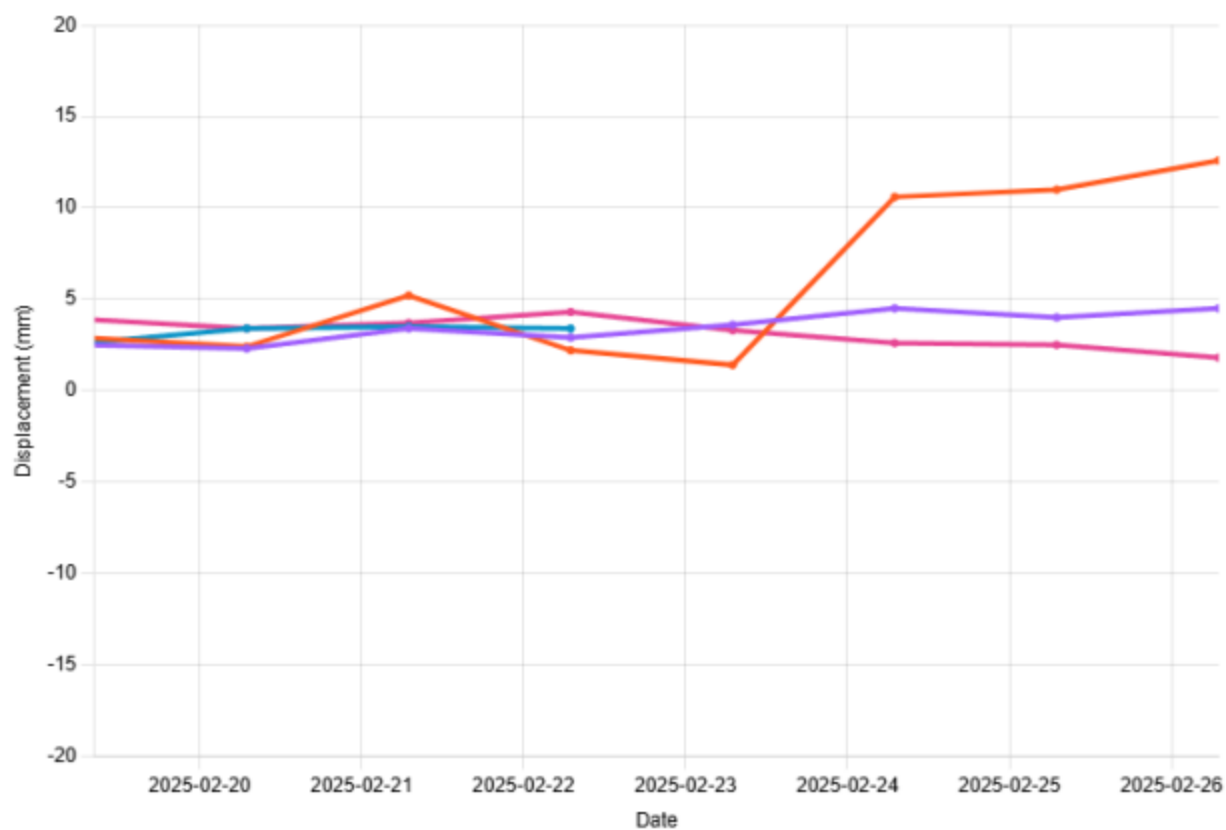
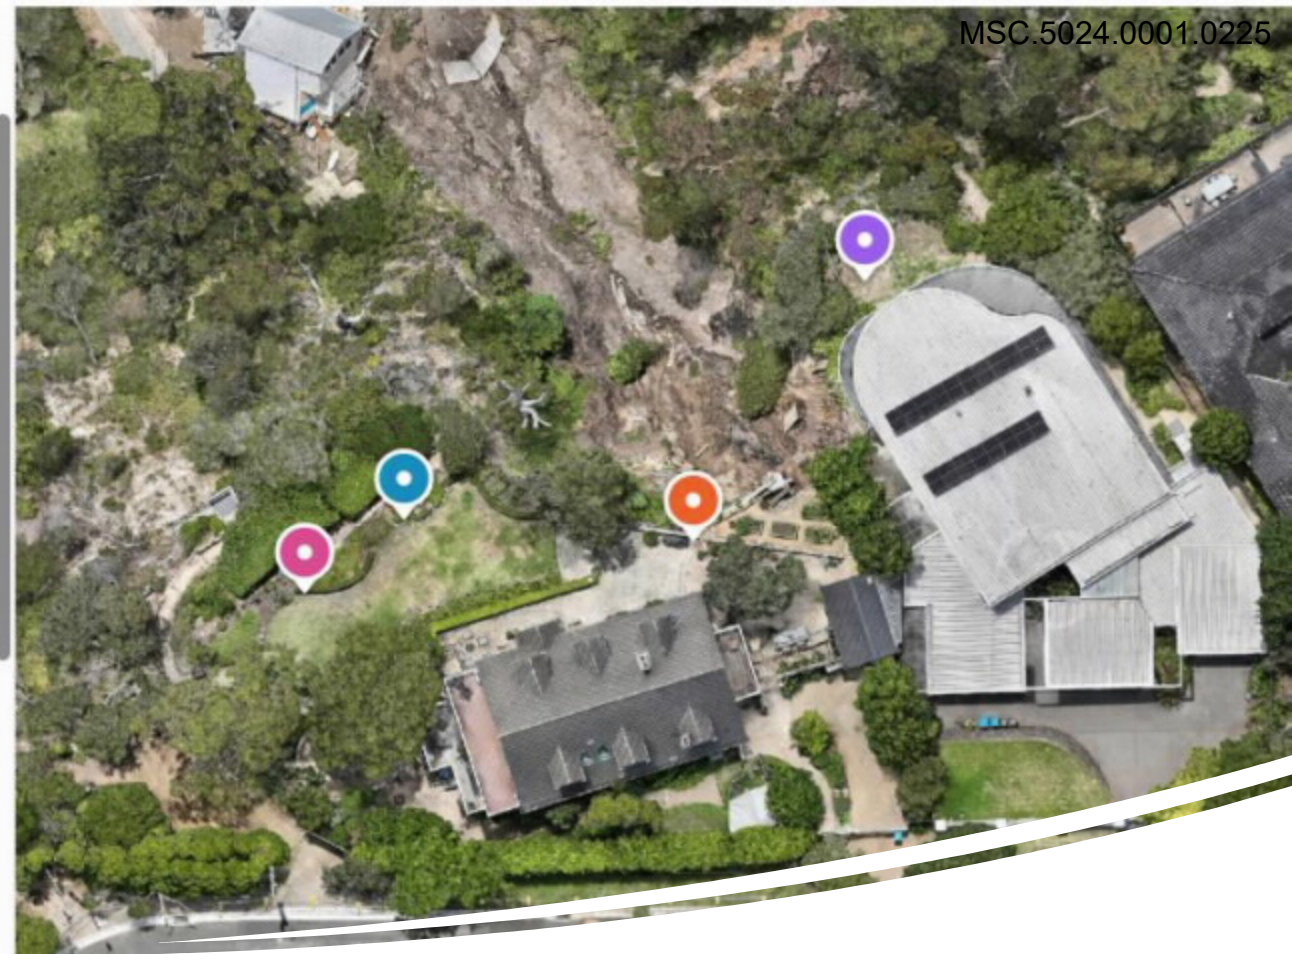
- Creep of the landslide head scarp is ongoing, indicating the landslide is active.
- The GPS sensor on the top of the escarpment indicating movements within the soil.
- Radar, tilt and GPS sensors all support that the immediate vicinity of the landslide headscarp is subject to creep.

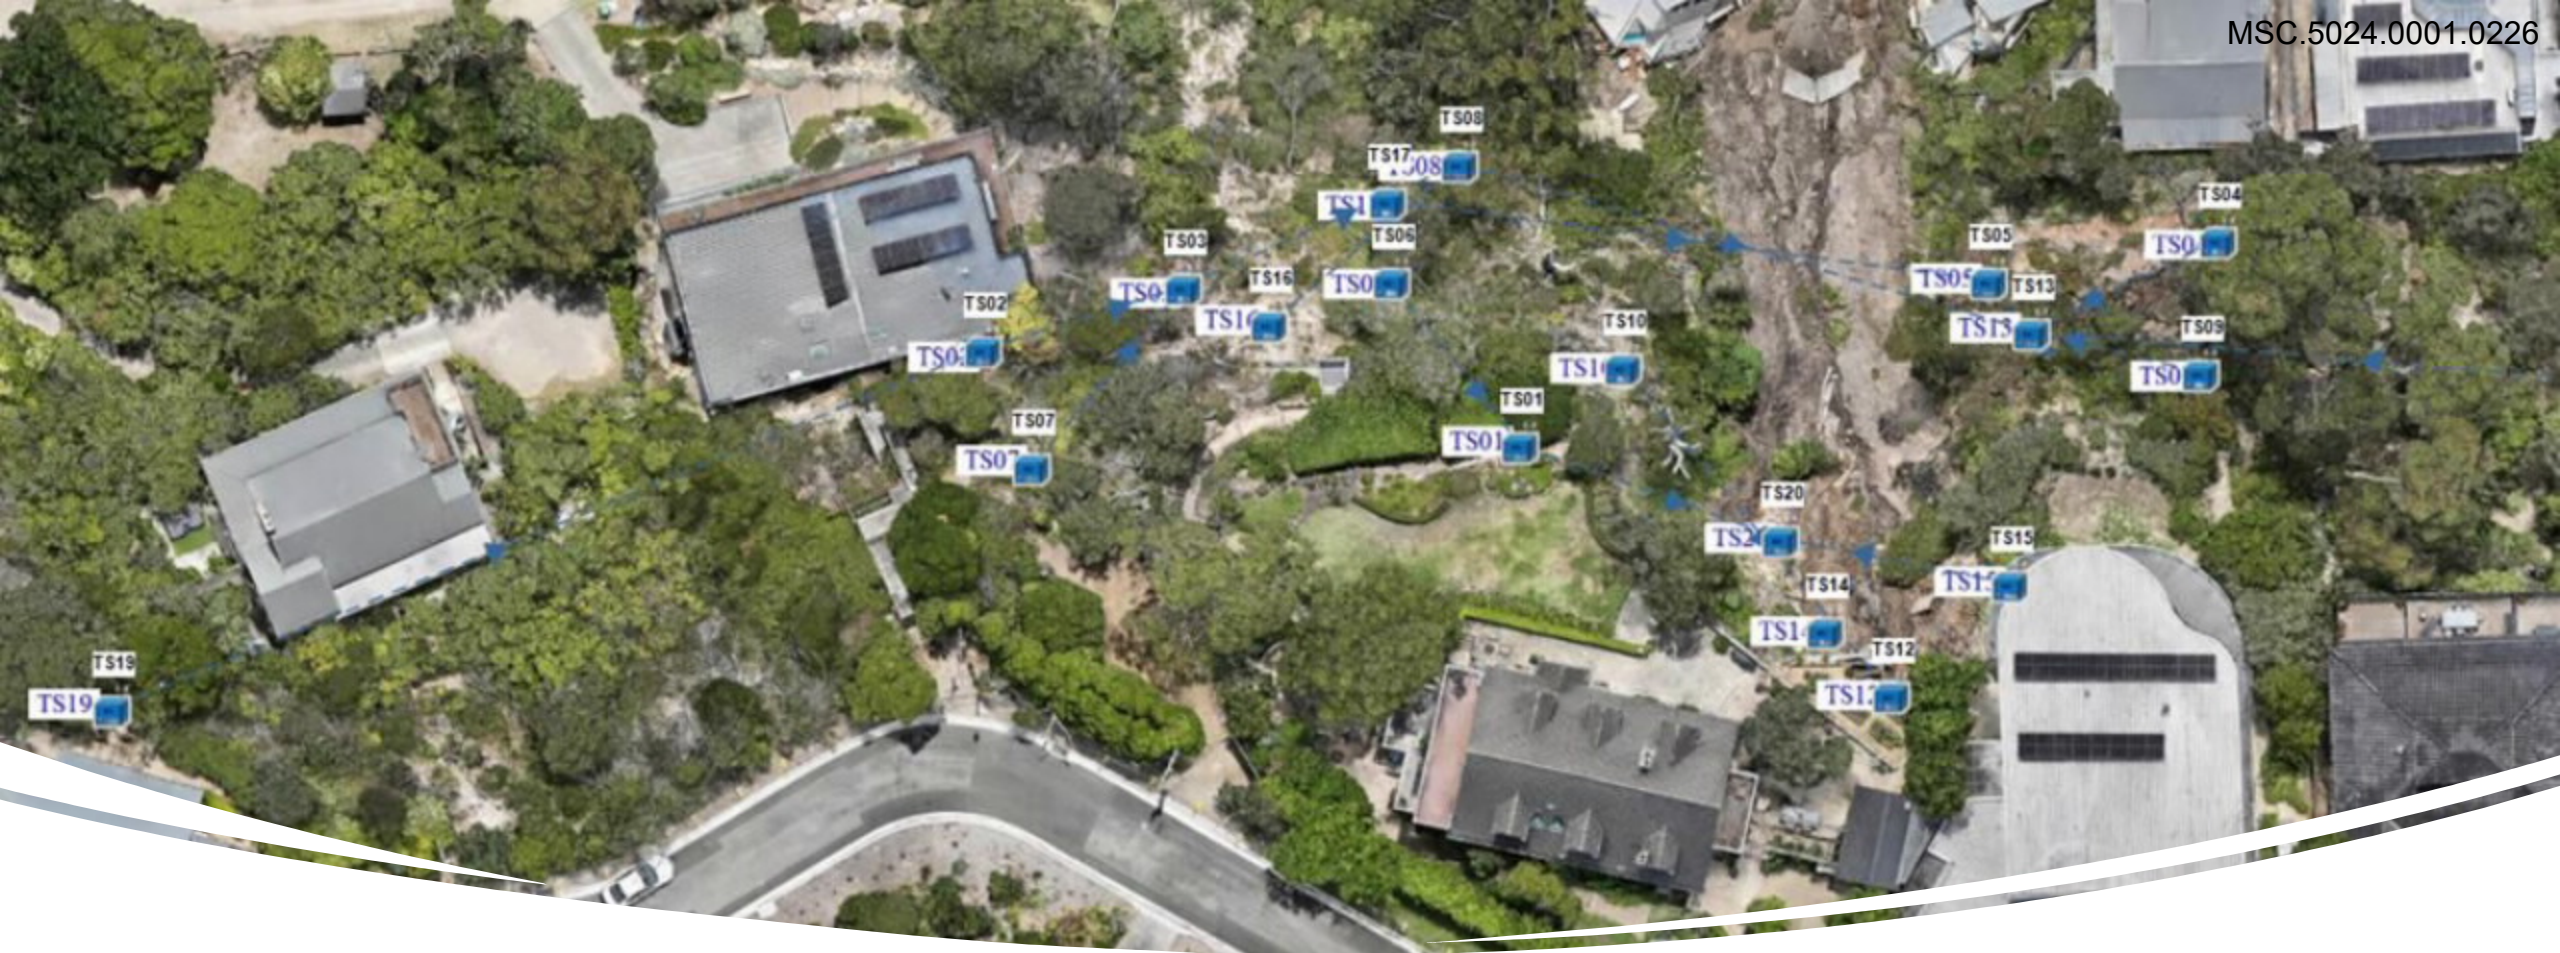
- Visual inspections indicate that localised erosion of the sand/gravel immediately around the retaining wall and headscarp is ongoing and expected to continue given the sandy nature of the surficial soils.
