# INITIAL INSPECTION REPORT

Application No: EO-147/22

Property Address: 3/613 Point Nepean Road MCCRAE VIC 3938

Date: 21/11/2022

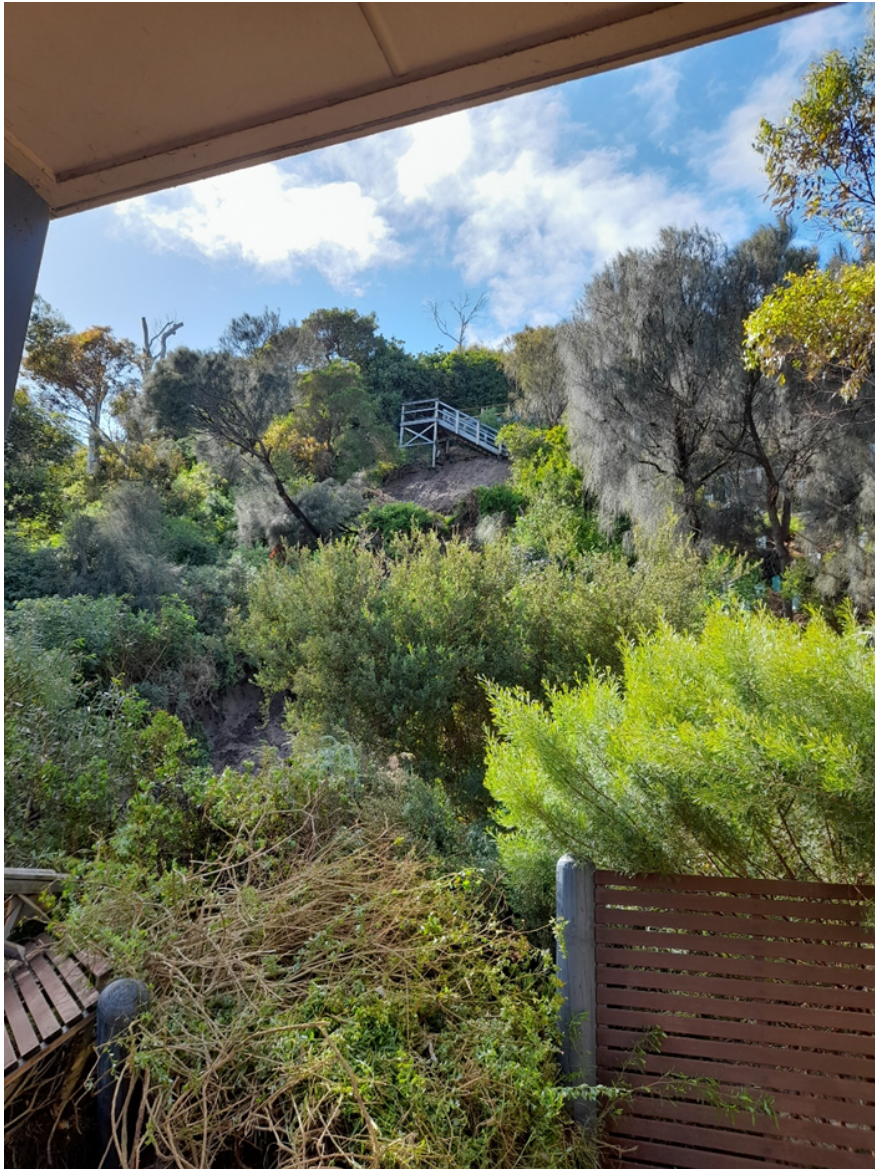
Photograph 2: The photo below is taken from the rear of 3/613 Point Nepean and 2 Penny Lane

There was built up soil against the rear external wall of the dwelling approx. 2 to 3 feet of soil in height at the time of inspection however as the unit is considered in the in line with the path of land slip it could be impacted if further land slip were to occur, A Geologist is expected to attend the land slip at 1:30pm today to survey land affected and to provide a report of the land slip impact.
