# INITIAL INSPECTION REPORT

Application No: EO-151/22

Property Address: 2 Penny Lane MCCRAE VIC 3938

Date: 21/11/2022

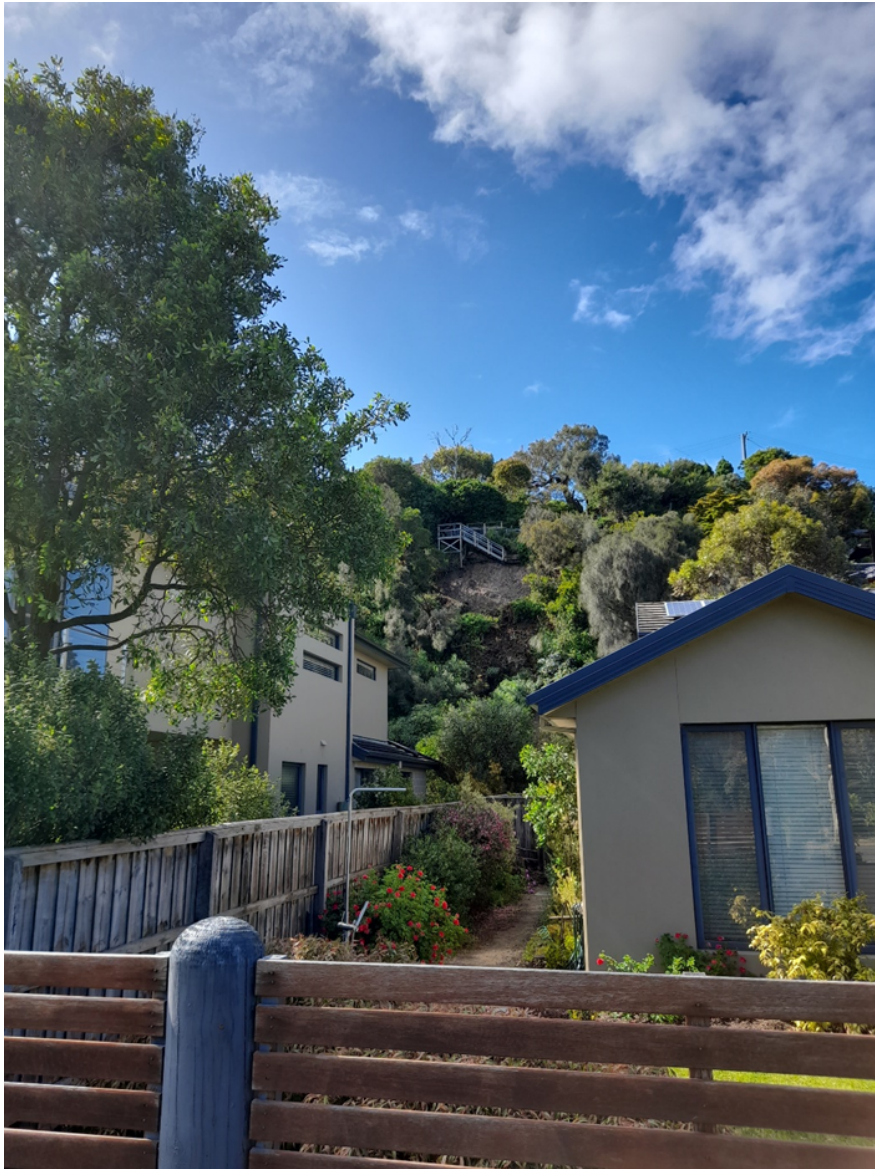
I observed from Point Nepean road perspective the land slip up at the top of the crest to a number of properties that face another road at the top of the embankment. Soil has collapsed from the top crest embankment and has slid approx. halfway down the embankment bring vegetation down with the displaced soil/rock. Some of the soil that has been further displaced and descended to the natural ground level at the bottom of the hill has become liquified due to a burst water hose saturating the soil whereby the soil has fallen into the backyards of 2 Penny Lane and 3/613 Point Nepean rd McCrae.

Photograph 1: The photo below is taken from the street Point Nepean Road, McCrae

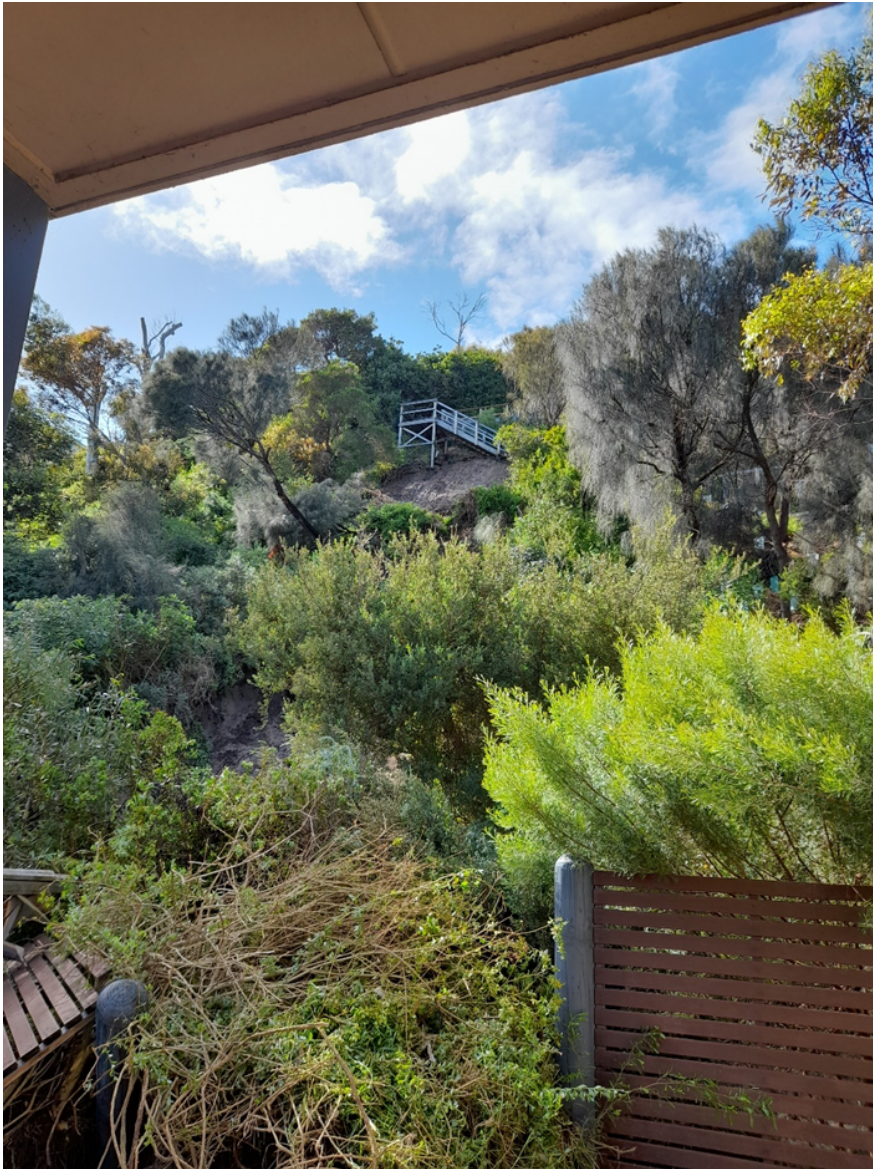
There did not appear to be any visual signs of damage/impact the subject dwelling however a rear fence appeared to have been damaged by soil displaced from the land slip and the soil was very close to the subject dwelling at the time of inspection however as the dwelling is considered in line with the path of land slip it could be impacted if further land slip were to occur, A Geologist is expected to attend the land slip at 1:30pm today to survey land affected and to provide a report of the land slip impact.

Photograph 2: The photo below is taken from the rear of 3/613 Point Nepean and 2 Penny Lane

As there was no one home during my inspection I left an Emergency Order at the front door of the dwelling which was later hand delivered to the owner Mr Wells by Ashley Hansen the Municipal Building Surveyor.
