# INITIAL INSPECTION REPORT

Application No: EO-147/22

Property Address: 3/613 Point Nepean Road MCCRAE VIC 3938

Date: 21/11/2022

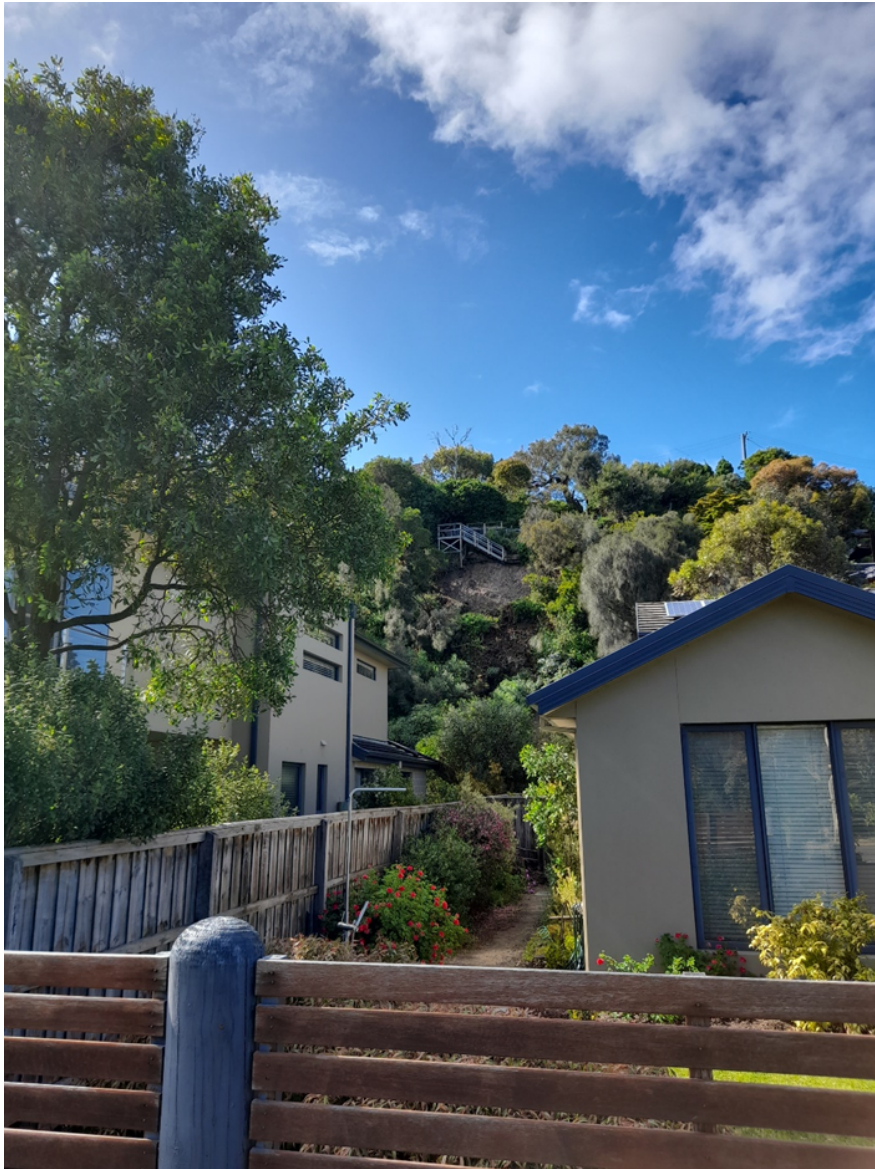
Photograph 1: The photo below is taken from the street Point Nepean Road, McCrae

I observed from Point Nepean road perspective the land slip up at the top of the crest to a number of properties that face another road at the top of the embankment. Soil has collapsed from the top crest embankment and has slid approx. halfway down the embankment bring vegetation down with the displaced soil/rock. Some of the soil that has been further displaced and descended to the natural ground level at the bottom of the hill has become liquified due to a burst water hose saturating the soil whereby the soil has fallen into the backyards of 2 Penny Lane and 3/613 Point Nepean rd McCrae.

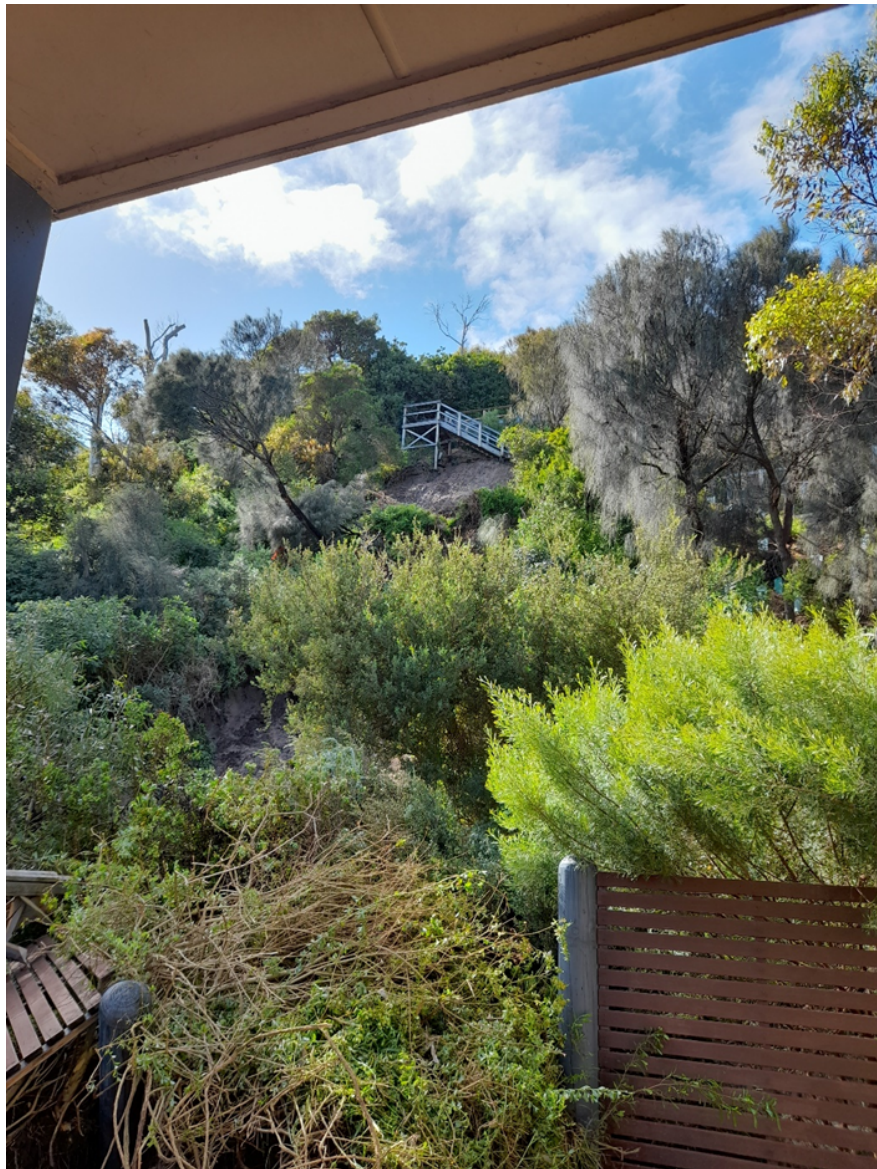
Photograph 2: The photo below is taken from the rear of 3/613 Point Nepean and 2 Penny Lane

There was built up soil against the rear external wall of the dwelling approx. 2 to 3 feet of soil in height at the time of inspection however as the unit is considered in the in line with the path of land slip it could be impacted if further land slip were to occur, A Geologist is expected to attend the land slip at 1:30pm today to survey land affected and to provide a report of the land slip impact.

As there was no one home during my inspection I left an Emergency Order at the front door of the dwelling.

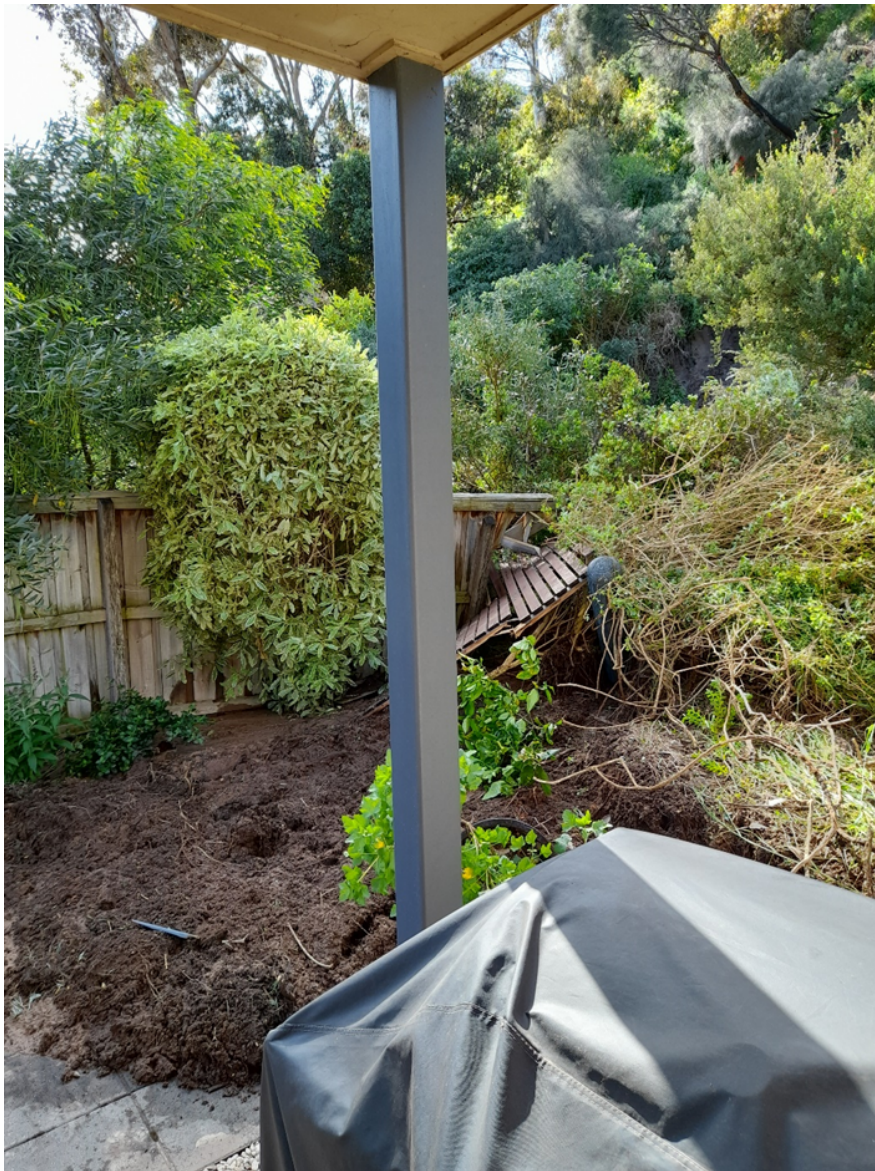
Photo taken of soil disbursement onto 2 Penny Lane rear yard with partial fence collapse.
