## RE: Report on road condition Coburn Avenue McCrae

Please see information below on road surface conditions at Coburn Avenue McCrae as requested.

## Coburn Ave McCrae

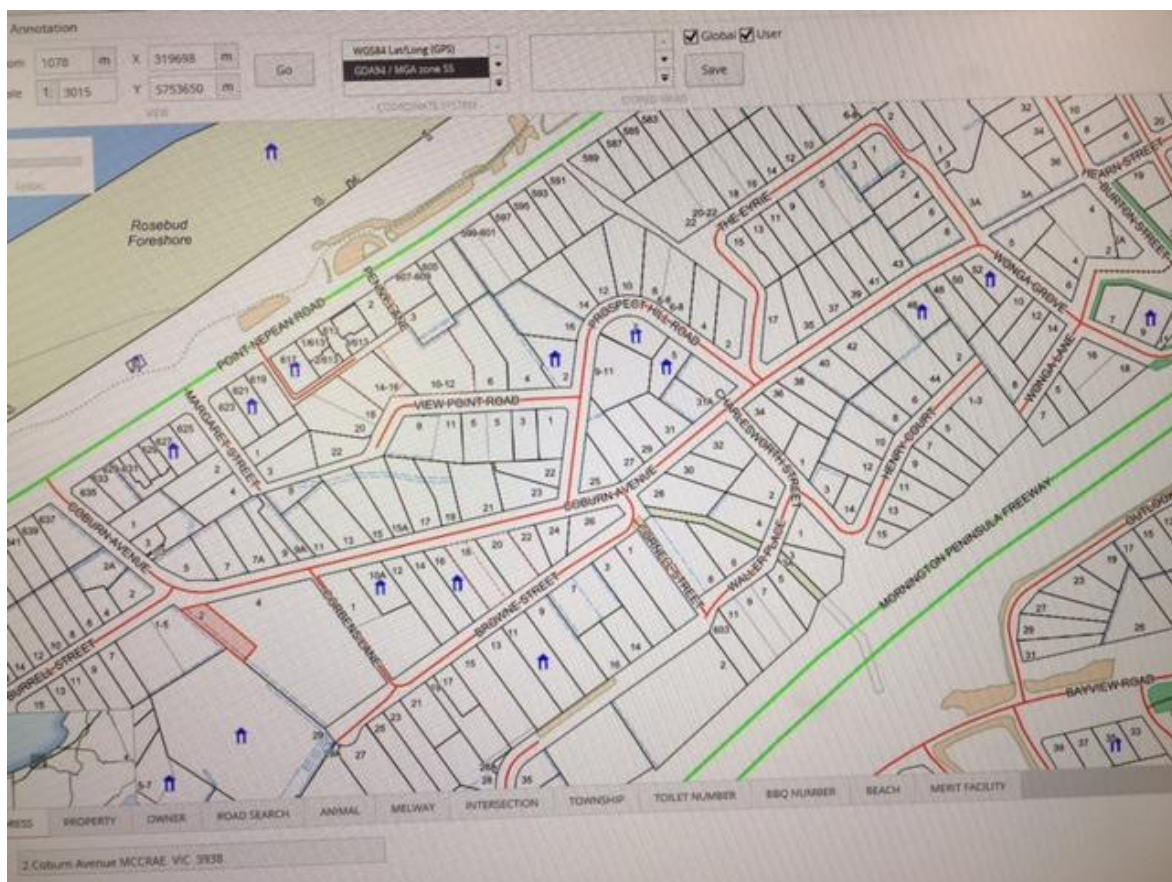
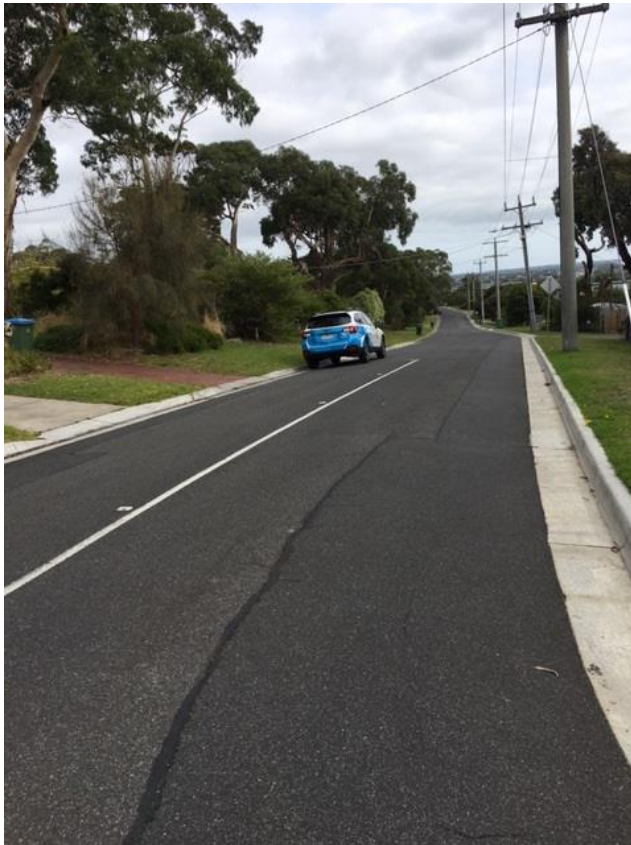
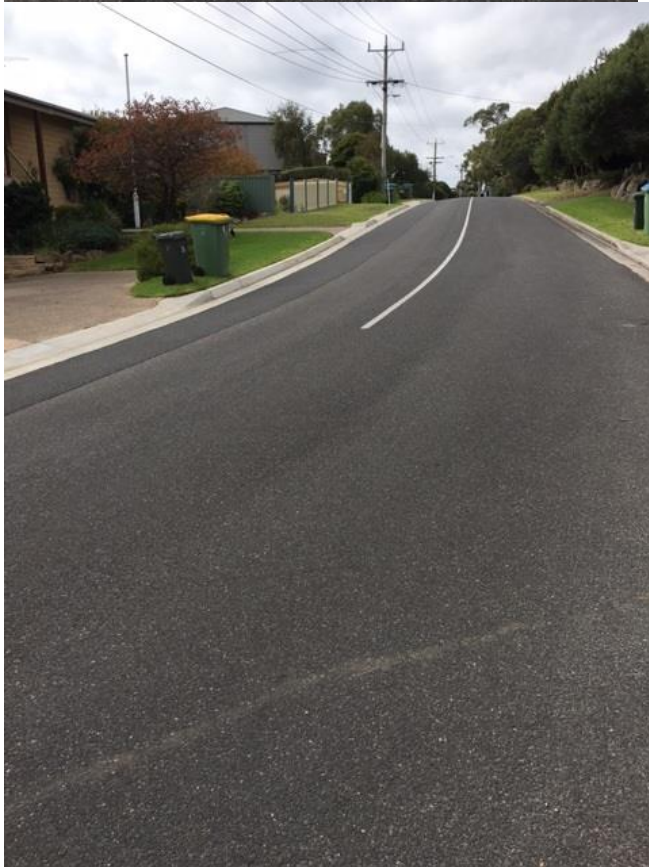
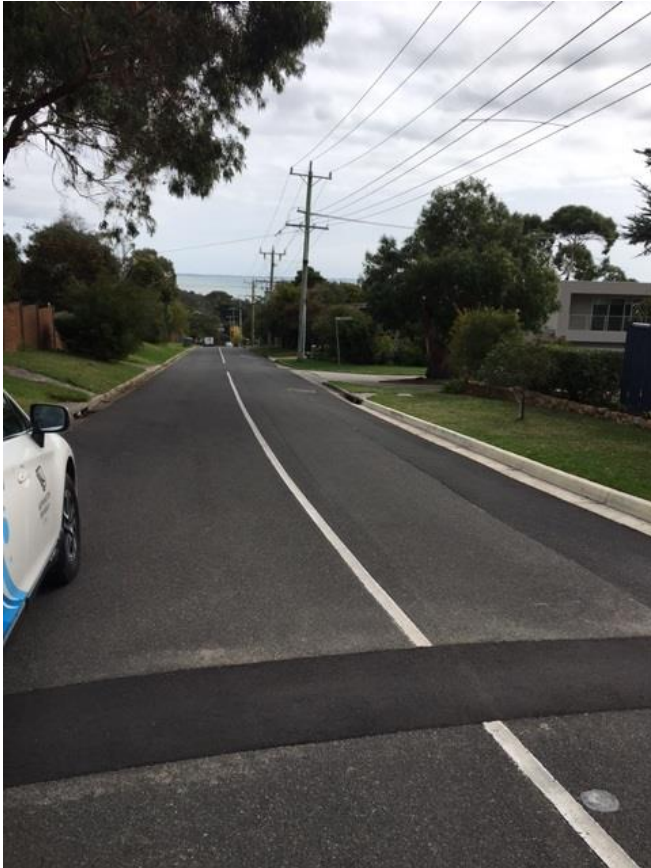
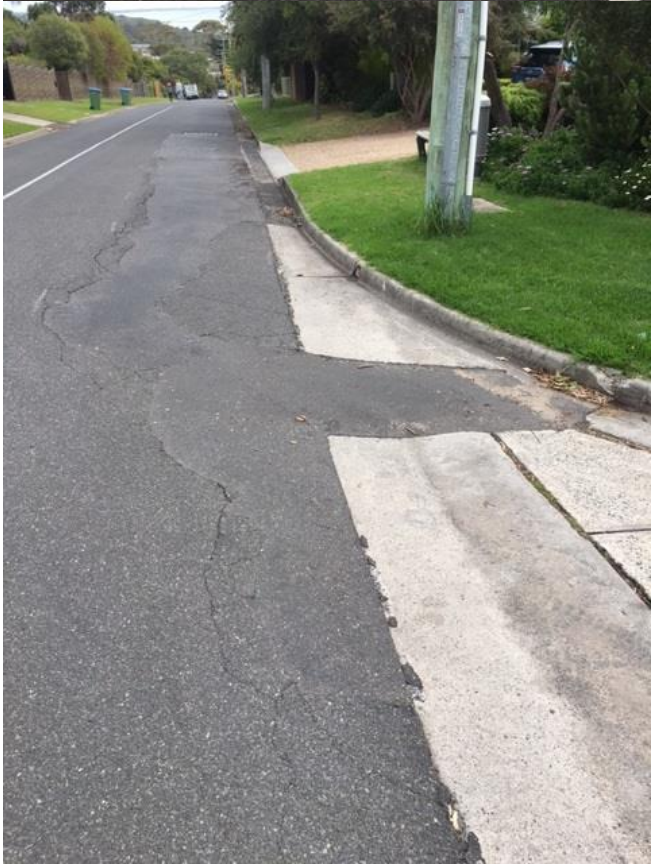
Photo 1 Photo 2 Photo 3 Photo 4 & 5

Looking from Wonga Grove into Coburn Road in good condition, Looking from Browne Street in Coburn back towards Wonga, Looking from Browne Street in Coburn downhill towards In front of 23 Coburn, slightly rough and undulating area needing attention. Looks like an old service trench no signs of stress. generally good condition number 23, generally good condition with some minor repairs needed at number 23

- \* Photo 4&5 23 Coburn Ave, looks to be marked up for work? SEW or DMR
- \* Photo 11 Coburn Ave, Pt Nepean to Burrell, west side, are works planned?

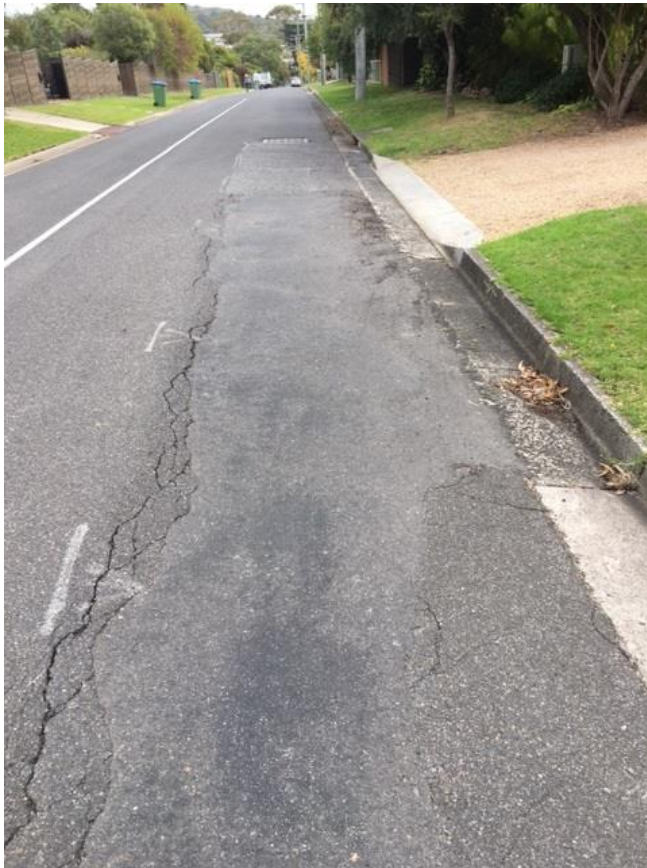
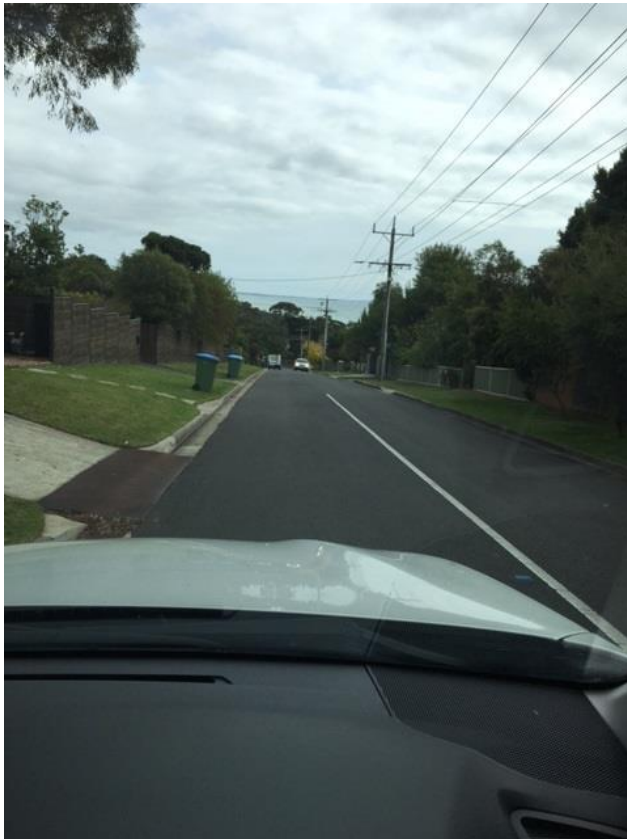
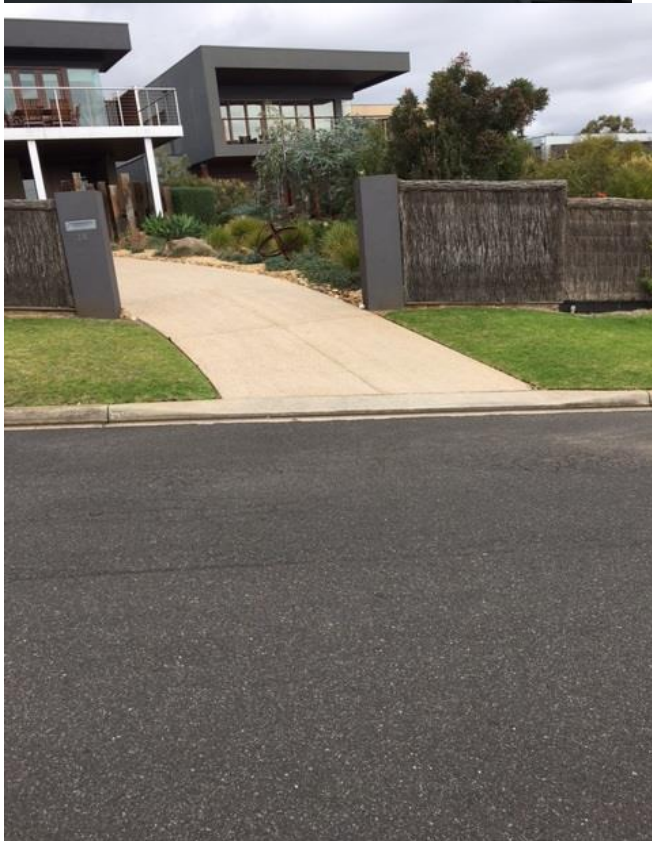
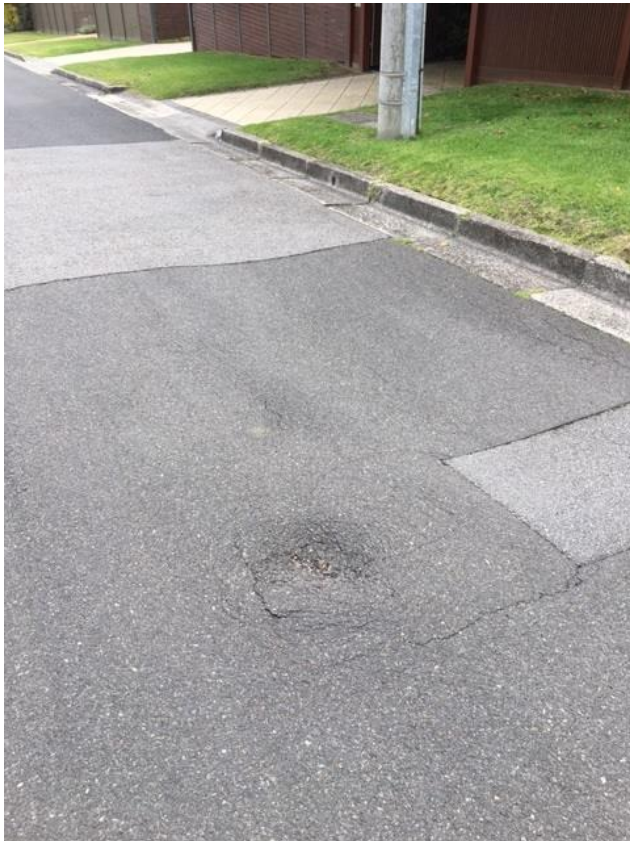
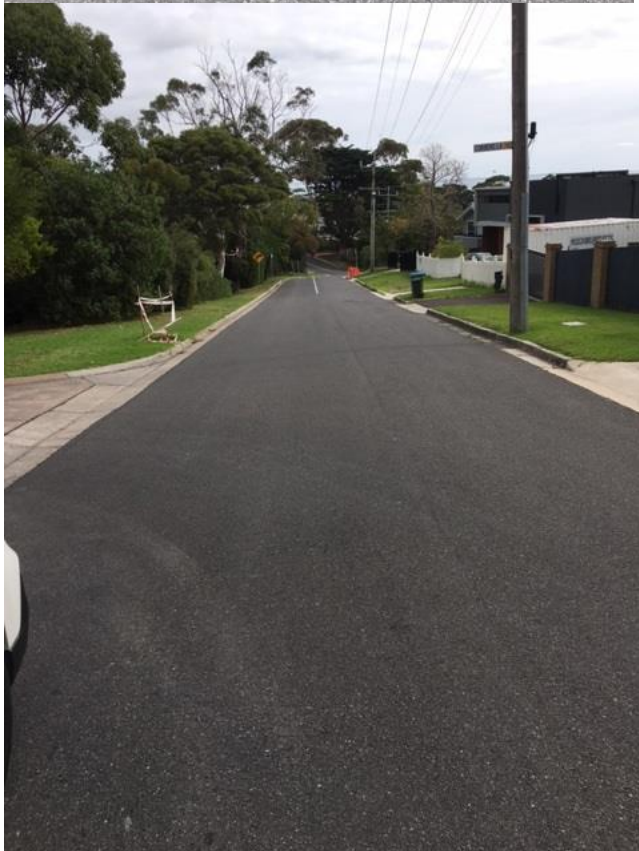
Photo 6 Photo 7 Photo 8 Photo 9 Photo 10

Looking down the hill in Coburn towards Burrell Street. Number 16 Coburn, some surface cracking and minor Number 15A, minor subsidence developing near old Looking downhill from Cobens Lane towards Number 9 Coburn, large area of surface cracking and old Road in good condition undulation. Service cut. Burrell Street pothole repair

The inspection team picked up multiple pothole defects which have all since been repaired.

TASK ID: 11381.0593 3x potholes On Coburn Ave , 50m in from Pt Nep Rd .(Completed 27.02.23)

TASK ID: 5314.0595 2x potholes 30m in from Pt Nep Rd (Completed 25.02.23)

TASK ID: 11382.0593 1x pothole outside #9 (Completed 27.02.23)

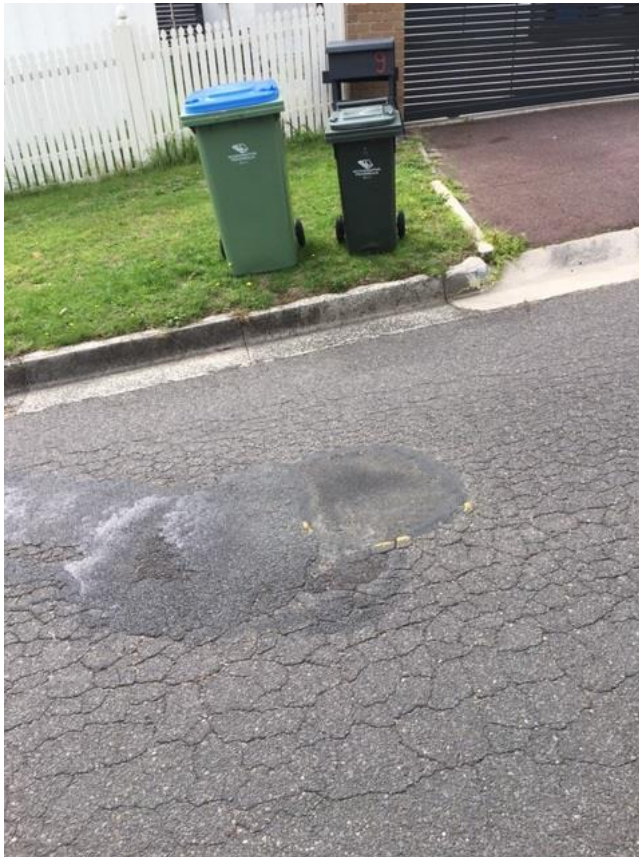
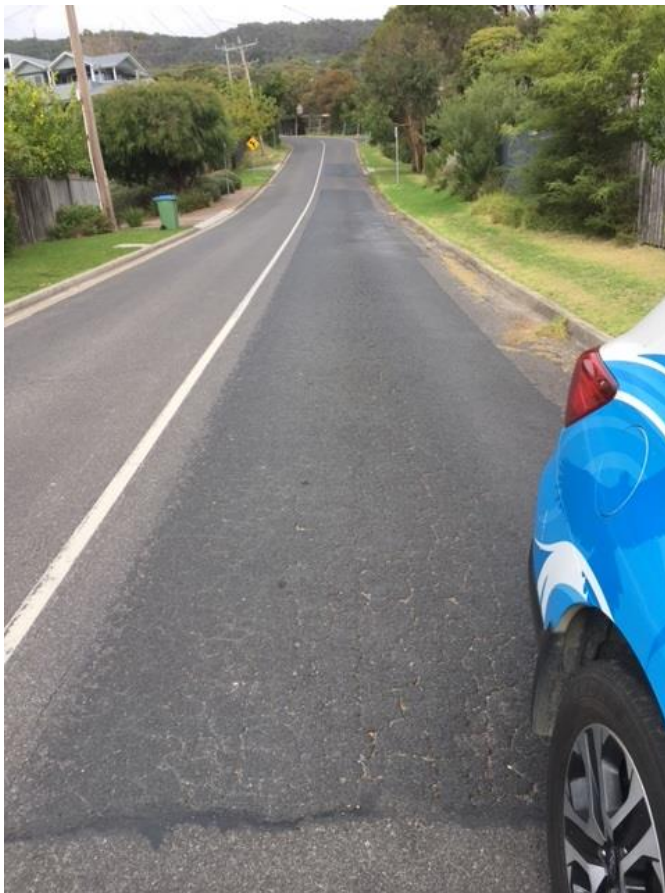
Photo 11 **Generally looking at Coburn Avenue I believe the road surface is in relatively good condition except for the few areas identified in the attached photos.**

Looking at Coburn from Point Nepean Road uphill towards Burrell Street there is a large patch of While there is some surface cracking and some minor undulation in several areas, if residents consider this road is an example of poor condition, they must have very good roads around this area, or they expect very high standards. cracking and signs of subsurface material starting to pump through the pavement surface. This area needs attention. **See Courtney from DM Roads comments on maintenance at that location below.**

**I spoke about this site with Courtney form DM Roads and her comments are below.**
